FIELD INSPECTION REPORT

Date: July 19, 2007
Site Name: Mineral Springs Works
Site Number: V00195
Location: West Seneca (T), Erie County
Project Engineer: David Szymanski, NYSDEC - Buffalo
Contractor: Charles Burke - NFG overseeing Nature's Way Environmental.

Purpose of Inspection: Site inspection for direct-push soil borings; Stream bank excavation.

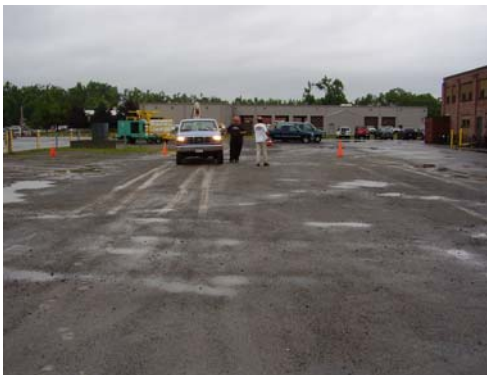
< Area of boring grid.

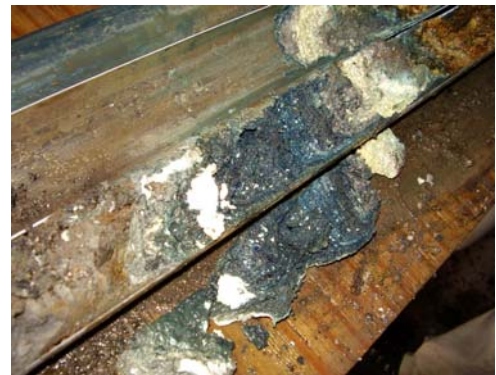
- 0930 - 1100 Hours, on Site.
- Nature's Way performing direct-push soil borings in a gridded area southwest of Building #8 where blue discoloration has been observed recently.
- A layer of blue-colored fill from <1" to ~ 4" thick seen in most opened cores, at about 1- 2' depth.

Blue-colored fill. >

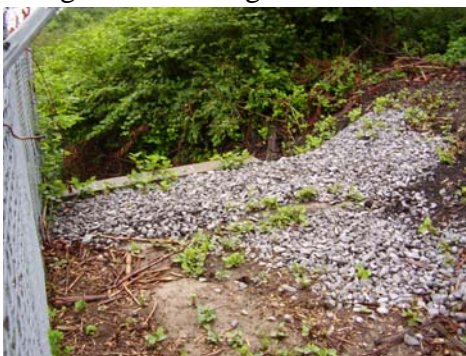
< Repaired drainage pipe inlet.

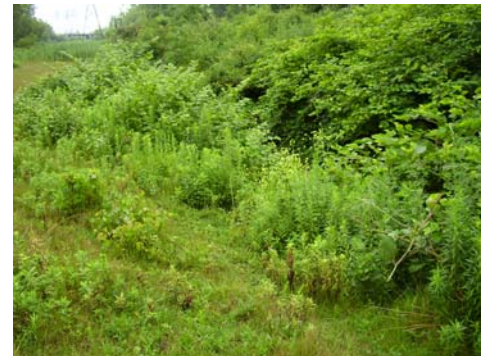
- Samples from the cores were bagged and checked for headspace readings with a PID. Two southmost cores in grid had a layer >500ppm on PID. These were placed into 4-oz. Jars in a cooler if NFG determines a need to analyze.
- Nature's Way to decommission out of service wells south of Building #8 and repair broken well cover on Calais Street after soil probe work.
- No Utility stakeouts completed along southern fence near proposed stream bank work,. Nature's Way to contact UFPO and have them coordinate with C. Burke.
- Area along stream bank where blue-stained soil appeared during recent drainage pipe work is overgrown with vegetation. Nature's Way to perform excavation next week.

Overgrown stream bank. >
