New York Department of Environmental Conservation  
Division of Environmental Remediation  
Region 9 Office-Buffalo

**FIELD INSPECTION REPORT**

**Date:** July 20, 2007  
**Site Name:** Mineral Springs Works  
**Site Number:** V00195  
**Location:** West Seneca (T), Erie County  
**Project Engineer:** David Szymanski, NYSDEC - Buffalo  
**Contractor:** Nature's Way Environmental (for NFG).

**Purpose of Inspection:** Site inspection for direct-push soil borings; Stream bank excavation.

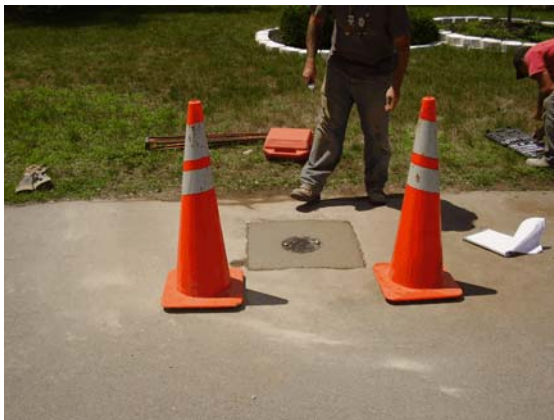
< MW-21

- 1330 -1400 Hours, on Site.
- Nature's Way drill rig on Calais Street. MW-21 has been repaired. Elevation of well set with survey level.
- MW-20 has broken concrete collar, but looks to still be usable. Noted by Nature's Way for NFG's information.
- Soil borings southwest of Building #8 completed yesterday. Await decision from NFG on course of action.
- No excavation work at stream bank yet.
