**FIELD INSPECTION REPORT**

**Date:** August 1, 2007  
**Site Name:** Mineral Springs Works  
**Site Number:** V00195  
**Location:** West Seneca (T), Erie County  
**Project Engineer:** David Szymanski, NYSDEC - Buffalo  
**Contractor:** Charles Burke - NFG overseeing Nature's Way Environmental.

**Purpose of Inspection:** Site inspection for Stream bank excavation.

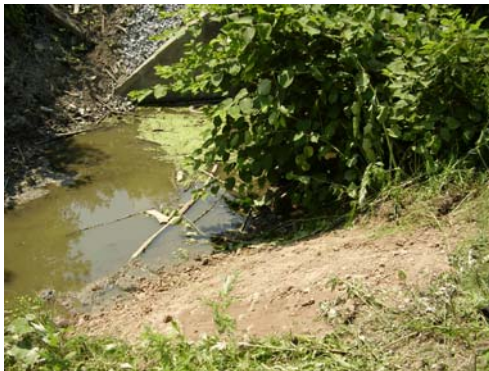
- 1330 - 1415 Hours, on Site.
- Nature's Way has excavated an area along the southern stream bank where blue MGP waste was observed recently. Material was excavated until no material was observed in cut area.
- Approximately 2 Cubic Yards of soil and waste was excavated and is staged on bermed poly and covered awaiting off-site disposal.
- Area of excavation will be repaired with clay, a layer of geotextile, and finished with rip-rap stone.

< Excavated Area.

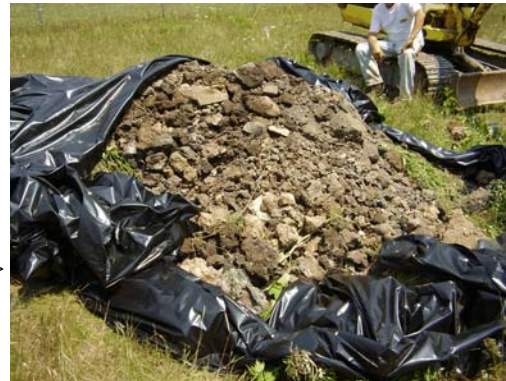
Staged Material. >

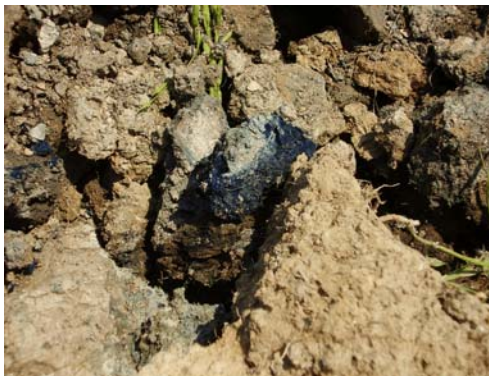
< Waste Material

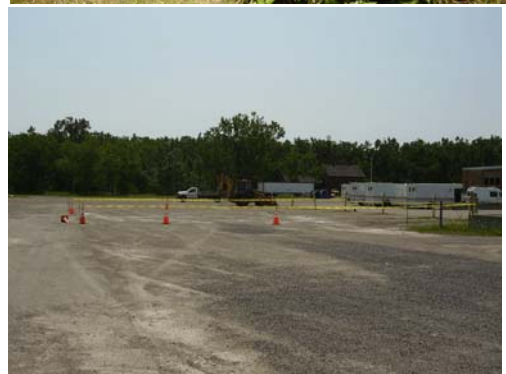
Borings Area. >

- Area where direct-push soil borings were taken has been taped off and cones set up to restrict traffic. No proposal has been made by NFG regarding further work in this area. C. Burke is working on cost numbers for NFG.
