David Szymanski - Fencepost Installation Summary

Re: Summary of Materials Encountered
Mineral Springs Fence Replacement

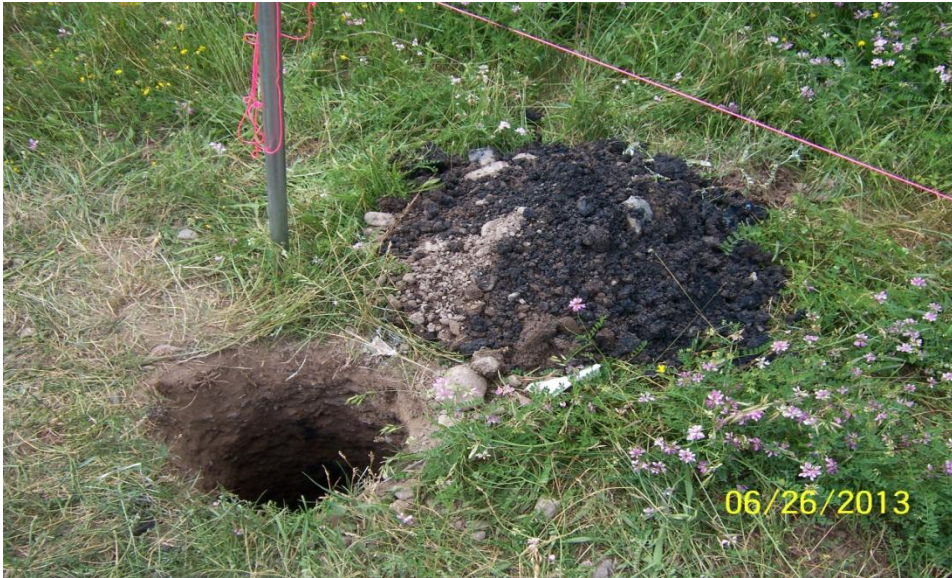
Photo 001: Suspect purifier box waste

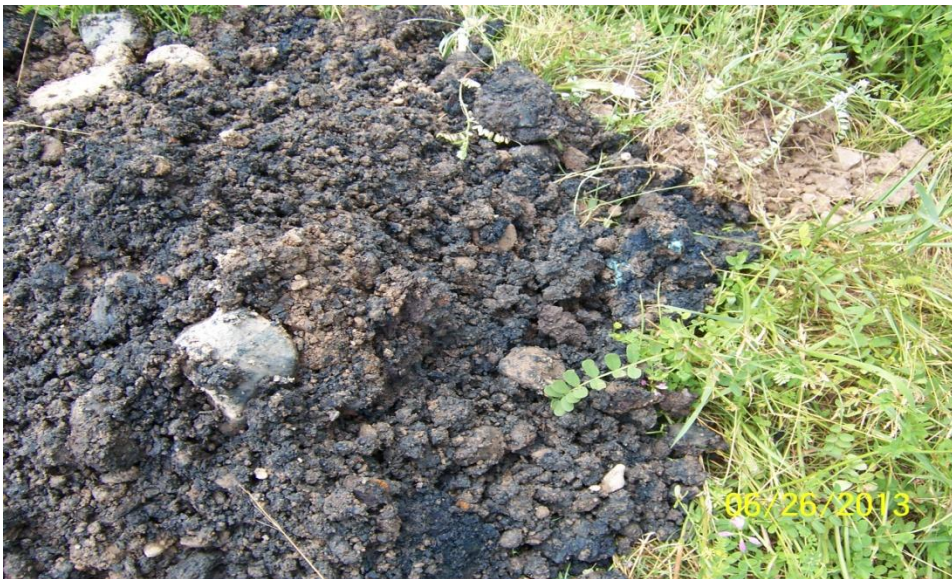
Photo 002: Suspect purifier box waste

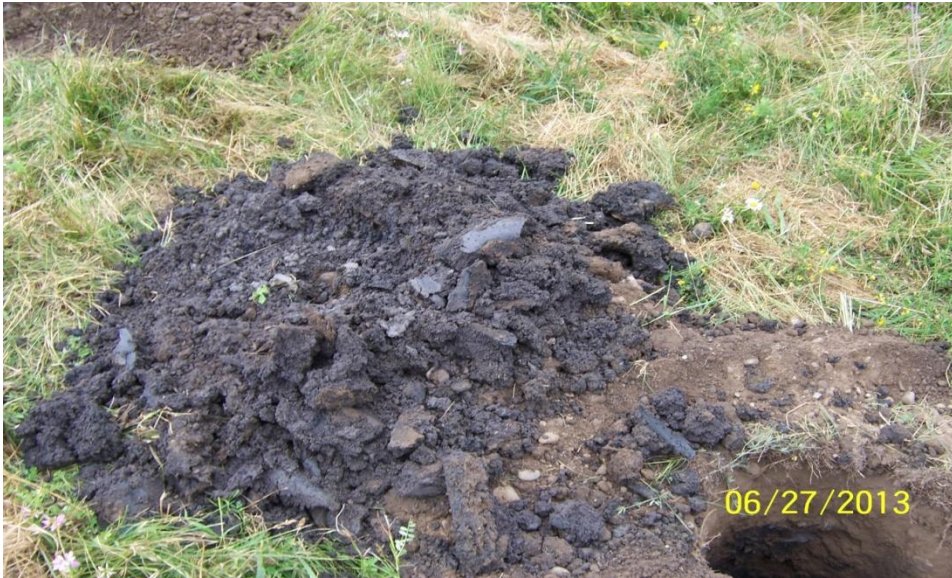
Photo 003: Suspect purifier box waste

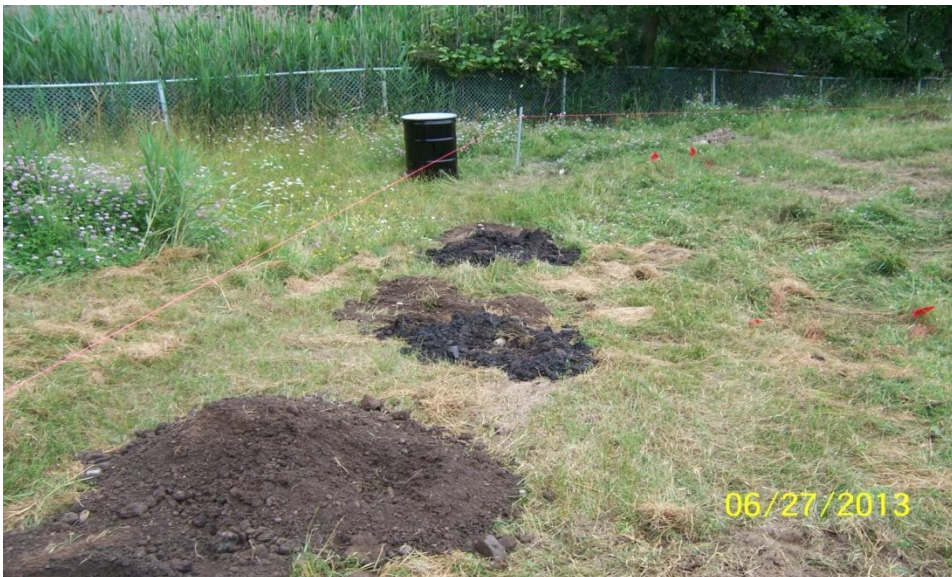
Photo 004: View facing west-northwest of new fencepost holes with suspect purifier box waste.
