July 3, 2013

Re: Summary of Materials Encountered  
Mineral Springs Fence Replacement

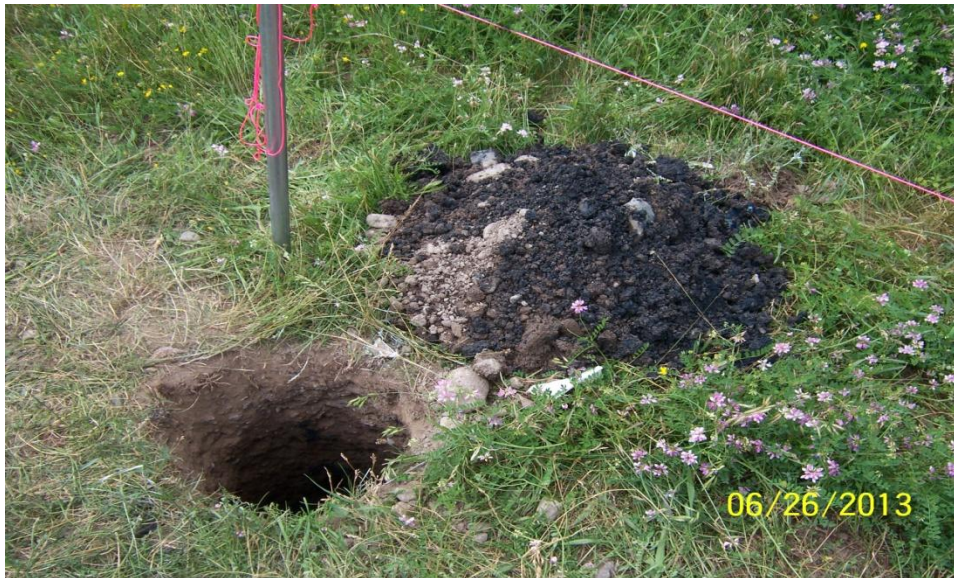
Photo 001: Suspect purifier box waste

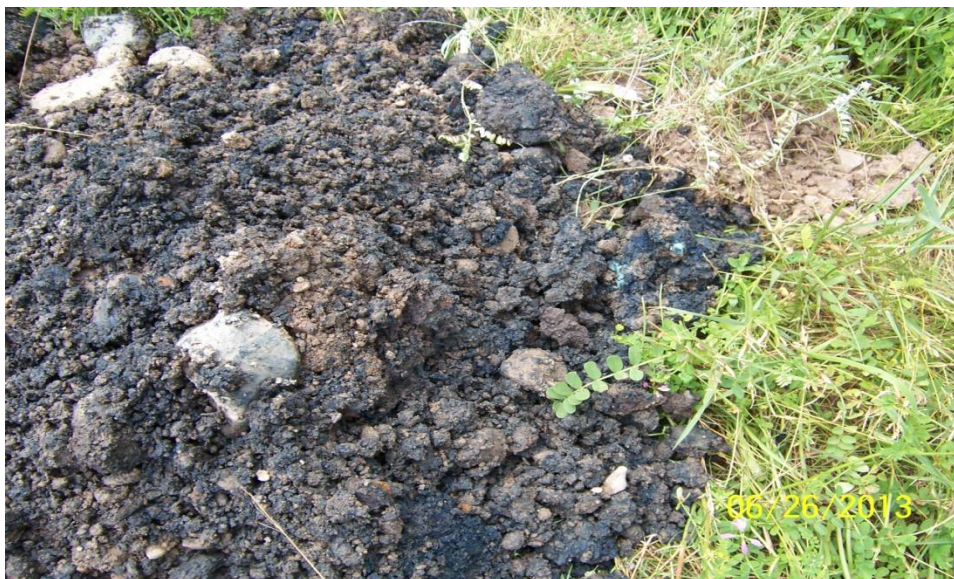
Photo 002: Suspect purifier box waste

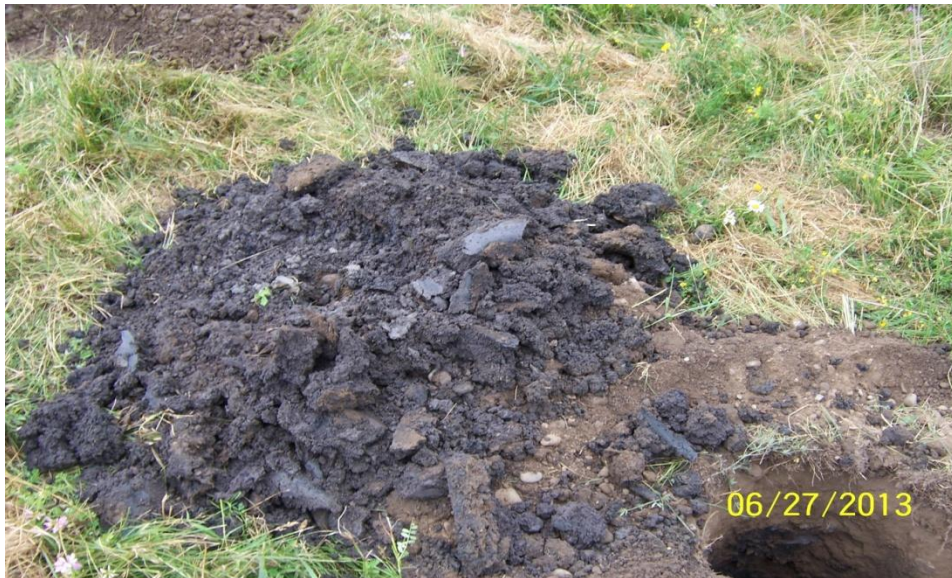
Photo 003: Suspect purifier box waste

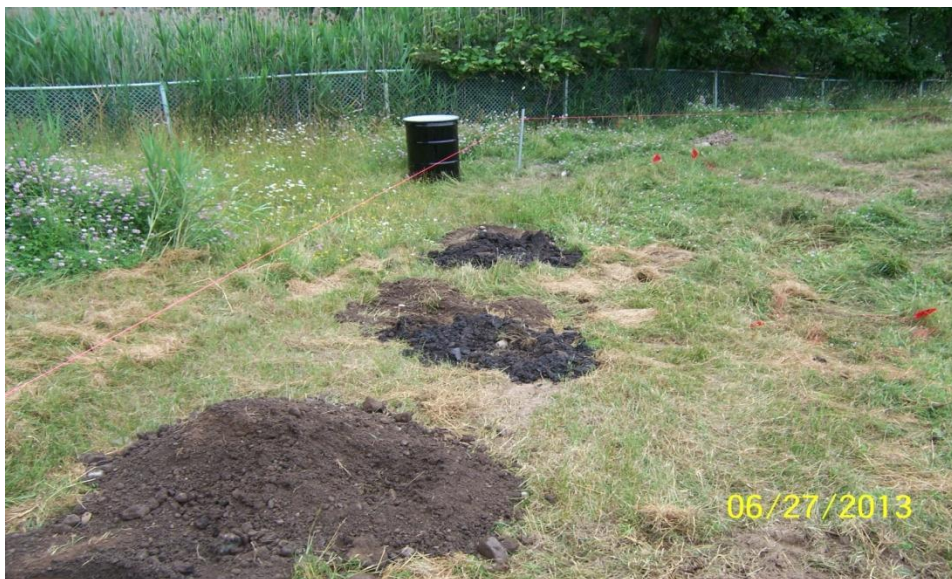
Photo 004: View facing west-northwest of new fencepost holes with suspect purifier box waste.
