AECOM
257 West Genesee Street
Suite 400
Buffalo, NY 14202

November 6, 2017

**RE: 2017 Periodic Review Report
Mineral Springs Road Former Manufactured Gas Plant Site
NYSDEC Site #V00195**

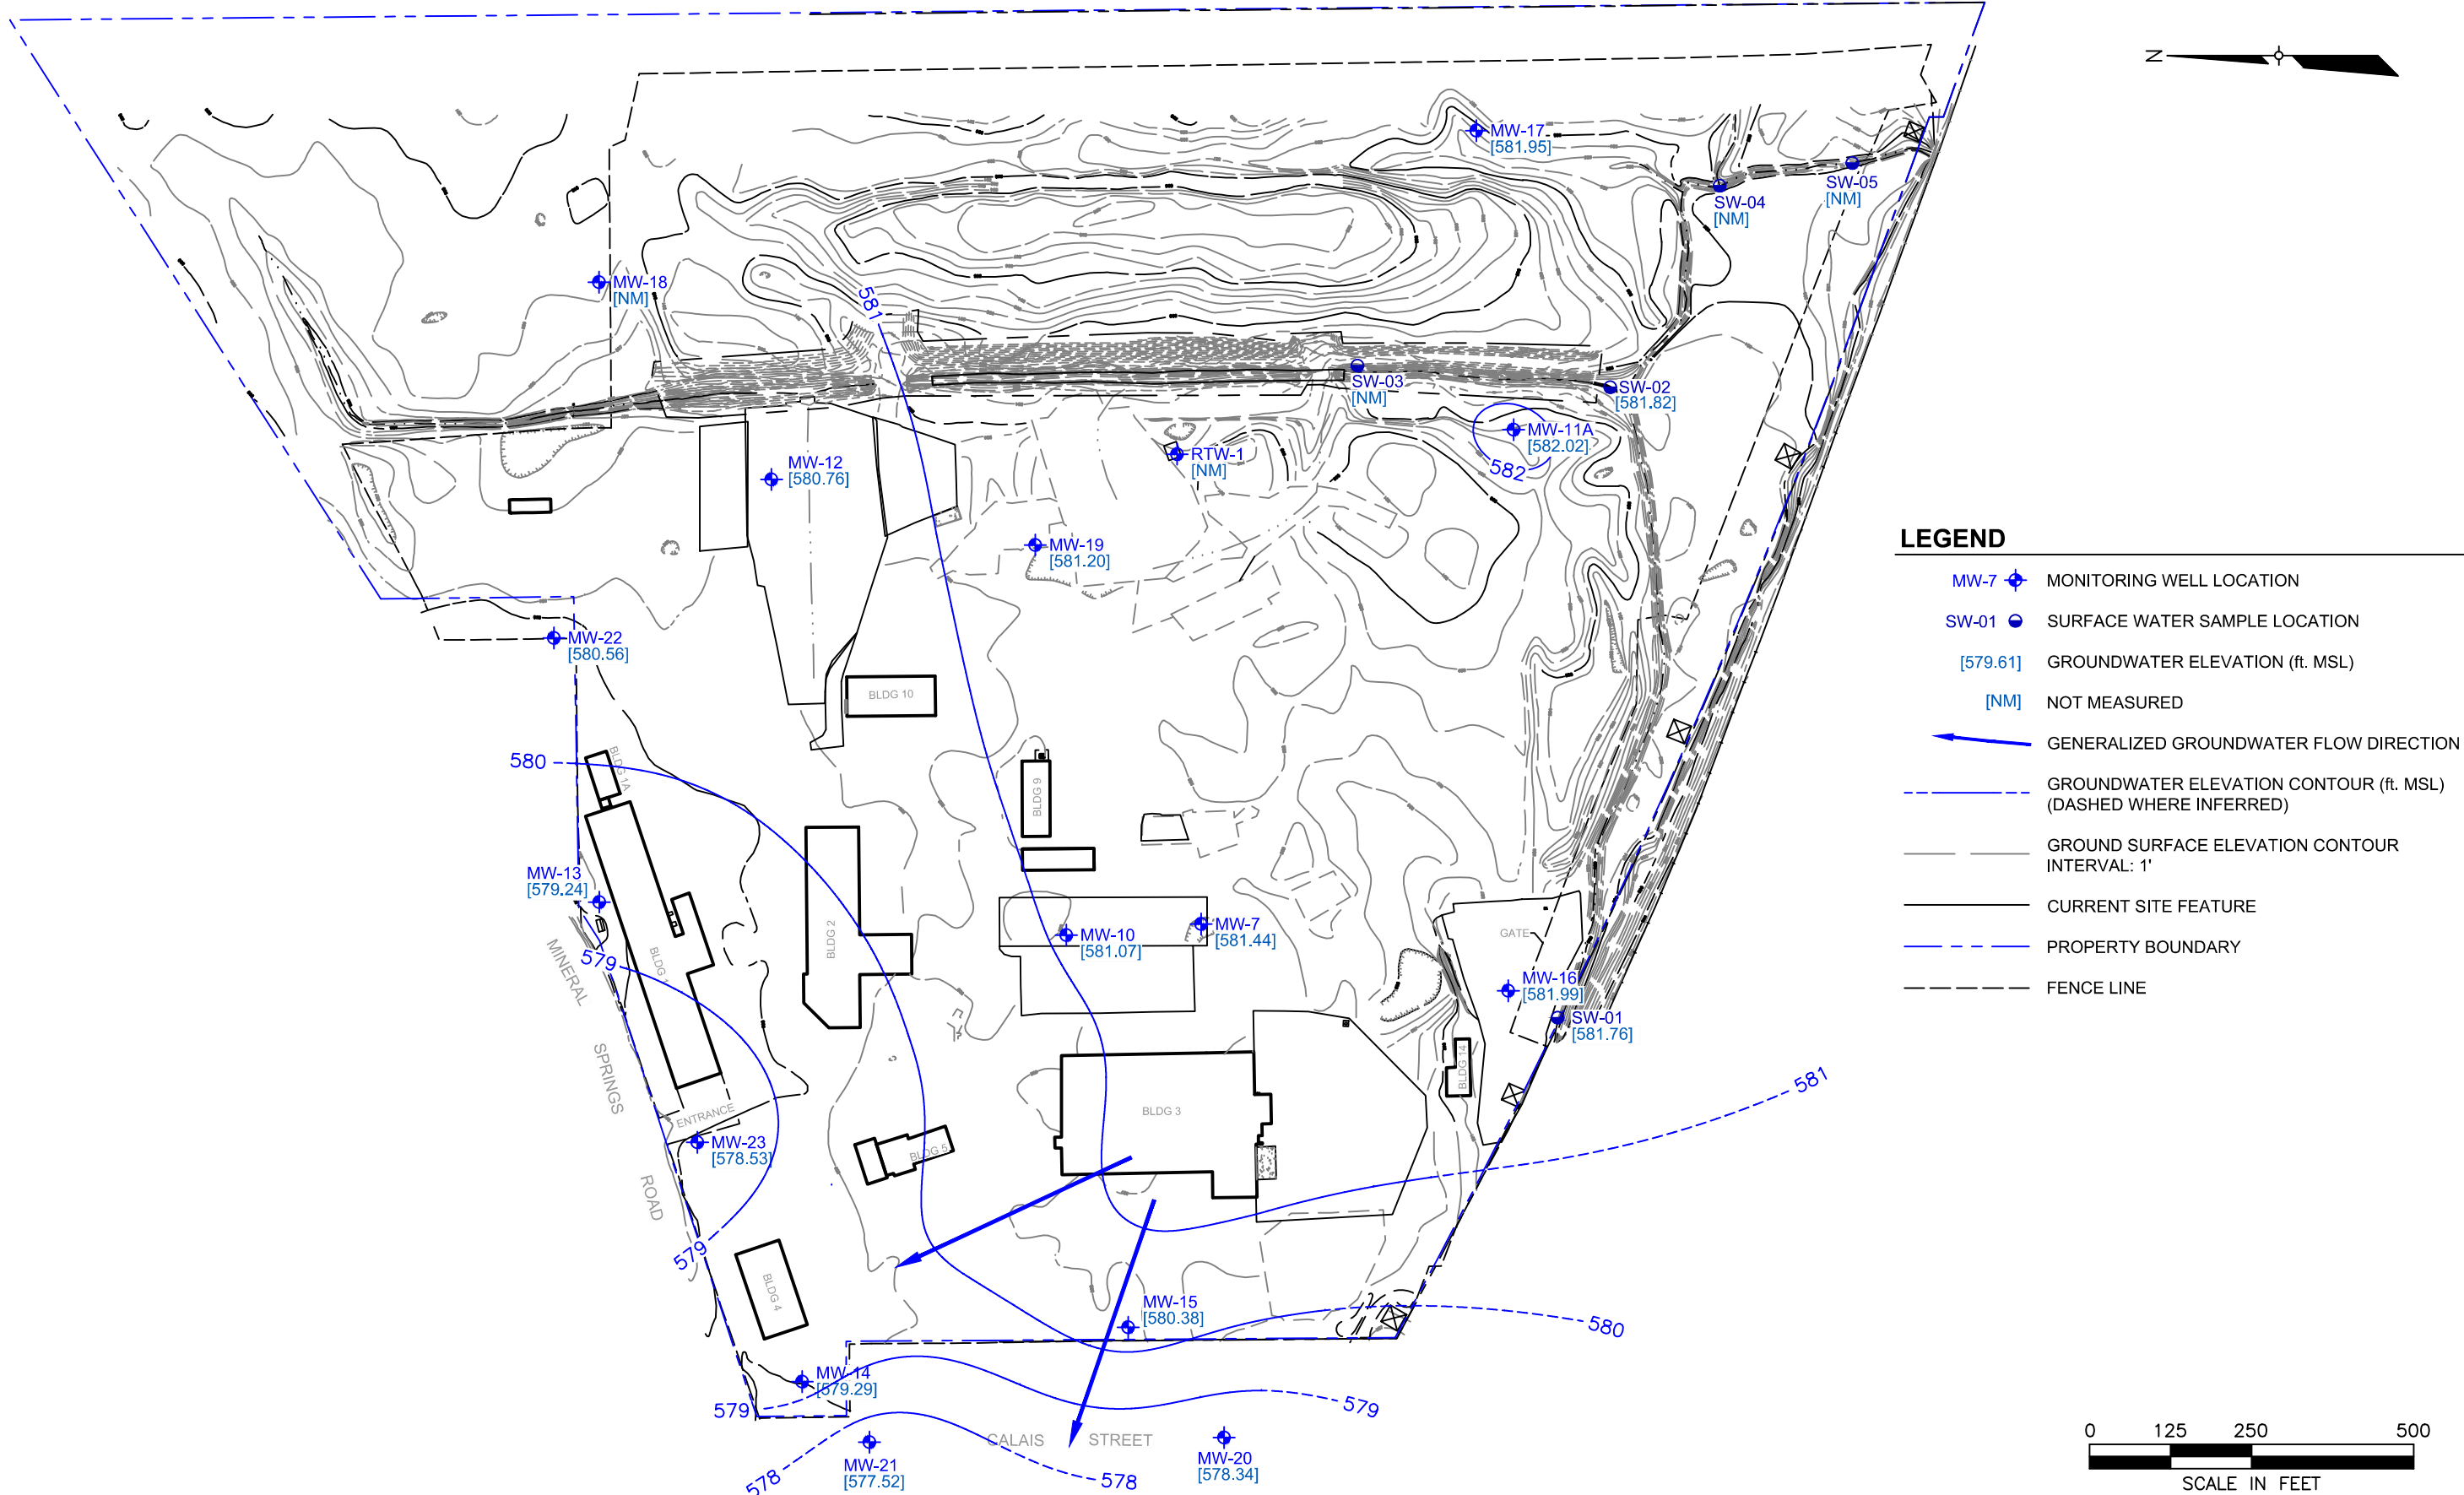
NATIONAL FUEL GAS MINERAL SPRINGS ROAD MGP SITE 60538249-100			GROUNDWATER ELEVATION CONTOURS AUGUST 2017	
DATE: 08/09/2017	DRWN: HAP		FIGURE 3

- The groundwater elevation at monitoring well MW-11A was observed to be higher than the surface water elevation at location SW-02. Data collected show that there is a potential that a small, local groundwater mound may exist in the vicinity of monitoring well MW-11A (Figure 3).

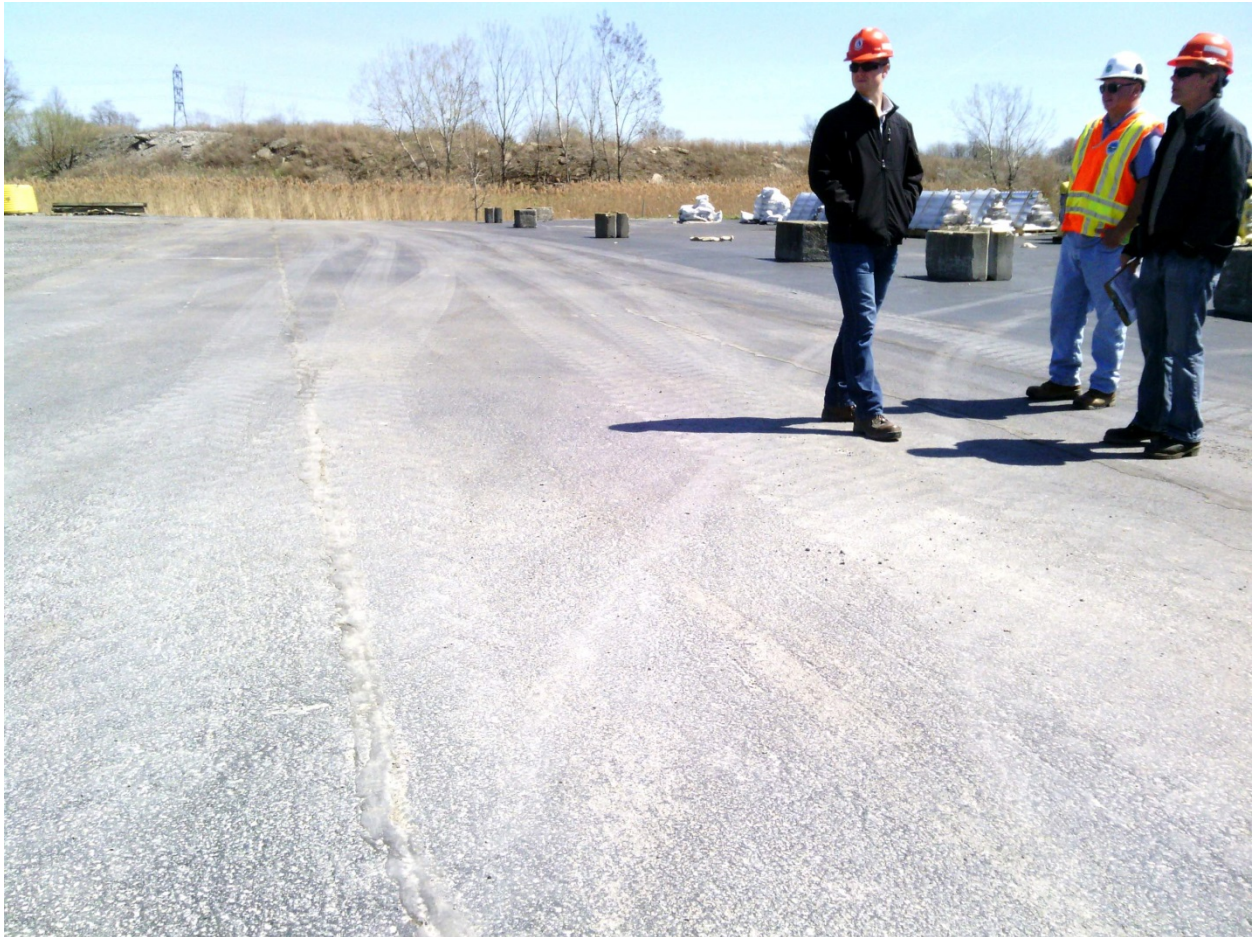
Looking east at Eastern Swale North Asphalt Cap (ESNAC), in good condition.

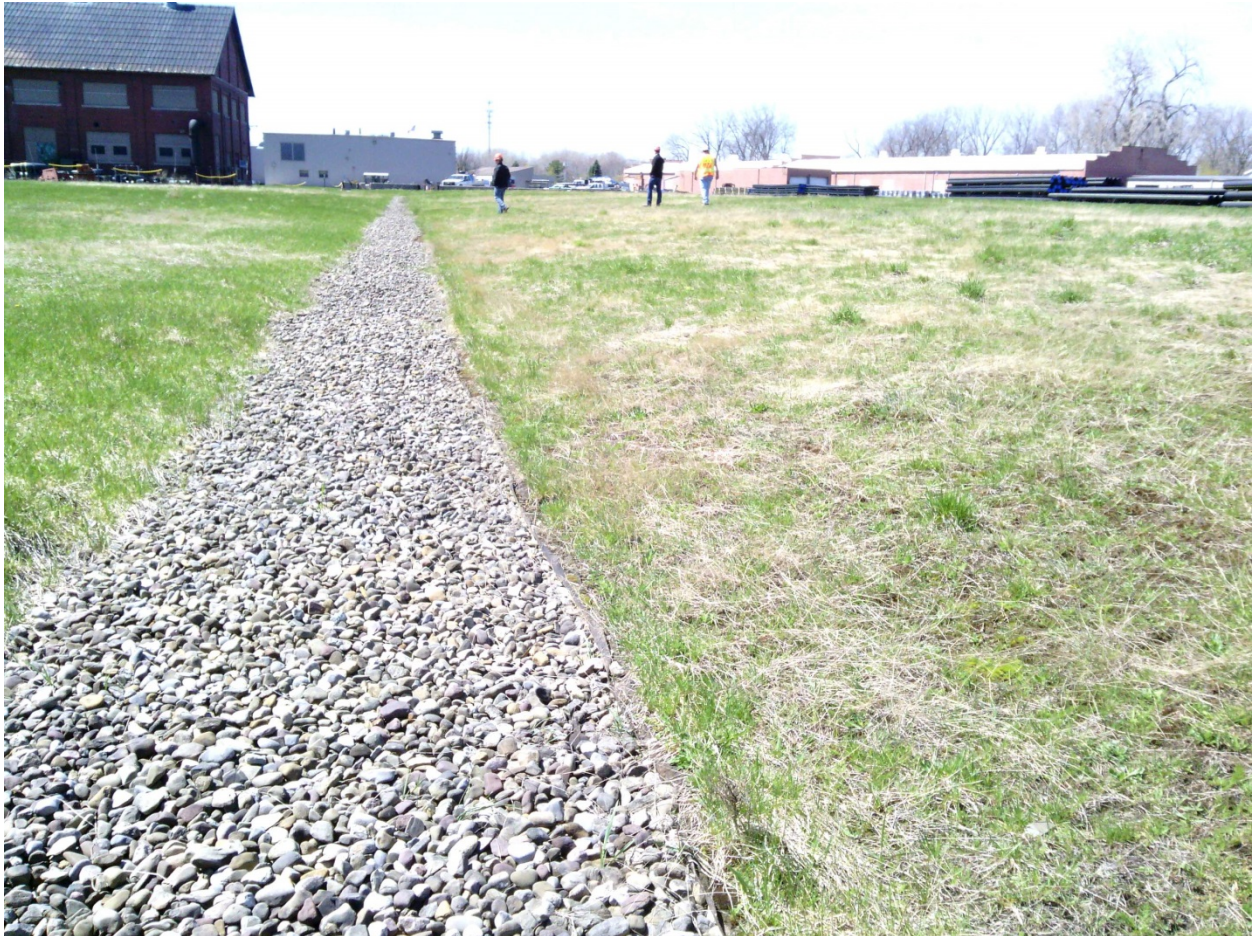
Looking west at French drain in Eastern Swale HDPE Cap (ESHC), in good condition.

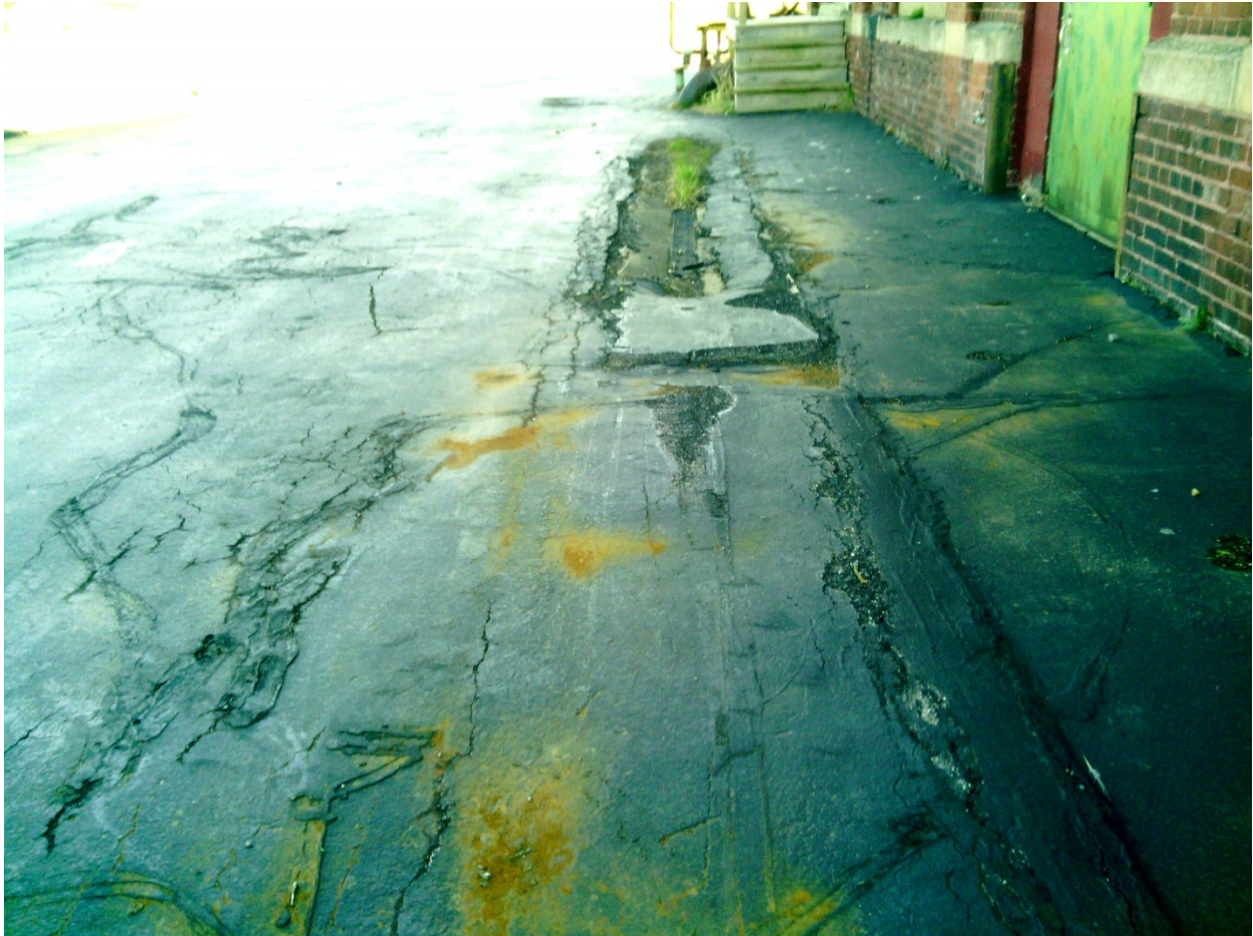
One small area of significant cracking was observed in the B10AC and some areas of significant cracking were observed in the B3SAC. These areas have since been repaired and sealed since the inspection.

Look east at portion of the Building 10 Asphalt Cap (B10AC) observed with significant cracking that requires patching or repaving.

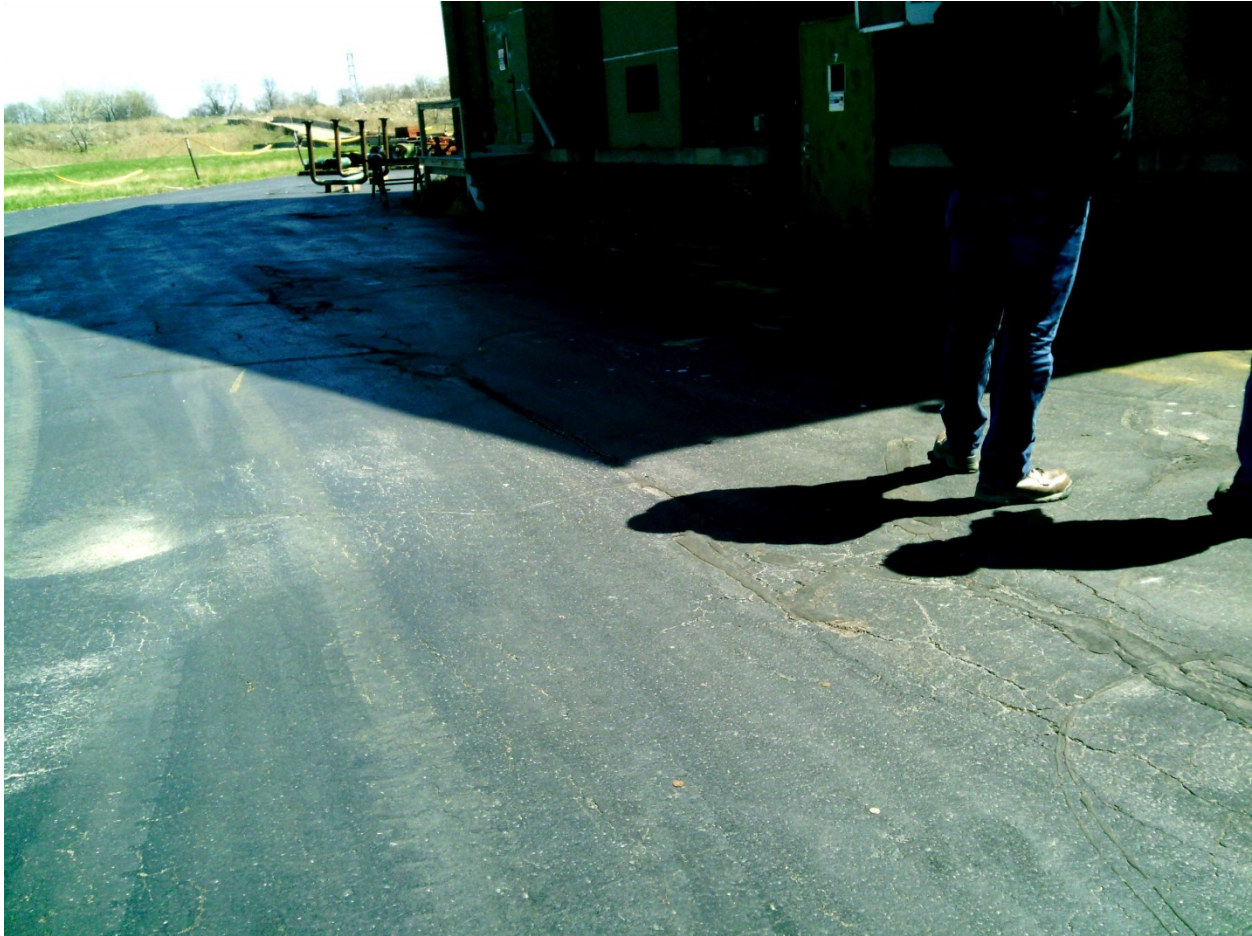
Looking east at stable portion of the Building 10 Asphalt Cap (B10AC).

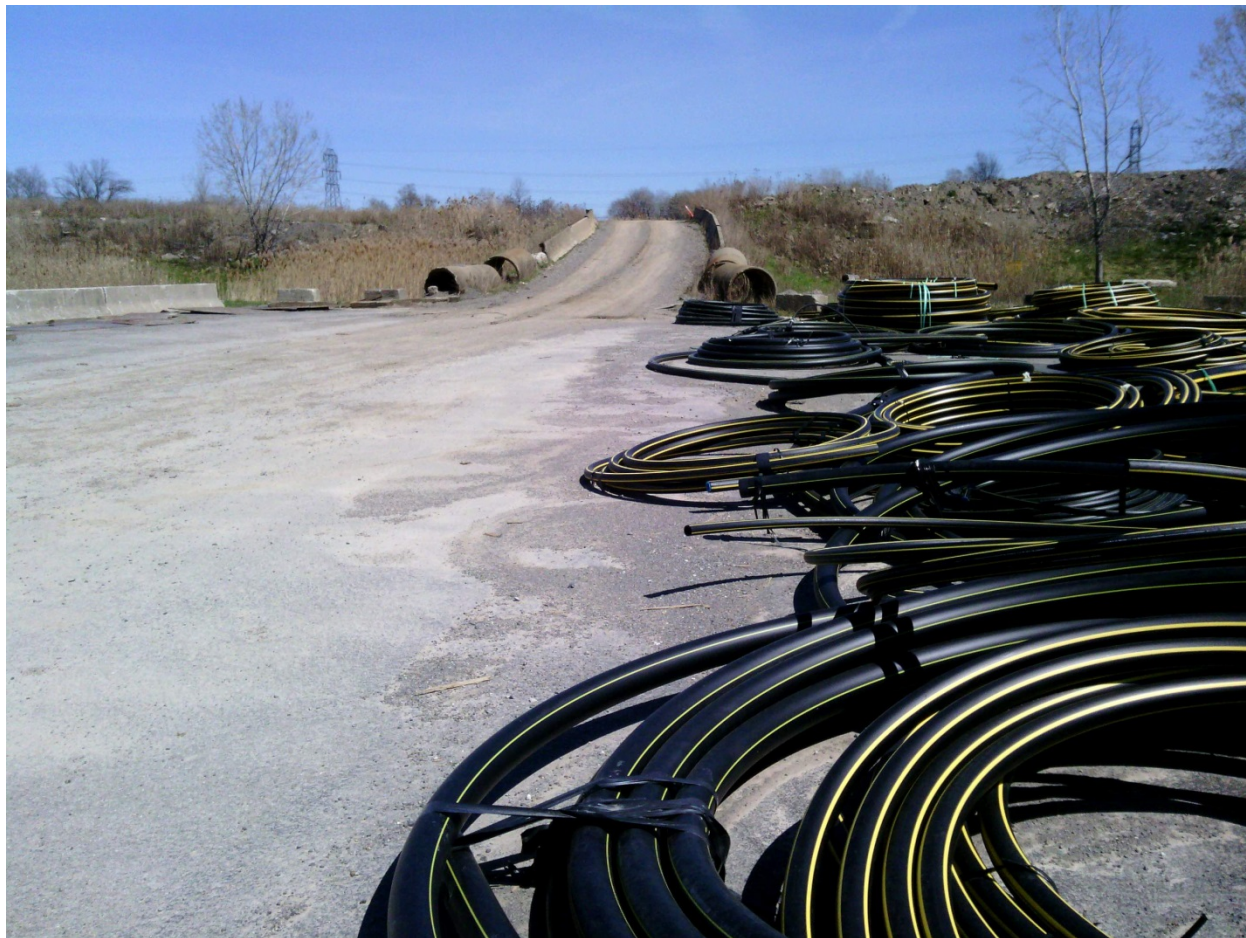
Looking east at Eastern Swale South Asphalt Cap (ESSAC), in good condition.

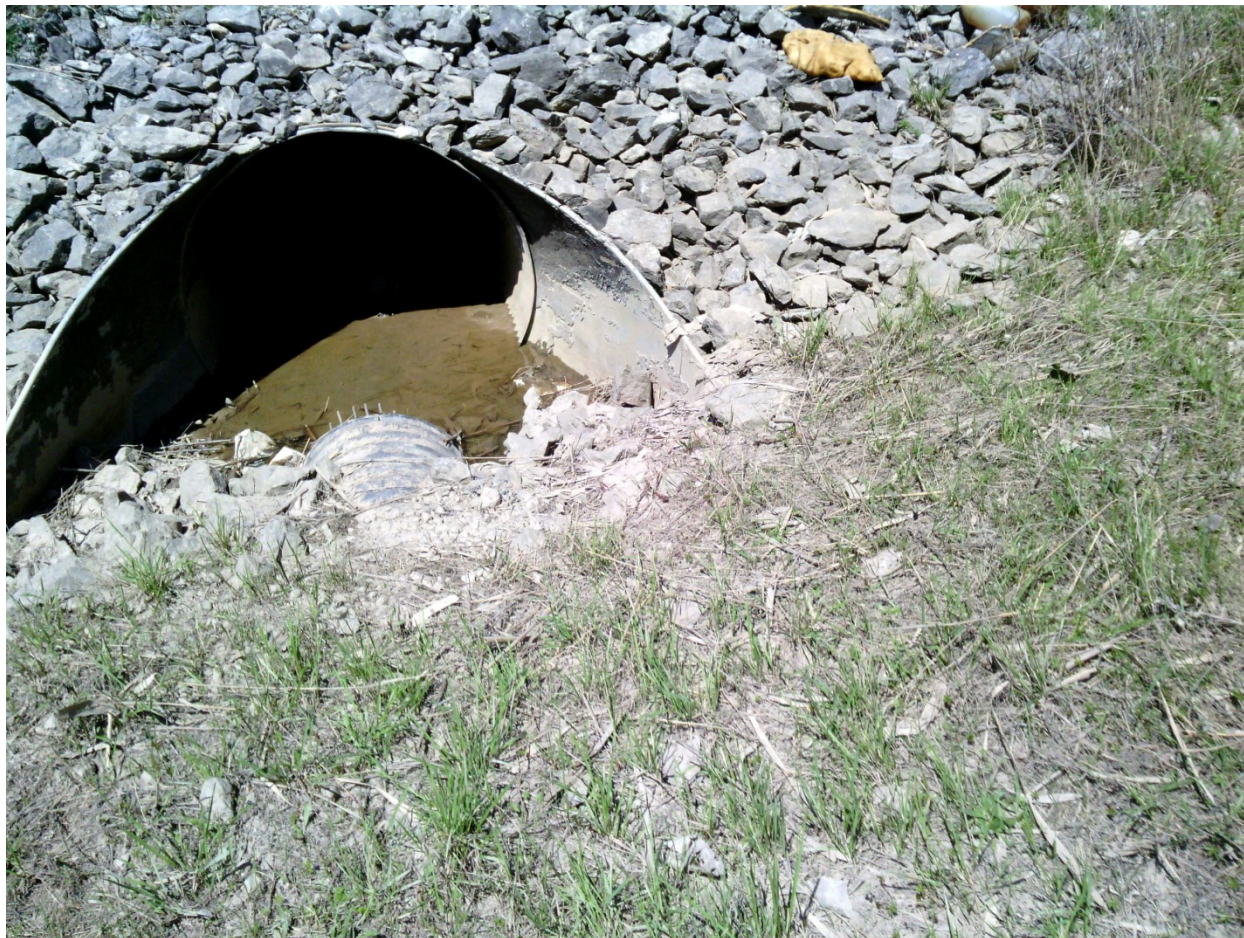
The outlet to the north culvert to the mid-section (HDPE cap) of the Eastern Drainage Ditch (EDD).

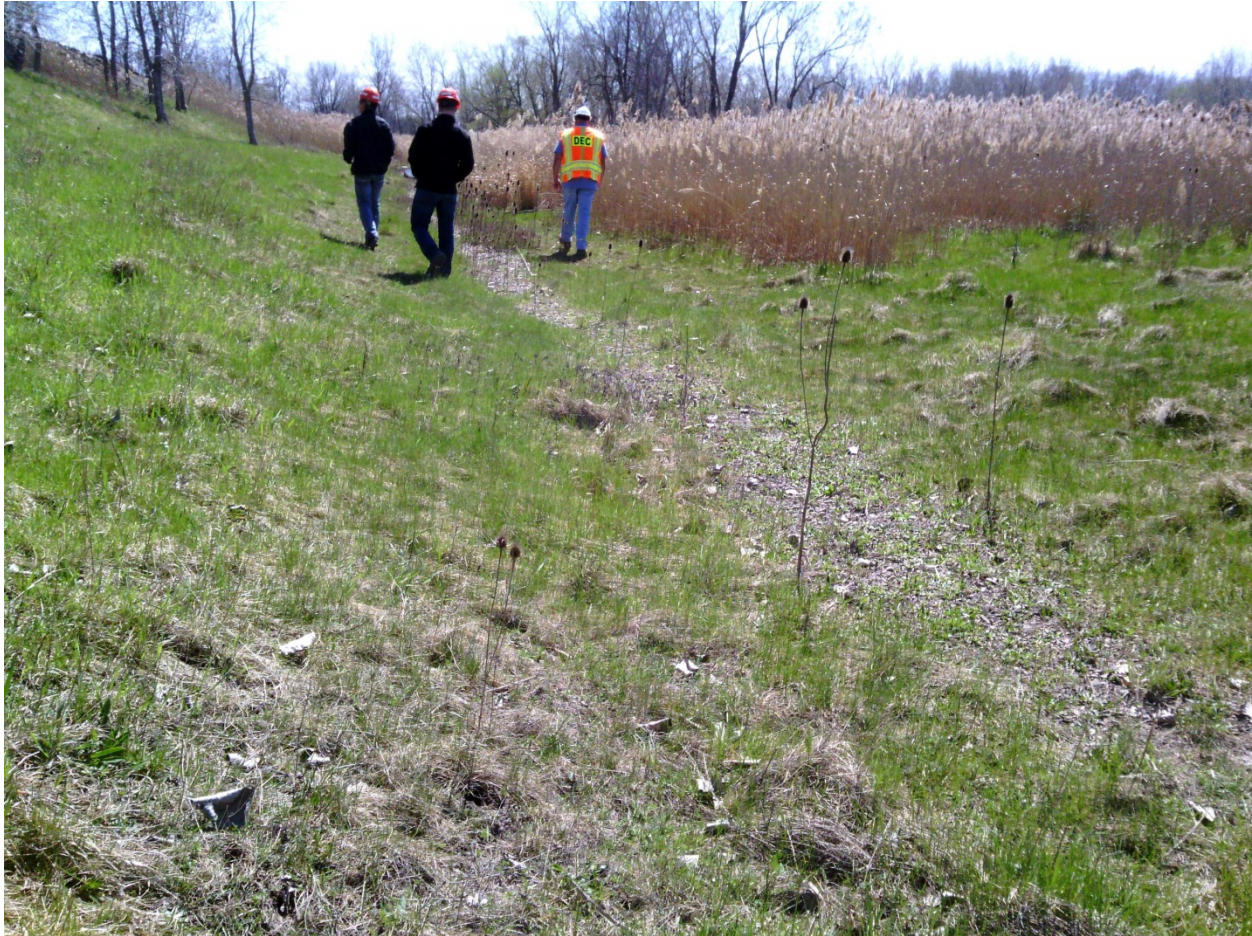
Looking south at the mid-section (HDPE cap) of the Eastern Drainage Ditch (EDD).

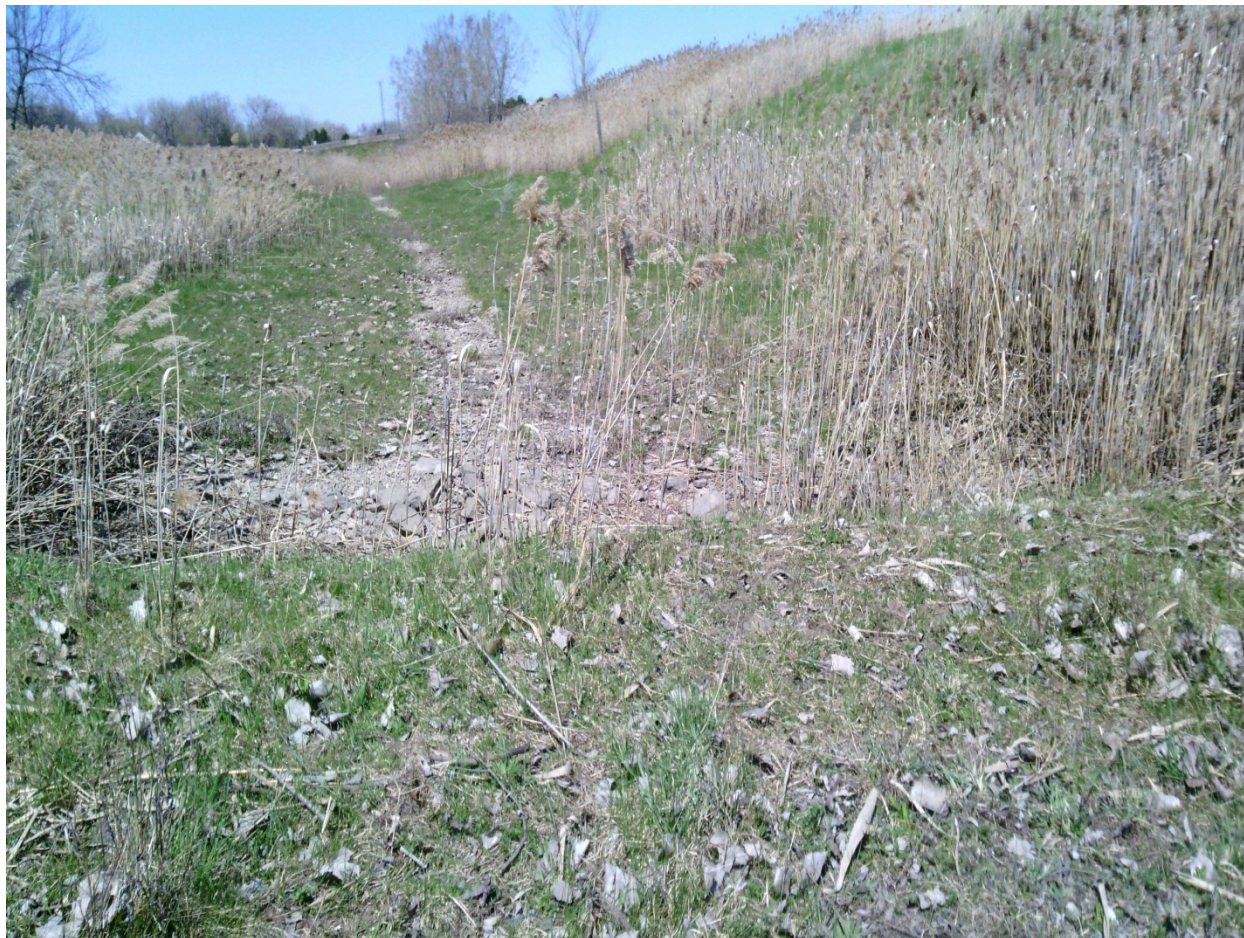
Looking north at the mid-section (HDPE cap) of the Eastern Drainage Ditch (EDD).

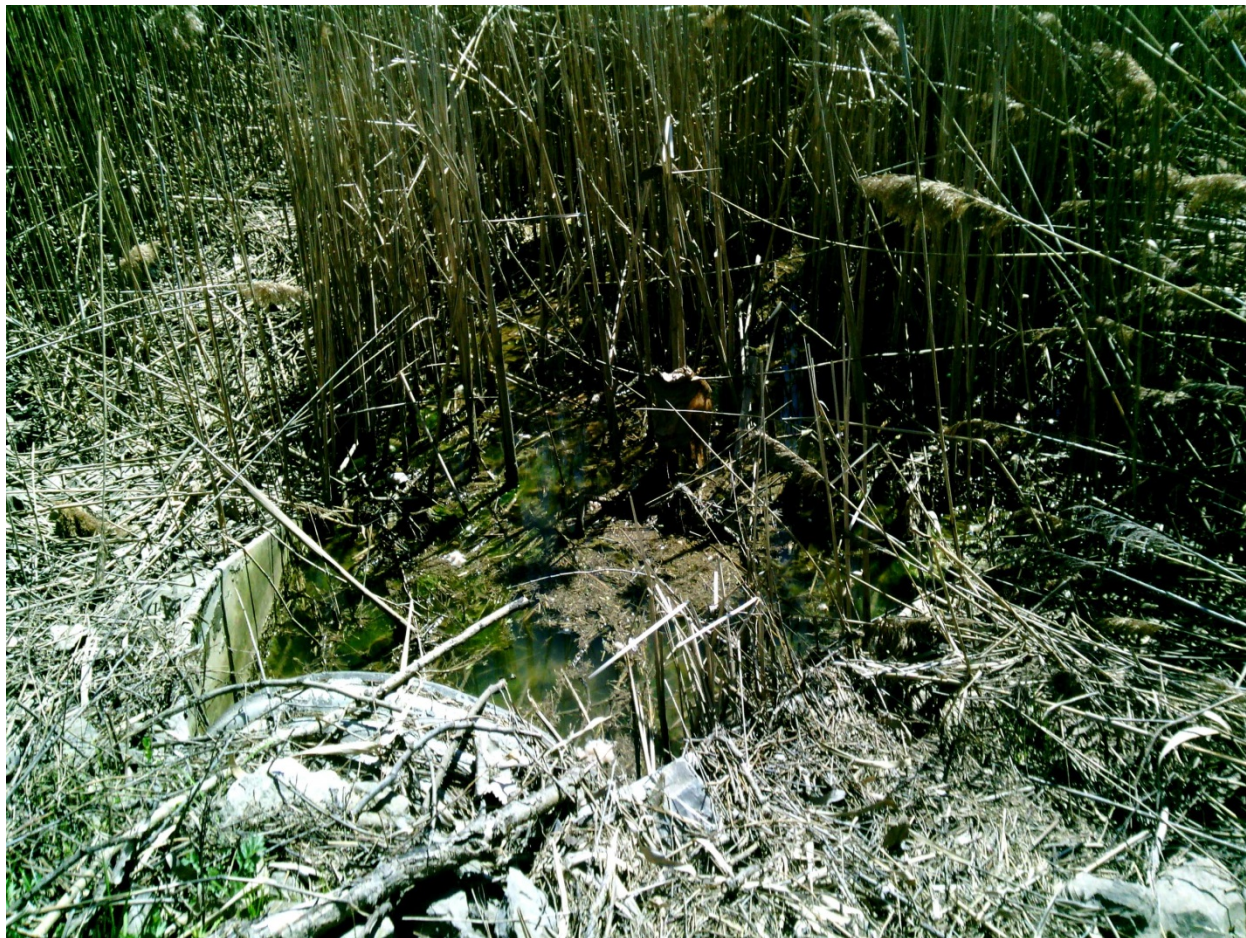
The outlet of the south culvert to the southern portion (clay cap) of the Eastern Drainage Ditch (EDD).

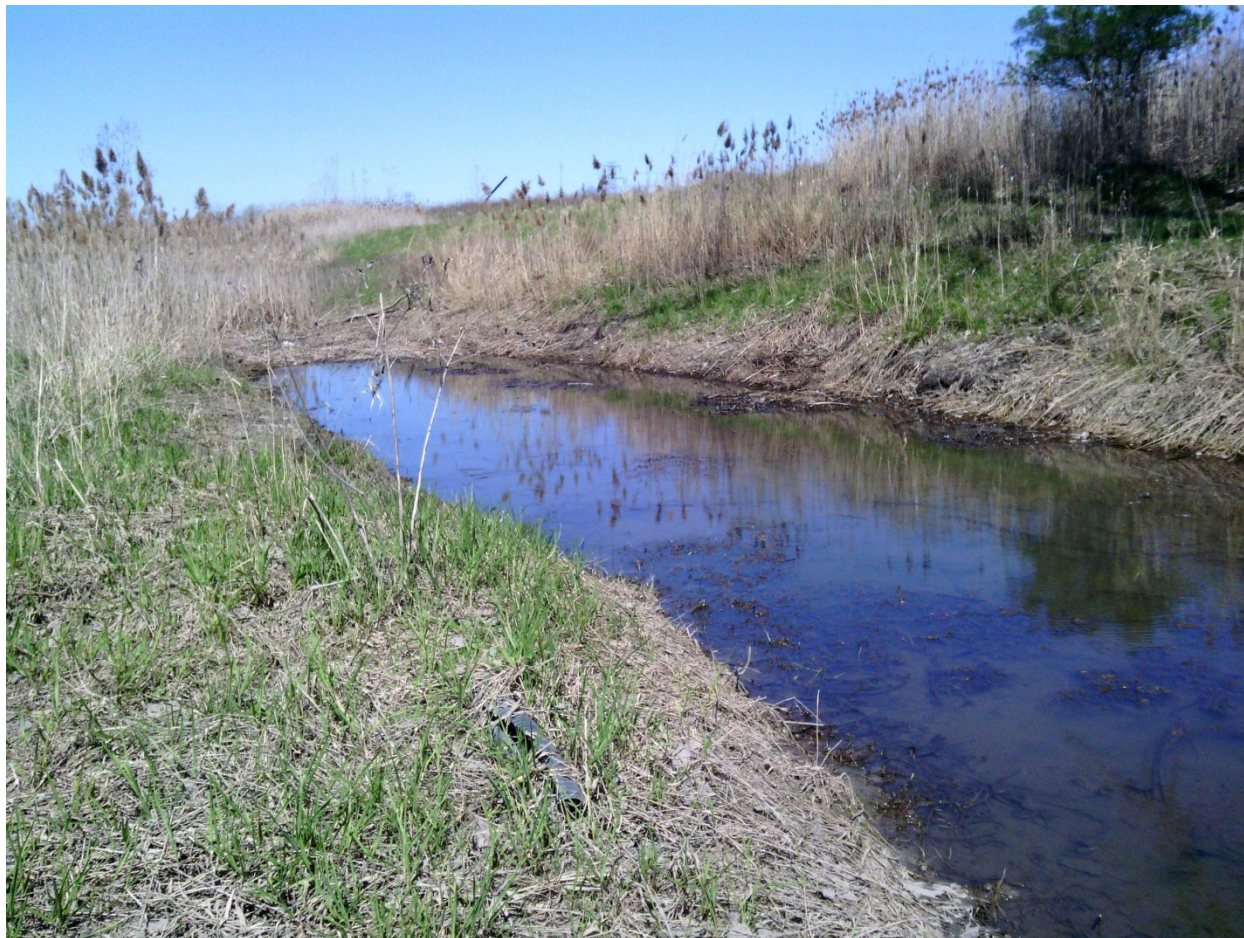
Looking north at the southern portion (clay cap) of the Eastern Drainage Ditch (EDD), just upstream of connection with unnamed tributary.

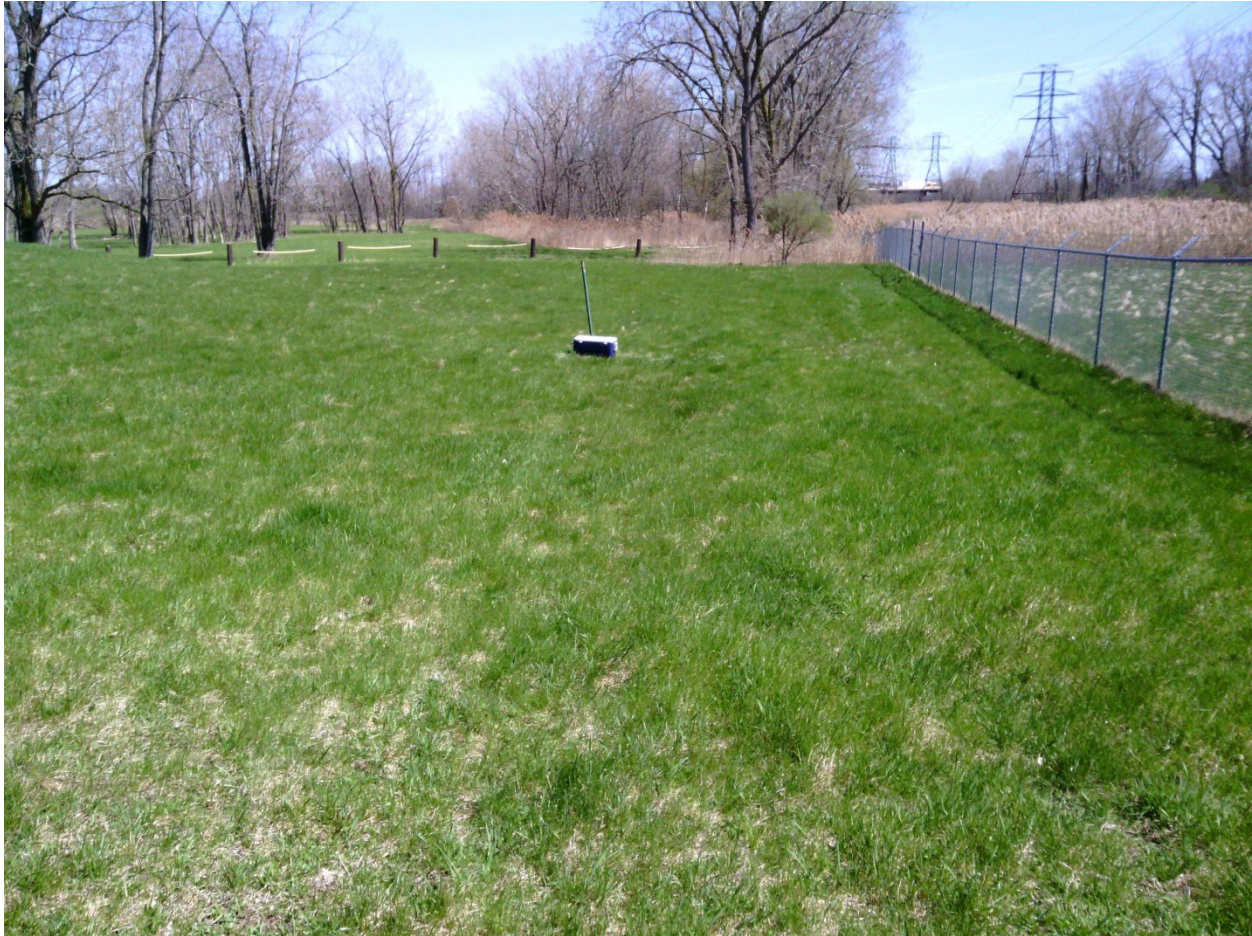
Looking east at the Clay Cap (CC) area. No issues noted.

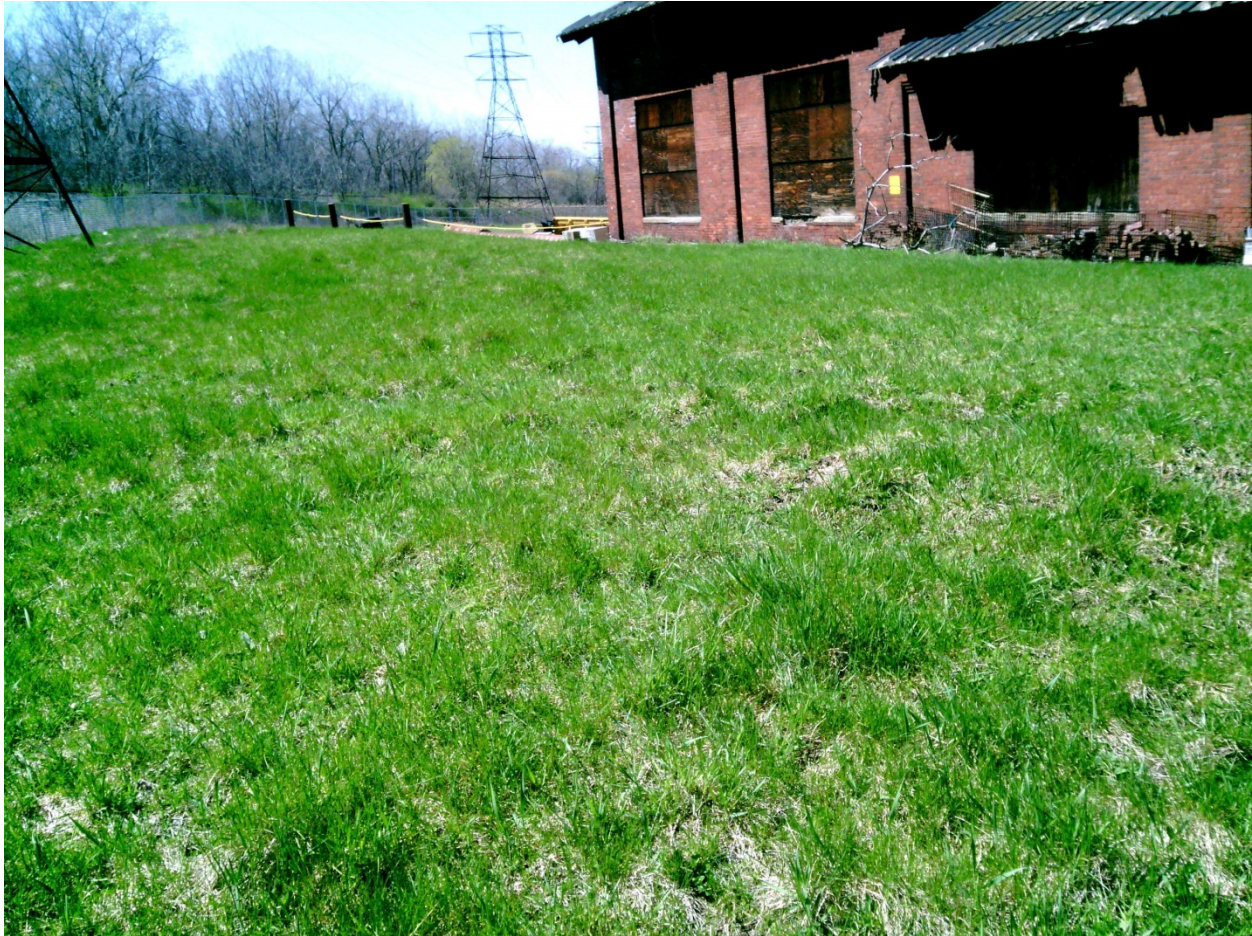
The CC area has been mowed periodically to prevent tree growth. No blue-stained soils were observed during the inspection. The surface of the CC was intact and no sink holes were observed. An animal burrow was observed on the CC. The animal has been trapped and relocated, and the burrow has been filled.

Looking west at the Clay Cap (CC) area. No issues noted. Animal burrow noted last year at the foot of the electrical tower (left edge of picture) has been filled.

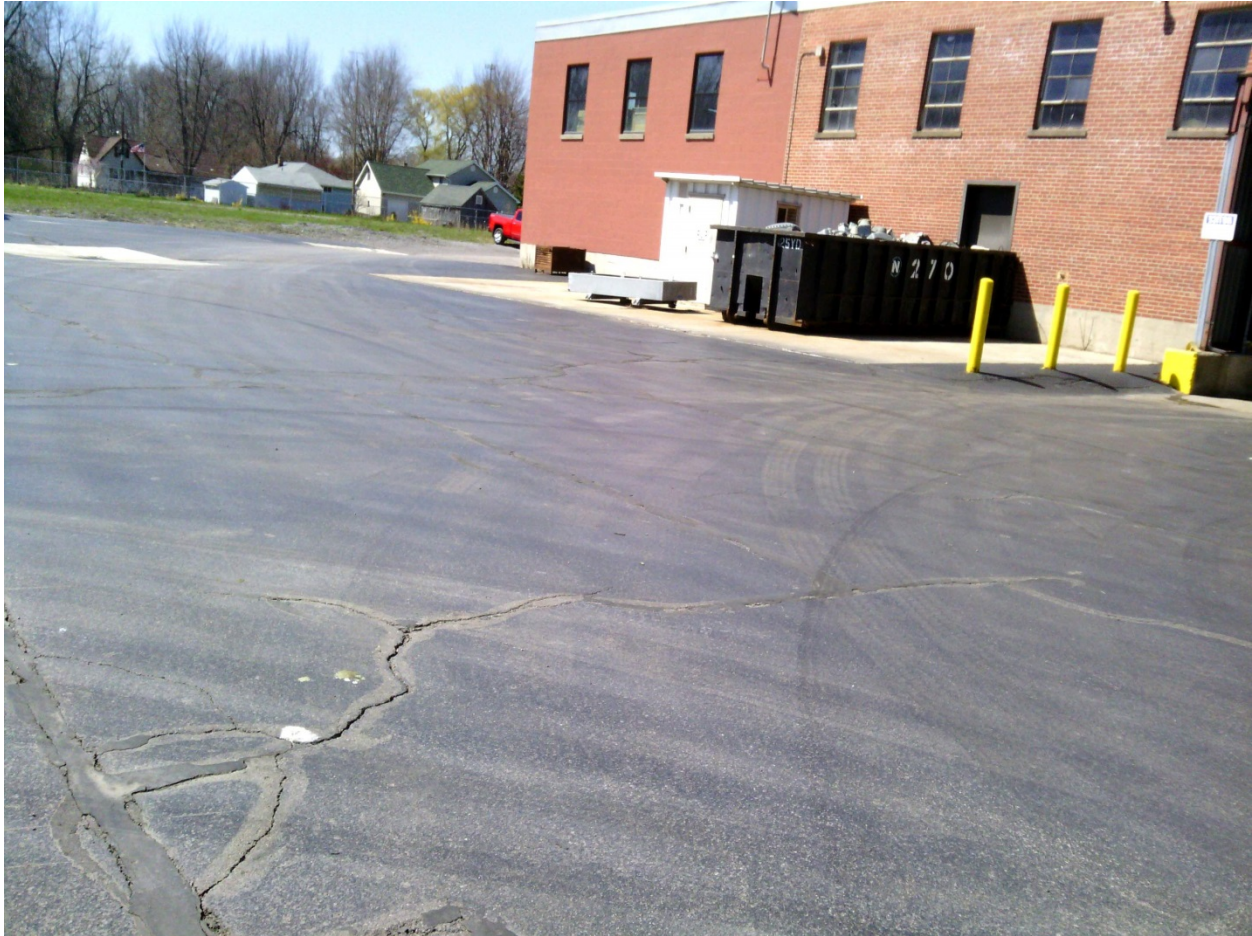
Looking northwest at a portion of the Building 3 South Asphalt Cap (B3SAC) showing an area with some significant cracking that needs to be sealed or patched.
