**Subject: Site Management Periodic Review Report and IC/EC Certification
Submittal – 2022, Revised PRR
Mineral Springs Road MGP Site (NYSDEC Site #V00195)**

Site Management Periodic Review Report and IC/EC Certification (2022)

NFG - Mineral Springs MGP - Site No. V00195
West Seneca, New York

December 2022 (Revised February 2023)

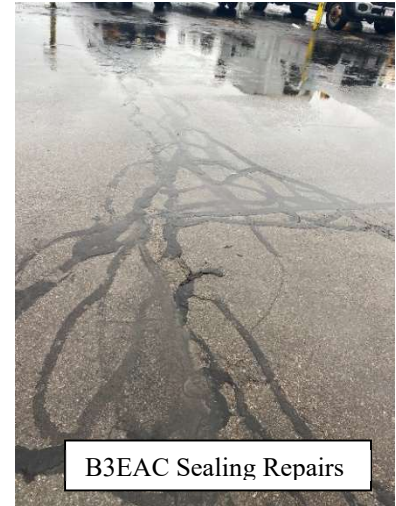
Building 3 East Asphalt Cap (B3EAC): No blue stained soil or significant edge erosion was observed. Cap repairs including replacement of catch basin aprons were completed in 2019 and remain intact. Cap surface condition is generally good with some surficial cracking. Sealing repairs were completed the week of November 7, 2022 (see photo).

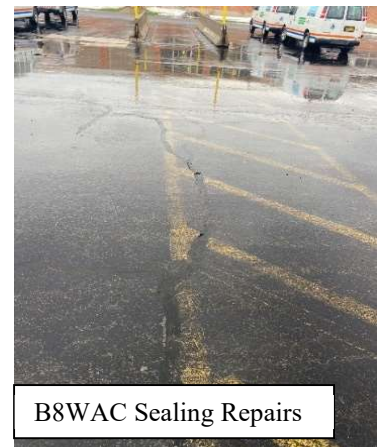
Former Building 8 West Asphalt Cap (B8WAC): No blue stained soil or edge erosion was observed. Cap repairs including replacement of catch basin aprons were completed in 2019 and remain intact. Cap surface condition is generally good with some surficial cracking. Sealing repairs were completed the week of November 7, 2022 (see photo).

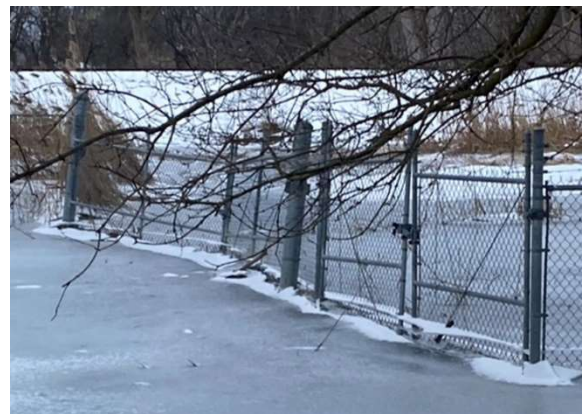
Perimeter fencing was observed to be in good condition on the west side of the property. As noted during the April 2022 inspection, a fallen tree was observed to have fallen on the barbed wire top guard at the central section of the south perimeter fence. The tree compressed the barbed wire but no damage to the chain-link mesh or the top rail was noted. The tree will be removed in the Spring of 2023 when ground conditions (snow/ice) improve for safe access. Also, near this location, the fence post at the gate spanning the stream had come loose. Repairs to the gate were made in summer of 2022 as shown in the photograph provided.

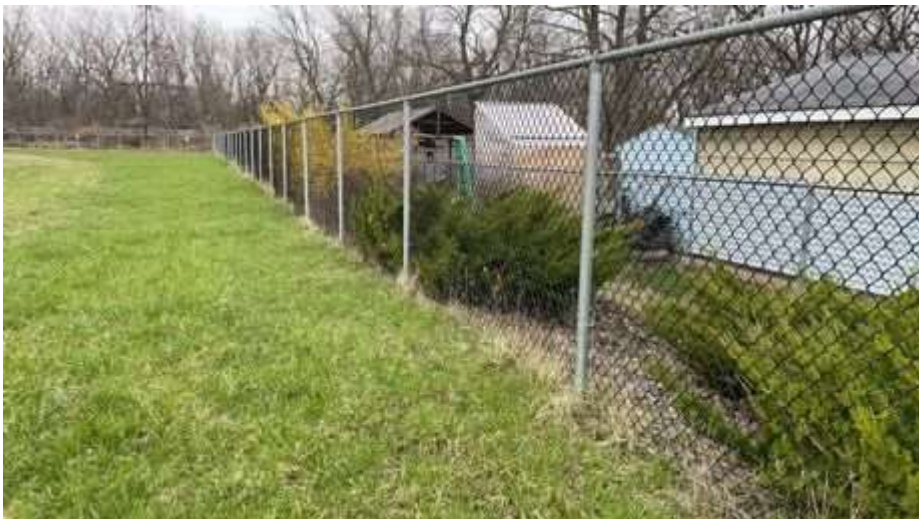
Perimeter fencing was observed to be in good condition on the west side of the property (Photo 4). A fallen tree was observed to have caused damage to the barbed wire top guard at the central section of the south perimeter fence (Photo 9). Also, near this location, the fence post at the gate spanning the stream has come loose and should be repaired and secured (Photo 10). The functionality of the gate section should be assessed and repaired/modified as appropriate.

PHOTOGRAPH NO: 3	DATE: April 19, 2022	LATITUDE: 42.8586870257381	LONGITUDE: -78.7995839770449
DIRECTION: South	SITE LOCATION: MINERAL SPRINGS FACILITY - BUFFALO, NEW YORK		
DESCRIPTION: Corrective Measures Area: Stone Cover and Fencing in Good Condition (Looking South)	 		
PHOTO BY: RICK FRAPPA, P.G.			
PHOTOGRAPH NO: 4	DATE: April 19, 2022	LATITUDE: 42.8594710330311	LONGITUDE: -78.8000650964245
DIRECTION: South	SITE LOCATION: MINERAL SPRINGS FACILITY - BUFFALO, NEW YORK		
DESCRIPTION: West Fence (Looking South)

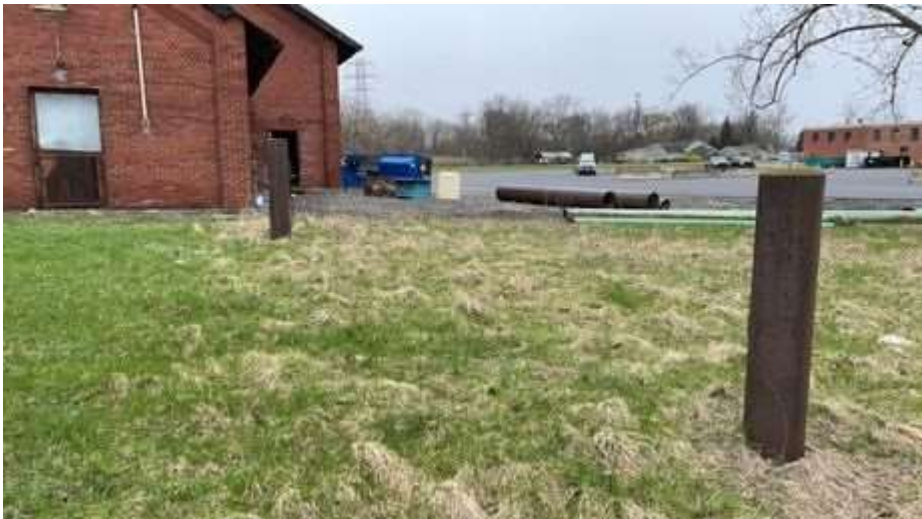
The cable marking the edge of the Clay Cap between bollards east of Building 14 was observed to be missing and will be replaced. In addition, a new bollard should be installed outside the southwest corner of the Clay Cap near the southern perimeter fence to allow placement of a cable between the new bollard and the existing bollard in the northwest corner to restrict vehicle access along the west side of the cap. The cable will be equipped with a lock to allow permitted access along the right of way. Signage indicating restrictions on digging and vehicle access should also be added around the perimeter of the Clay Cap. National Fuel Gas reports that these items will be addressed during the 2023 PRR period.

Clay Cap South of Building 14 (B14CC): No blue stained soil or erosion was observed. No animal burrows were observed. The vegetative cover was intact and free of trees and no hydrocarbon sheens were observed (Photos 5, 8). The cable between bollards east of Building 14 was observed to be missing and should be replaced (Photo 7).

PHOTOGRAPH NO: 7	DATE: April 19, 2022	LATITUDE: 42.8580213475384	LONGITUDE: -78.79852322886
DIRECTION: West	SITE LOCATION: MINERAL SPRINGS FACILITY - BUFFALO, NEW YORK		
DESCRIPTION: Missing Bollard Cable East of Building 14

4. The cable marking the edge of the Clay Cap between bollards east of Building 14 was observed to be missing and should be replaced. In addition, a new bollard should be installed outside the southwest corner of the Clay Cap near the southern perimeter fence to allow placement of a cable between the new bollard and the existing bollard in the northwest corner to restrict vehicle access along the west side of the cap. The cable should be equipped with a lock to allow permitted access along the right of way. Signage indicating restrictions on digging and vehicle access should also be added around the perimeter of the Clay Cap.

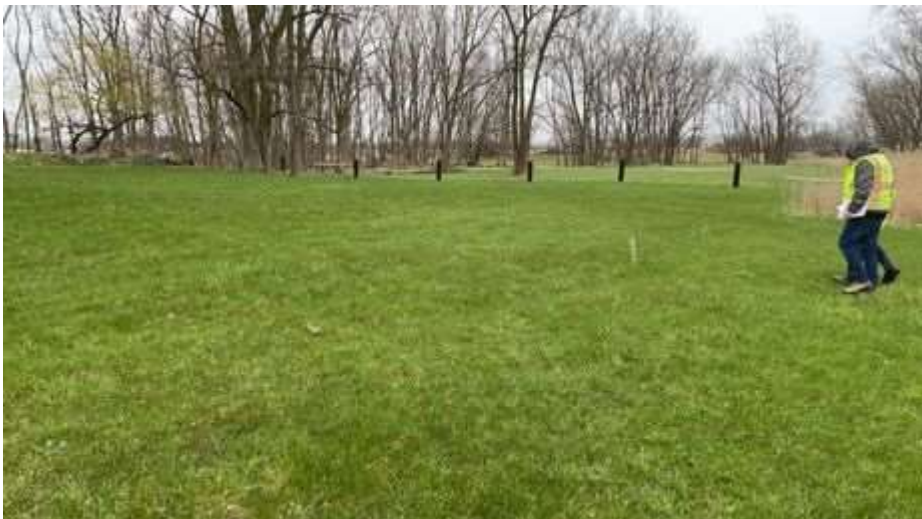
PHOTO BY: RICK FRAPPA, P.G.			
PHOTOGRAPH NO: 8	DATE: April 19, 2022	LATITUDE: 42.8580083418864	LONGITUDE: -78.7979897851736
DIRECTION: Northeast	SITE LOCATION: MINERAL SPRINGS FACILITY - BUFFALO, NEW YORK		
DESCRIPTION: Clay Cap South of Building 14 Looking Northeast

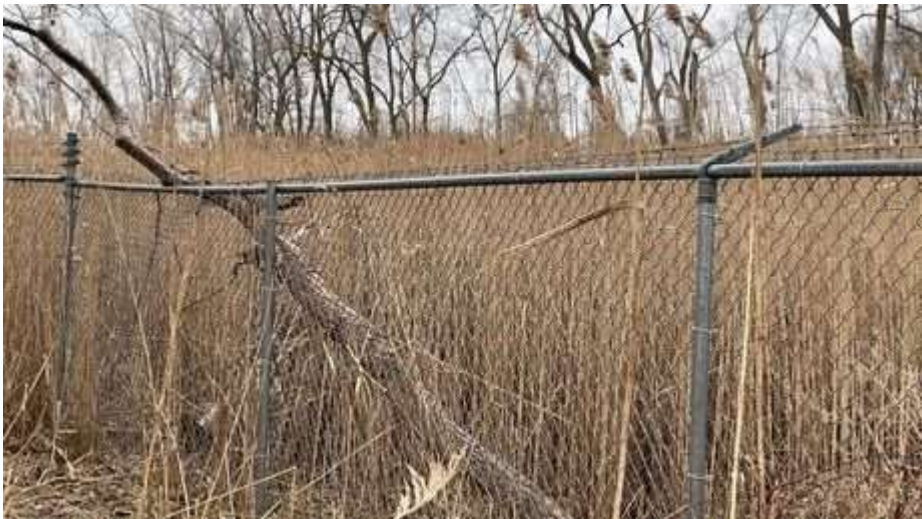
PHOTOGRAPH No: 9	DATE: April 19, 2022	LATITUDE: 42.8575399438037	LONGITUDE: -78.7960439795171
DIRECTION: Southeast	SITE LOCATION: MINERAL SPRINGS FACILITY - BUFFALO, NEW YORK		
DESCRIPTION: Barbed Wire Top Guard Damage: Center Area of South Perimeter Fence

1. The fence post at the gate spanning the stream on the southwest side of the property should be repaired and secured. The top guard damaged by the tree fall should also be repaired.

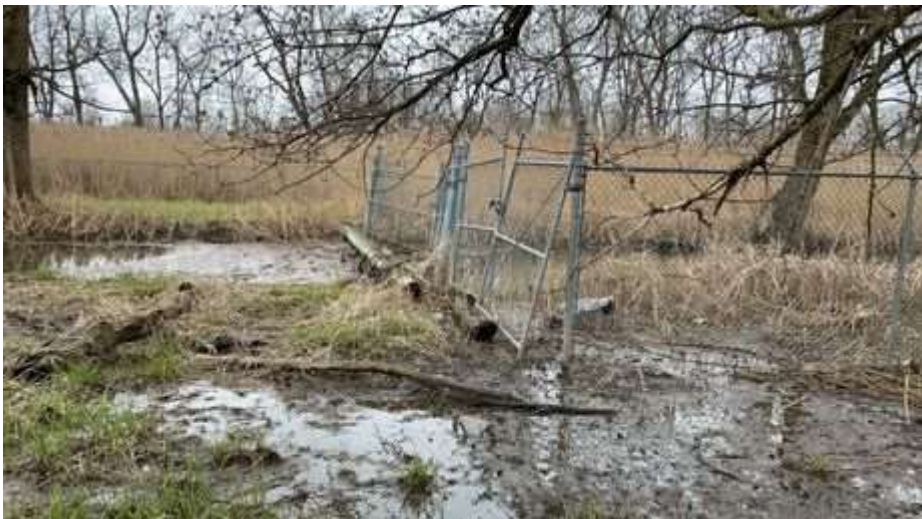
PHOTO BY: RICK FRAPPA, P.G.			
PHOTOGRAPH No: 10	DATE: April 19, 2022	LATITUDE: 42.8575246342408	LONGITUDE: -78.7960422973404
DIRECTION: South	SITE LOCATION: MINERAL SPRINGS FACILITY - BUFFALO, NEW YORK		
DESCRIPTION: Damaged Gate at Stream: Center Area of South Perimeter Fence

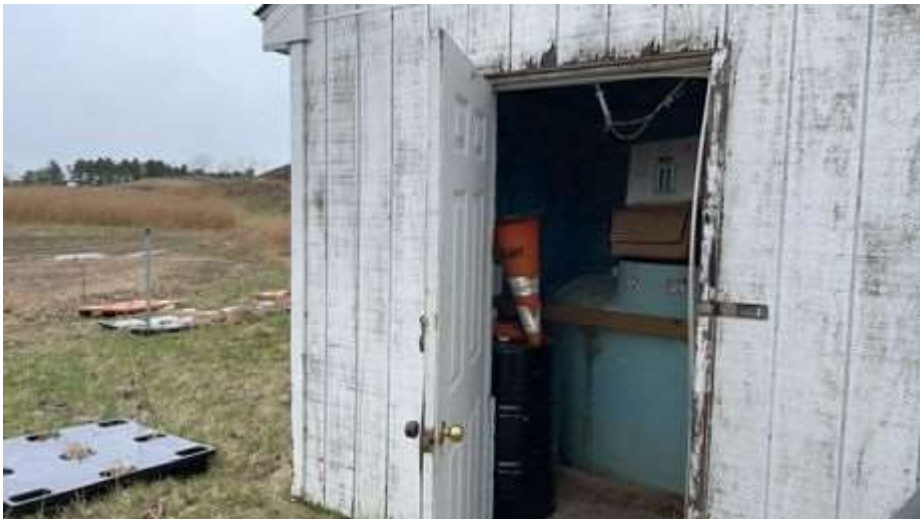
The DNAPL shed on the east side of the property was observed to have a deteriorated door frame. National Fuel Gas reported that repairs will be made in 2023.

The DNAPL shed on the east side of the property was observed to have a deteriorated door frame and should be repaired (Photo 15).

PHOTOGRAPH No: 15	DATE: April 19, 2022	LATITUDE: 42.8588760316026	LONGITUDE: -78.7946733046444
DIRECTION: South	SITE LOCATION: MINERAL SPRINGS FACILITY - BUFFALO, NEW YORK		
DESCRIPTION: DNAPL Shed Door and Frame in Need of Repair

2. The DNAPL shed door frame should be repaired.
3. Minor surficial cracks in the Building 3 East, Building 8 West, Eastern Swale North, and Eastern Swale South asphalt caps should be sealed.

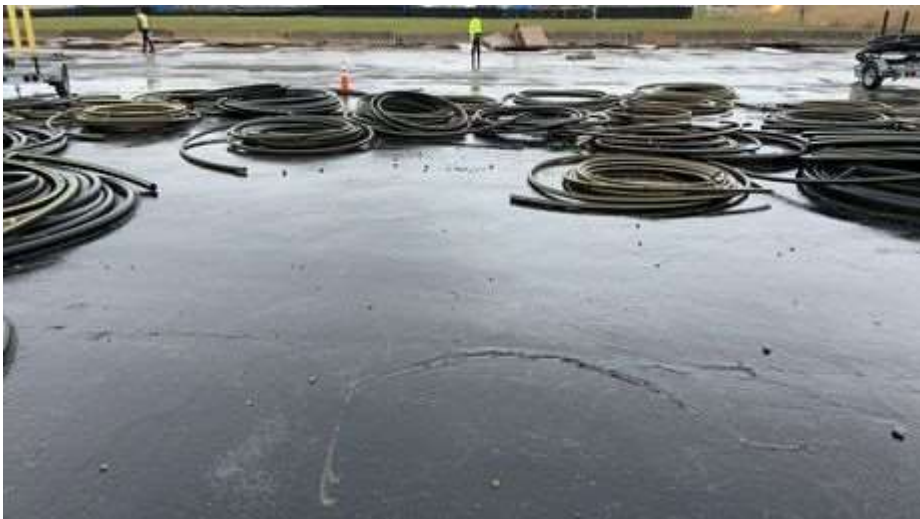
Eastern Swale South Asphalt Cap (ESSAC): No blue stained soil or edge erosion was observed. As noted above for the ESNAC, surface cracks in the sealant were observed, but none appeared open through the asphalt wearing course layer (Photo 16, 17). Minor sealing repairs would be appropriate.

PHOTOGRAPH No: 16	DATE: April 19, 2022	LATITUDE: 42.8594107338415	LONGITUDE: -78.7951129046073
DIRECTION: North	SITE LOCATION: MINERAL SPRINGS FACILITY - BUFFALO, NEW YORK		
DESCRIPTION: Eastern Swale South Asphalt Cap

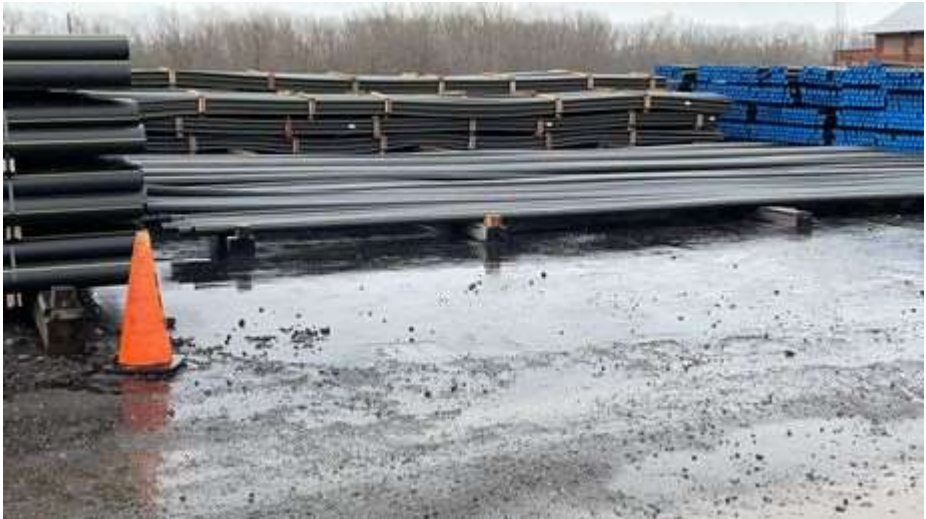
Eastern Swale North Asphalt Cap (ESNAC): No blue stained soil or edge erosion was observed. Repaired surface cracks in the sealant were abundant. The sealant in some of the repaired cracks has weathered leaving small voids, but none appeared open through the asphalt wearing course layer (Photo 21). Minor sealing repairs would be appropriate. The area is currently used for pipe storage.

PHOTOGRAPH No: 21	DATE: April 19, 2022	LATITUDE: 42.8614277451553	LONGITUDE: -78.7946780540909
DIRECTION: South	SITE LOCATION: MINERAL SPRINGS FACILITY - BUFFALO, NEW YORK		
DESCRIPTION: Eastern Swale North Asphalt Cap

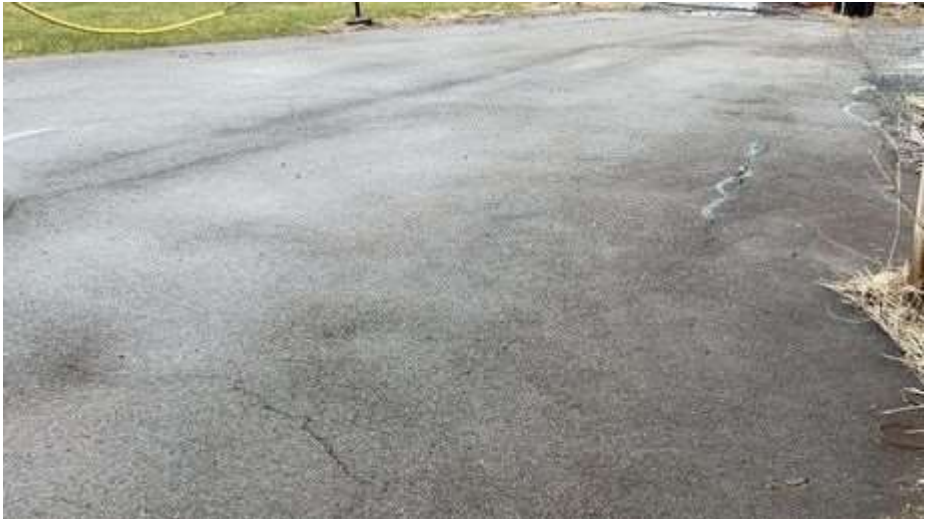
Building 10 Asphalt Cap (B10AC): This cap was repaired in 2018 and 2019 and appears to remain adequately sealed (Photos 22, 23).

PHOTO BY: RICK FRAPPA, P.G.			
PHOTOGRAPH No: 22	DATE: April 19, 2022	LATITUDE: 42.8614655595414	LONGITUDE: -78.7949968038332
DIRECTION: East	SITE LOCATION: MINERAL SPRINGS FACILITY - BUFFALO, NEW YORK		
DESCRIPTION: Building 10 Asphalt Cap
