# Annual Periodic Review Report

Former EDO Corporation Facility

DATE August 14, 2025

REFERENCE 0560708

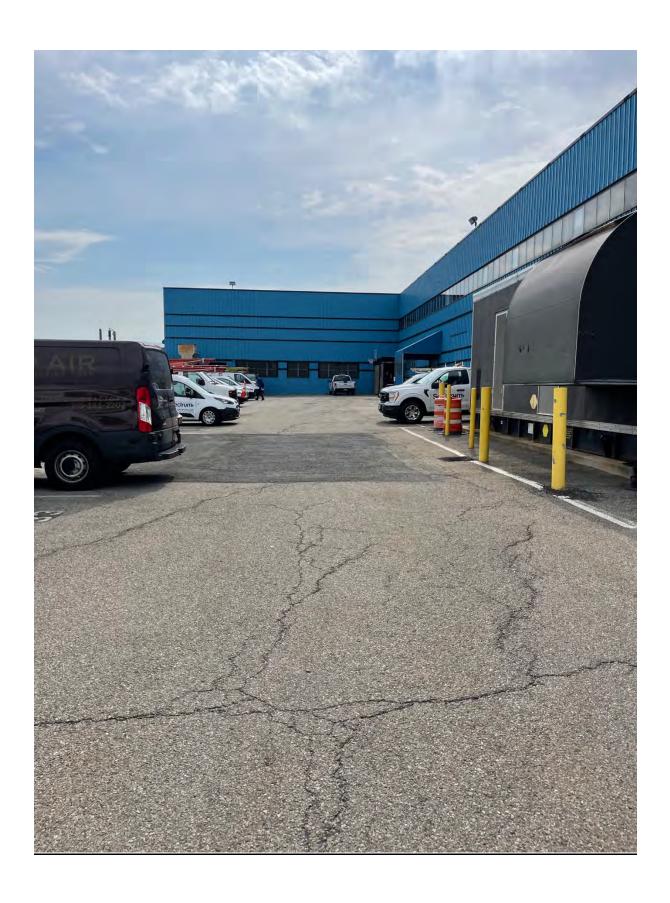
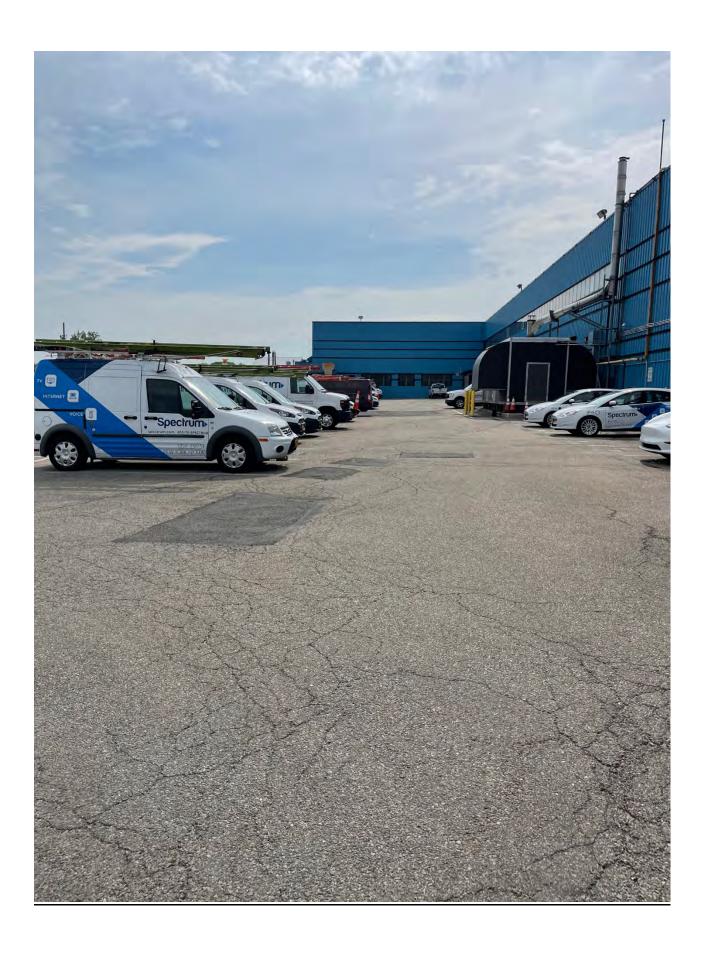
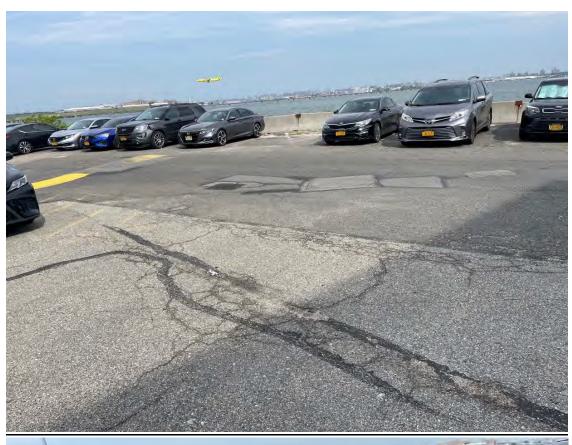
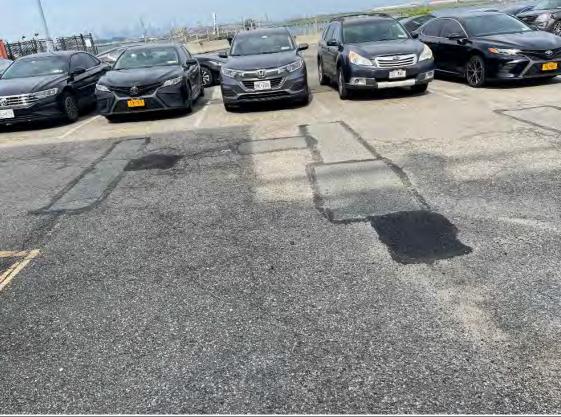
Observed Condition(s): <u>During the site inspection the pavement area was</u> covered with spectrum fleet vehicles and general cabling equipment/storage. No visible signs of digging / disturbance of the pavement cover were observed.
