# Annual Periodic Review Report

Former EDO Corporation Facility

Reporting Period: June 15, 2022 - June 15, 2025

DATE  
August 14, 2025

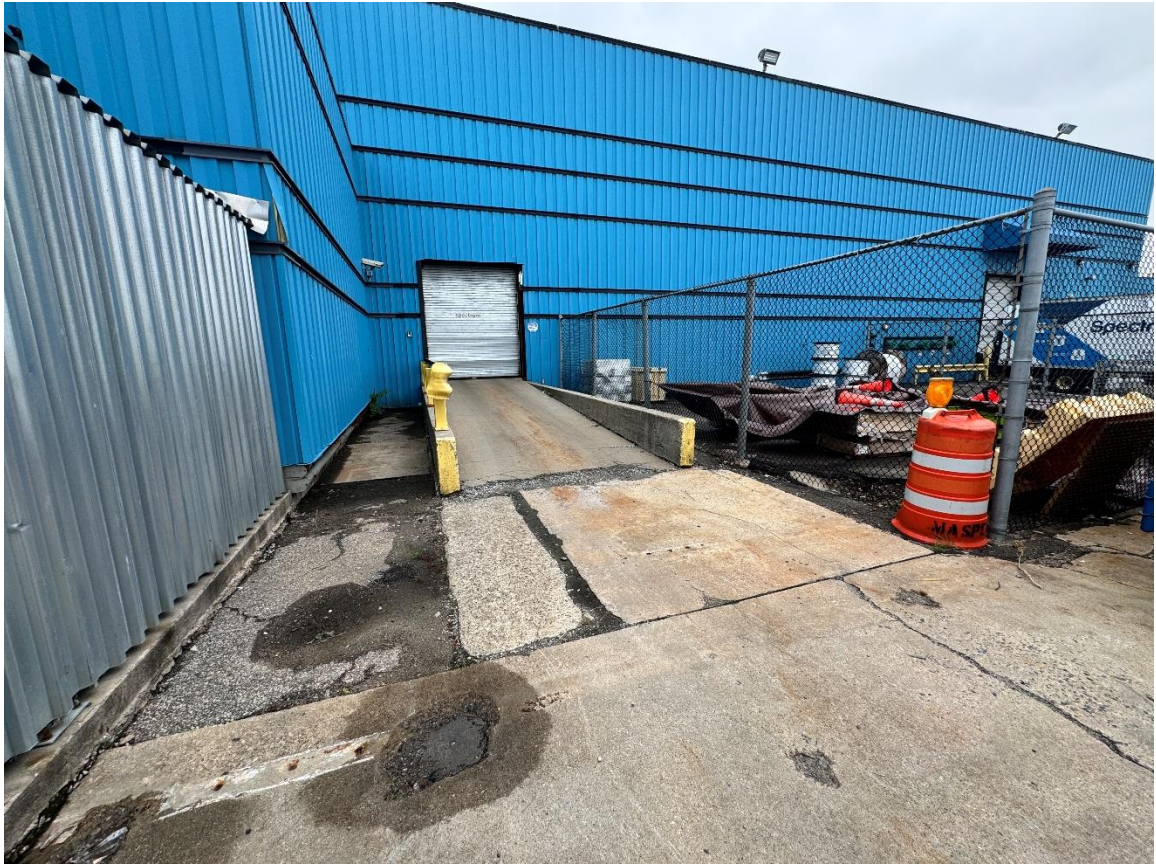
Photo 1: Former Jet Test Pads

**Observed Condition(s):** No visible signs of digging / disturbance of the pavement cover were observed.

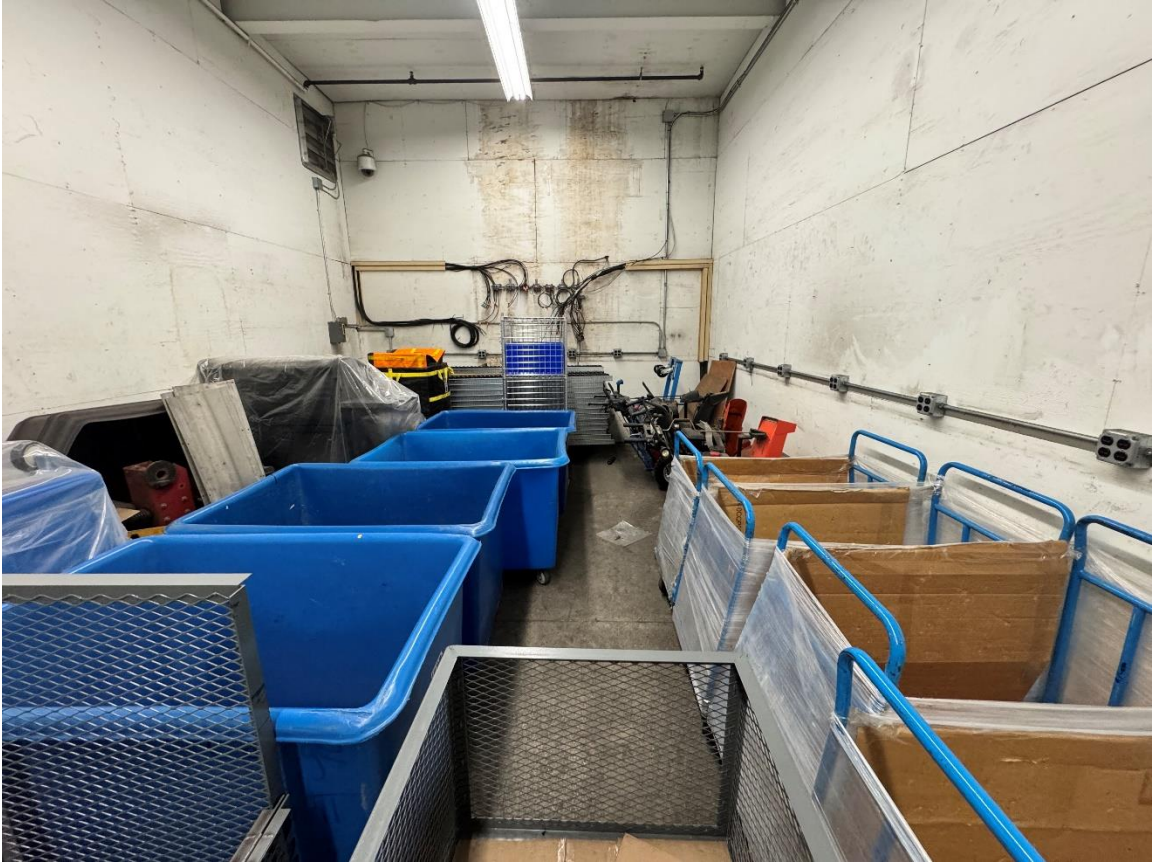
Photo 1: Former Plating Room

**Observed Condition(s):** During the site visit, the former plating room, the floor and surrounding areas were observed for changes. No disturbance/ holes/ digging to the concrete cover were noted during the site visit.

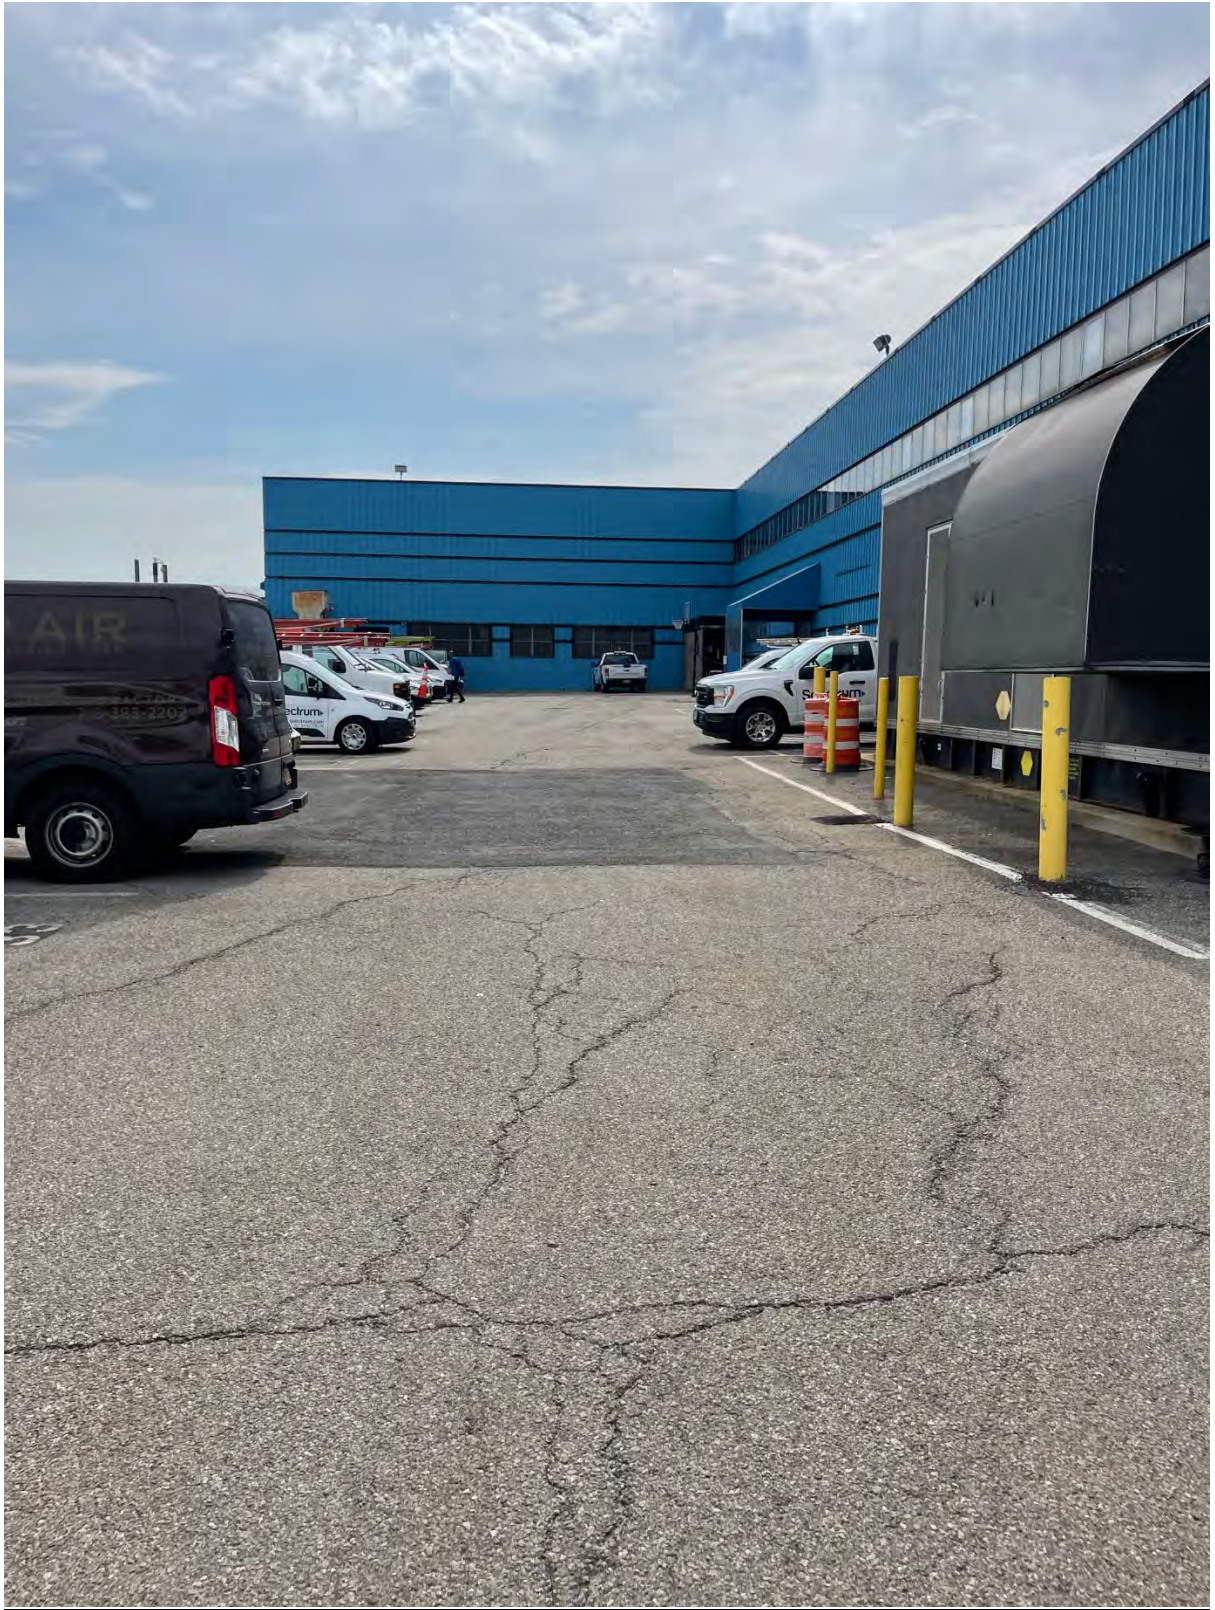
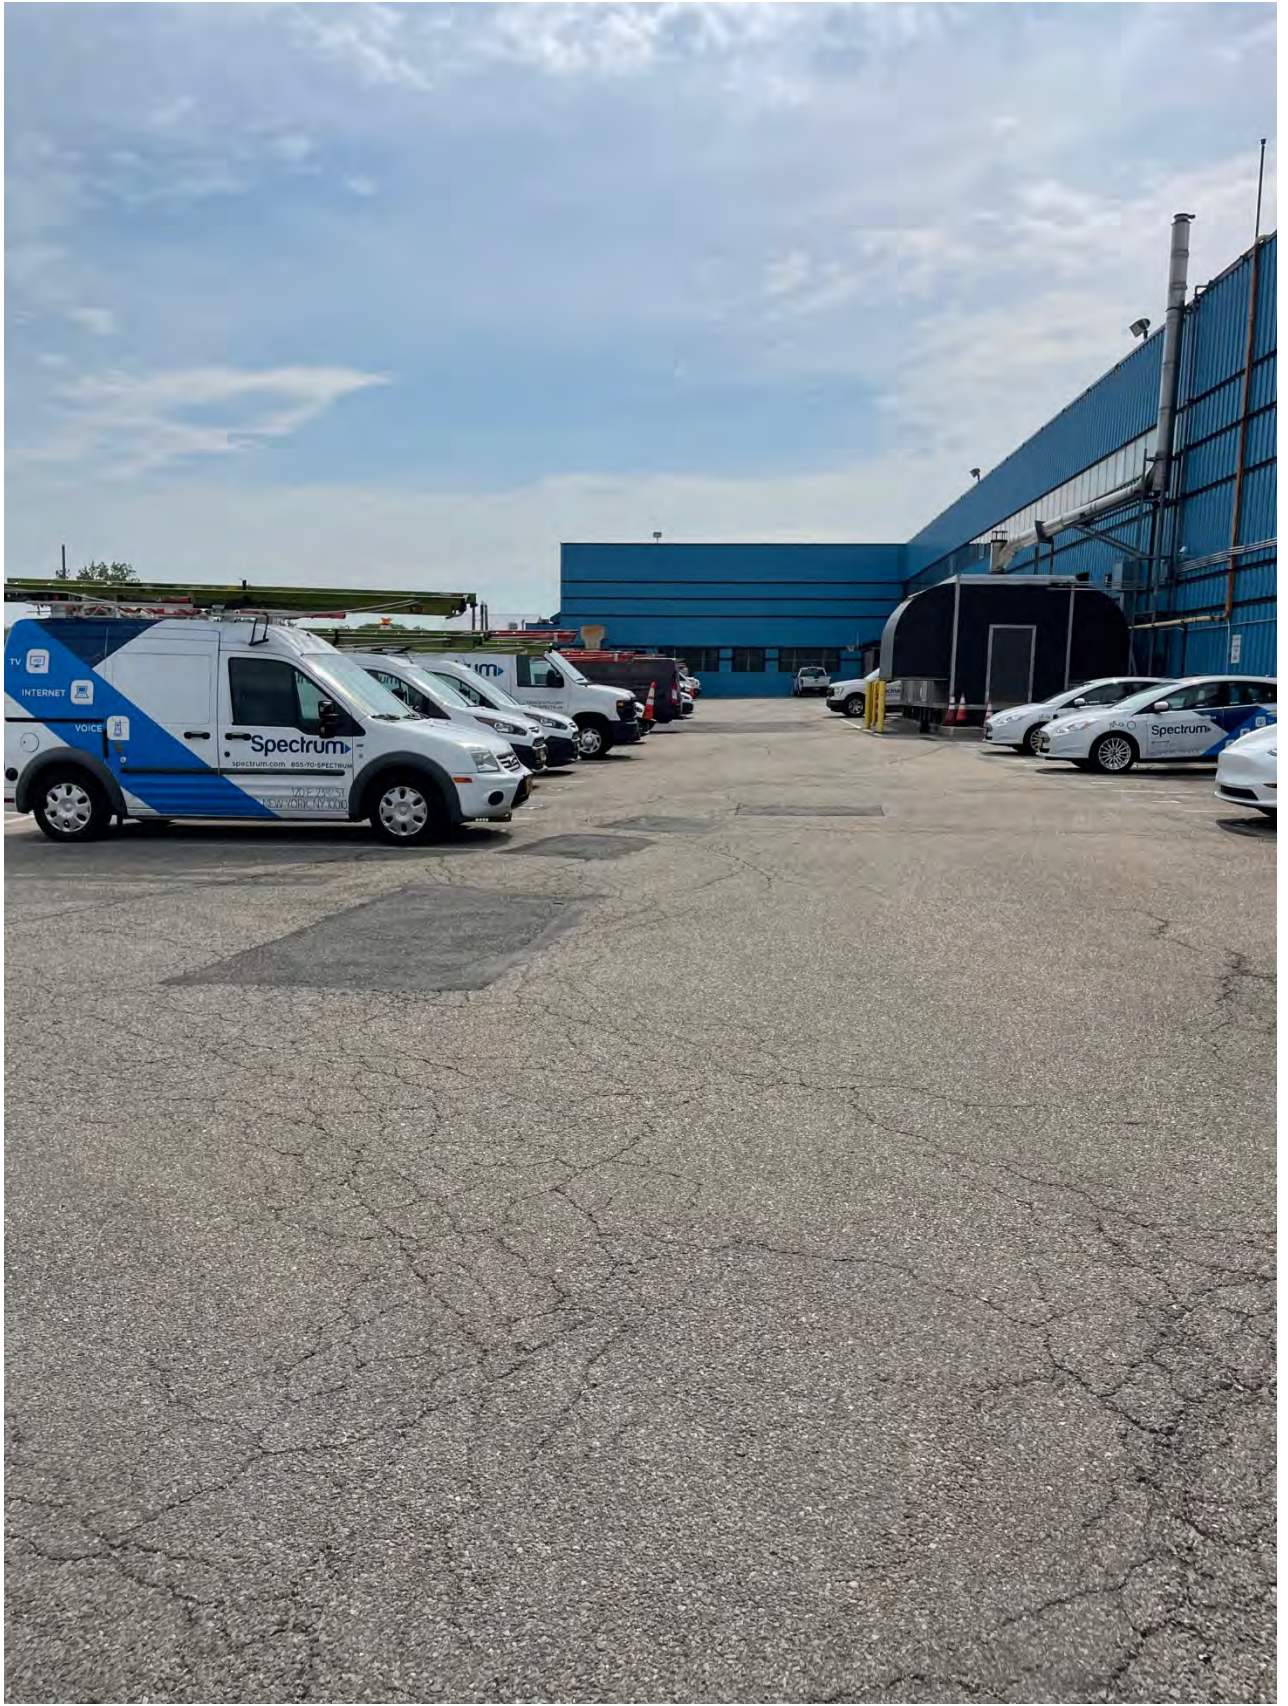
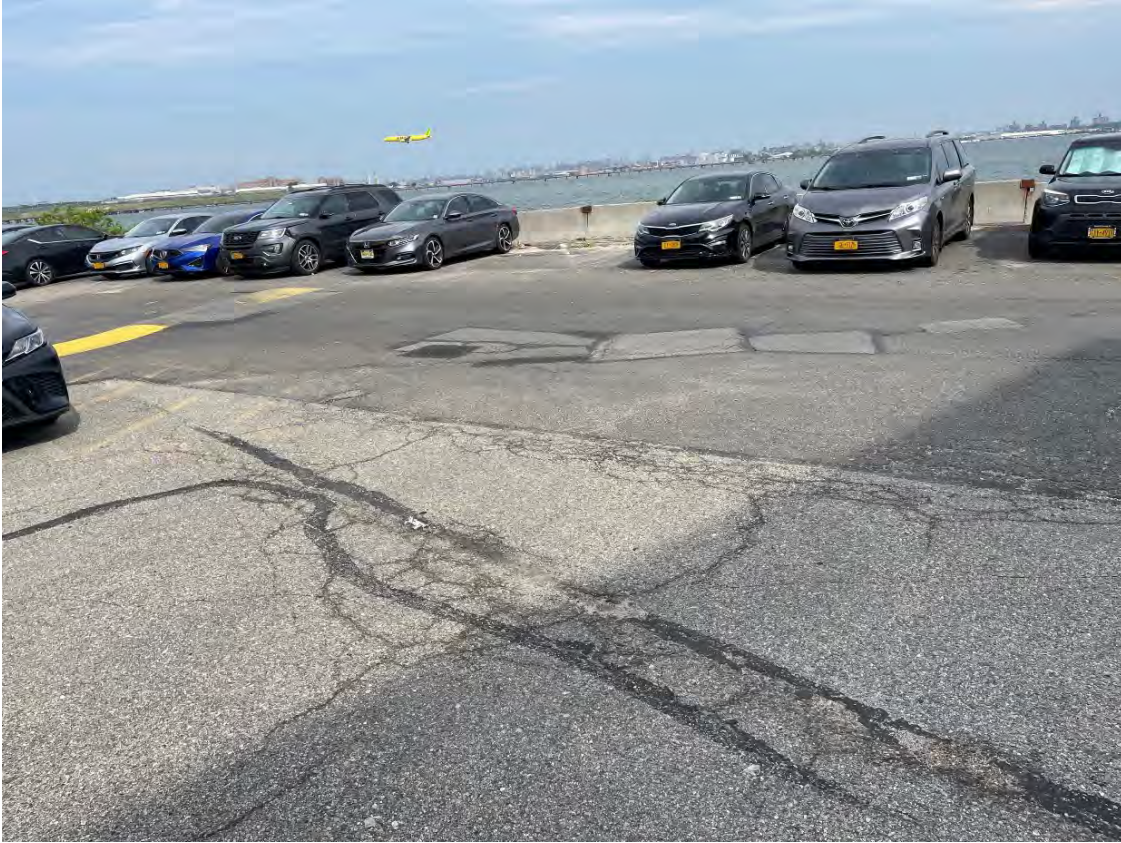
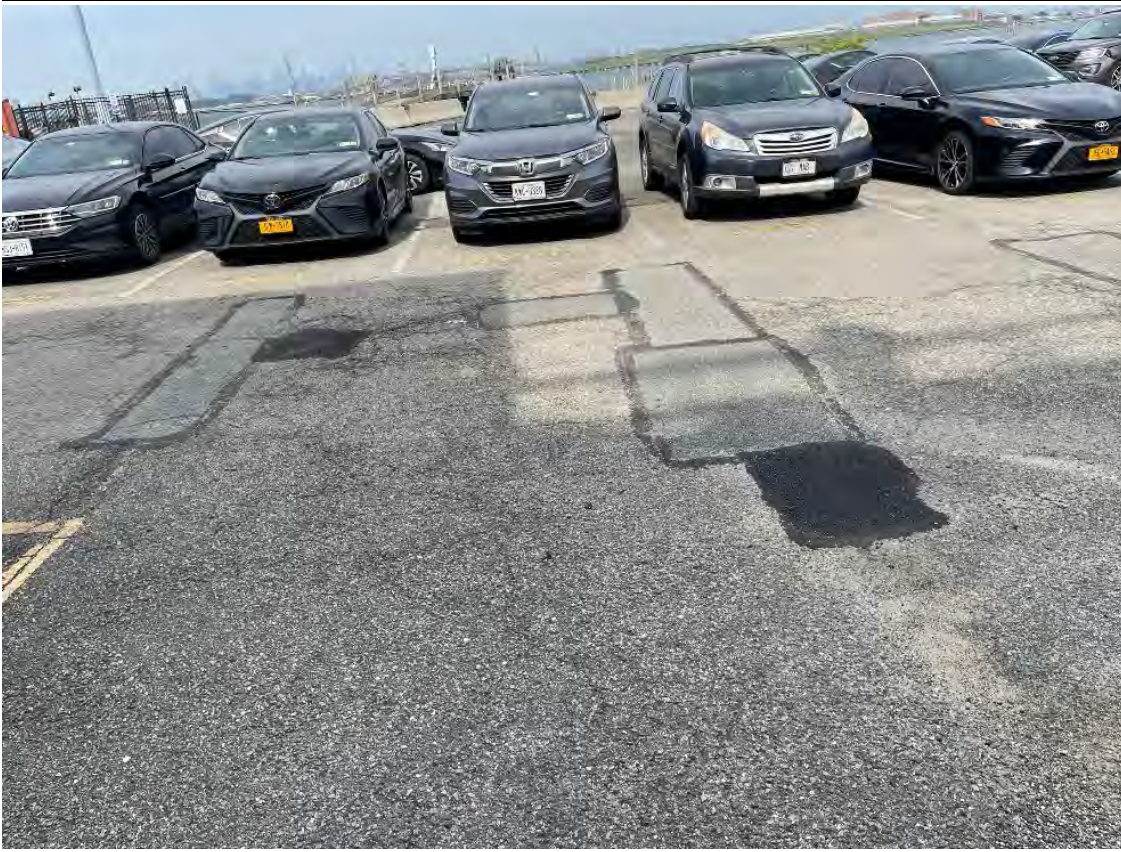
**Observed Condition(s):** During the site inspection the pavement area was covered with spectrum fleet vehicles and general cabling equipment/storage. No visible signs of digging / disturbance of the pavement cover were observed.
