LETTER OF TRANSMITTAL

| Copies | Date | No. | Description |
|---|---|---|--|
| 1 | Jan. 31, 2014 | C1525 | Periodic Review Report, VCP Site No. V00213 500 Mamaroneck Avenue, Harrison, NY |

**Re: Periodic Review Report
Agreement Index No. W3-0851-99-05
VCP Site No. V00213
Commercial Property: 500 Mamaroneck Avenue, Harrison, NY**

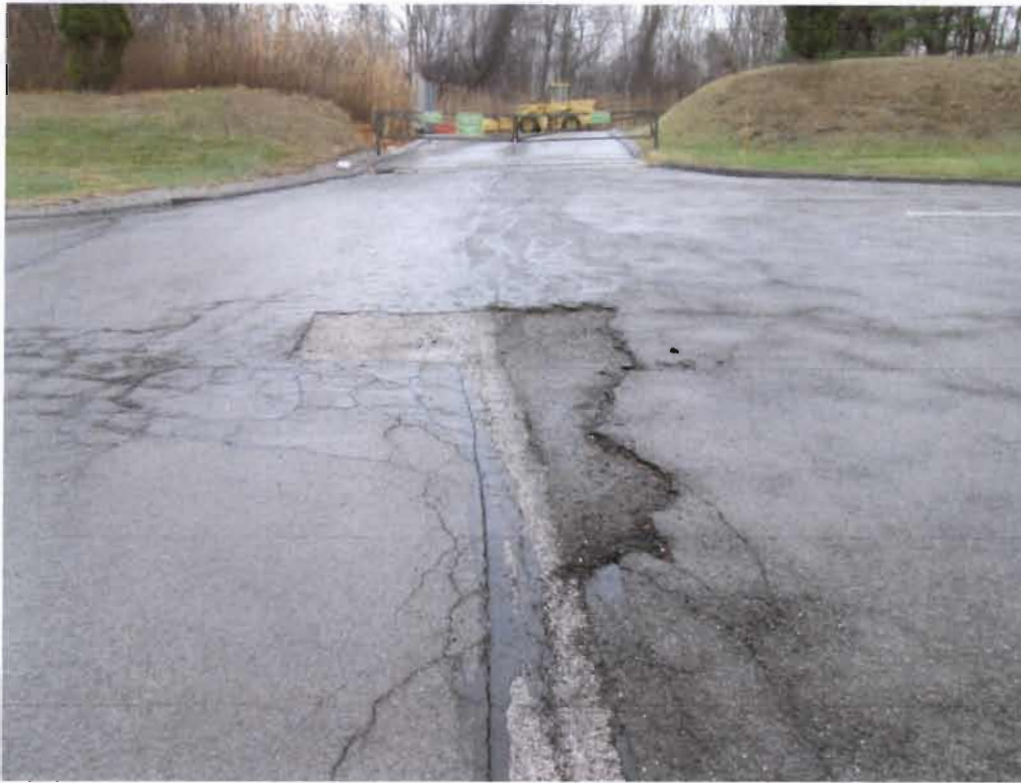
Area 1: At the southeast corner of the southern parking lot, CONECO observed an area approximately 10-feet long and 18-inches wide where the top layer of asphalt has deteriorated. The base course of asphalt in this area is intact acting as a protective barrier to ensure no direct exposure to underlying fill material. Corrective Action to this area will be performed in the Spring of 2014, by replacing the top course of asphalt pavement.

Southeast corner of parking lot, top layer peeling (10-feet by 18-inches), base layer intact, to be repaired in Spring 2014.

Corrective Action will be performed on the three (3) above identified areas, (**Area 1, Area 2, and Area 3**) in the Spring of 2014, by replacing the top course of asphalt pavement. No other Corrective action is recommended at this time.

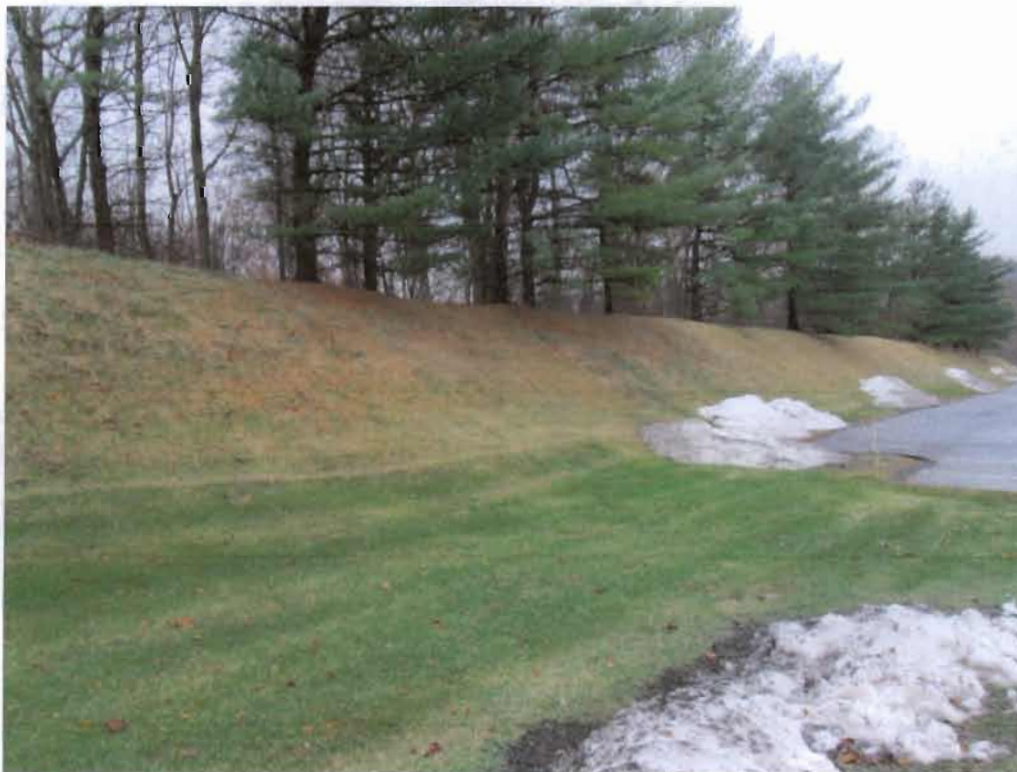
Southern Berm area in very good condition, no erosion observed.

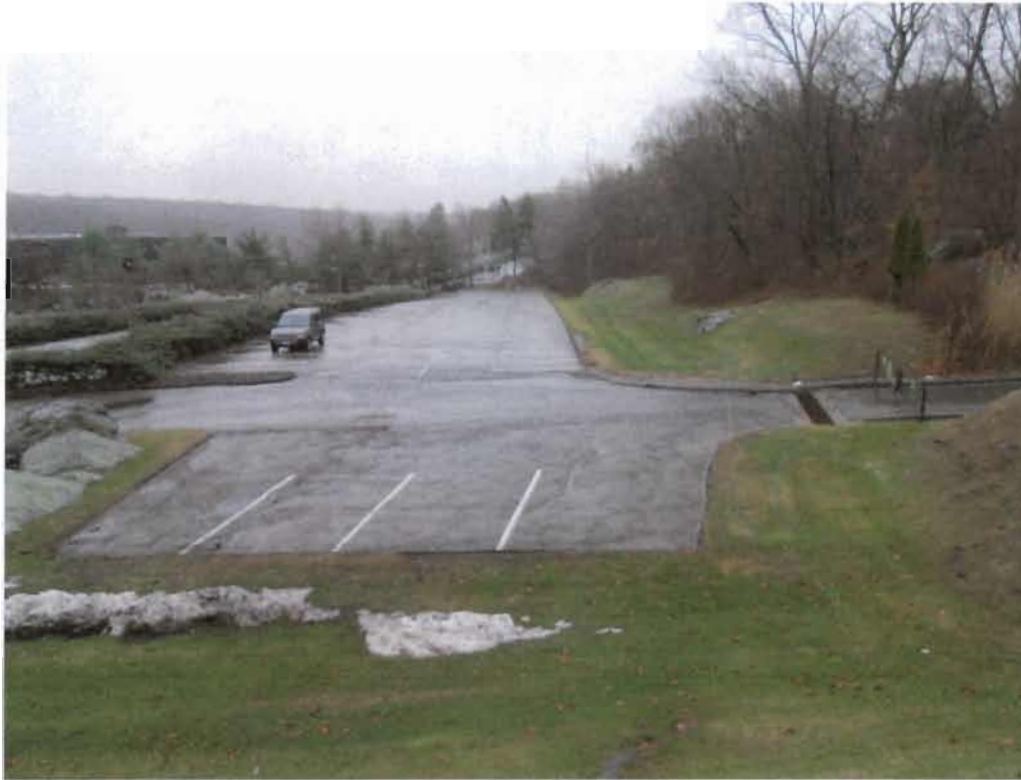
Parking Lane 8, southern upper parking lane observed to be in very good condition.

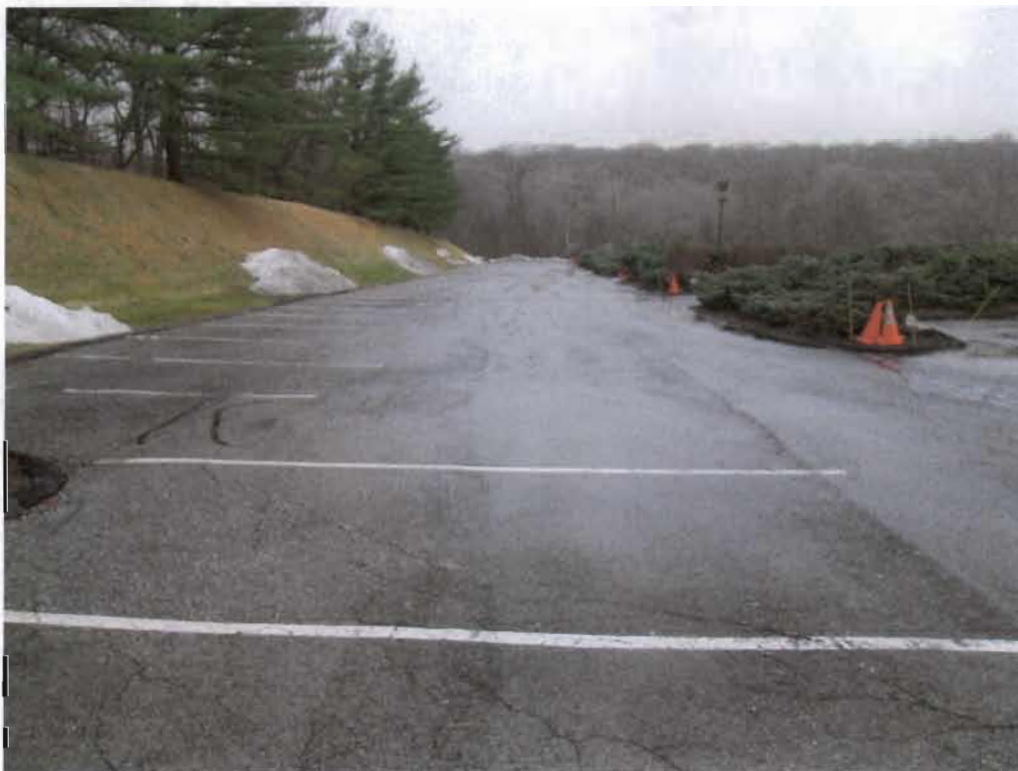
View looking west along southern edge of asphalt parking lot. One area to be repaired see next page, no other cracks or erosion observed.

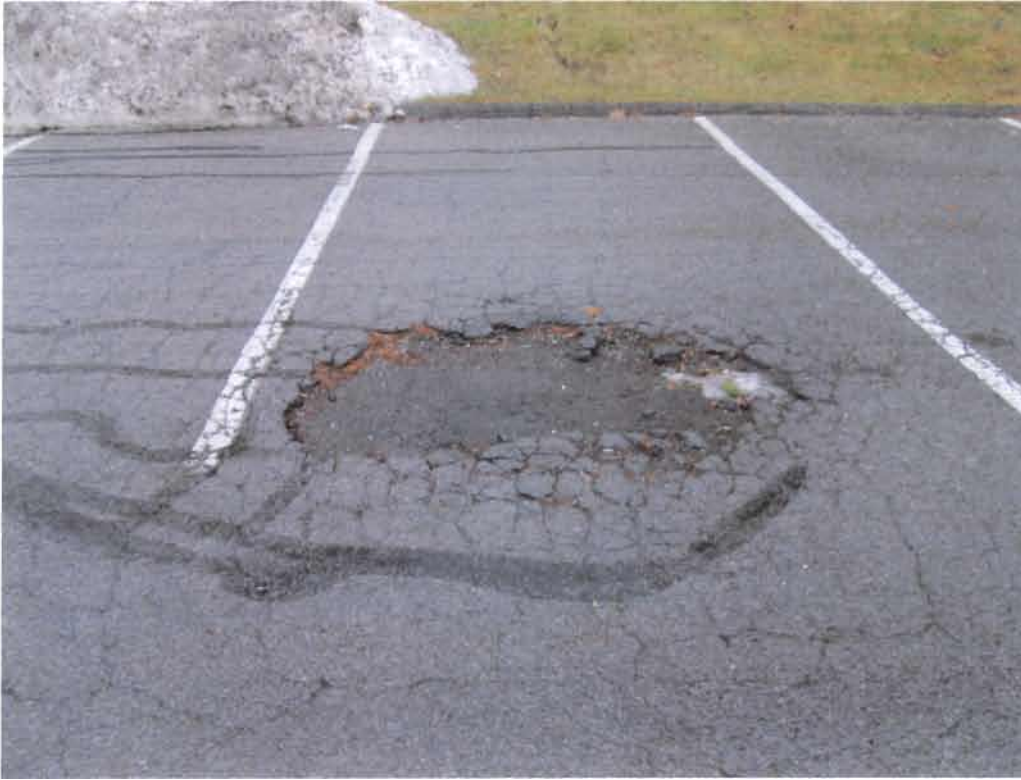
Area 2: At the south end of Parking Lane 6, located on the south side of the Site building, CONECO observed an approximately 3-foot diameter deteriorated section of the asphalt paved parking lot. The top course of asphalt is in pieces and some has washed away. The base course of asphalt in this area is intact acting as a protective barrier to ensure no direct exposure to underlying fill material. Corrective Action to this area will be performed in the Spring of 2014, by replacing the top course of asphalt pavement.

3-foot diameter repair area at south end Parking Lane 6, south side building, to be repaired in Spring 2014. Base layer intact.

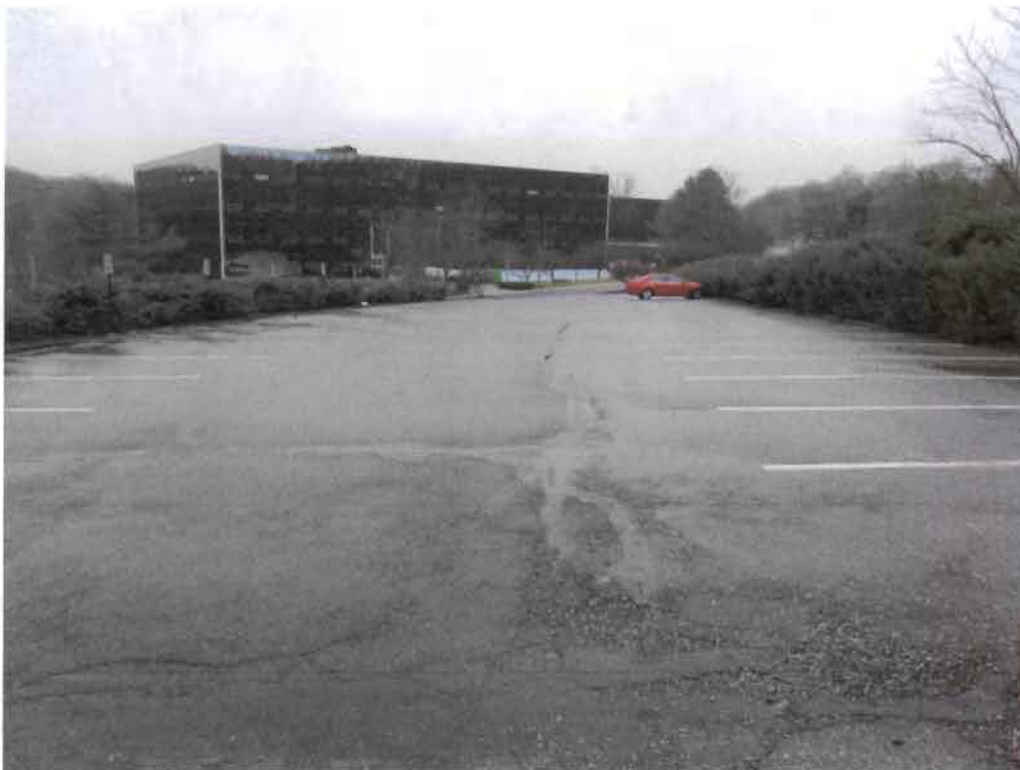
Parking Lane 3, south side building, in very good condition no repairs.

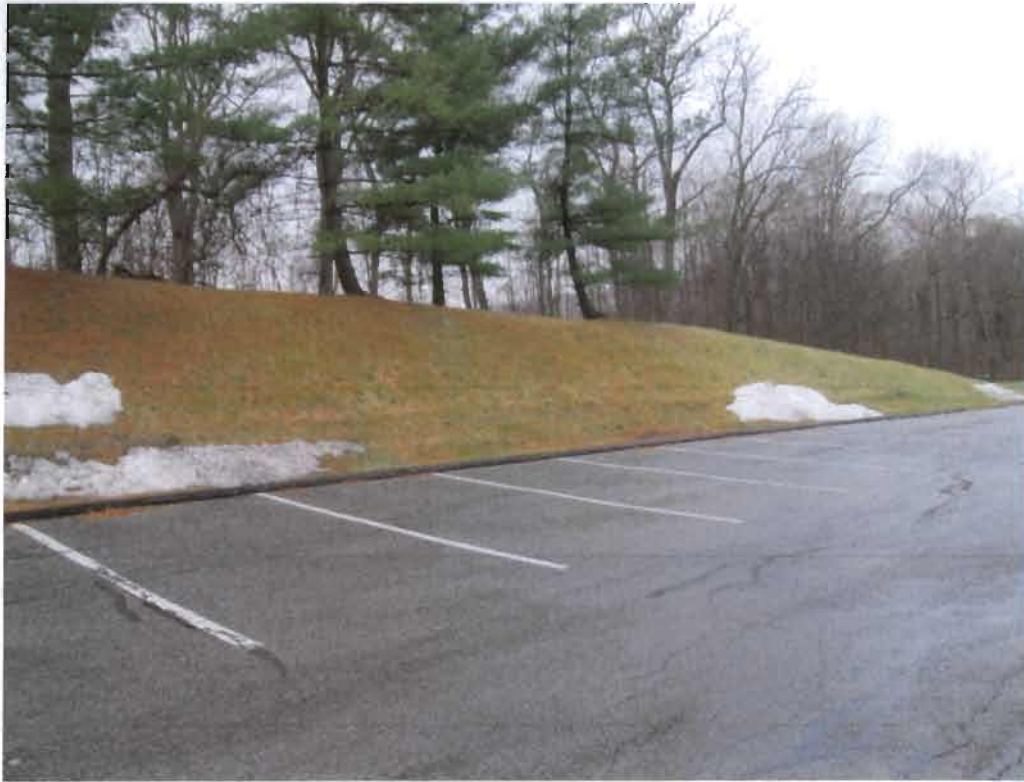
Southwestern Berm in very good condition, no repairs.

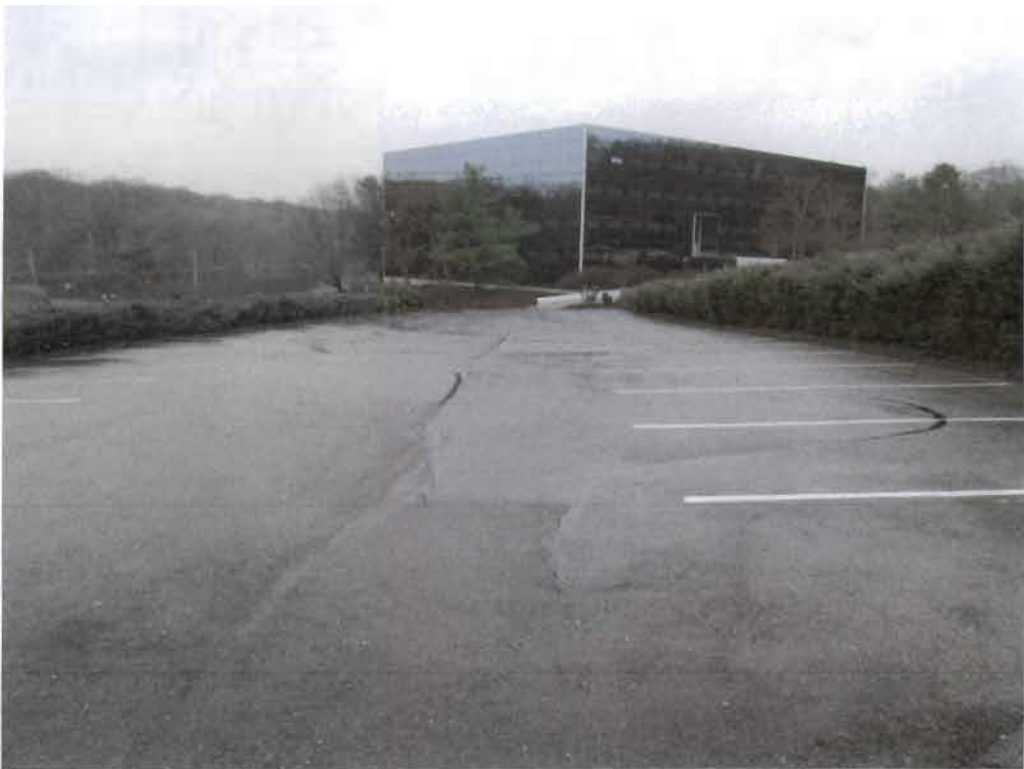
Parking Lane 2, south side building, very good condition no repairs.

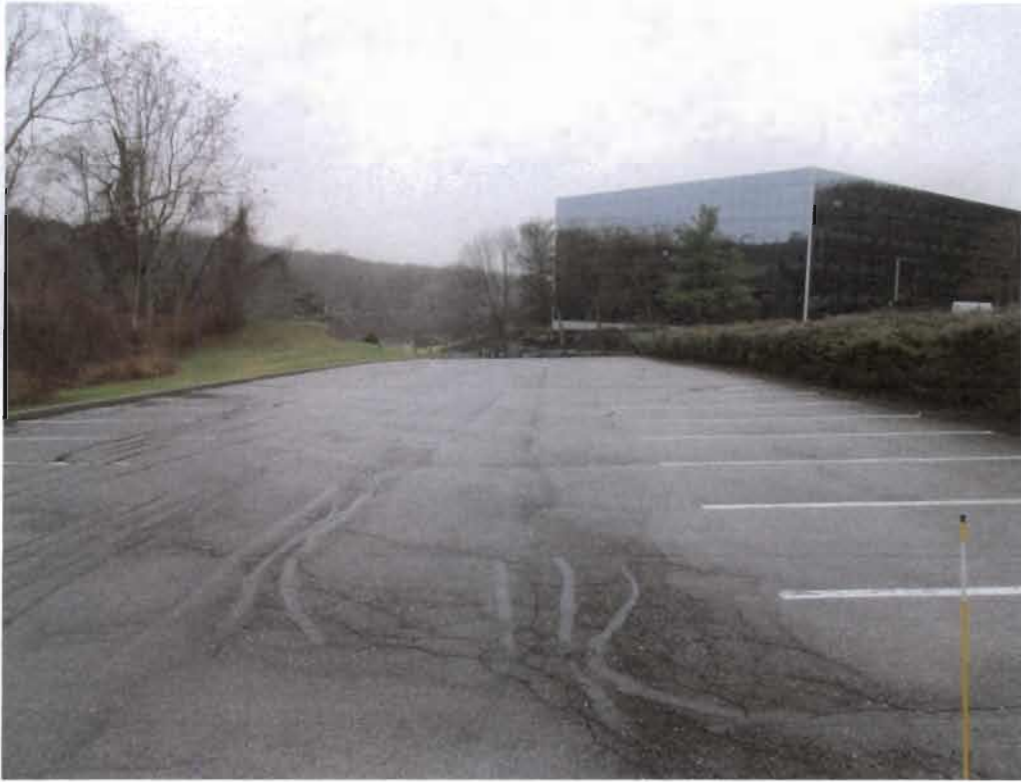
Parking Lane 1, south side of building, very good condition with one repair see below.

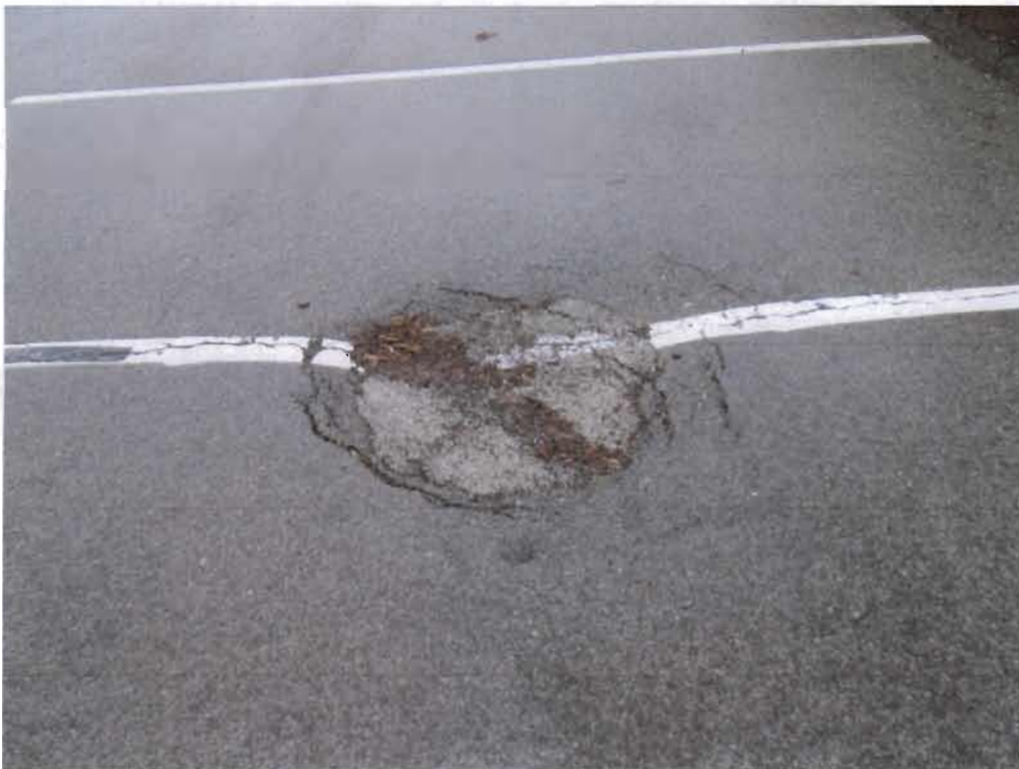
Area 3: At the middle of Parking Lane 1, located on the south side of the Site building, CONECO observed an approximately 2-foot diameter depression in the asphalt. This area has been patched to prevent further deterioration. The asphalt in the depression is intact acting as a protective barrier to ensure no direct exposure to underlying fill material.

Parking Lane 1, south side building, approximately 2-foot diameter sink-hole, base layer intact, repair in Spring 2014.

Corrective Action to this area will be performed in the Spring of 2014, by filling the depression, approximately 3-inches deep, and replacing the asphalt pavement.

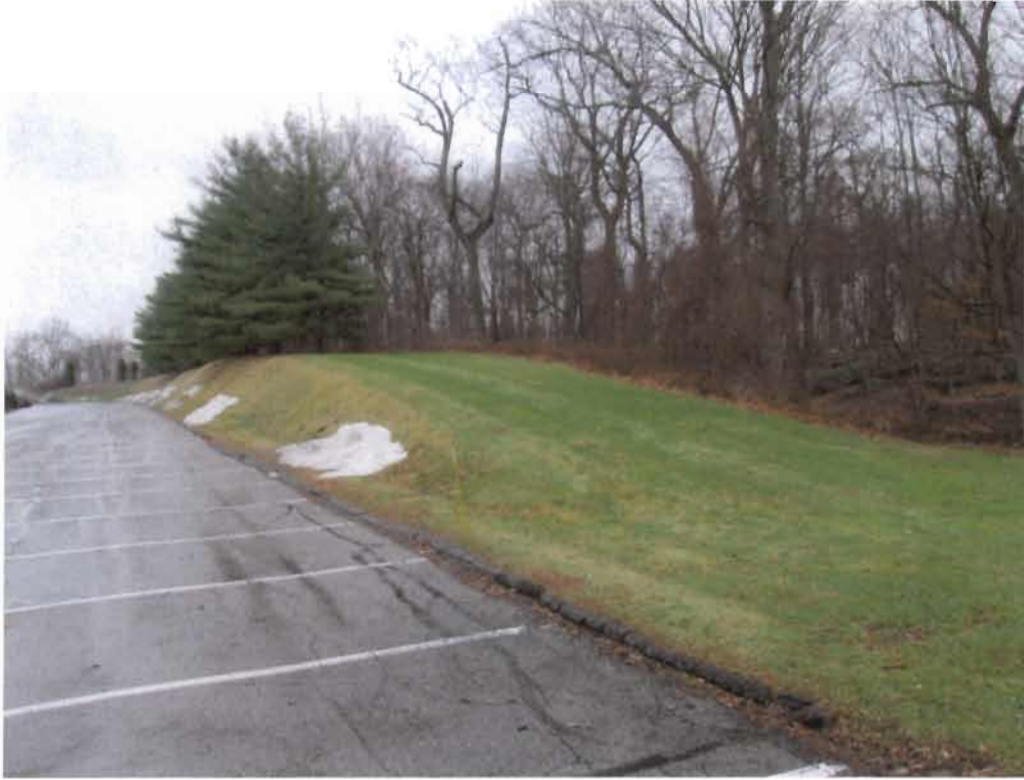
Southeastern Berm, very good condition, no erosion.

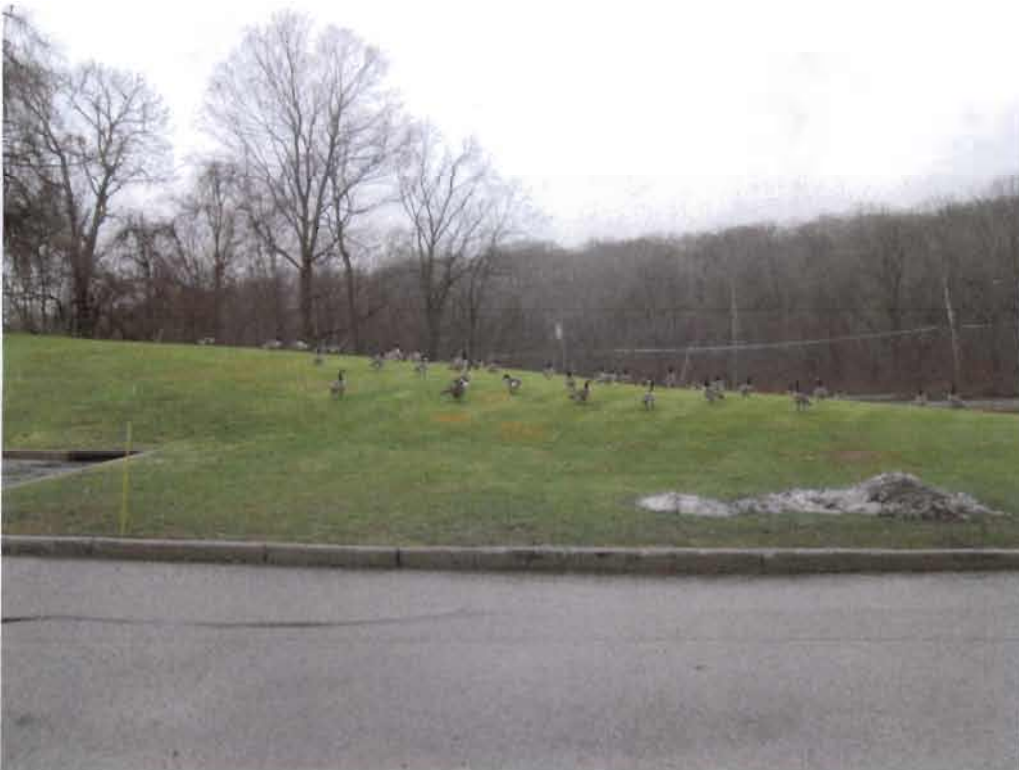
Southwestern corner of Site, very good condition no repairs.

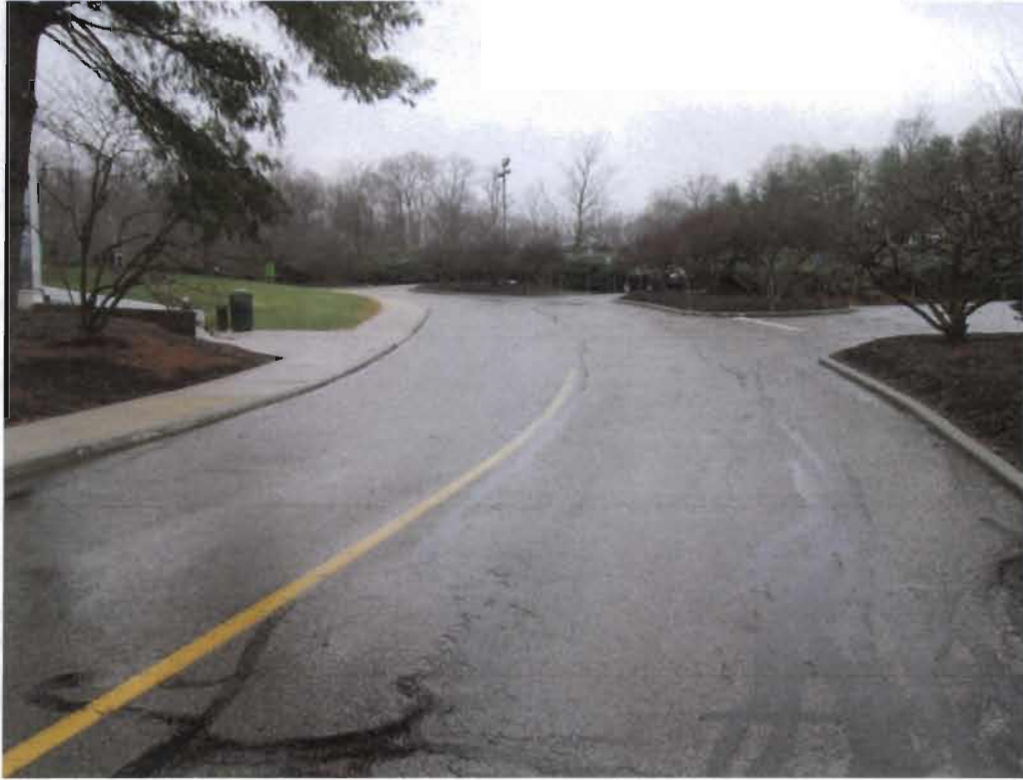
Driveway along south side of building, very good condition.

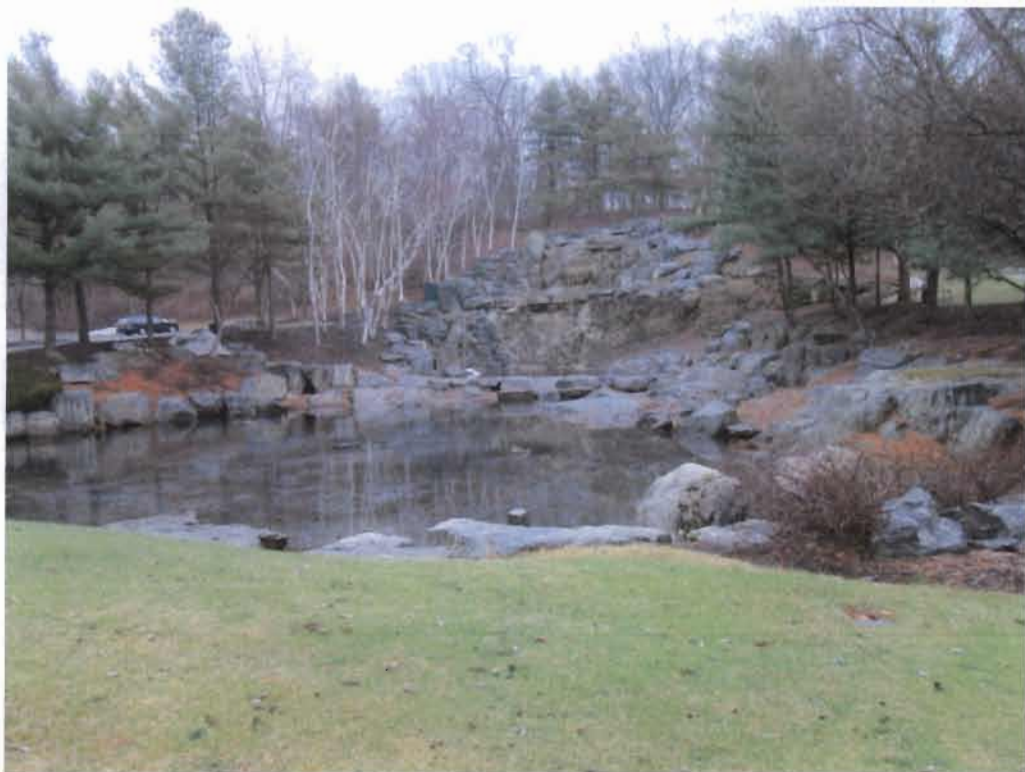
Pond area, very good condition no erosion.

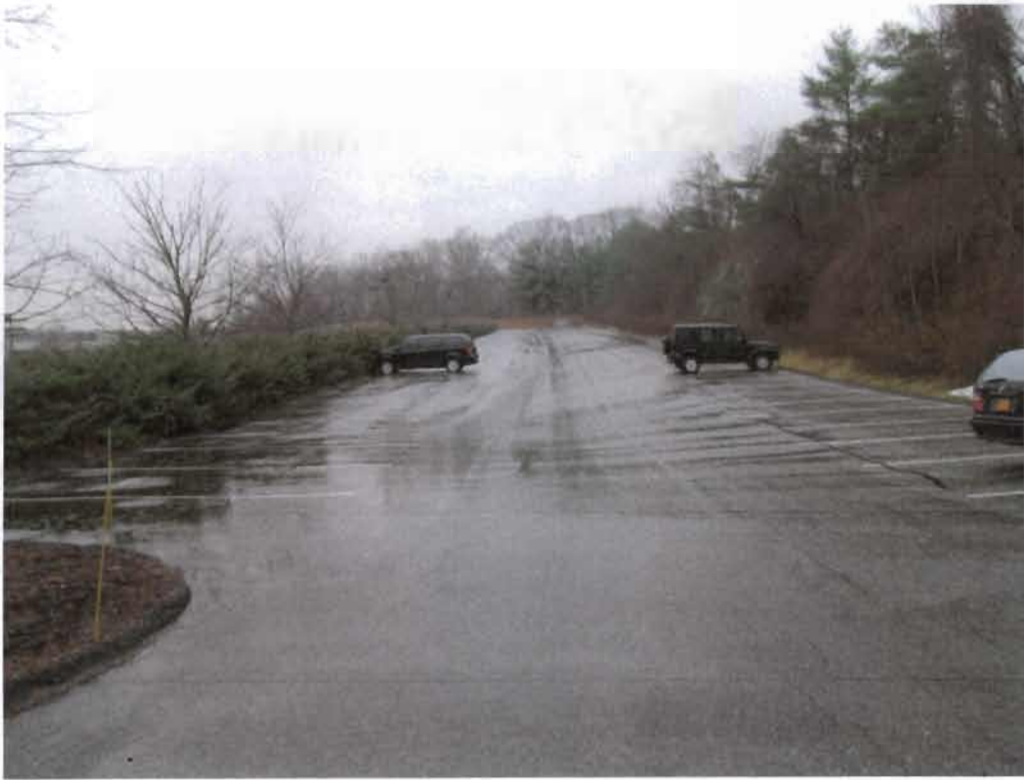
Parking Lane 6, north side of building, very good condition.

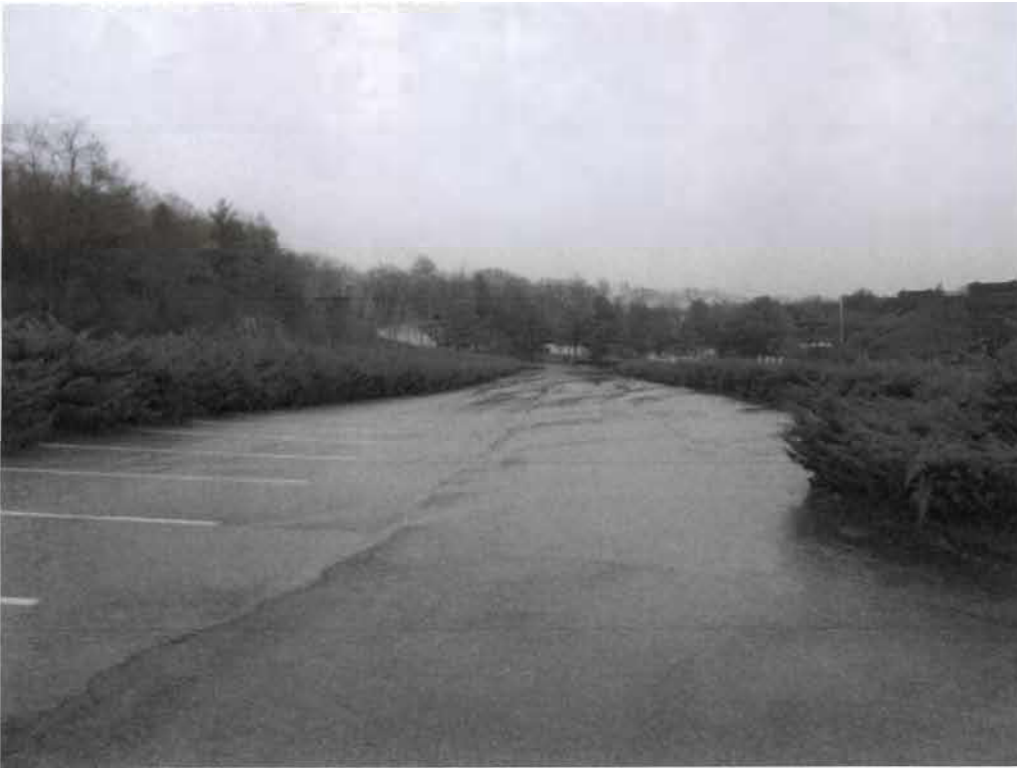
Parking Lane 5, north side of building, very good condition.

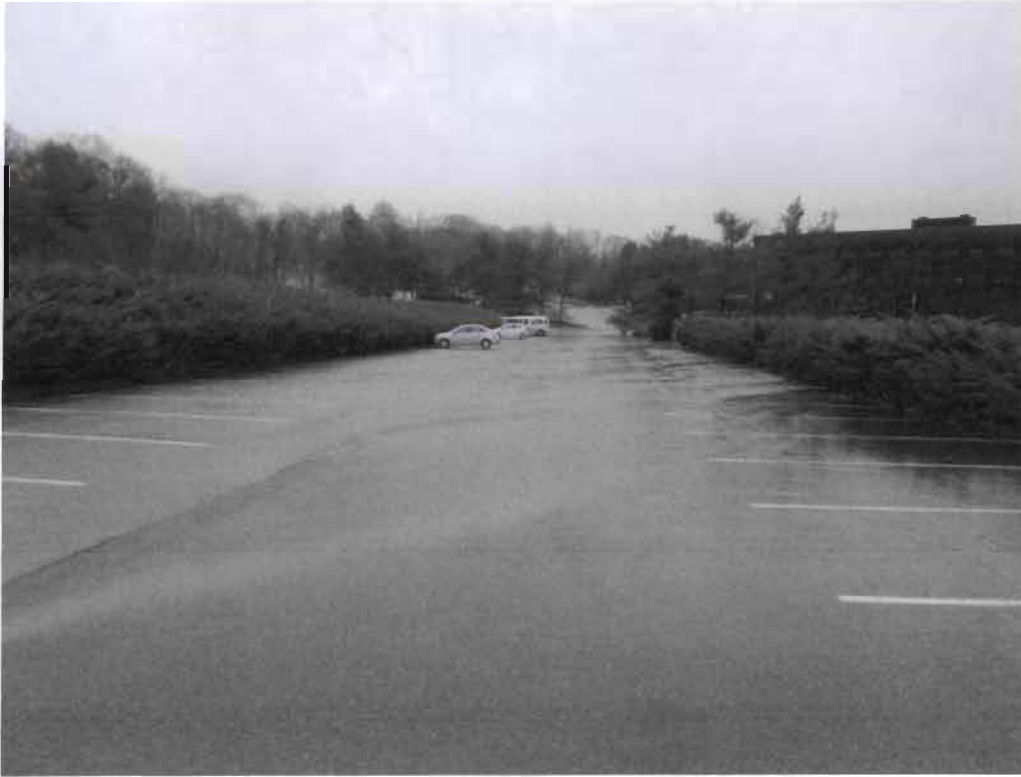
Parking Lane 4, north side of building, very good condition.

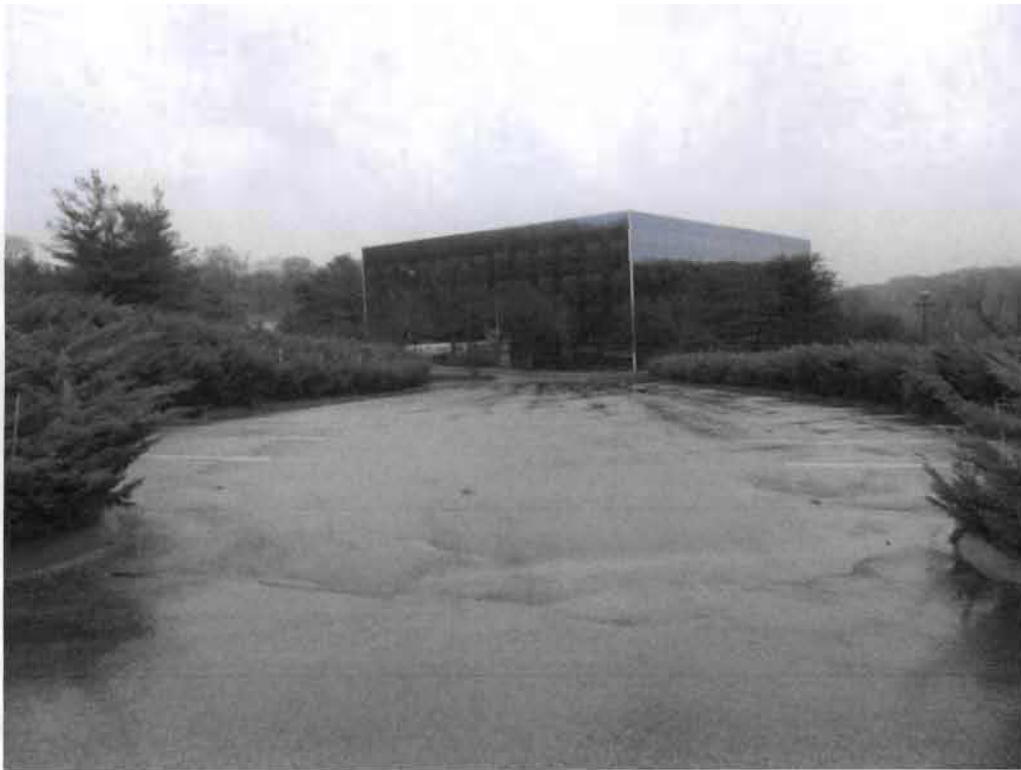
Parking Lane 3, north side of building, very good condition.

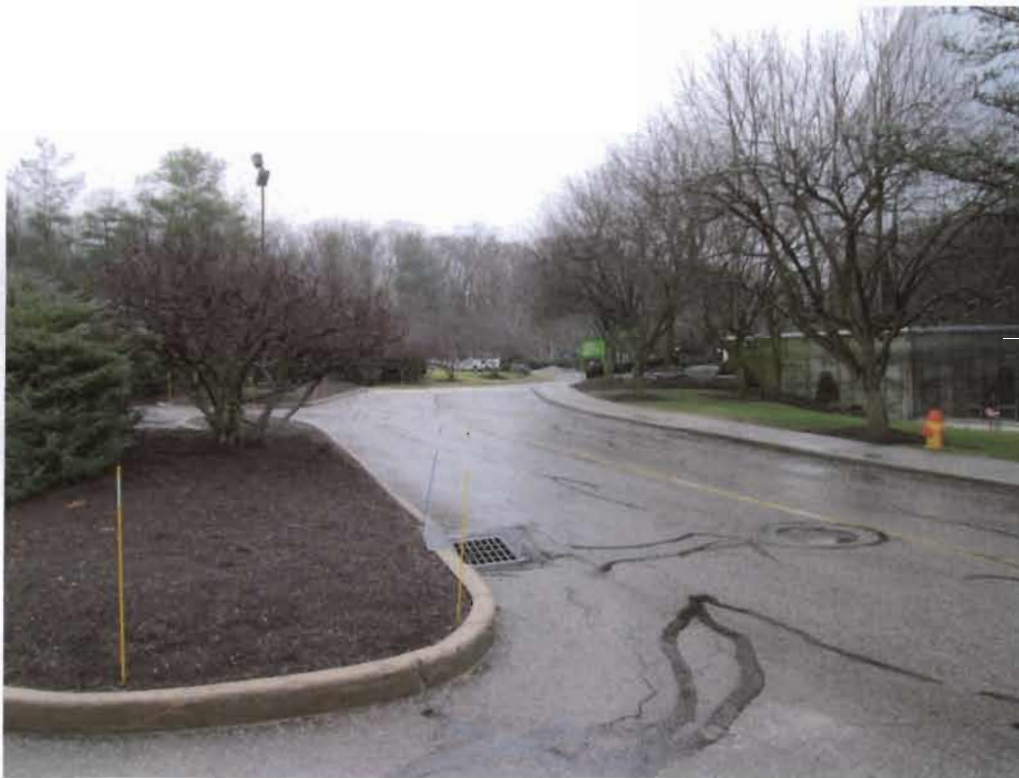
Driveway on north side of building, very good condition.

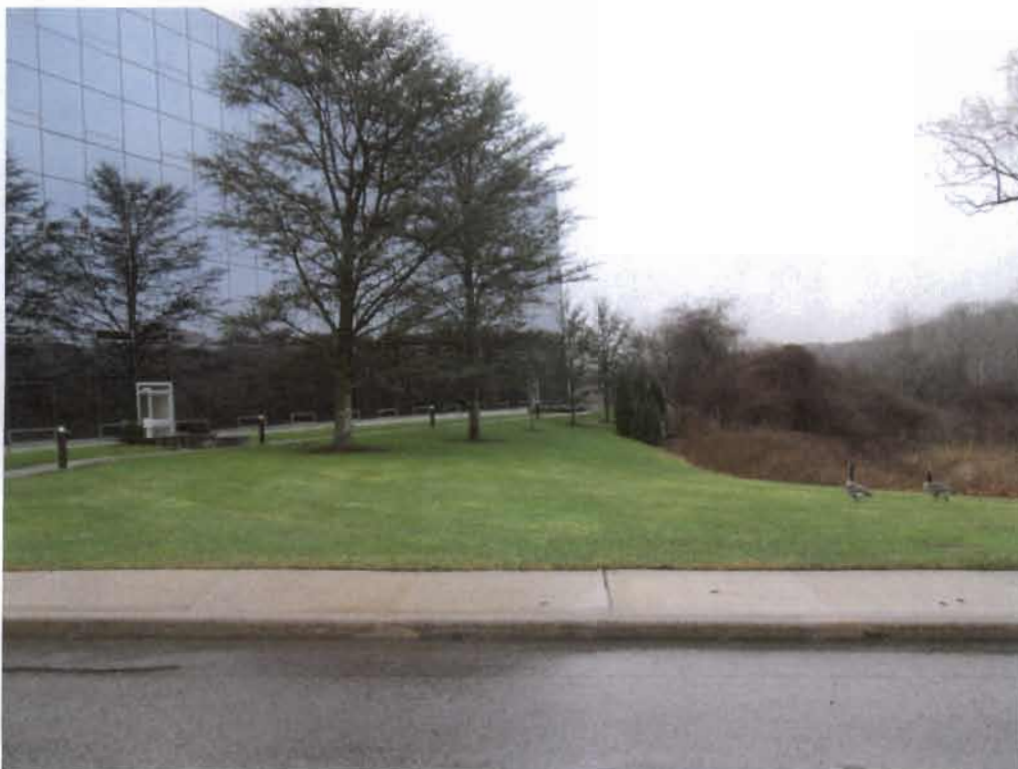
Landscaped area west of building, very good condition, no erosion.
