Re: Site Management Periodic Review Report
And IC/EC Certification Submittal
Brewer Street Site (V00214-8)
Rochester, NY

Site Management Periodic Review Report and IC/EC Certification

Brewer Street Site (V00214-8)
Rochester, New York

Project 1326870

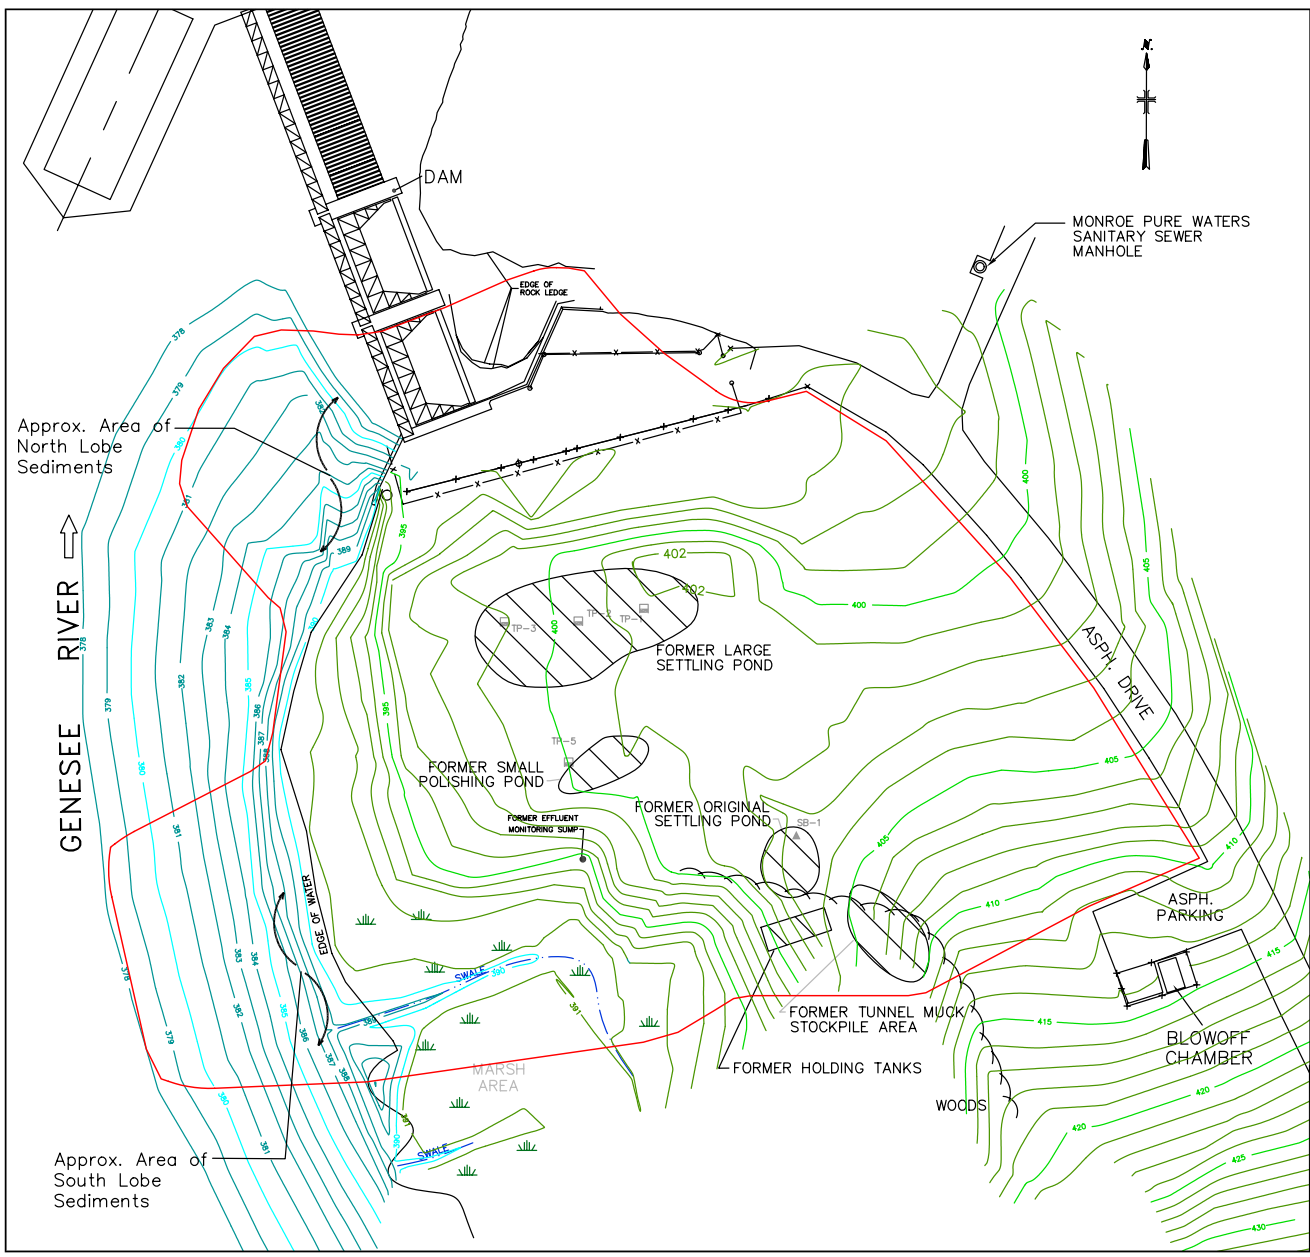
Figure
 2

As shown on Figure 1, the Site is located adjacent to the Middle Falls Dam in the Genesee River Gorge in Rochester, NY. The Site plan showing pre-remediation topography and features is shown on Figure 2. The approximate 3.25-acre Site was used to manage tunnel cuttings (i.e., “tunnel muck”) and waters (i.e., “construction water”) generated when the Cliff Street Siphon Tunnel was constructed under the Genesee River as part of the Monroe County Pure Waters Combined Sewer Overflow Abatement Program between 1984 and 1985. The tunnel muck and construction water were transferred to the Site and treated using settling and polishing ponds prior to effluent discharge. The tunnel muck contained aromatic volatile organic compounds (VOCs) including benzene, toluene, ethylbenzene and xylene (BTEX), and polyaromatic hydrocarbons (PAHs) in the aqueous phase and a dense non-aqueous phase liquid (DNAPL).

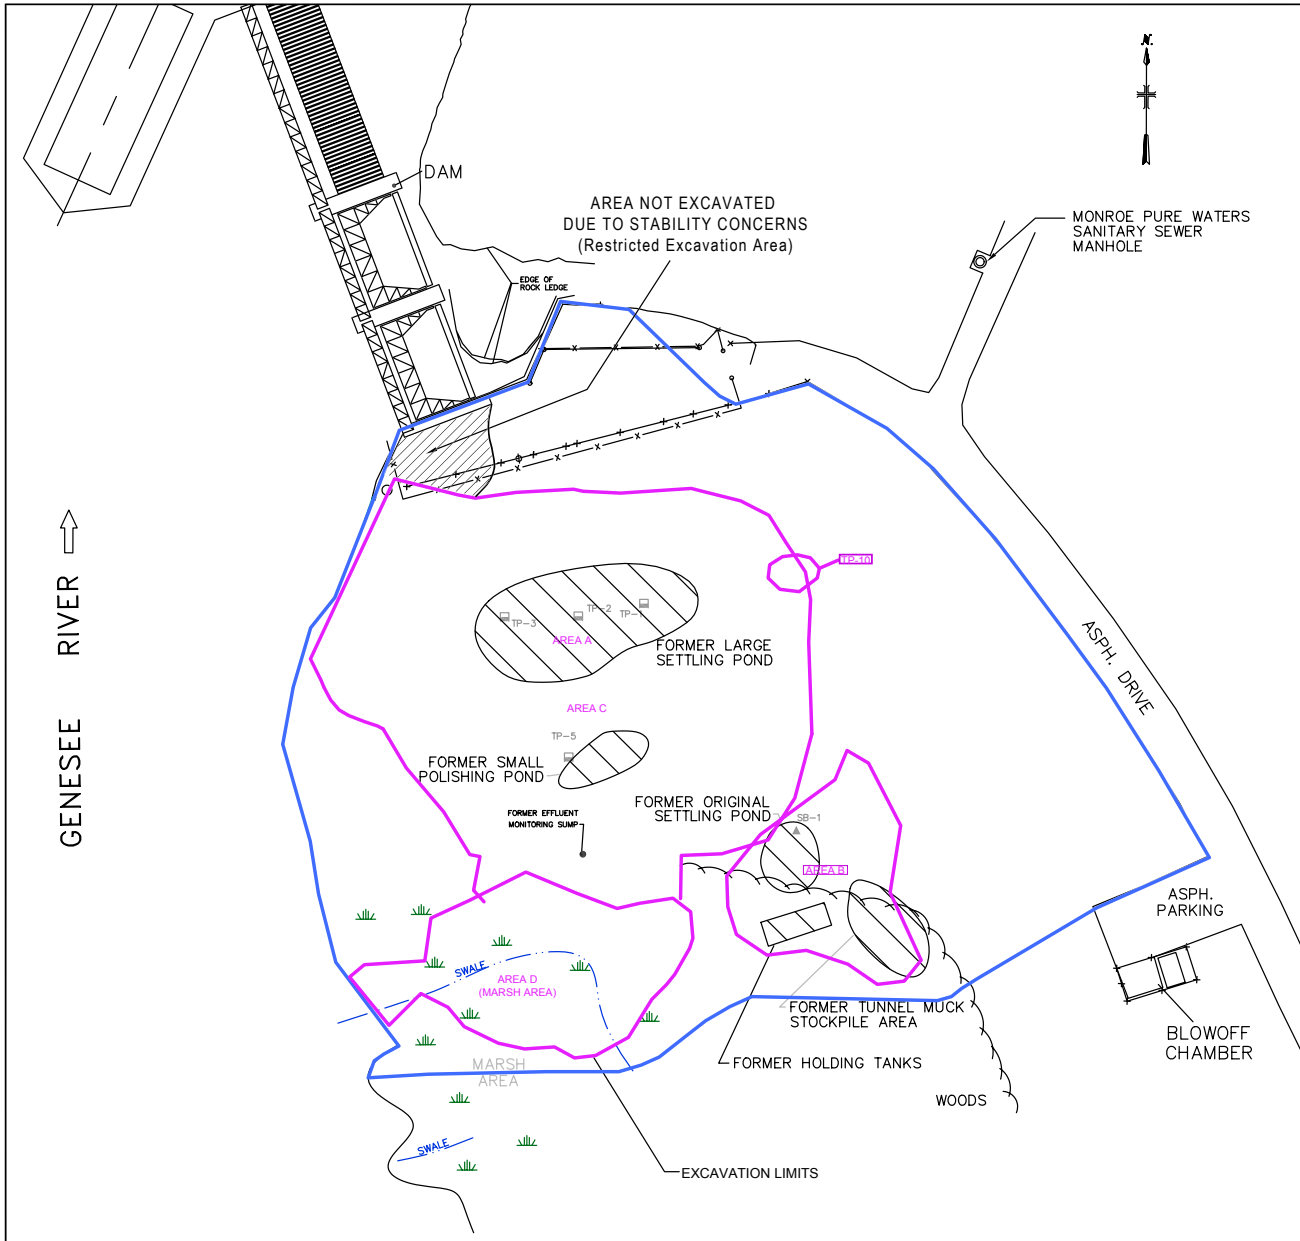
Figure
3

Soils excavation proceeded until cleanup objectives were attained at all locations. River sediments were excavated to bedrock within the areas designated for remediation in the approved RWP. A total of 62,195 tons of soils, weathered bedrock and sediment were removed from the Site between July 23, 2003 and October 10, 2003. The soil excavations were backfilled with clean soil and the Site was graded in accordance with the approved grading plan presented in the RWP. The 2003 remediation soil excavation areas are shown on Figure 3.

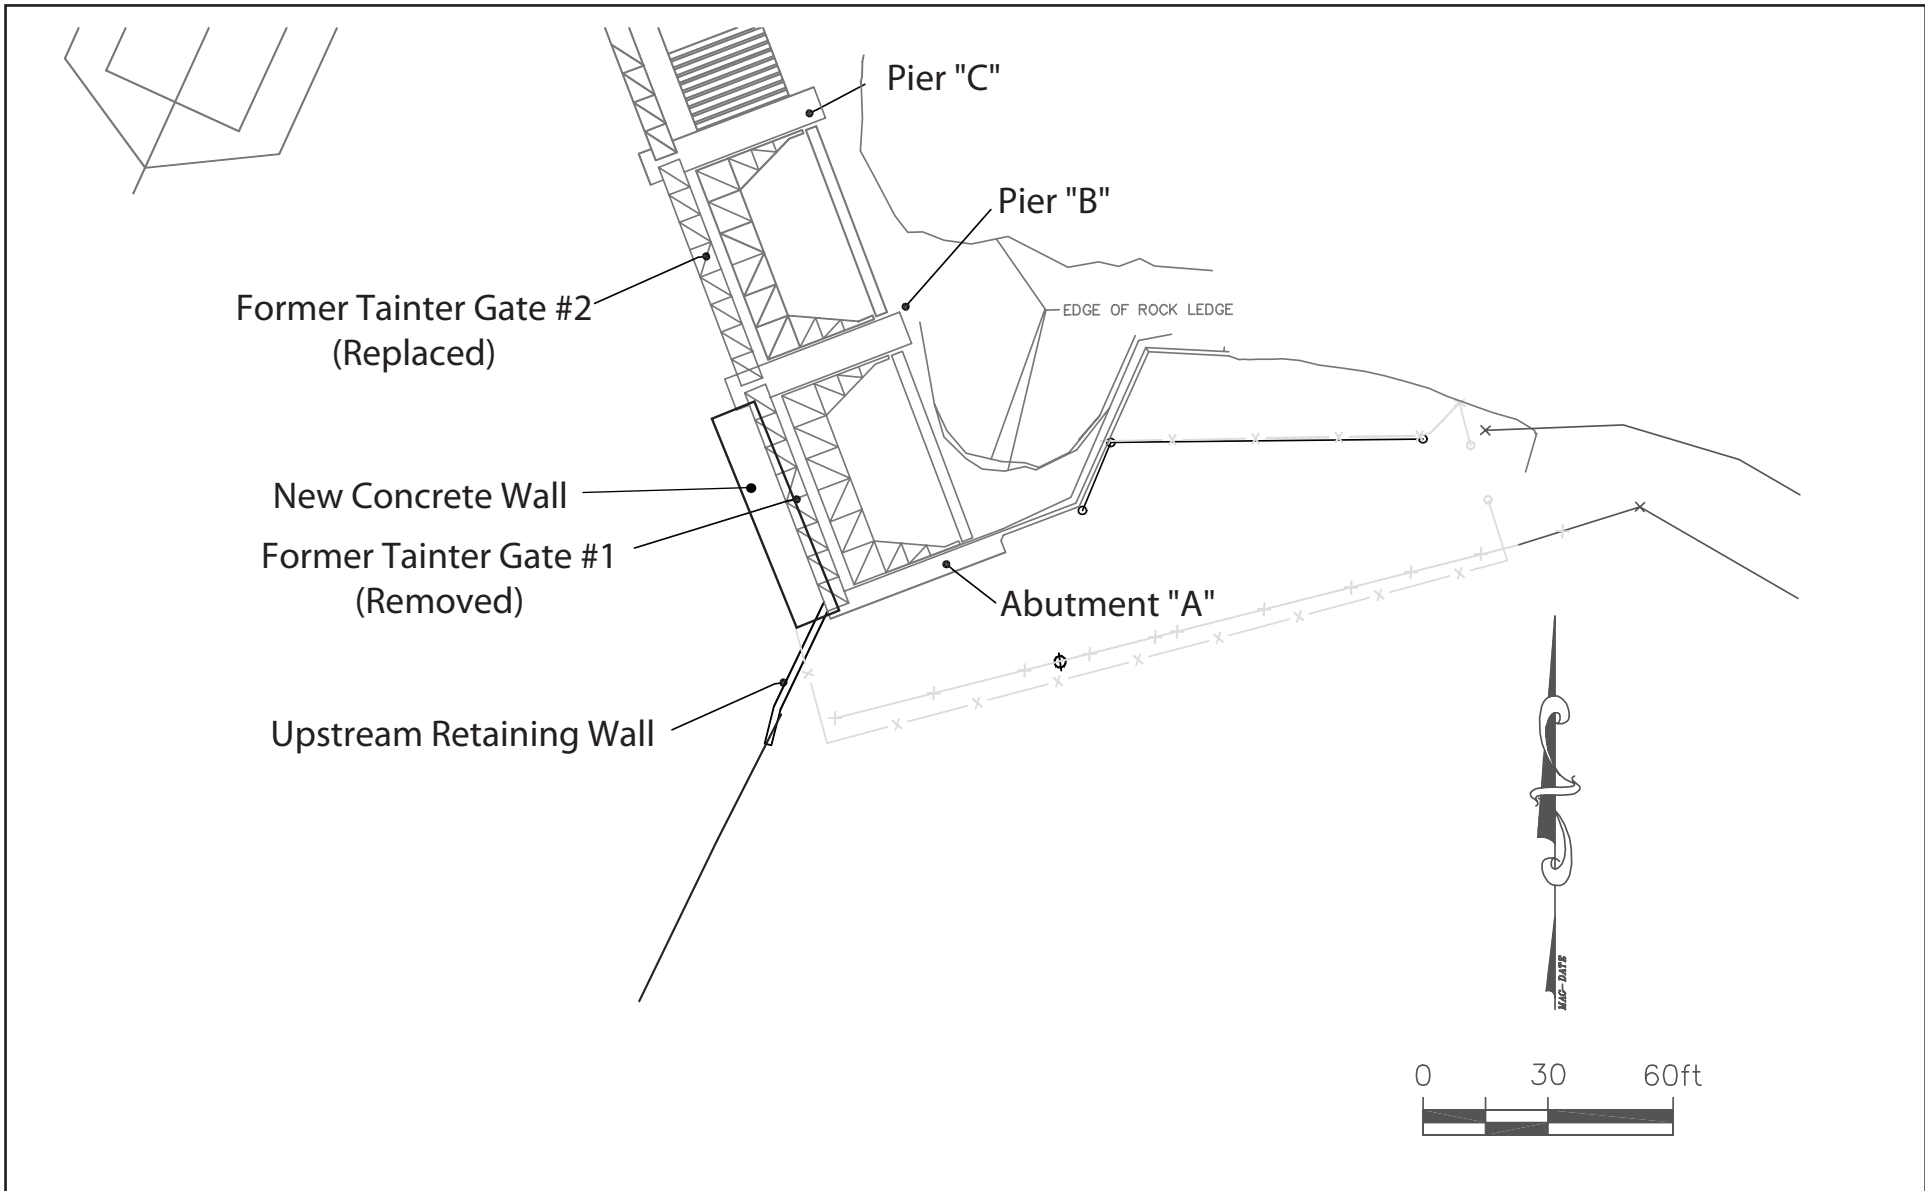
Figure
 4

between the eastern dam headwall (Abutment A) and Pier B (Rock Ledge). This area of the Site is shown on Figure 4. The 2006 remediation utilized grout injection to:

1. Displace mobile DNAPL upward to the Rock Ledge containment area (where it was removed); and
2. Immobilize any residual DNAPL presence within the bedrock fractures.

After completion of the pressure grouting and removal of displaced DNAPL, the Rock Ledge surface was sealed by capping with reinforced concrete constructed to withstand uplift force associated with the reservoir “pond level” behind the adjacent dam. In addition, the Rock Ledge Cap was designed to accommodate backfill and a new support wall required to stabilize Abutment A. The new support wall was constructed in 2007 from Pier B to Abutment A along the northern side of the Rock Ledge Cap.
