Ballpark at St. George Stadium – North Site 1

New York Wheel

December 15, 2014 to April 23, 2021 Periodic Review Report

NYSDEC VCP Site Number V00228

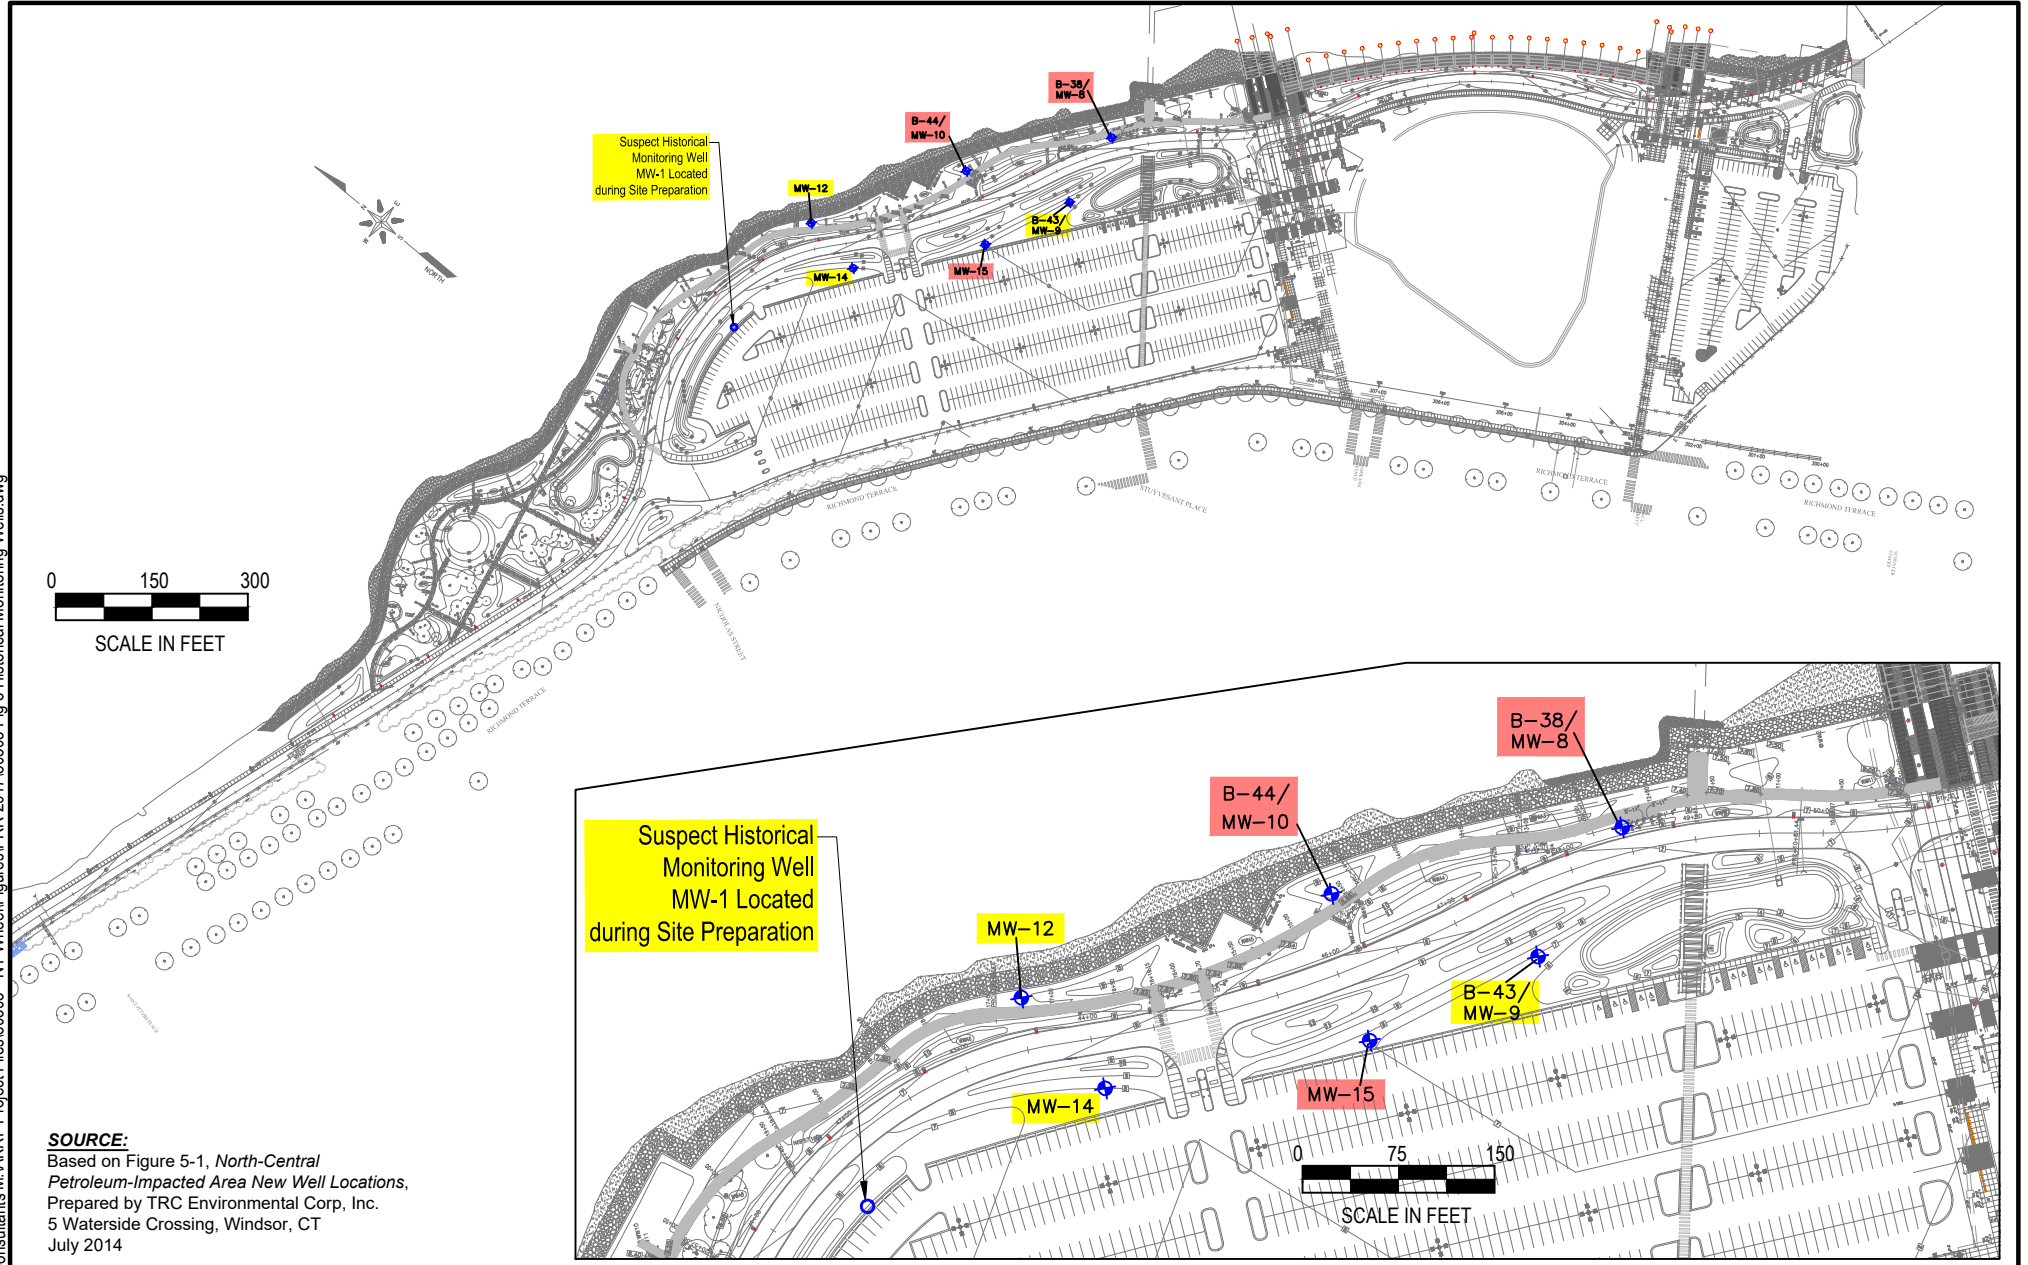
DATE 7/19/2017
PROJECT NO. 80305
FIGURE 3

As directed by NYSDEC, wells MW-9, MW-12 and MW-14 and suspected MW-1 were properly closed in accordance with NYSDEC Well Decommissioning Policy CP-43. The closure was conducted on April 8, 2015 prior to the start of major construction activities, which would otherwise damage and/or destroy the wells. The wells were filled with bentonite to within five feet of ground surface, the well cap was removed, the top one to five feet of well casing were cut and removed, and the remainder of the well was filled with bentonite to the ground surface. The former wells were then covered with asphalt patches. Construction diagrams for the historical wells are provided in Appendix K, and locations of the historical wells are provided on Figure 3.

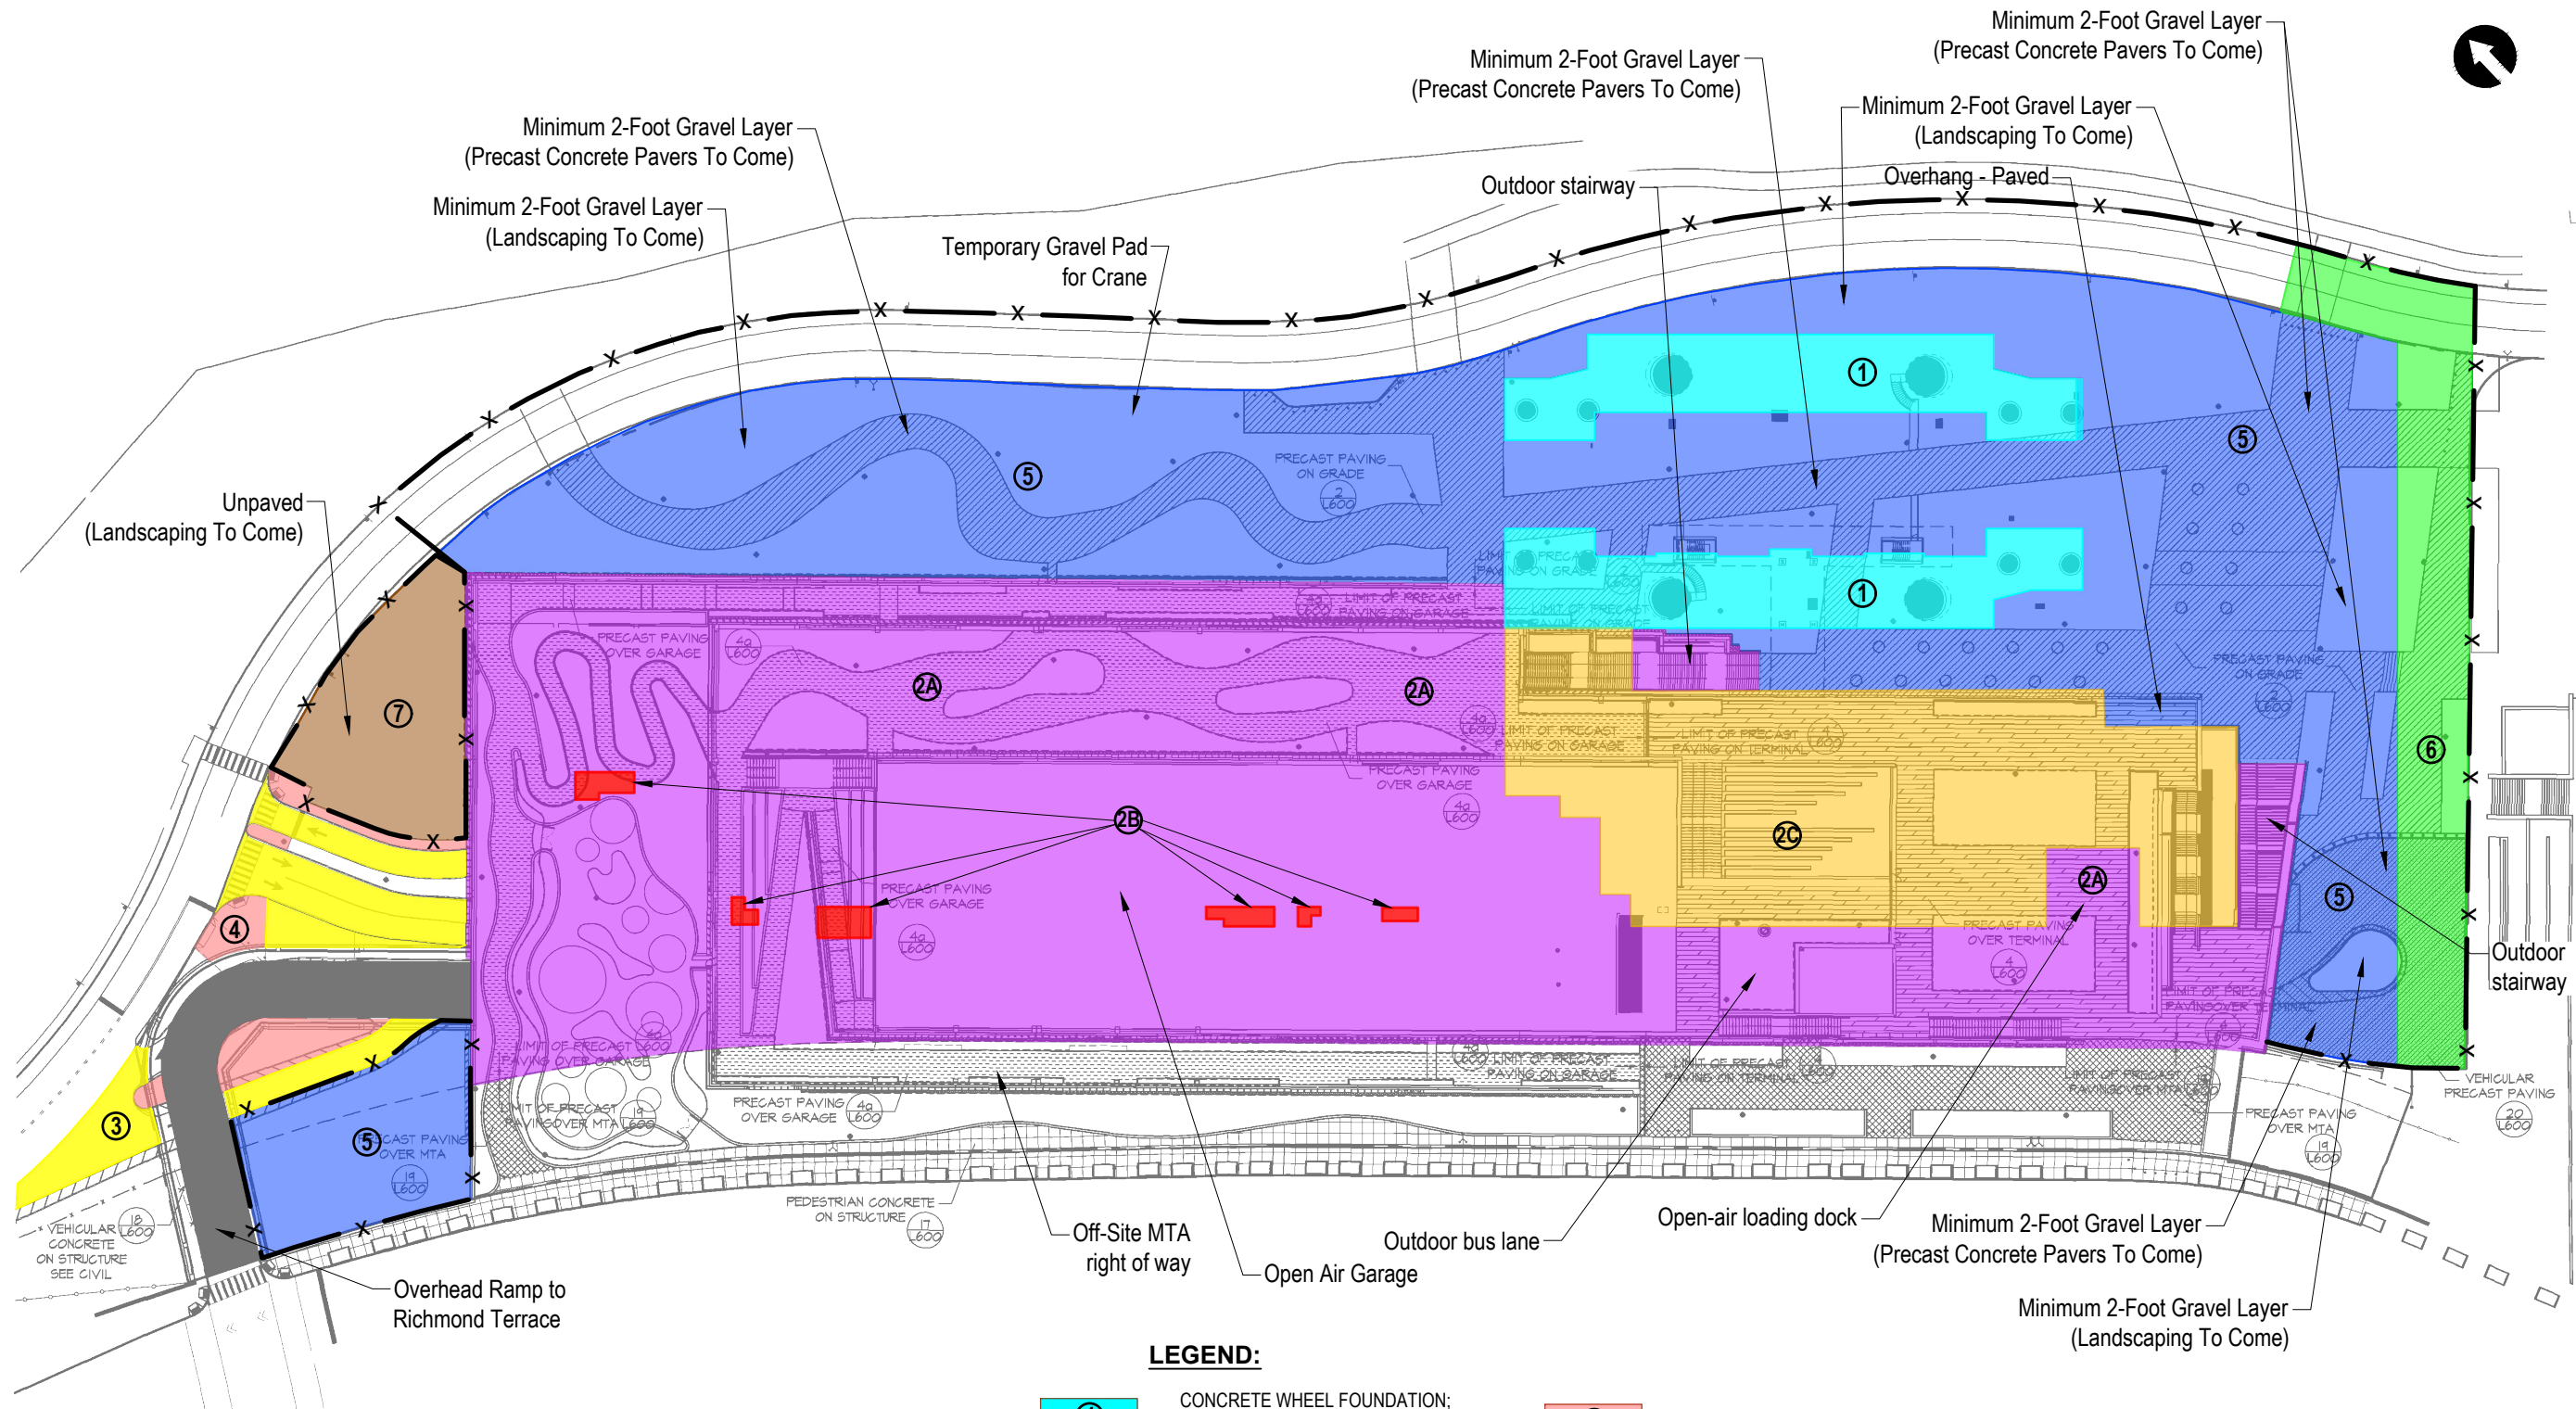
FIGURE
5

using a PID. No buried petroleum storage tanks, drums or other containers were encountered. Construction beneath the Site cover began in December 2014 and continued through September 2017. No further soil disturbance occurred on NS1 through the end of the current reporting period. As of April 23, 2021, the entire historical cover of NS1 had been removed, and portions of the new NS1 cover consisting of concrete foundation elements and asphalt and concrete pavement have been constructed on NS1, as shown on Figure 5. A temporary site cover on most of the NS1 exterior area (consisting of a minimum of two feet of imported gravel, as shown on Detail 5 of Figure 8), and a small unpaved area in the western portion of NS1 (consisting of original on-site soil/fill, as shown on Detail 7 of Figure 8), are also shown on Figure 5.

The Garage, Terminal Building and Wheel concrete foundations were constructed, as shown on Figure 5, and will serve as part of the demarcation layer. Per the SMP, a physical demarcation layer was not installed at the base of the excavations where concrete was placed. A demarcation layer will be placed below the clean soil cap in future landscaped areas.

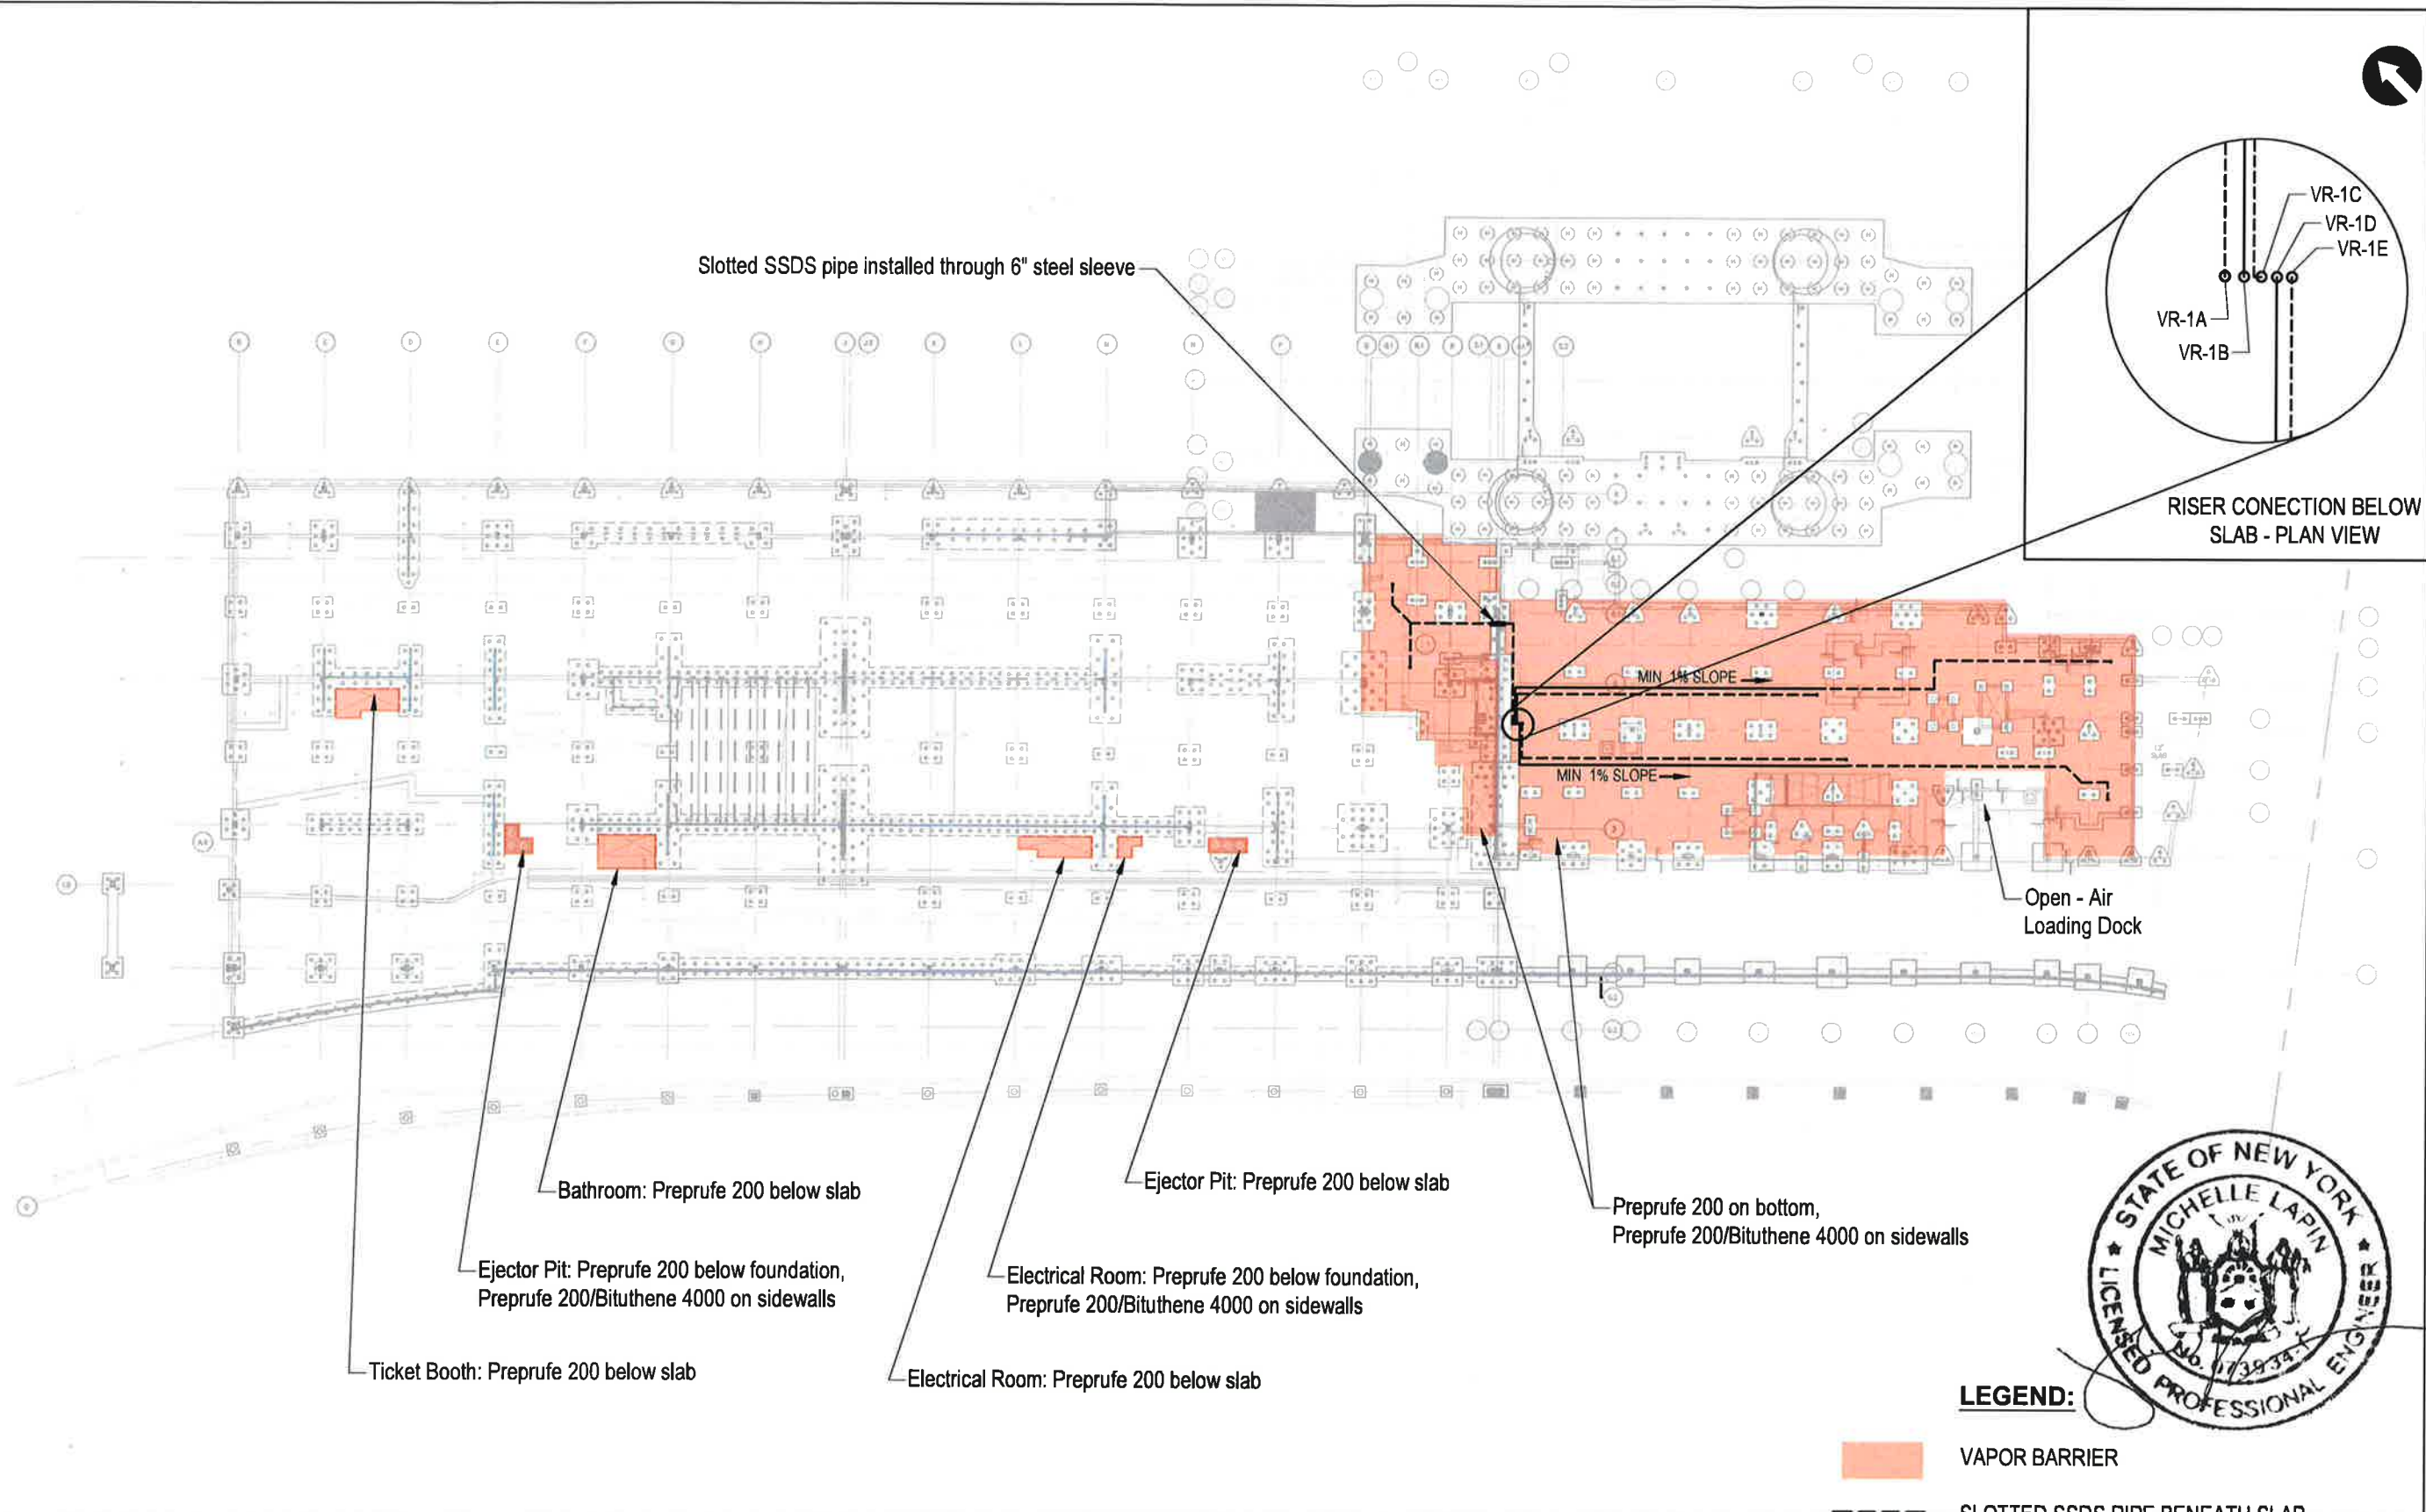
Two new structures have been constructed: the open-air parking garage; and the Terminal Building (whose interior has been only partially completed). The Wheel foundations were also constructed. A vapor barrier (described below) was installed beneath the foundations and below-grade sidewalls of the Terminal Building. A vapor barrier was also installed beneath a small area in the eastern portion of the garage, which is enclosed and connected to the Terminal Building, and other ground-level enclosed garage spaces (several small utility rooms and a bathroom), to prevent the potential intrusion of subsurface vapors. The Wheel foundations contain no below-grade enclosed spaces, and no at-grade enclosed spaces were proposed as part of the Wheel. A sub-slab depressurization system (SSDS) and a vapor barrier are not warranted for most of the proposed garage building, since it is open to air. A passive SSDS was installed beneath the Terminal Building, extending below the small portion of the garage that will be enclosed and connected to the Terminal Building by a doorway. By January 22, 2018, the vapor barrier and SSDS were installed, and the SSDS rooftop riser was temporarily capped with a Weathershield Marine chimney rain cap, which will be replaced with a wind turbine cap when building construction resumes. Vapor barrier specifications are included in Appendix C. As-built vapor barrier and SSDS details and locations are shown on Figures 6 and 7.

The majority of the vapor mitigation system on NS1 had been installed at the time of the inspection. The below-ground components of the SSDS system beneath an enclosed area in the eastern portion of the Garage and beneath the Terminal Building foundation had been constructed. Foundation slabs for enclosed areas of the Garage were underlain by Grace Preprufe[®] 200 vapor barriers, and below-grade sidewalls for Garage utility pits and a stairwell were lined with Grace Preprufe[®] 200 or Grace Bituthene[®] 4000 vapor barriers. In accordance with the manufacturer's recommendations, the vapor barriers extended approximately 12 inches beyond the footprint of the enclosed areas or (where the enclosed area extended to Garage walls) were terminated at the walls. The majority of the above-ground components of the SSDS system had been installed, with the exception of the wind turbine cap on the rooftop SSDS riser, which will be installed as building construction progresses. As-built SSDS and vapor barrier plans are shown on Figures 6 and 7.
