October 13, 2022
Project 2203514

**Re: Annual Inspection Methane Monitoring System and
Sub-Slab Depressurization System
Empire Outlets
55 Richmond Terrace, Staten Island, NY**

**Appendix B – Photo Log
Annual Inspection Report
Empire Outlets
55 Richmond Terrace, Staten Island, New York**

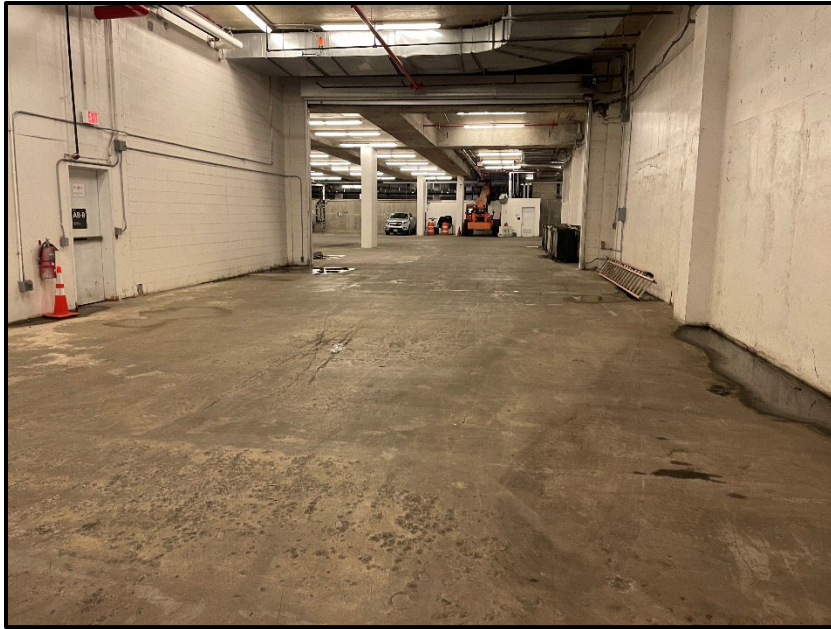
Visual inspection of the integrity of the site cover system was performed on September 14, 2022. The cover system consists of building slabs with vapor barrier, and paving materials along the waterfront esplanade. Although minor cracks were observed in the floor of the parking structure, no evidence of significant damage to the site cover or soil disturbance activities was observed. Facilities management at the site informed GEI that no soil disturbing activities have been

Photo 1. Site cover system inspection: parking level P1.

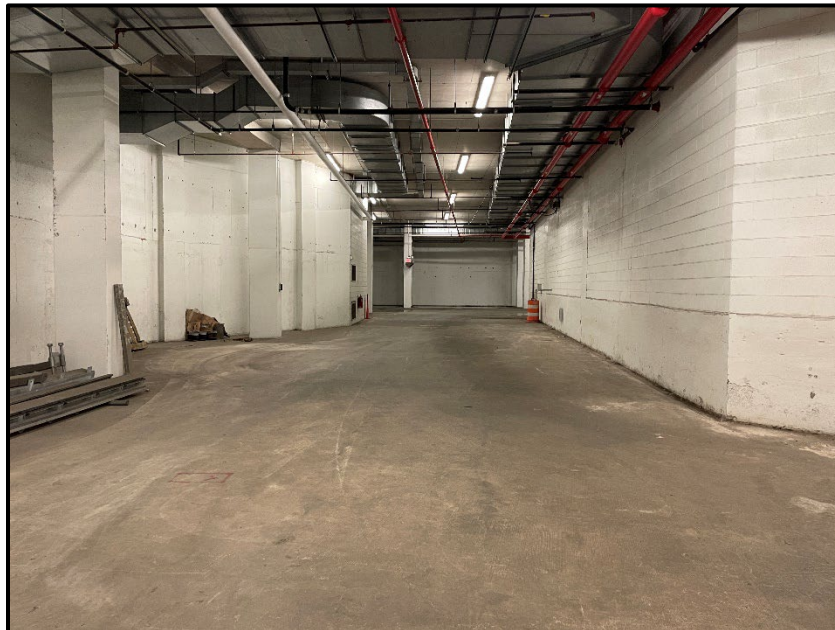
Photo 2. Site cover system inspection: parking level P1.

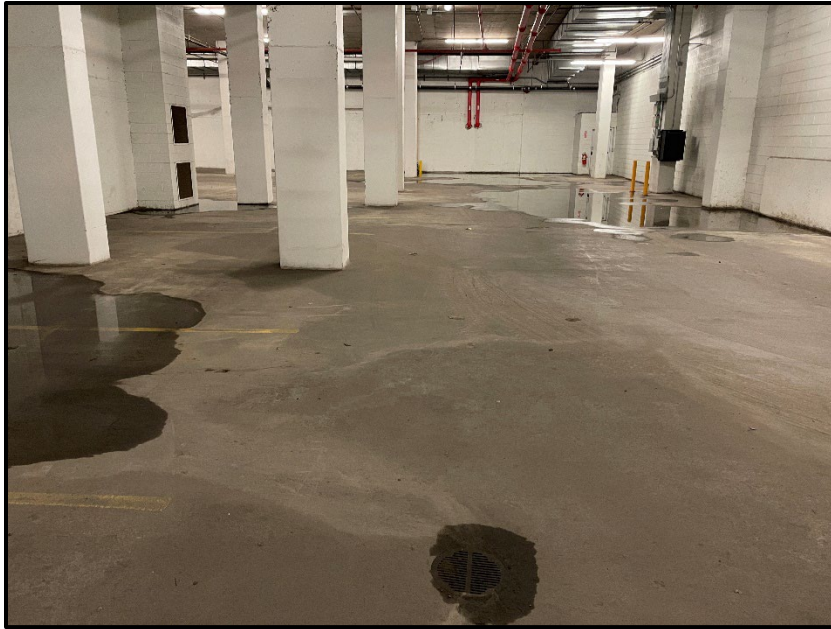
Photo 3. Site cover system inspection: parking level P1.

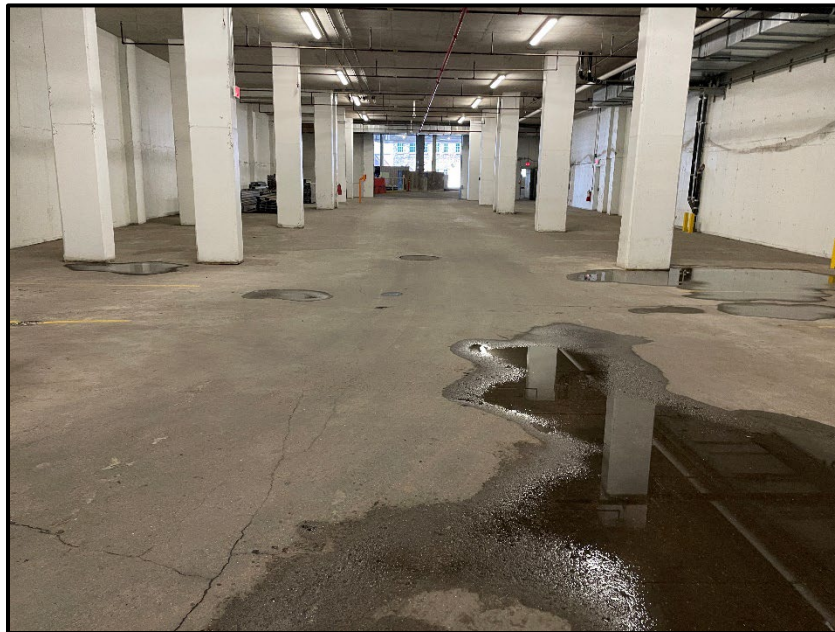
Photo 4. Site cover system inspection: parking level P1.

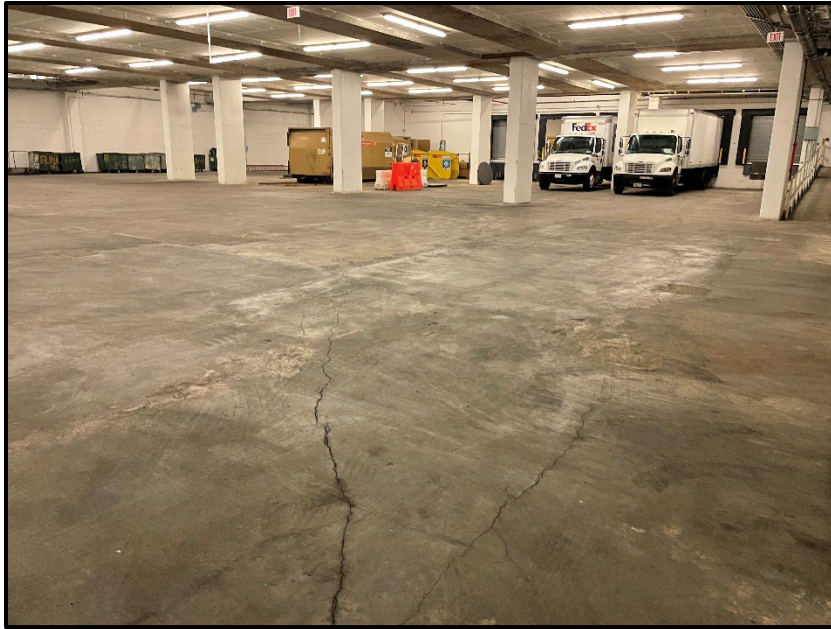
Photo 5. Site cover system inspection: parking level P1.

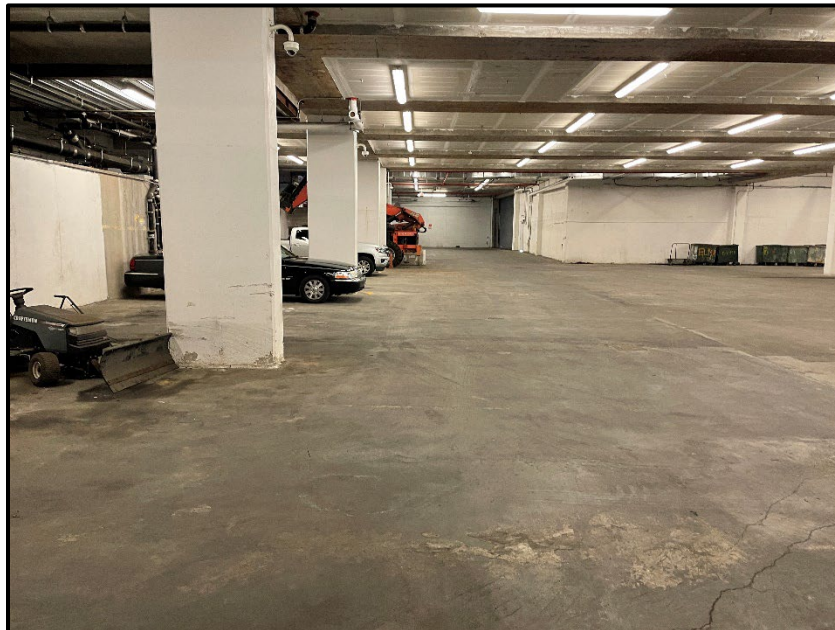
Photo 6. Site cover system inspection: parking level P1.

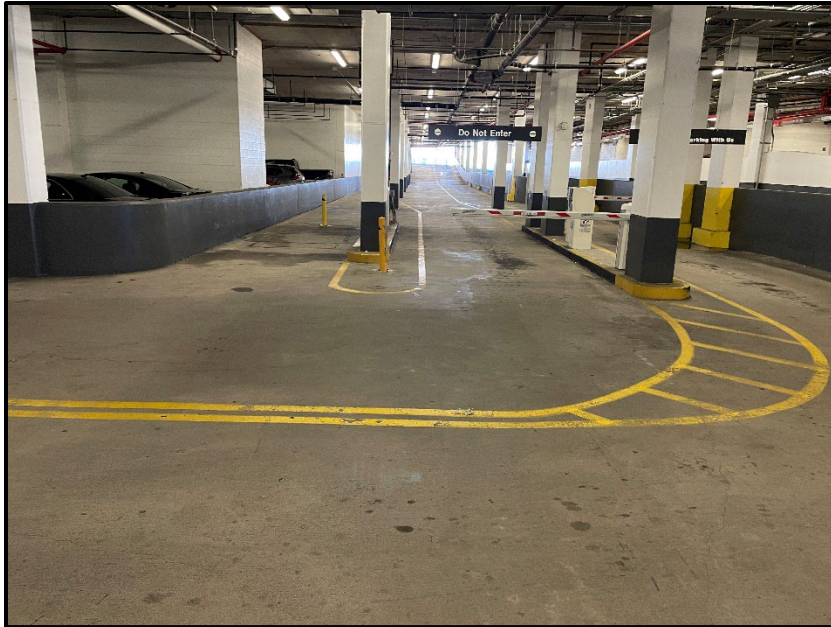
Photo 7. Site cover system inspection: parking level P1.

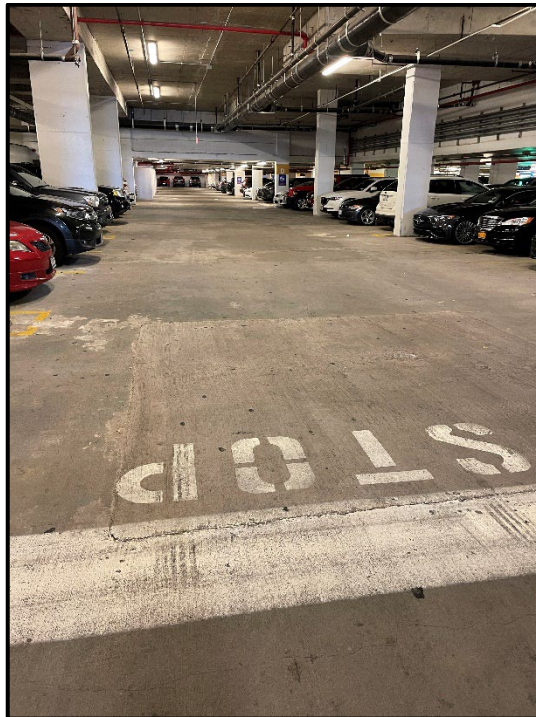
Photo 8. Site cover system inspection: parking level P1.

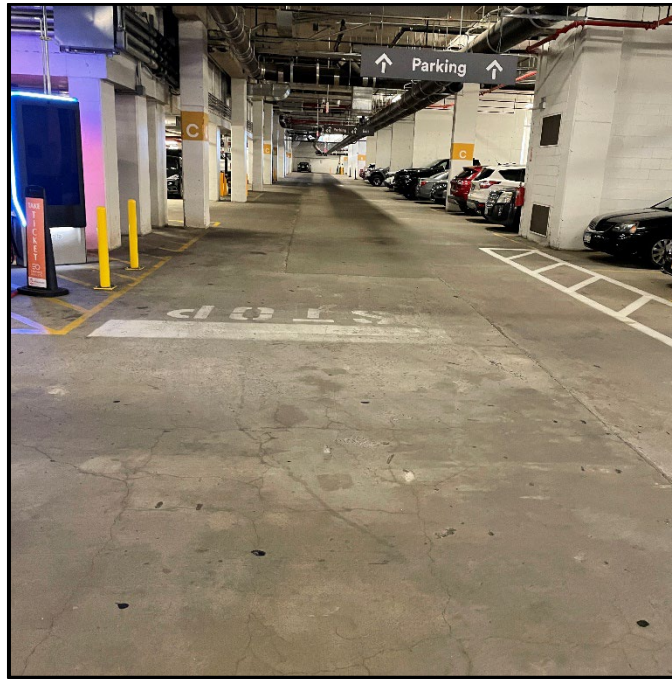
Photo 9. Site cover system inspection: parking level P1.

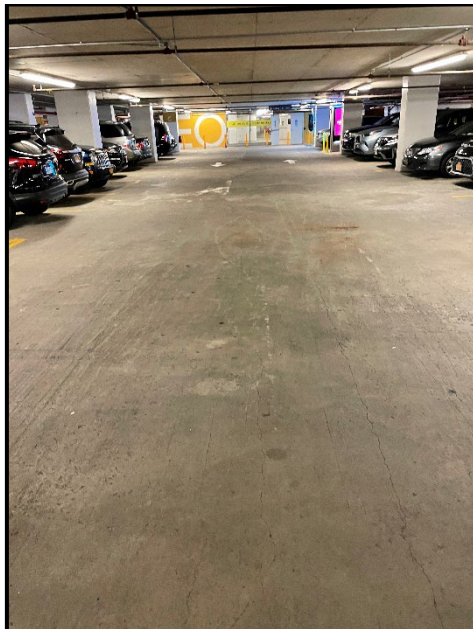
Photo 10. Site cover system inspection: parking level P1.

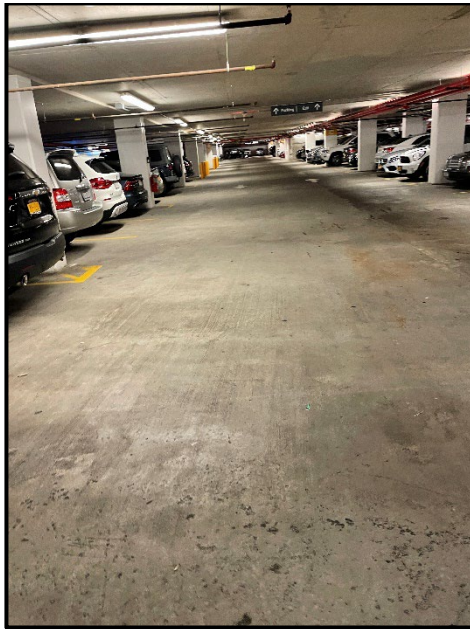
Photo 11. Site cover system inspection: parking level P1.

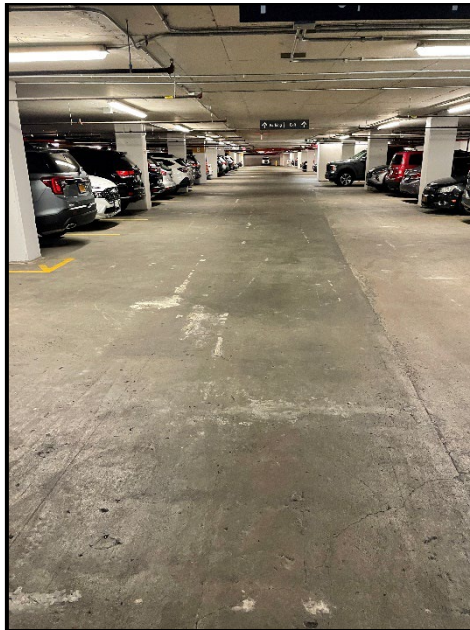
Photo 12. Site cover system inspection: parking level P1.

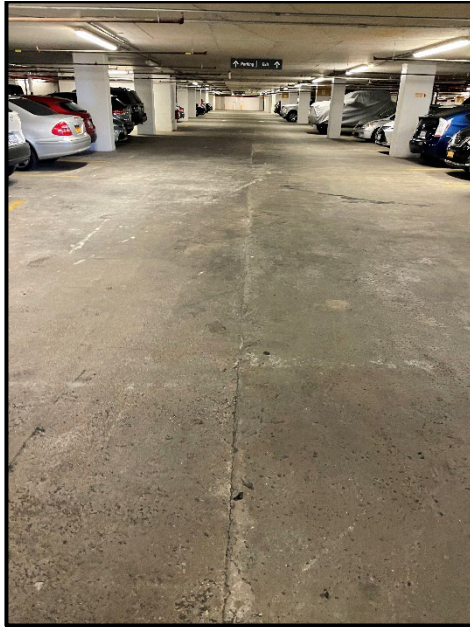
Photo 13. Site cover system inspection: parking level P1.

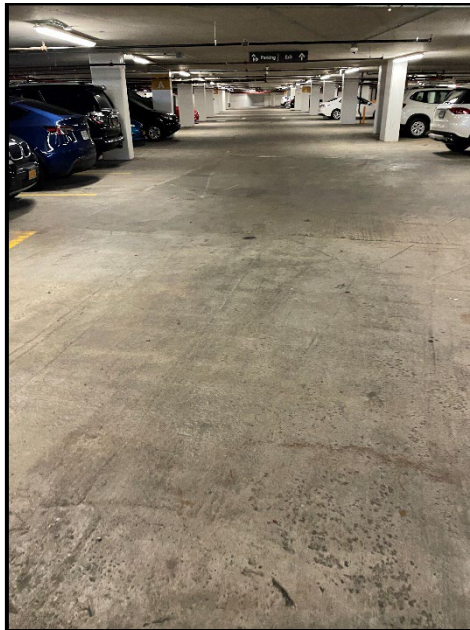
Photo 14. Site cover system inspection: parking level P1.

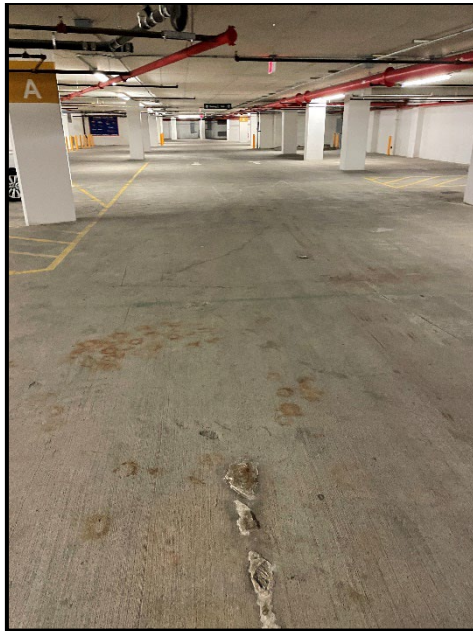
Photo 15. Site cover system inspection: parking level P1.

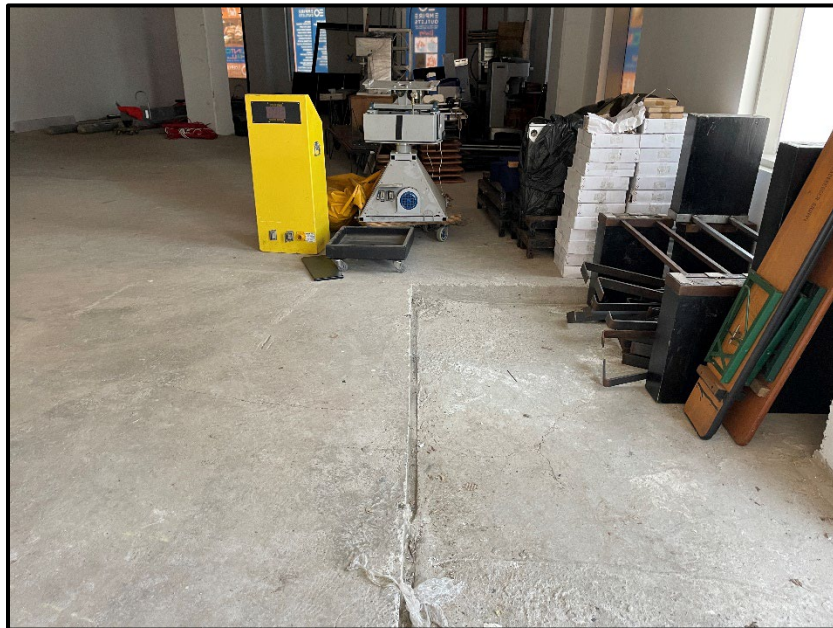
Photo 16. Site cover system inspection: parking level P1.

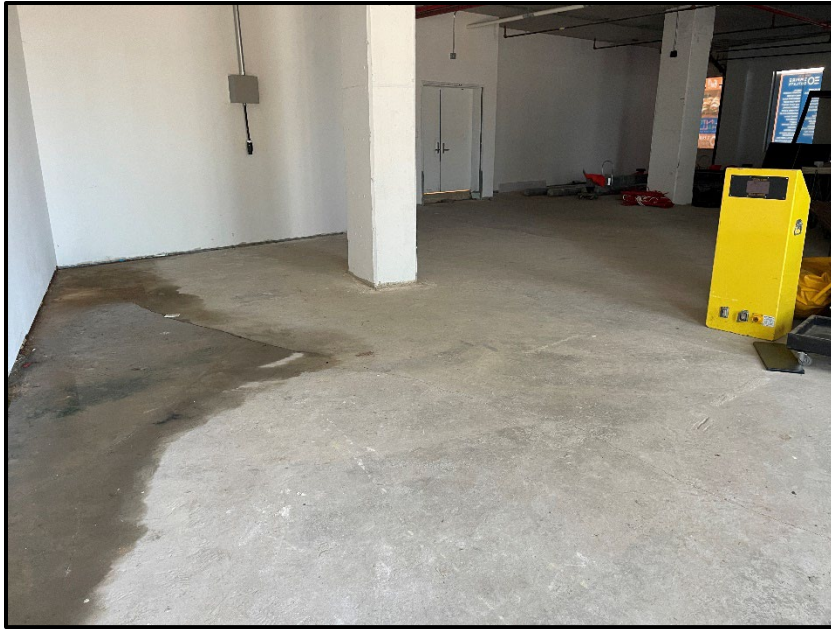
Photo 17. Site cover system inspection: parking level P1.

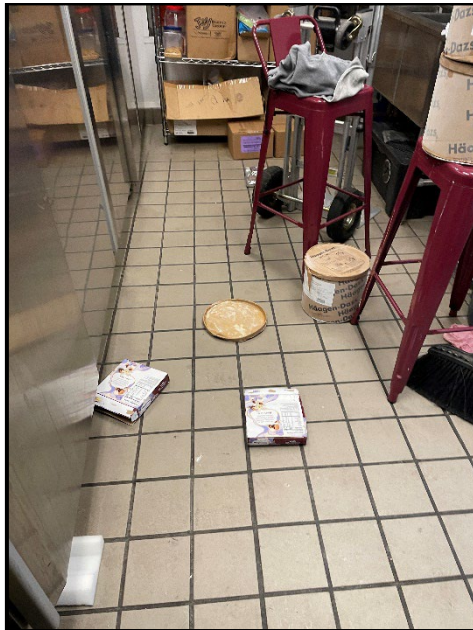
Photo 18. Site cover system inspection: Haagen Dazs back of house.

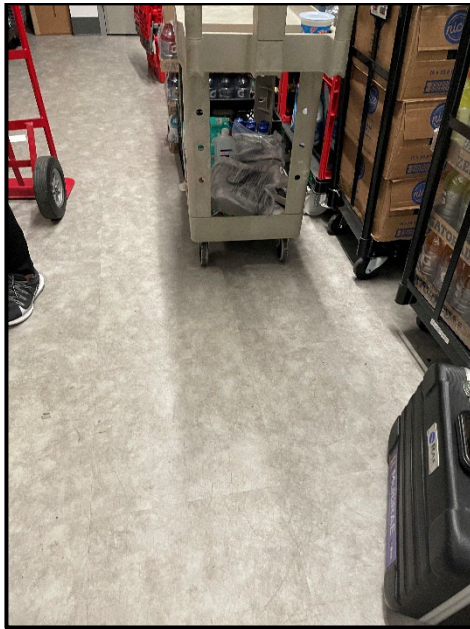
Photo 19. Site cover system inspection: Walgreens back of house.

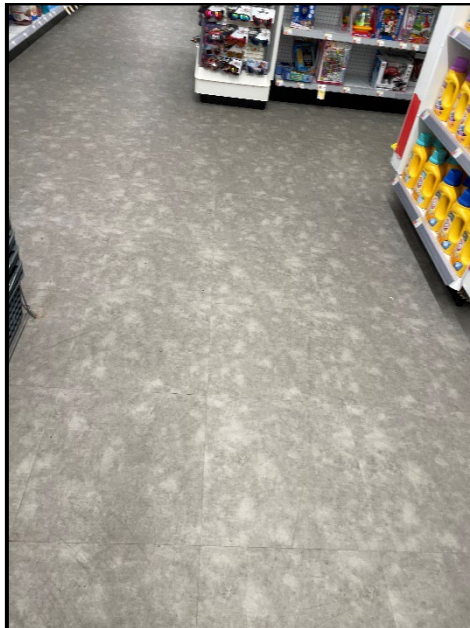
Photo 20. Site cover system inspection: Walgreens front of house.

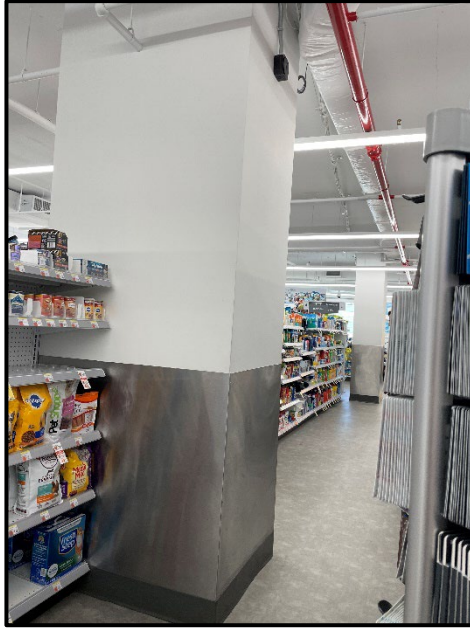
Photo 21. Site cover system inspection: Walgreens front of house methane detector location.

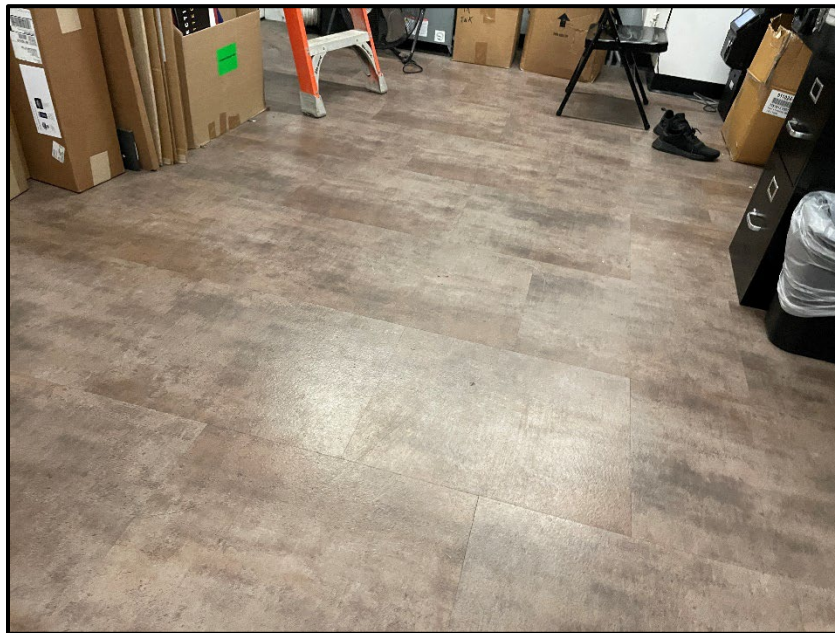
Photo 22. Site cover system inspection: Lids back of house.

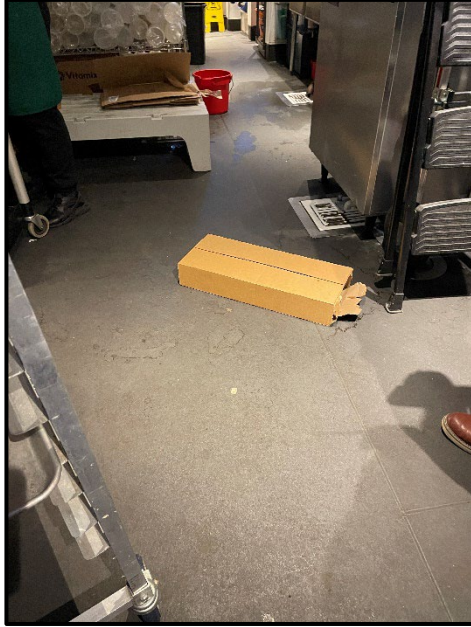
Photo 23. Site cover system inspection: Starbucks back of house.

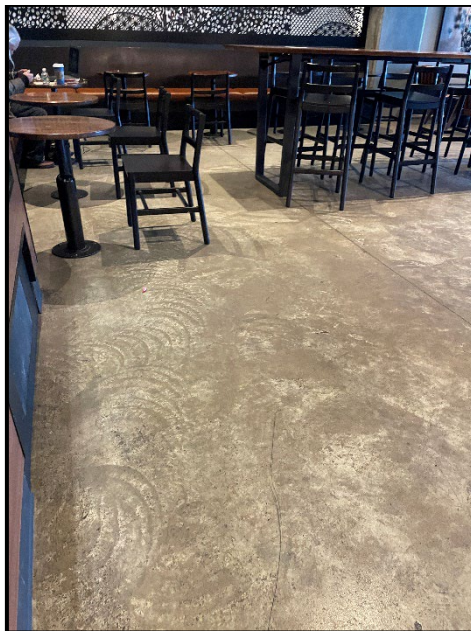
Photo 24. Site cover system inspection: Starbucks front of house.

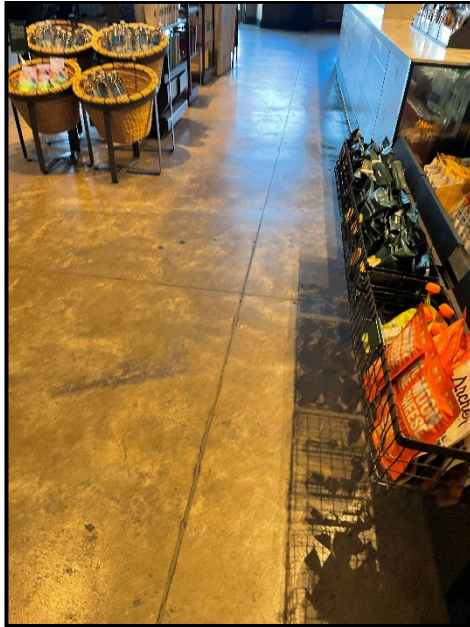
Photo 25. Site cover system inspection: Starbucks front of house.
September 14, 2022

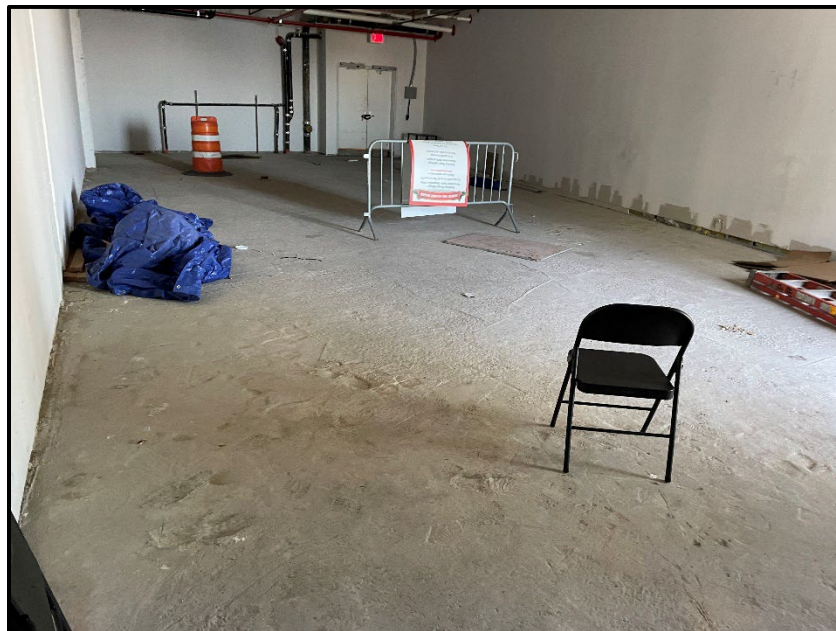
Photo 26. Site cover system inspection: Vacant unit #102A.

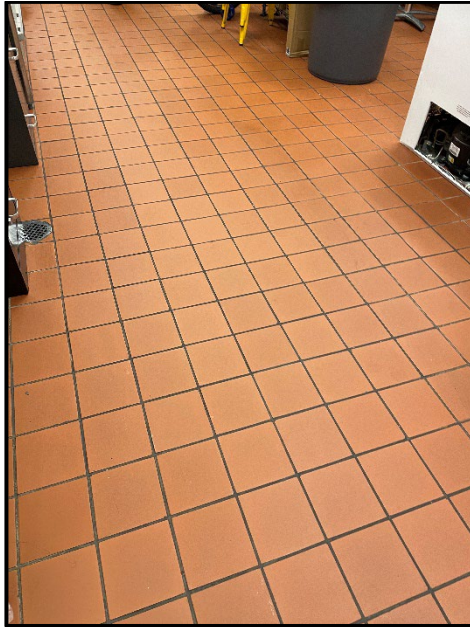
Photo 27. Site cover system inspection: Wetzels Pretzels back of house.

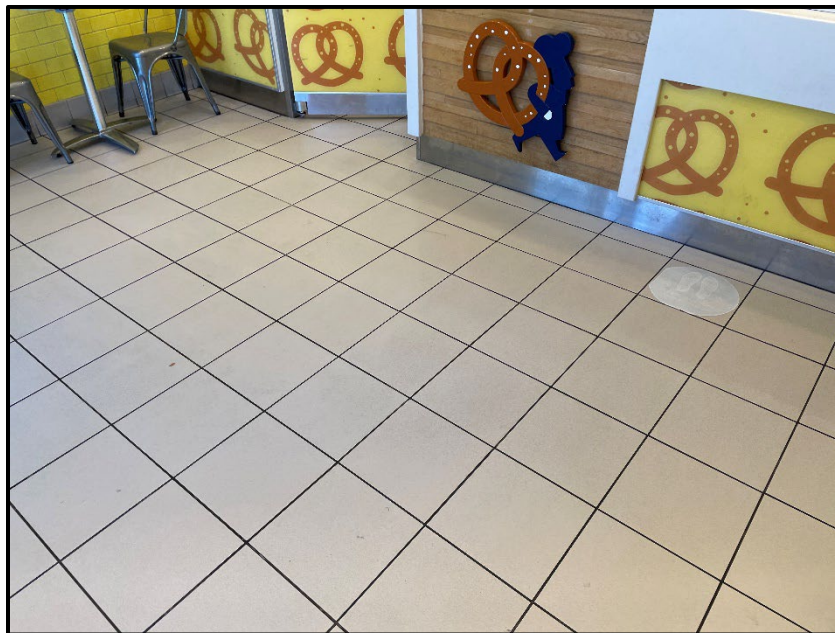
Photo 28. Site cover system inspection: Wetzels Pretzels front of house.

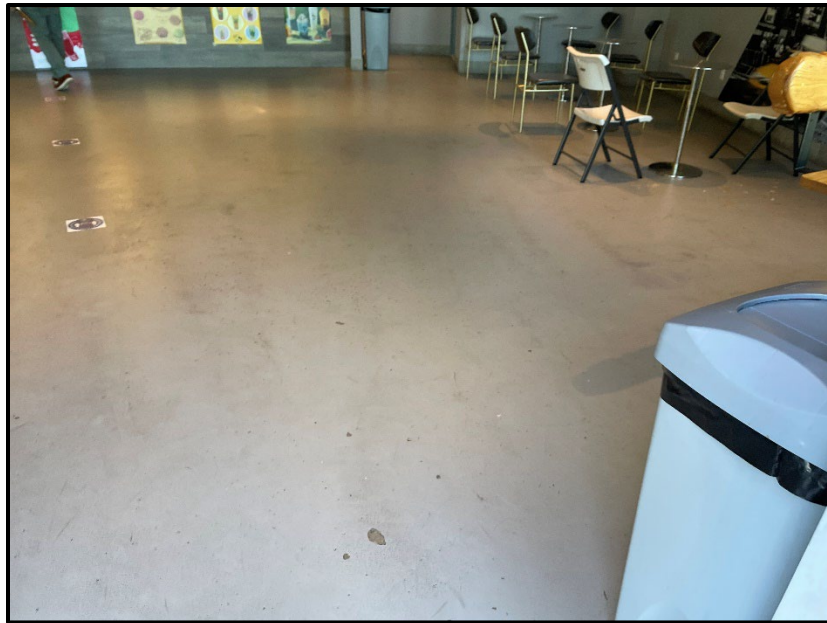
Photo 29. Site cover system inspection: Bake Culture front of house.

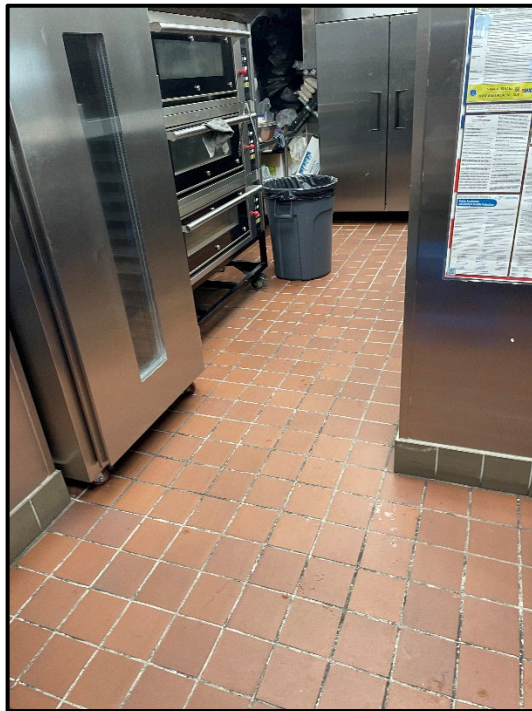
Photo 30. Site cover system inspection: Bake Culture back of house.

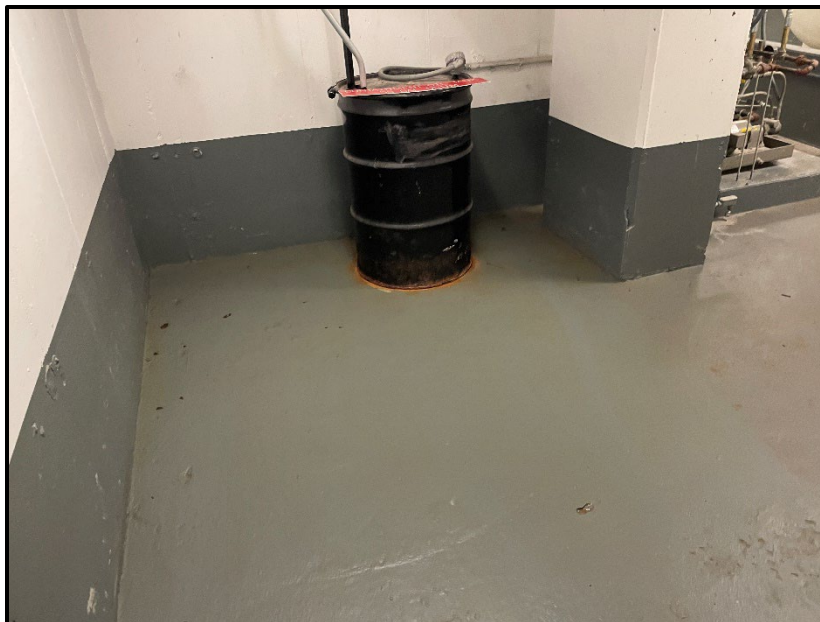
Photo 31. Site cover system inspection: fuel oil room.

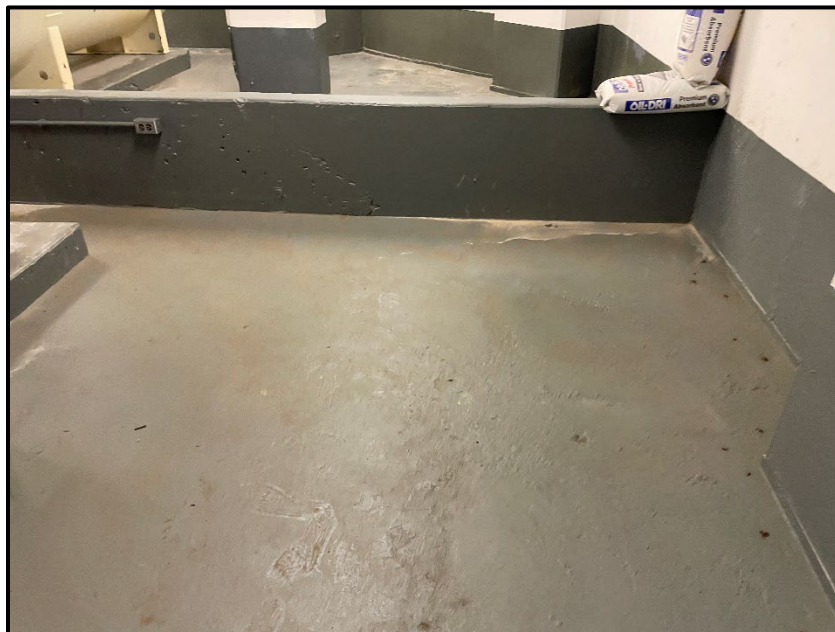
Photo 32. Site cover system inspection: fuel oil room.

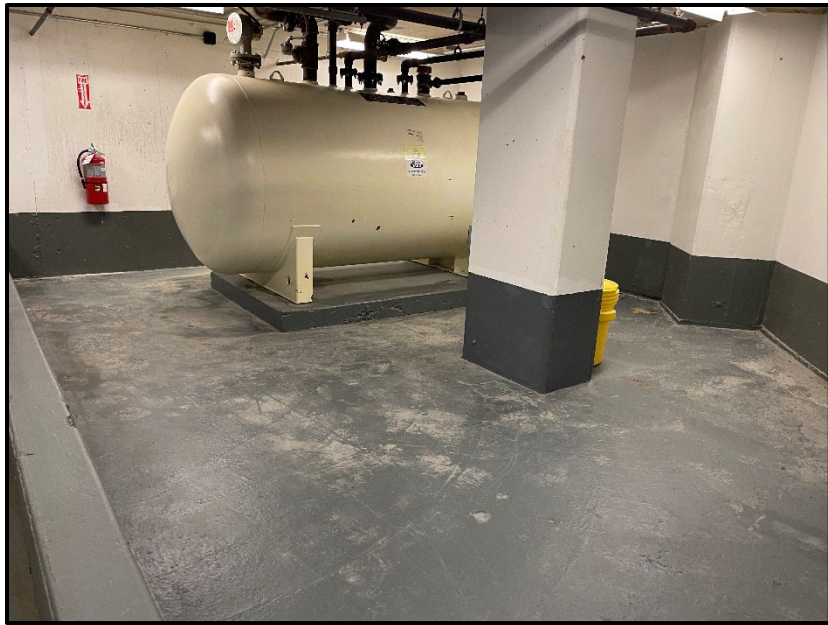
Photo 33. Site cover system inspection: fuel oil room.

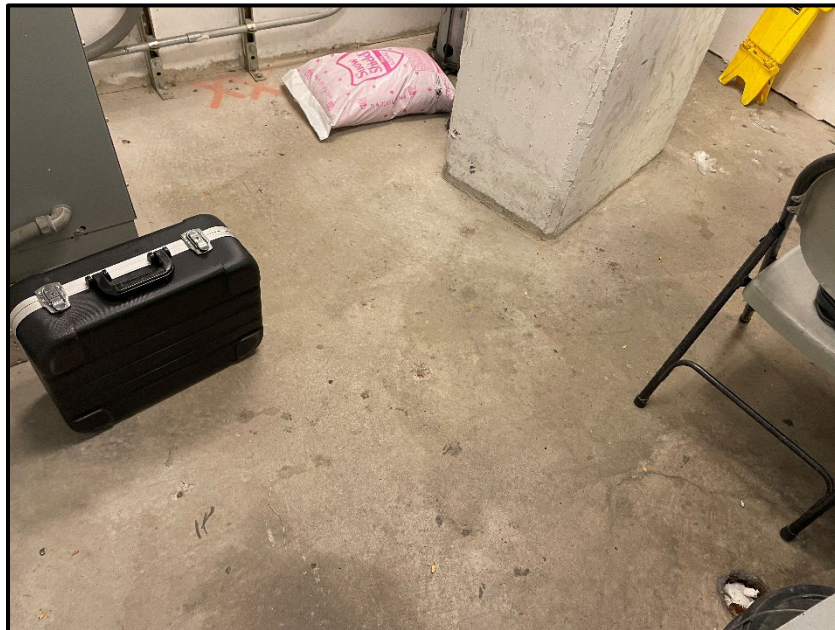
Photo 34. Site cover system inspection: guard booth.

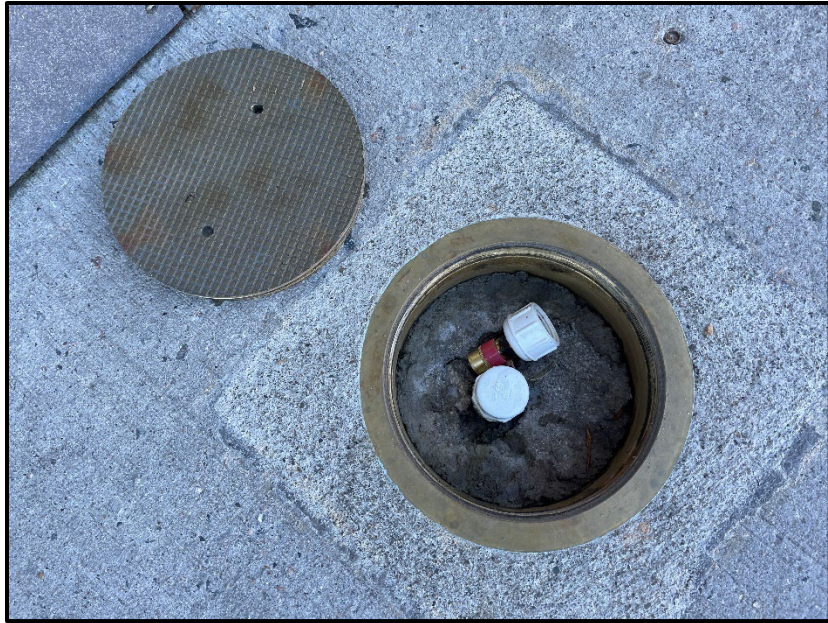
All accessible parts of the SSDS were visually inspected on September 14, 2022. Six vapor monitoring points (MP-1 through MP-6) were opened and found to be in good condition. The headspace of each monitoring point was screened with a multi-gas meter, with the exception of MP-2, which requires a quick connect fitting that was not available during this inspection. Soil vapor at MP-2 will be screened using the multi-gas meter during the next quarterly inspection scheduled for December 2022. The multi-gas meter used was a Rae Systems MultiRAE, serial number M01EA01926. No field detections of VOCs or methane were observed in any of the monitoring points. Soil vapor screening data is recorded on the SSDS Inspection Form, included in Appendix A. Photos documenting the condition of the monitoring points are included in Appendix B.

Photo 35. SSDS inspection: vapor monitoring point MP-1.

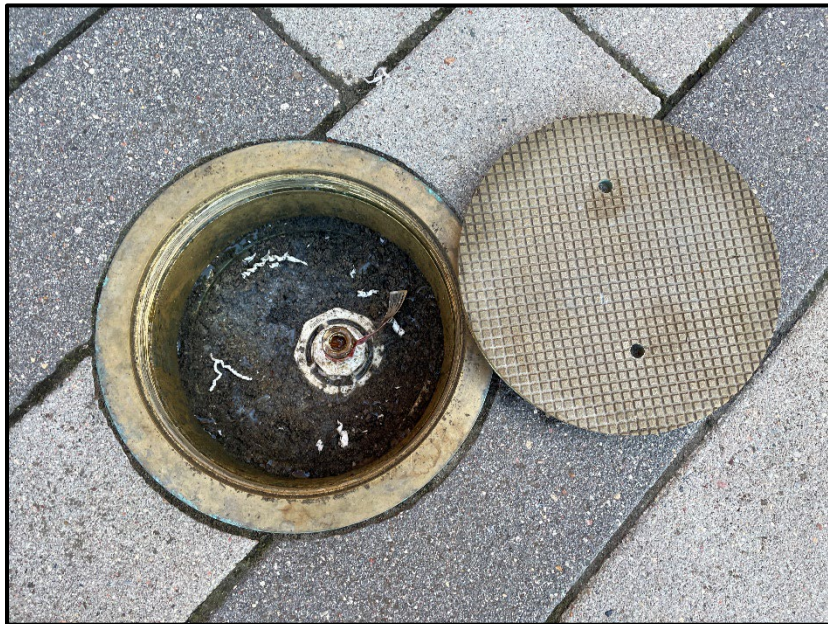
Photo 36. SSDS inspection: vapor monitoring point MP-2.

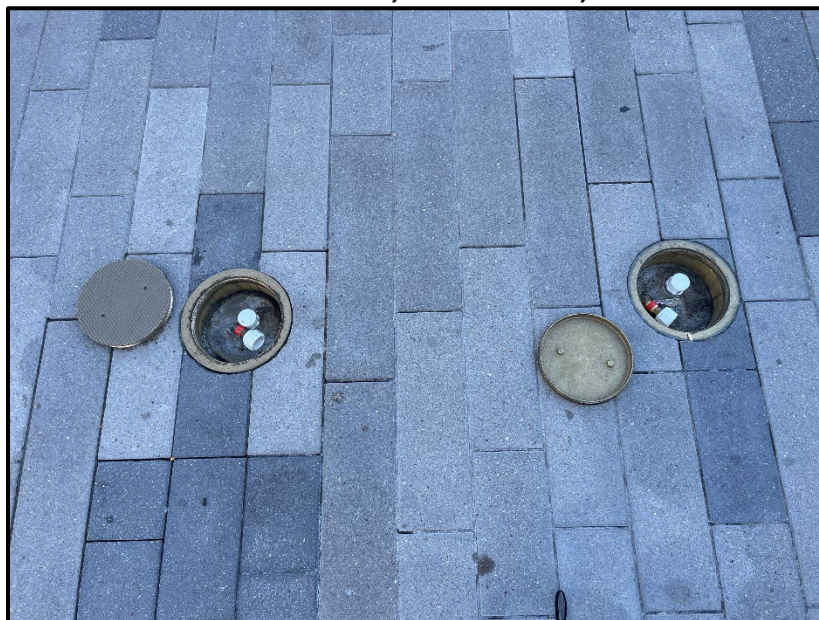
Photo 37. SSDS inspection: vapor monitoring points MP-3 and MP-4.

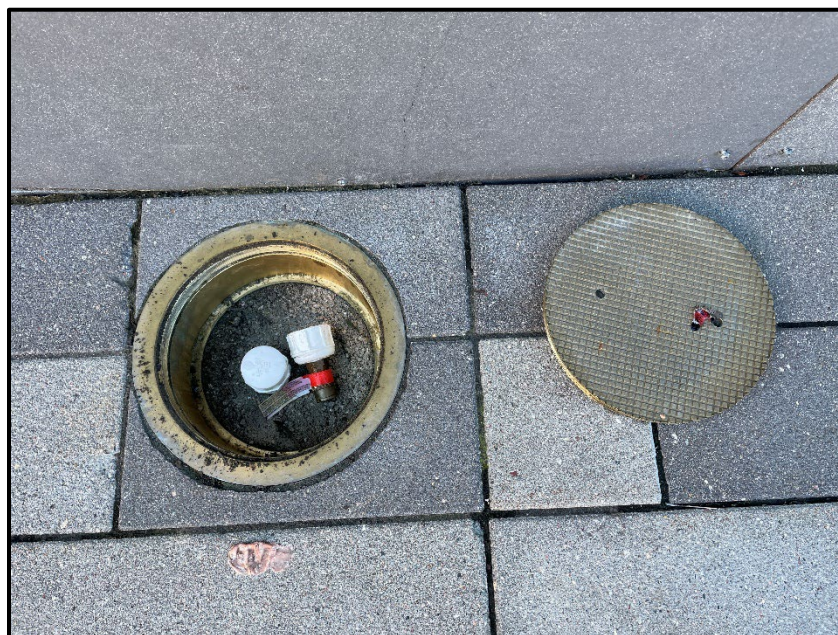
Photo 38. SSDS inspection: vapor monitoring point MP-5.

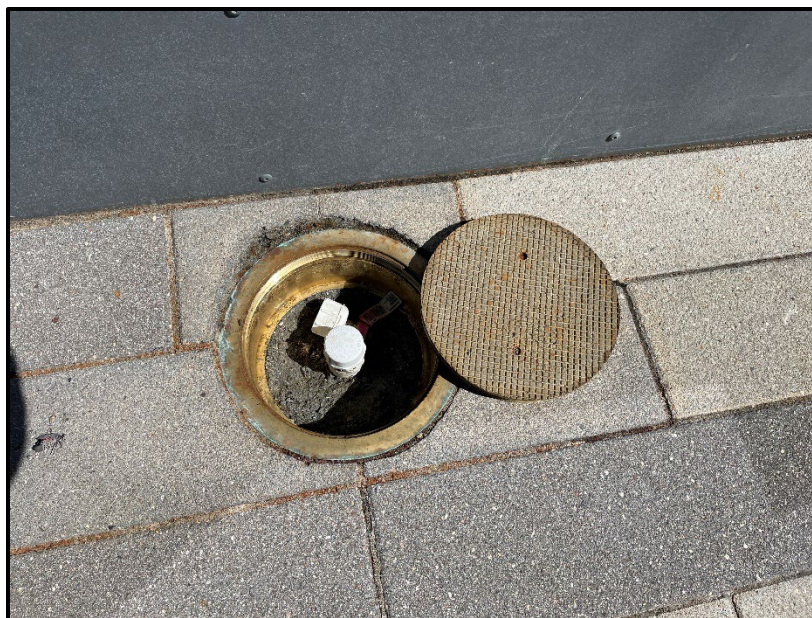
Photo 39. SSDS inspection: vapor monitoring point MP-6.

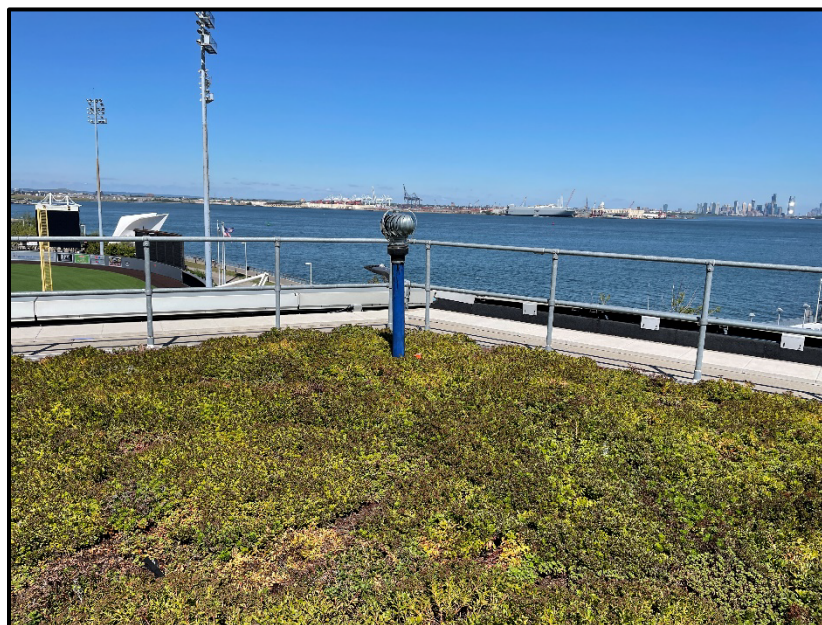
Six SSDS roof vents (VR-1 through VR-6) were visually inspected and found to be in good condition. Photos documenting the condition of the roof vents are included in Appendix B.

Photo 40. SSDS inspection: roof vent VR-1.

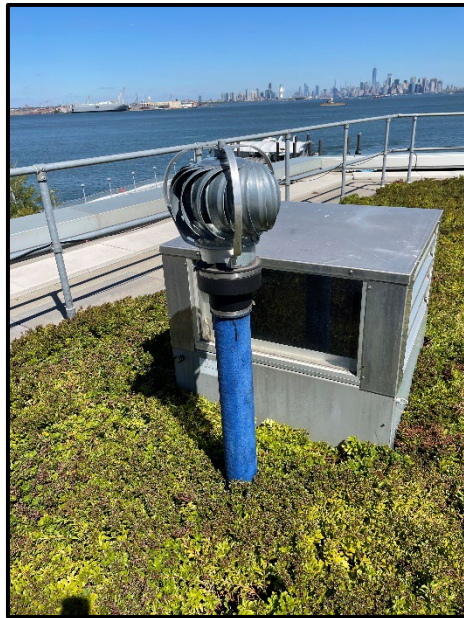
Photo 41. SSDS inspection: roof vent VR-2.

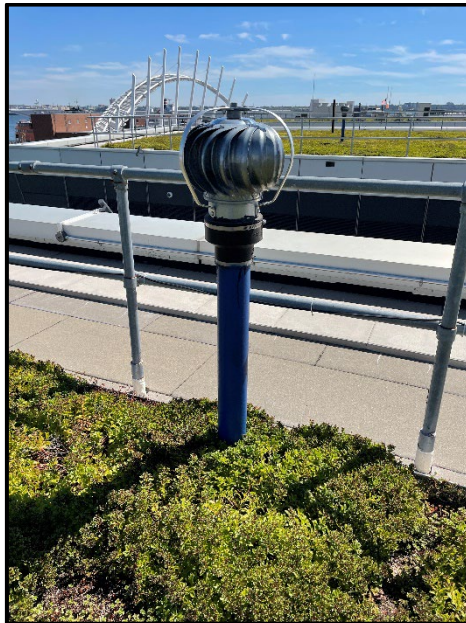
Photo 42. SSDS inspection: roof vent VR-3.

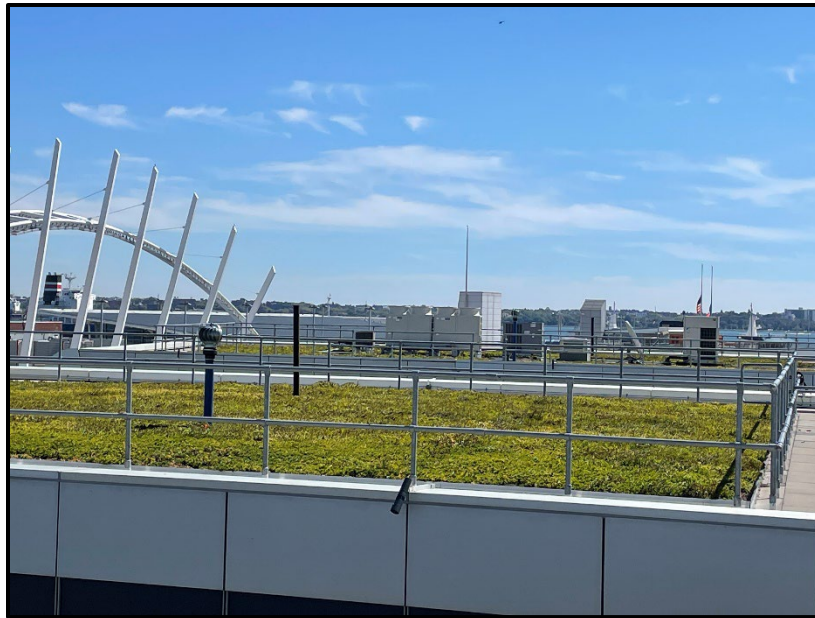
Photo 43. SSDS inspection: roof vents VR-4 and VR-5.

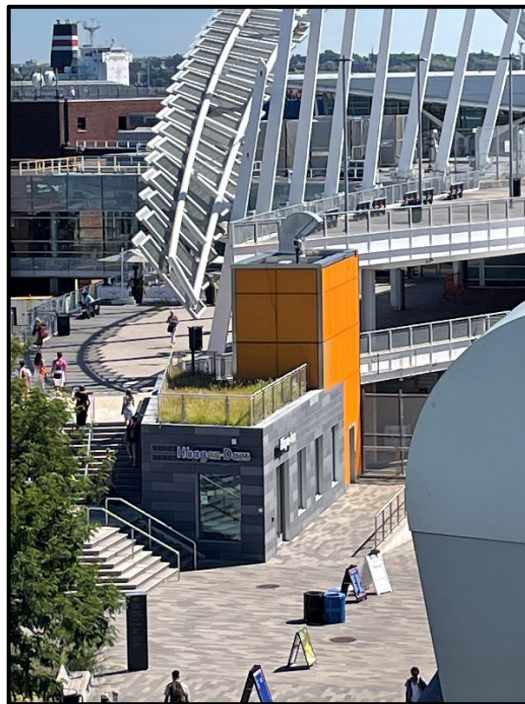
Photo 44. SSDS inspection: roof vent VR-6.
