PERIODIC REVIEW REPORT

Ballpark at St. George Station Staten Island, New York NYSDEC Site No. V00228

PERIODIC REVIEW REPORT 2022 - 2023

TRC Project No. 341863

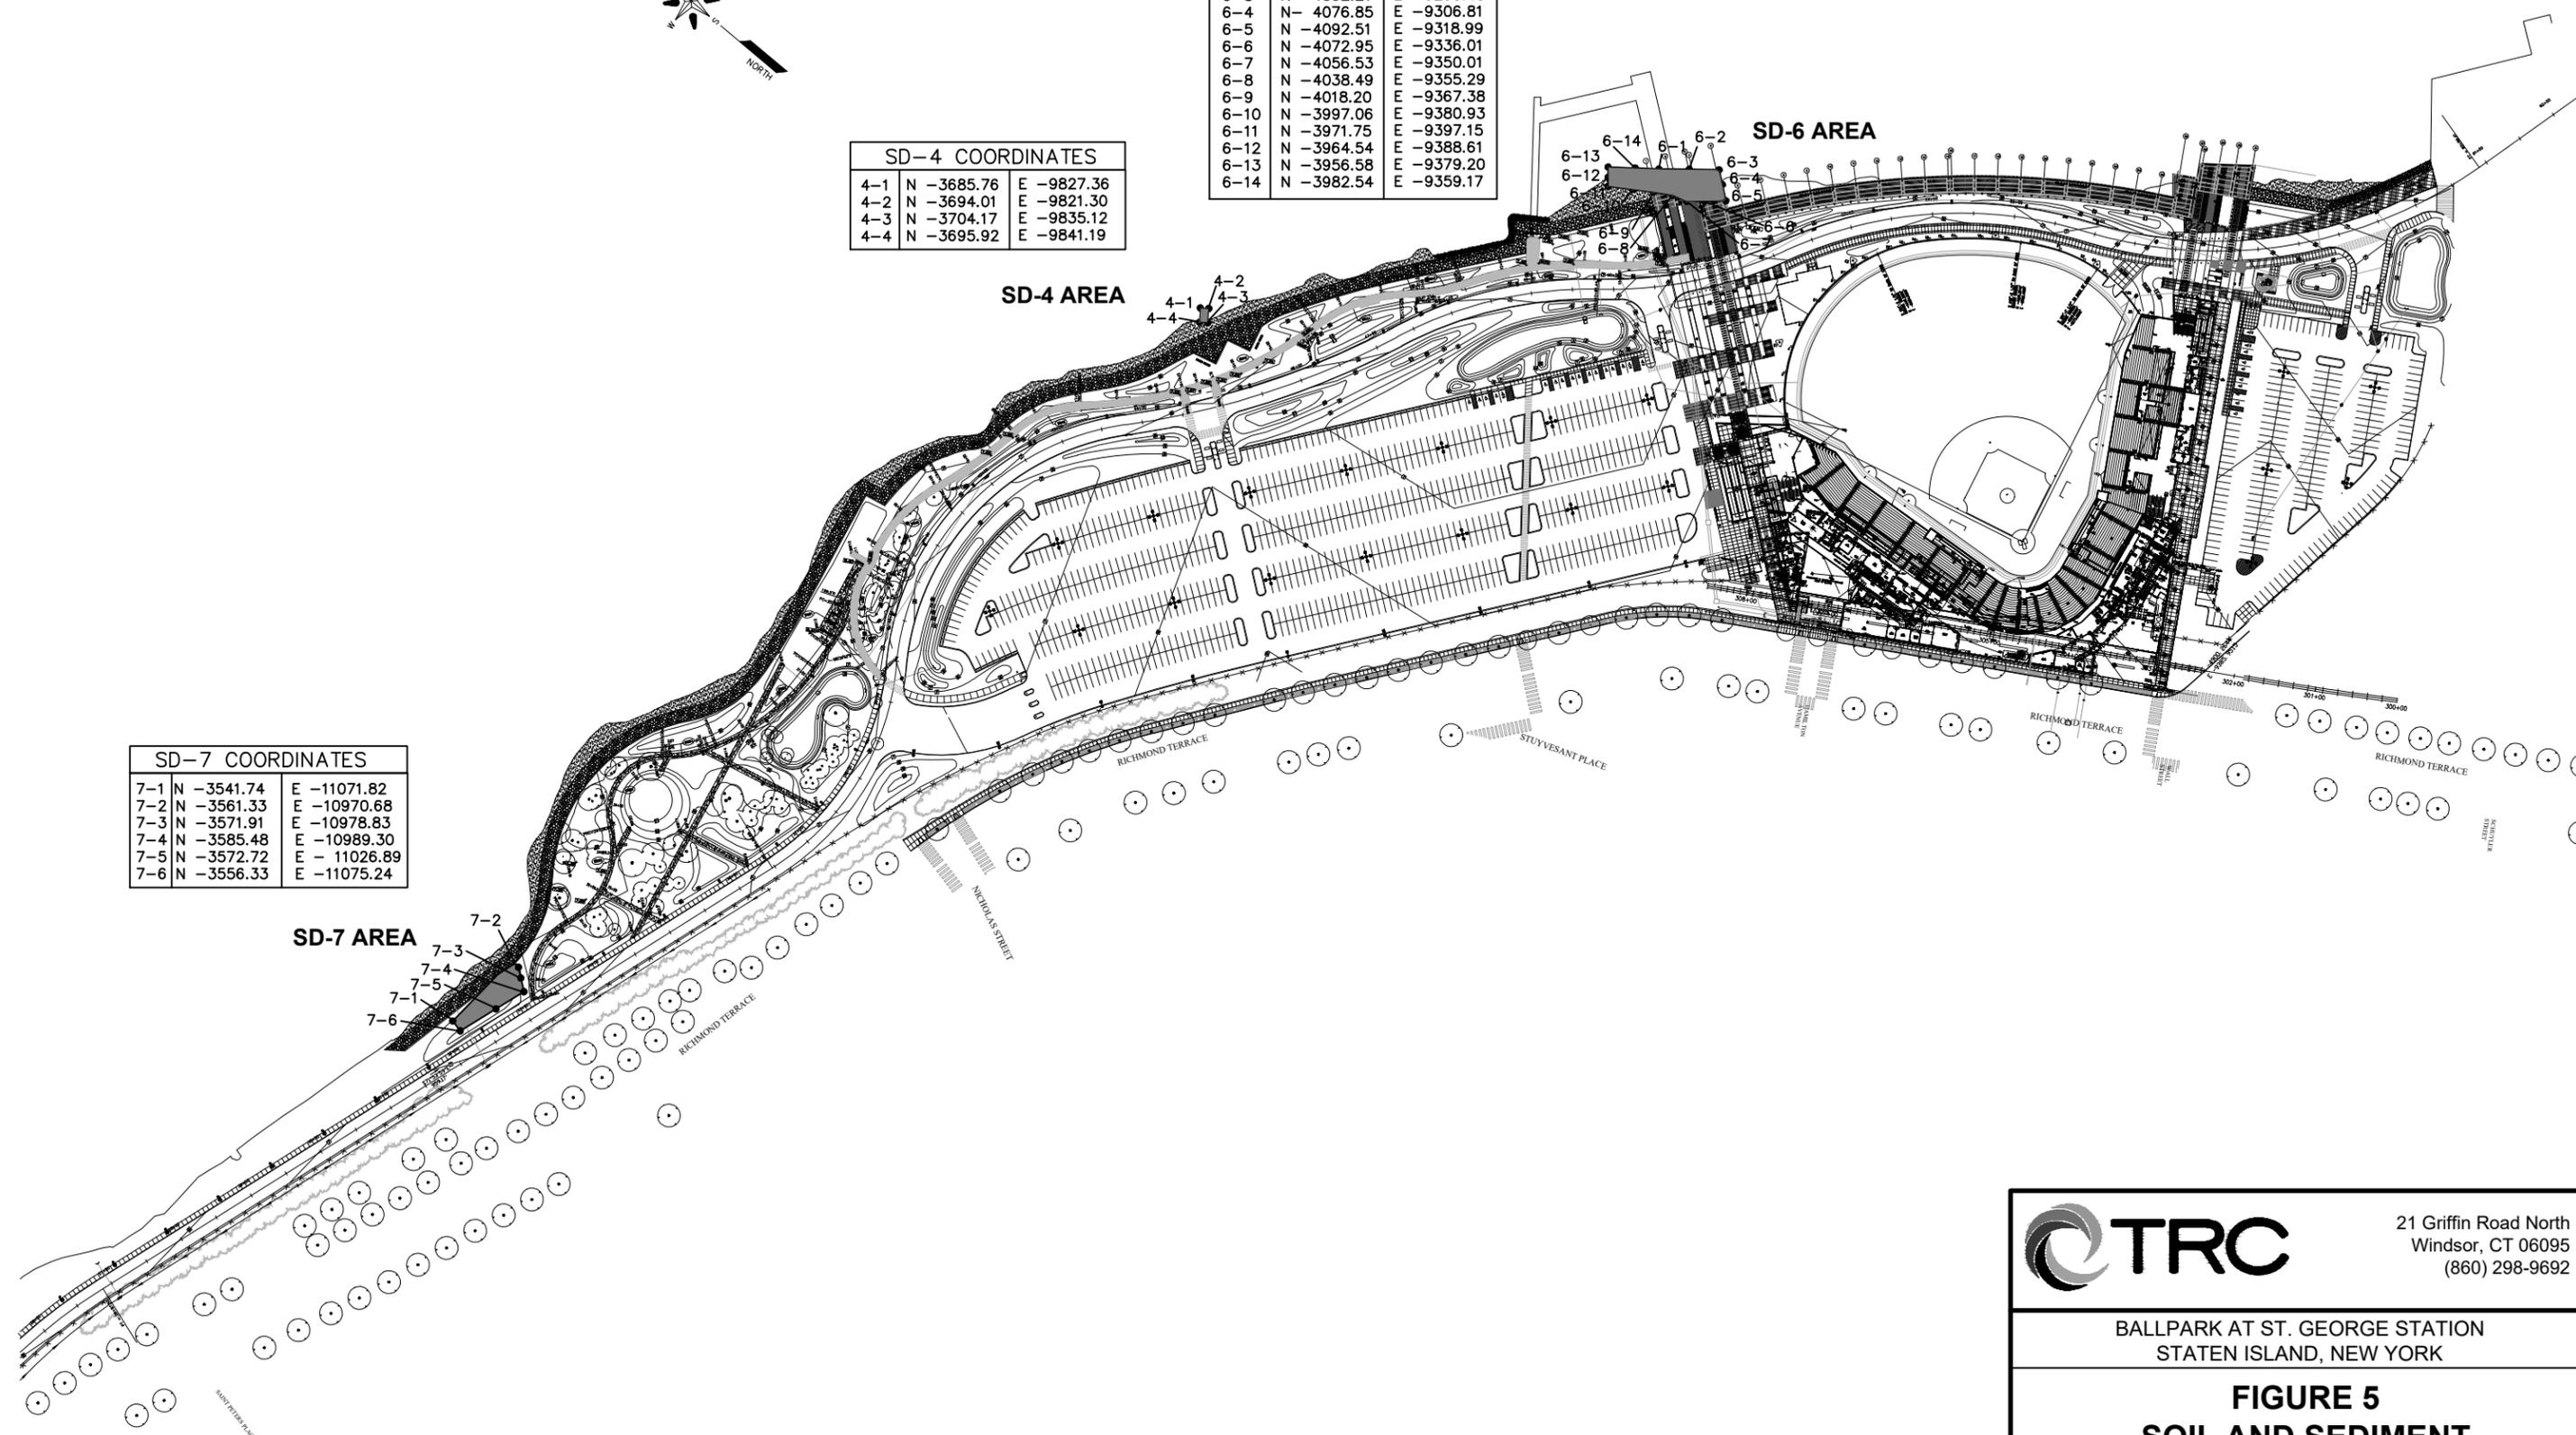
21 Griffin Road North Windsor, CT 06095 (860) 298-9692
	BALLPARK AT ST. GEORGE STATION STATEN ISLAND, NEW YORK
FIGURE 5 SOIL AND SEDIMENT REMOVAL LOCATIONS	
Date: 04/25/13	Project No. 177603-000050-000000

Prior to the baseball stadium development, sediments contaminated with lead were removed from the vicinity of sediment samples SD-4 and SD-6. The top 3 feet of sediment was removed from these two shoreline areas shown on Figure 5. Prior to backfilling the area with clean sand and gravel, a black geotextile filter fabric was placed over the excavated shoreline area. The geotextile filter fabric used is a non-biodegradable, black, ultraviolet resistant, nonwoven, needle punched polypropylene fabric. Natural stone riprap was provided over the SD-4 and SD-6 removal areas and along much of the shoreline for stabilization and to prevent erosion.
