Hunts Point Cooperative Market Redevelopment Plan

Final Engineering Report Site A Operable Unit 1

Lawler, Matusky & Skelly Engineers LLP

Revised September 2005

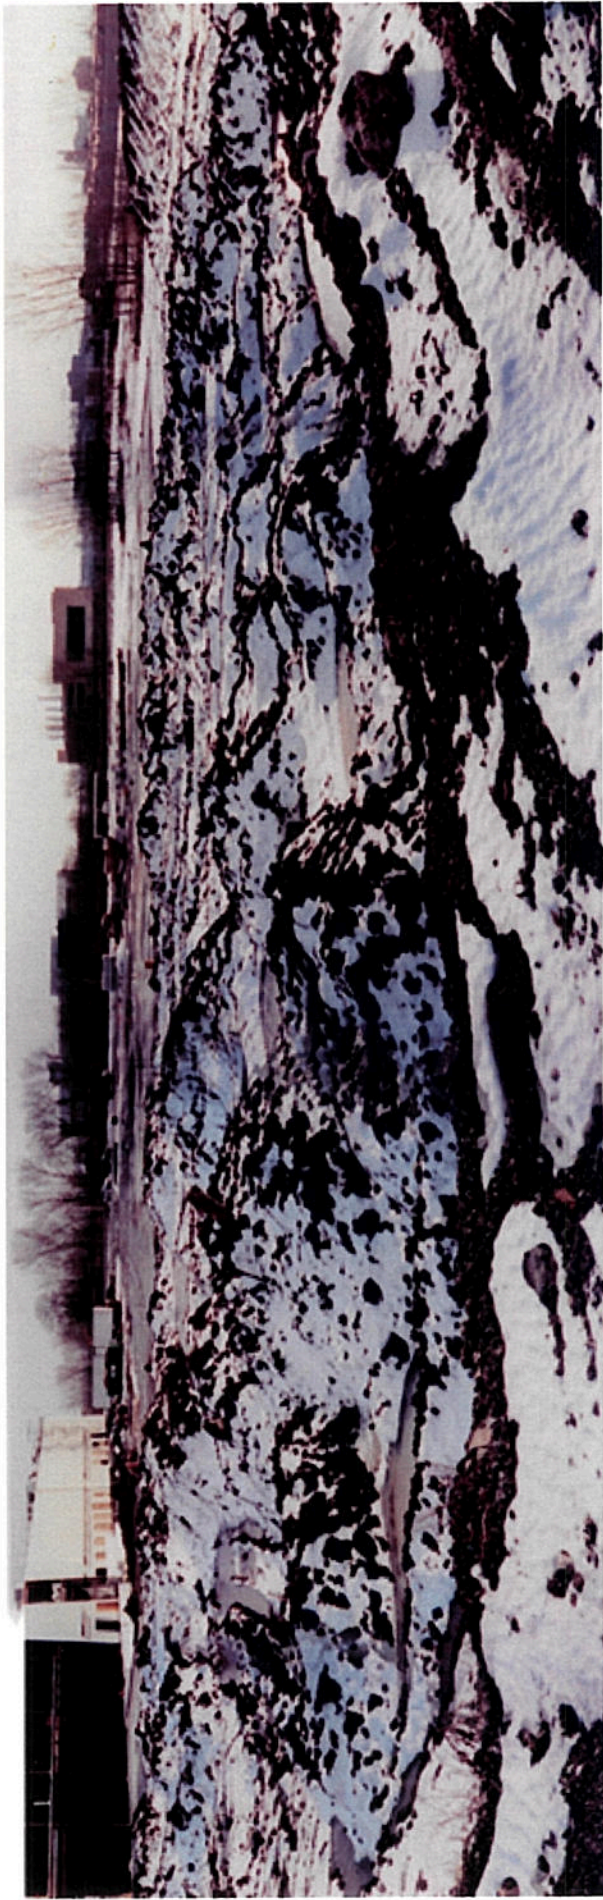
Photo 1. Panoramic view of staging area in winter 2000.

shows the storage area in the winter just prior to the installation of the fence.

- The panoramic photographs show that there was a large "L"-shaped berm of soil that was generated from material under the basic building footprint located on the parcel adjacent to Site A OU1.
- The existing ground surface of Site A OU1 was exposed fill of virtually the same composition as that of the material in the berm. Photo 2 shows the general composition of the material in the "L"-shaped berm as the same type of fill encountered in other portions of the area where investigations were performed.

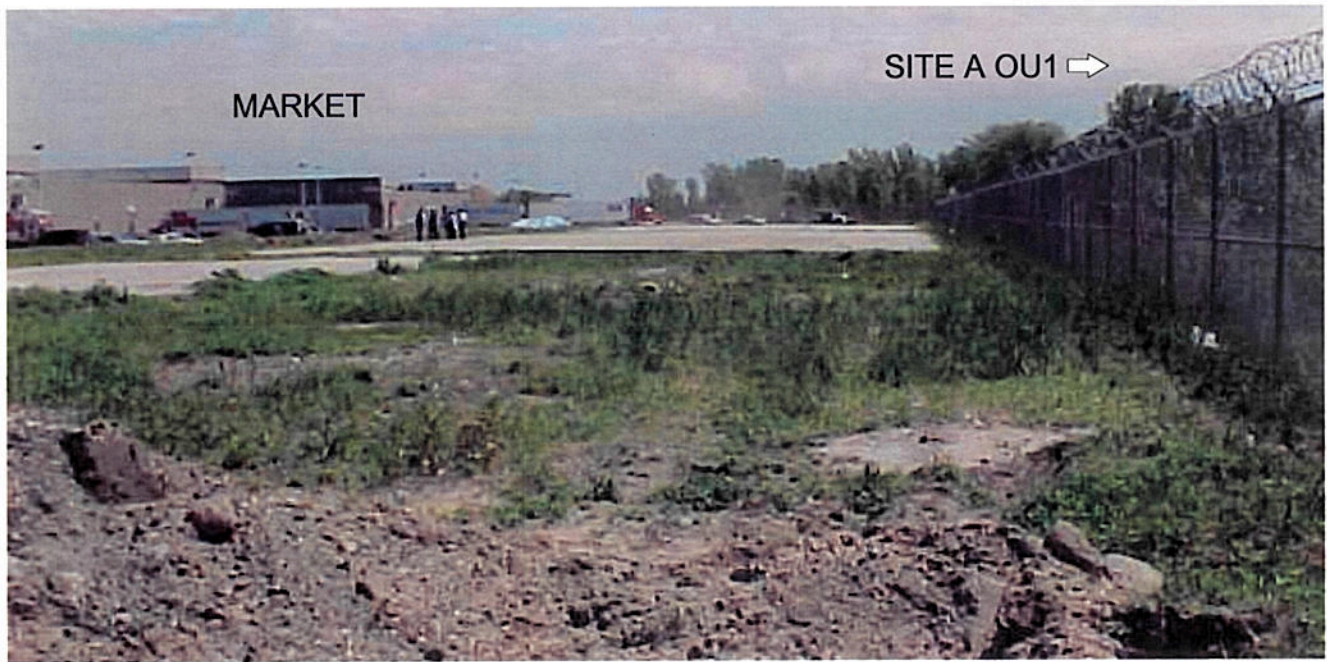
Photo 3. Preinvestigation photo of east end of Site A. (looking south)

During the course of the meat market construction, LMS periodically inspected the staging area and photographically documented the conditions to determine if the procedures and requirements that were discussed with the contractors were being performed. Photo 3 (looking south) shows the fence line between Site A OU1 and the Meat Market prior to the Site Investigation. The building footprint is located completely off the Site A OU 1 (left side of picture) side of this fence. Photo 4 was taken from within the material storage area and shows the continuous chain link fence that was installed around the staged excess material. The staging area was also surveyed by the contractor on two separate occasions using a NYS licensed surveyor to provide an ongoing documentation of the amount of material present. This was to insure that there was no additional material being placed.

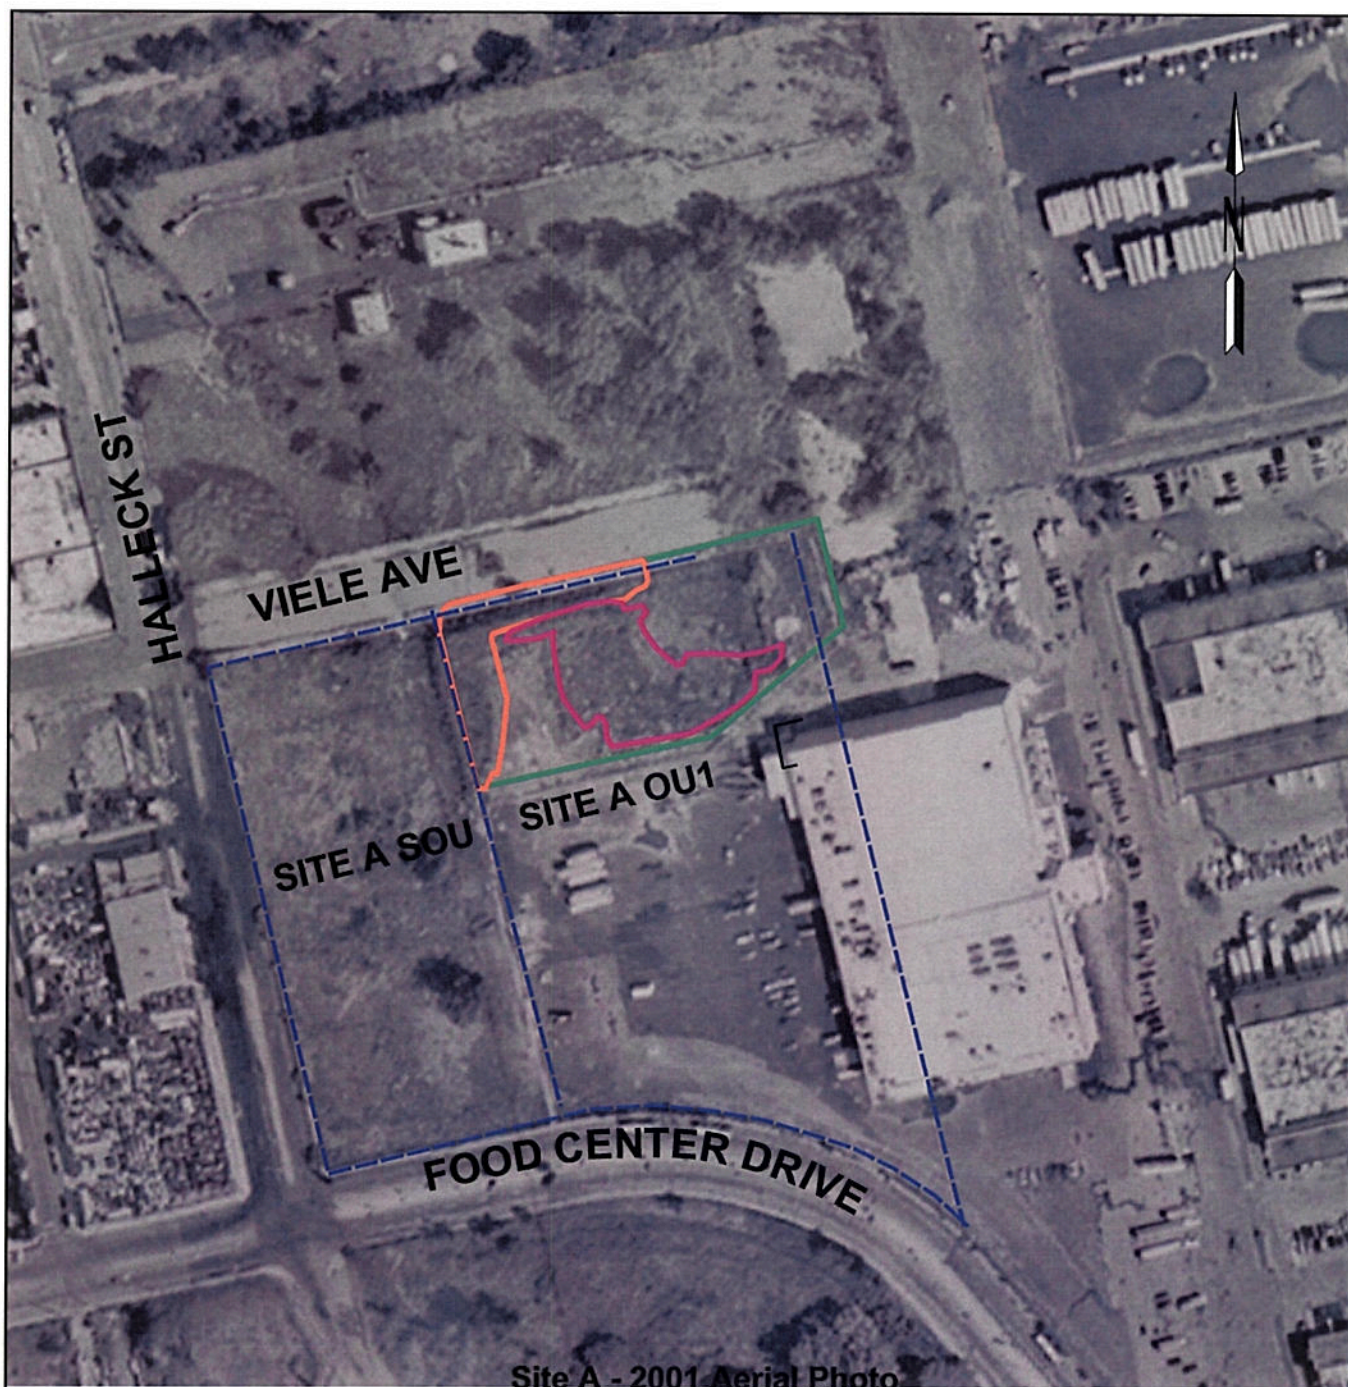
The survey information from the material was supplied on two separate occasions. The first was completed and information supplied in November 2000. An initial survey indicated that the berm contained just over 4100 cubic yards of fill. A subsequent survey confirmed that the "L"-shaped berm area contained 3740 cubic yards (Figure 6). The difference was determined to be the grade reference points on the pile. The more open area that contained smaller piles was also surveyed and found to contain approximately 3100 cubic yards (Figure 6). The total amount of stockpiled material was estimated to be just under 7000 cubic yards.

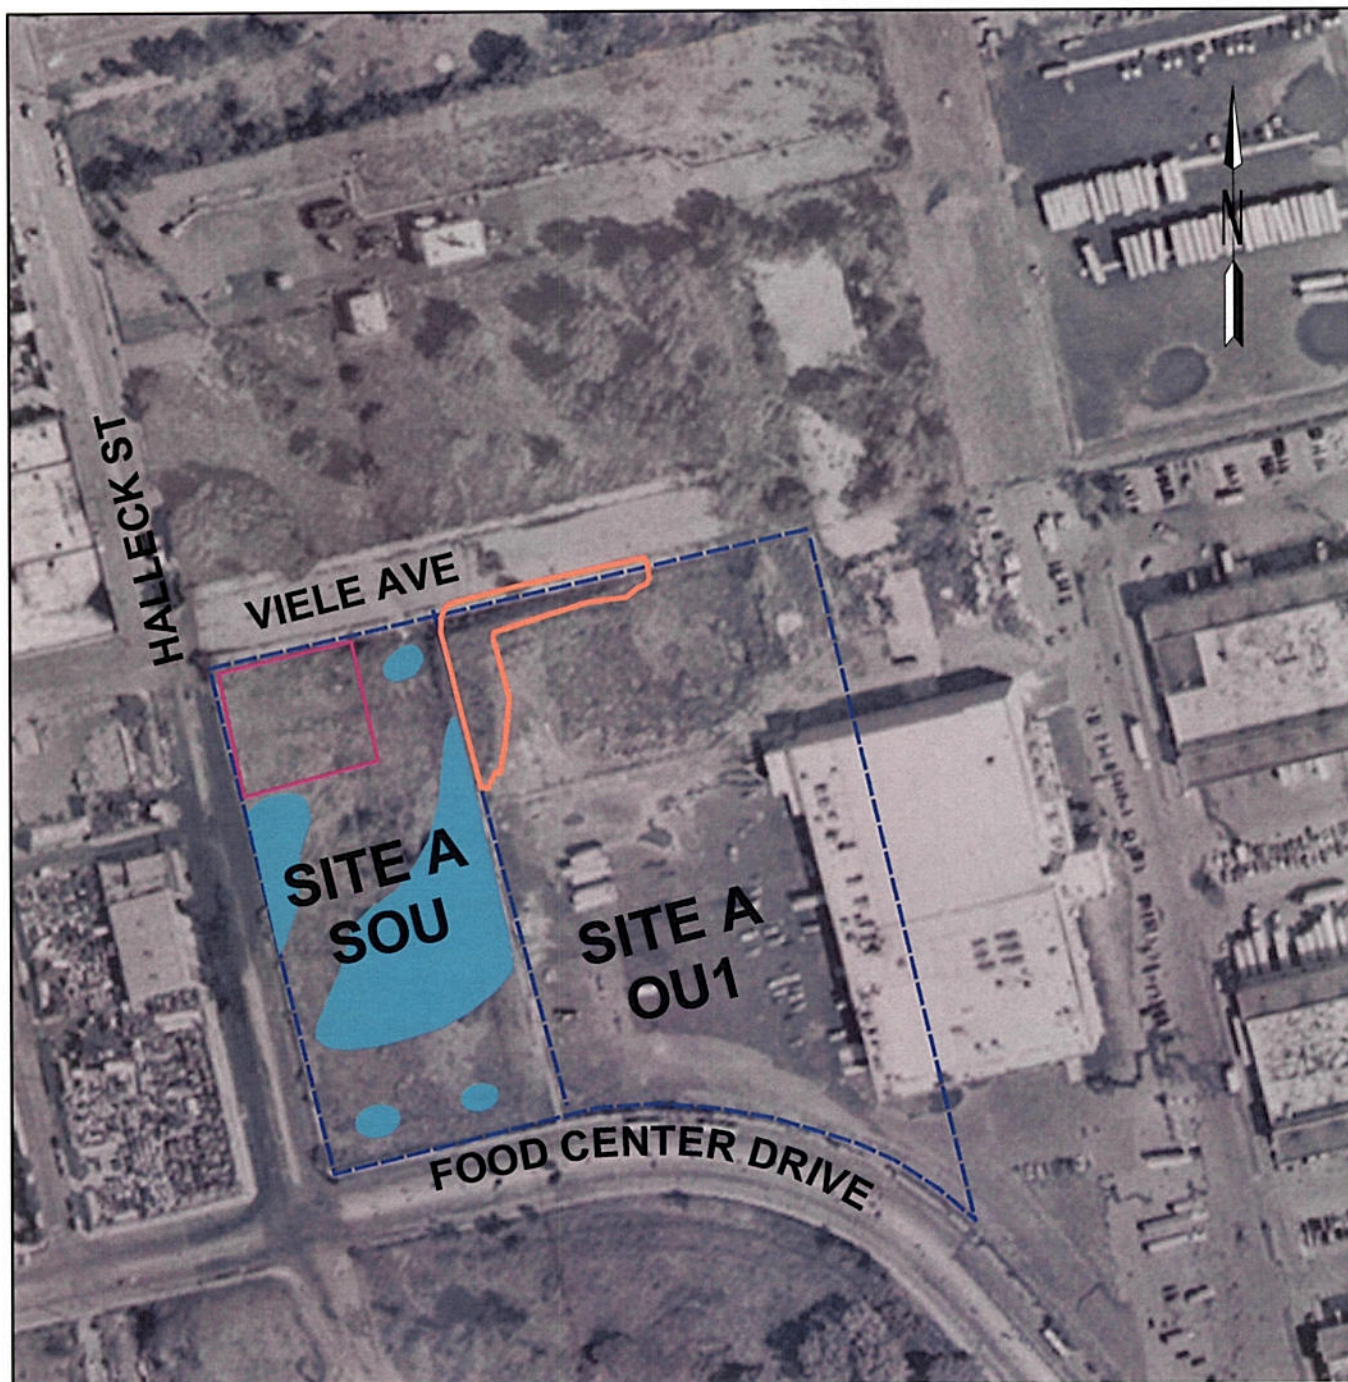
Figure 8 shows the location on the Site A SOU where the material is currently stockpiled and also shows where backfill will be required on Site A SOU. Photos 5 and 6 show the Meat Market parking area during and after construction. These two photos show the Site A SOU in the foreground (grassy areas beyond the Site A OU-1 fence).
