#### Re: OM&M Report (Routine Maintenance) for SSD Systems Installed at 40 Marbledale Road, Tuckahoe, Westchester County Weissman Holdings, Inc. (formerly Kings Electronics Co., Inc.) Site # V 00237-3

#### OM&M Report Summarizing Routine Maintenance of SSD Systems 40 Marbledale Road, Tuckahoe, Westchester County NYSDEC Site # V 00237-3 May 21, 2009

#### Re: SSD Routine Maintenance, May 21, 2009 Storage Deluxe (Former Kings Electronics Site) 40 Marbledale Rd., Tuckahoe, NY 10707

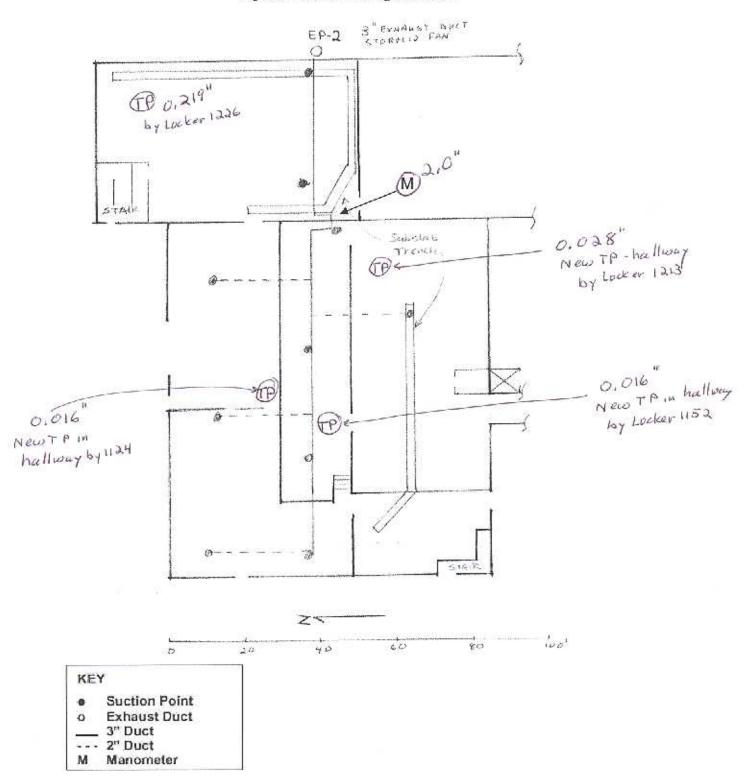
### Pressure Field Extension (TP) and Manometer (M) Vacuum - wci System 2, Buildings 3 and 4

Conduct appropriate pressure field extension testing of SSD System.	~	Three new This in Bldg 3
