# J.R. Holzmacher P.E., LLC

January 23, 2013

Re: Sound Pointe Seawall evaluation

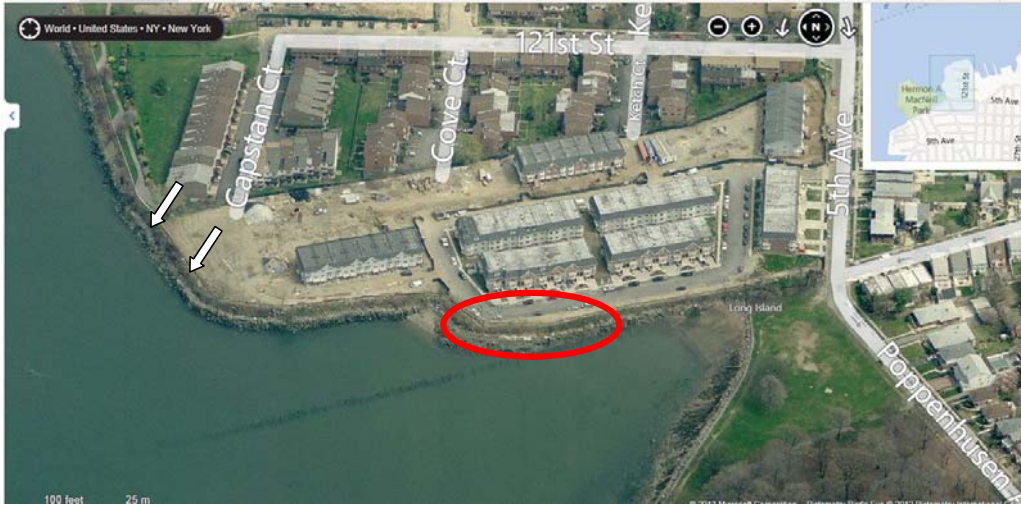
Figure 1 - Bing Maps aerial showing locations of erosion (arrows) and slope failure (red circle).

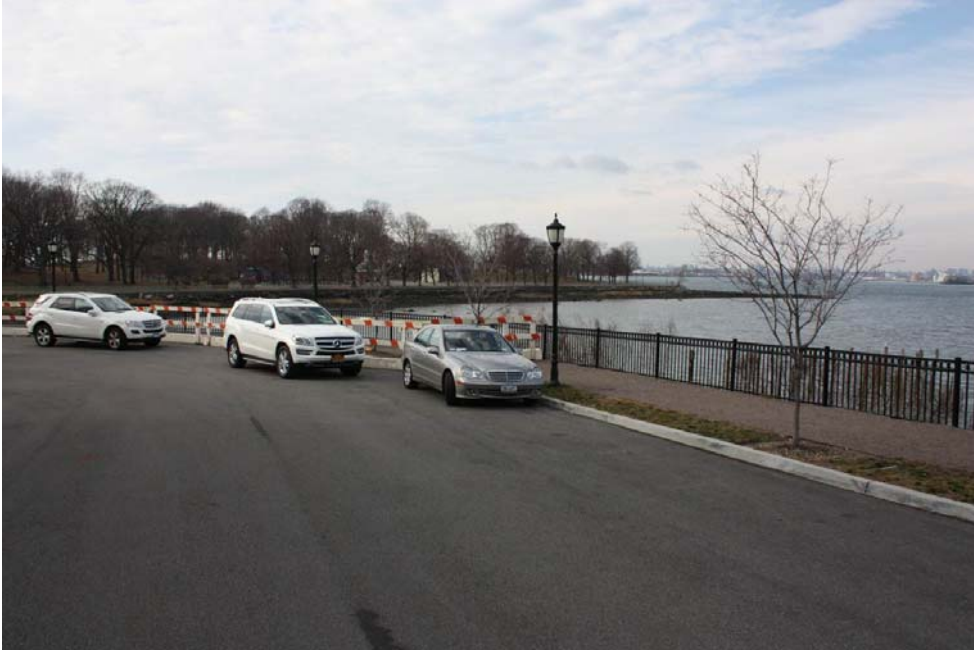
**Photograph 1 – Walkway and fence sections lost to erosion of the seawall.**

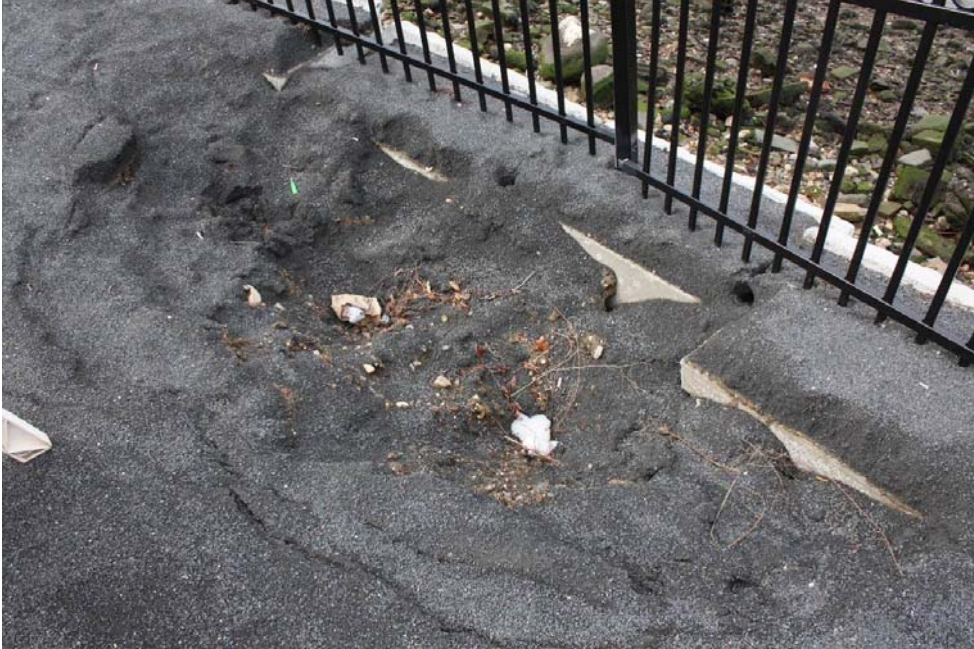
**Photograph 2 – Sinkhole forming in walking path where soil was washed out below.**

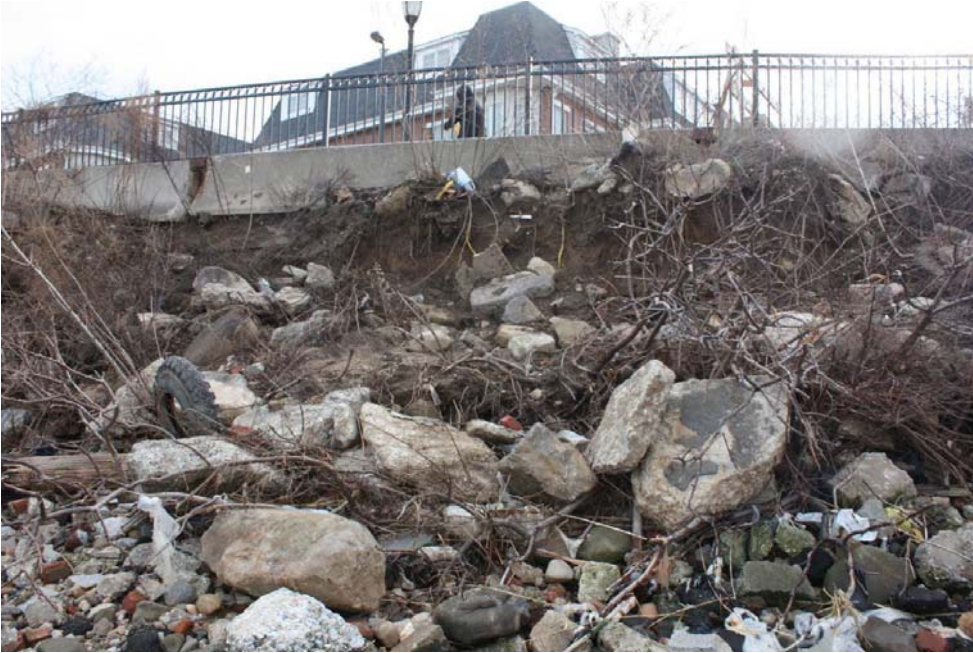
**Photograph 3 – Addition of rip rap alone will not secure the Jersey barrier nor prevent future movement.**

Our recommendation for remediation is twofold, taking cost into consideration. The ideal solution would be a driven sheet pile wall surrounding the property which would prevent movement of the soil and fill during heavy storm wave action. This solution would likely be prohibitively expensive and also prove difficult to successfully accomplish due to the extent of concrete debris and fill that was visible. A more economical solution would be to armor the seawall with three to five ton stones at the toe, and infill behind with broken concrete and riprap. The stone armoring at the toe would be designed to break the energy of the incoming waves, and the rip rap would then protect the slope. As soil is already being lost, we further recommend that the Jersey barrier be held in place through the use of driven H piles. The driving of these piles is recommended as the barriers are not set on a foundation, and will continue to move and likely fail as the slope below is eroded. Furthermore, if the area experiences tidal surge, as happened during Sandy, the submersion of soils in the water will weaken both their bearing capacity and are more likely to be drawn from under the barriers as the tidal surge rapidly recedes.

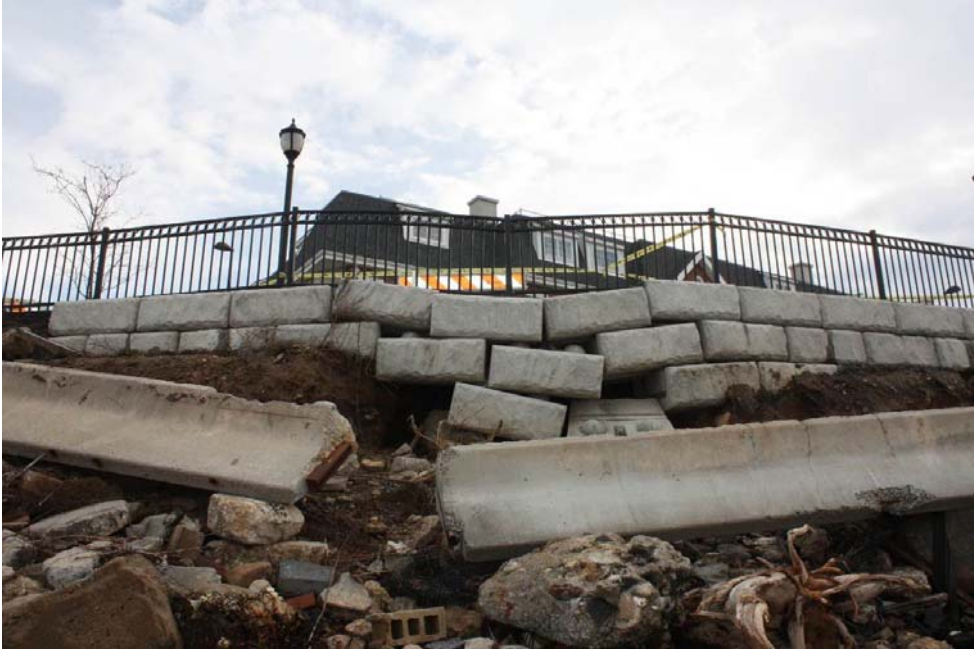
**Photograph 4– Failure of the slope due to wave action and erosion caused failure of the Jersey barrier and subsequent movement of the retaining wall.**

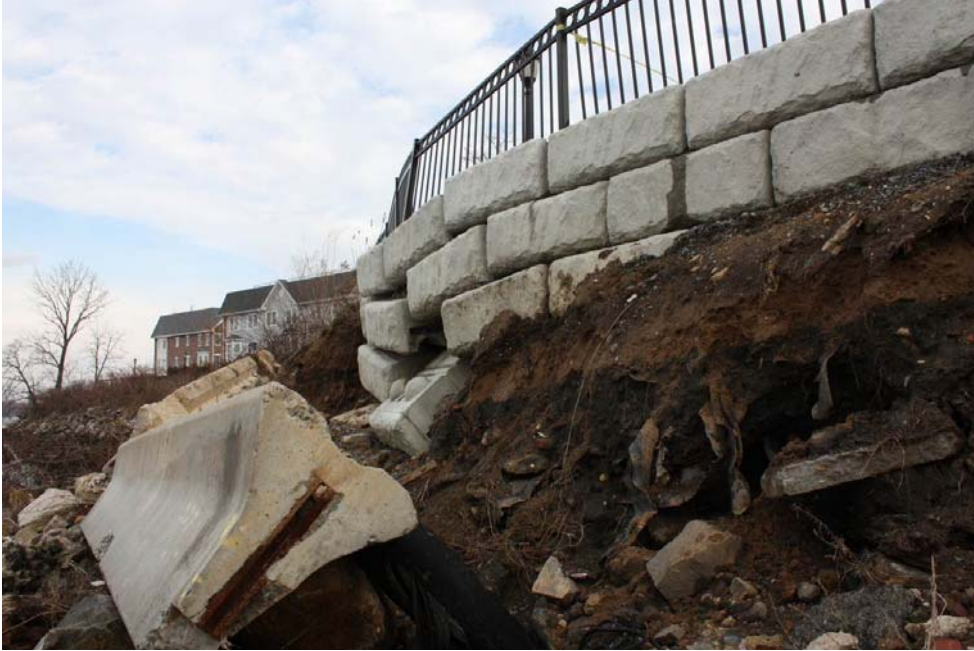
**Photograph 5 – Visible strata of fill and debris evident.**

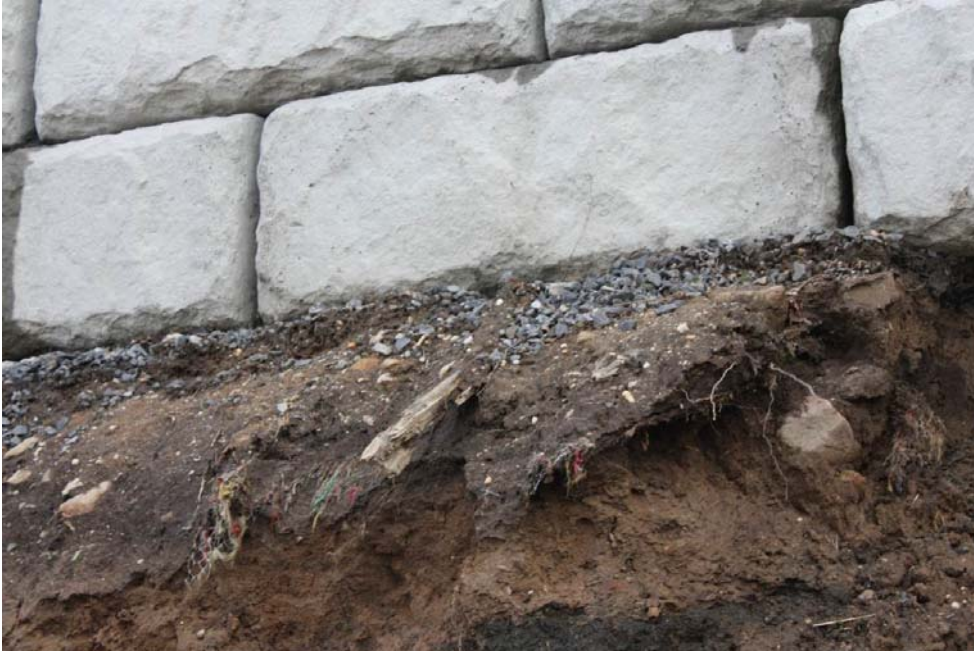
**Photograph 6 – Soil erosion due to wave action responsible for the collapse. Gravel setting bed is being undermined by erosion of soil.**

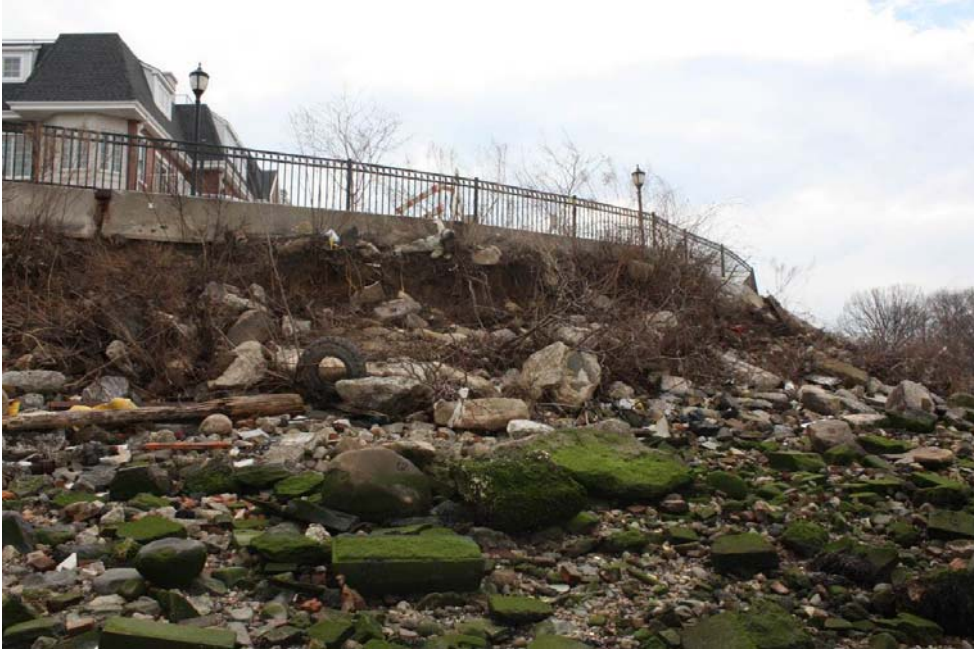
**Photograph 7 – Erosion of soil will cause Jersey barrier to collapse in the near future.**

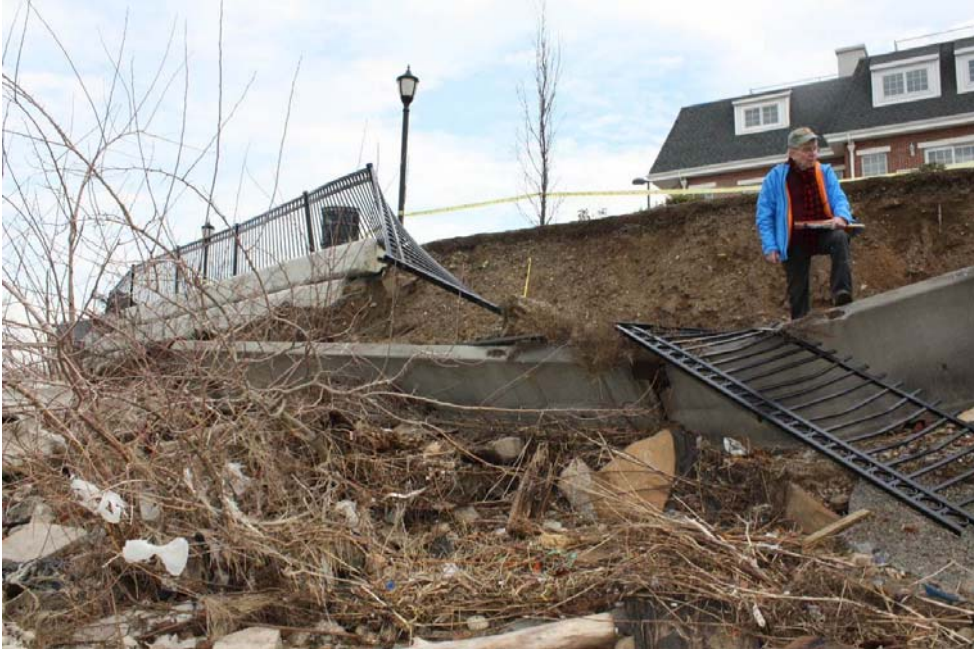
**Photograph 8– Failure of the slope due to wave action and erosion caused failure of the Jersey barrier.**

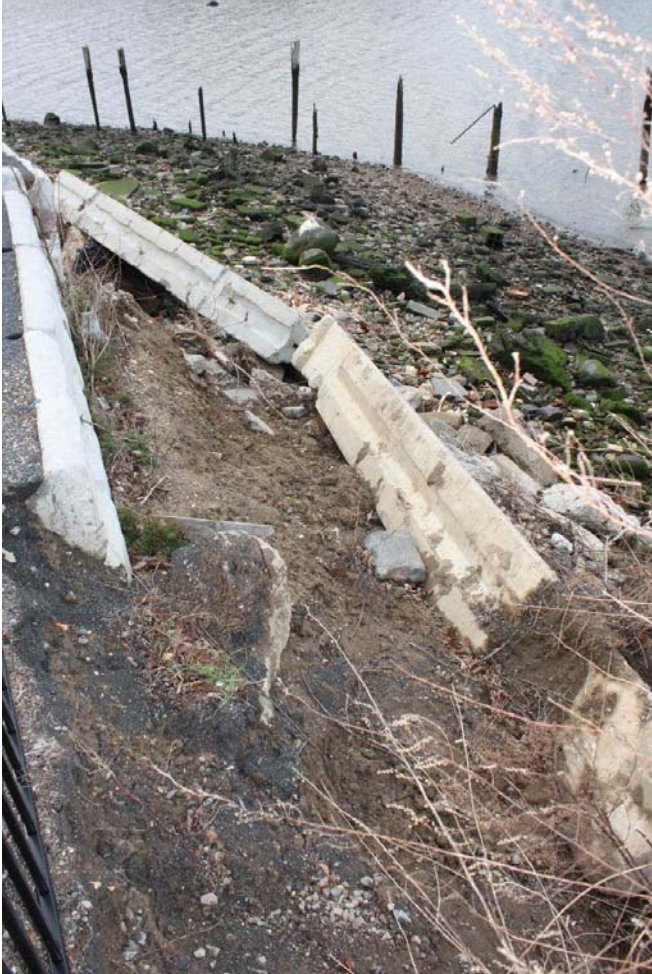
**Photograph 9 – Failure of the slope due to wave action and erosion caused failure of the Jersey barrier.**

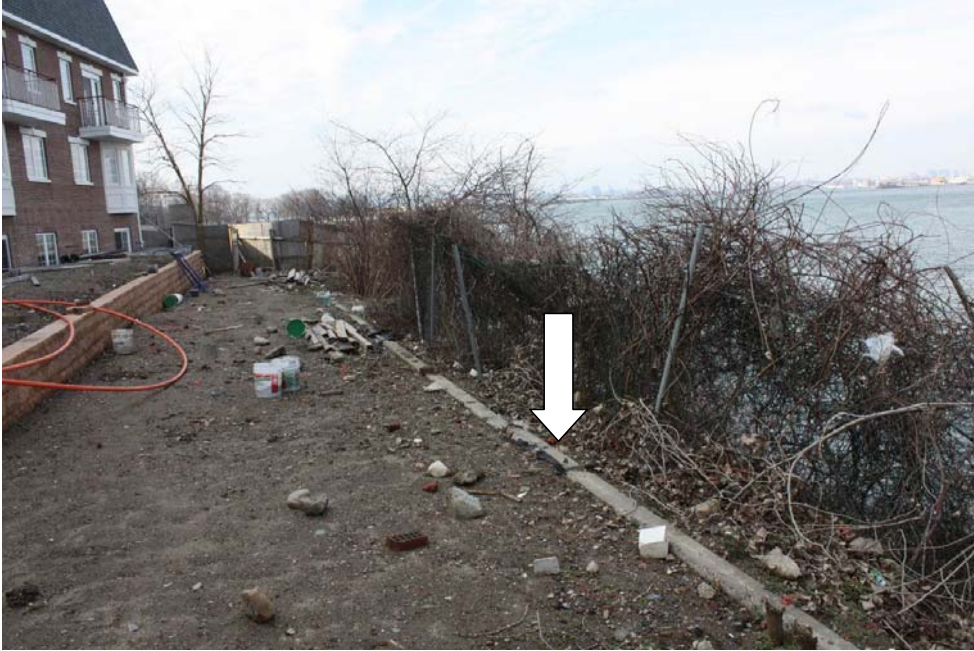
**Photograph 10 – Jersey barrier being used as retaining wall is beginning to become undermined and shift seaward.**

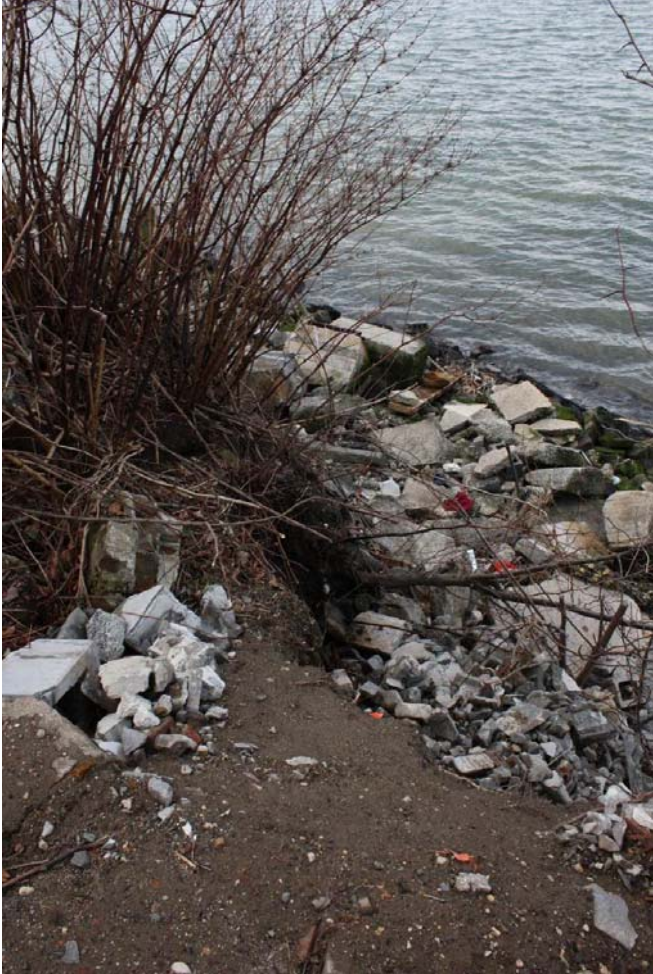
**Photograph 11 – Washout of North side slope will lead to failure of seawall rip rap and leave townhouses exposed to the East River.**

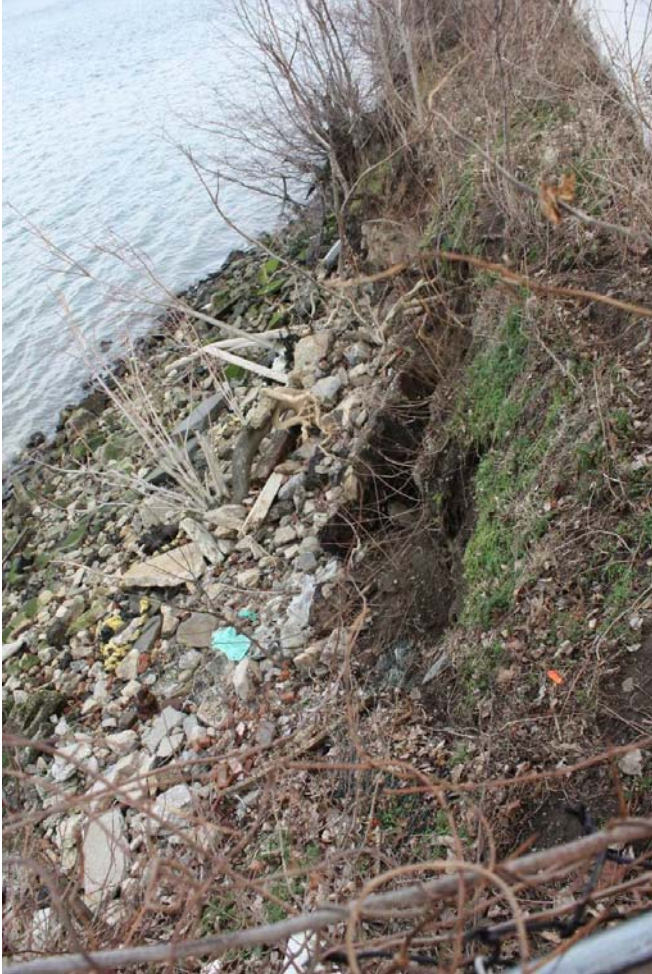
**Photograph 12 – Movement of North side of slope requires remediation before the failure extend back to the homes.**

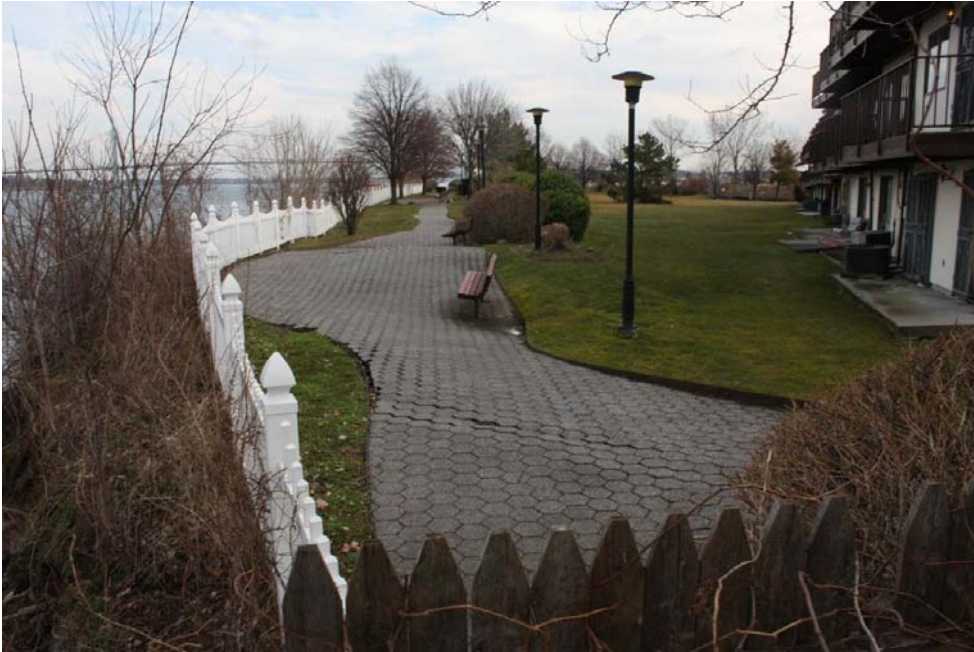
**Photograph 13 – Movement of walkway on property to the East indicates movement of the slope.**
