Subject: 2024 Annual Site-Wide Inspection Report

RG&E Brockport MGP Site

Village of Brockport, Monroe County, New York

NYSDEC Site #V00301-8

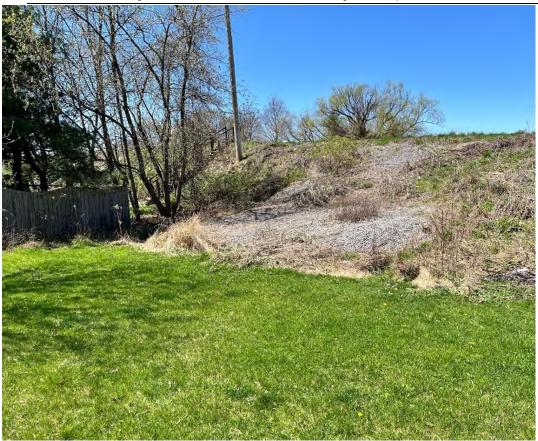
Photo 1 – Looking northwest at the northwestern portion of the Site.

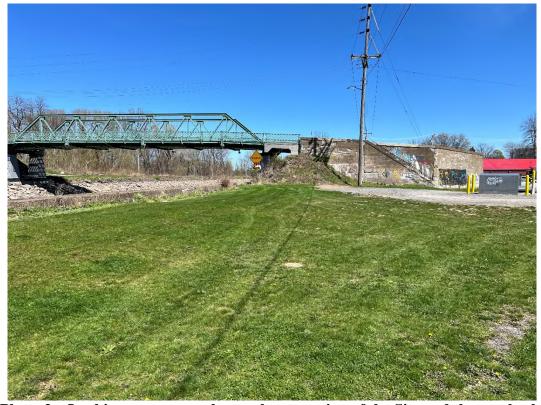
Photo 2 – Looking east across the northern portion of the Site and the northerly adjacent NYS Canal Corporation property.

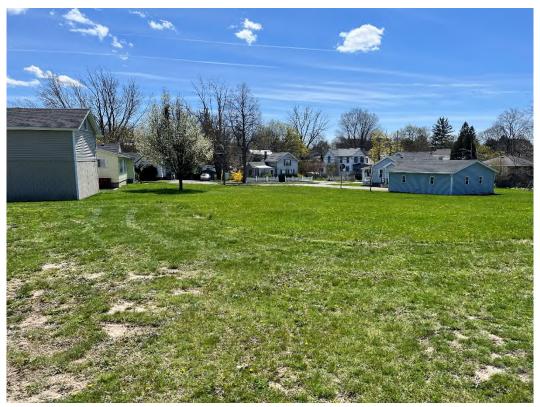
Photo 3 – Looking south across the central portion of the Site.

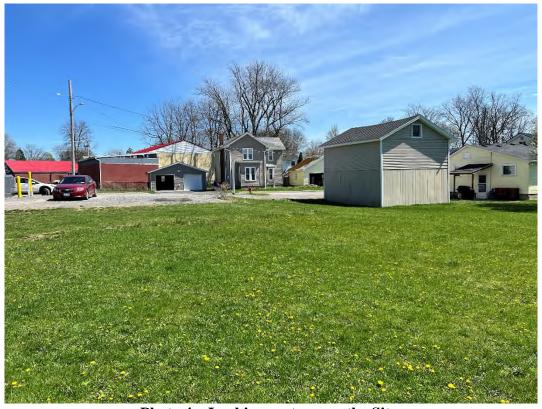
Photo 4 – Looking east across the Site.

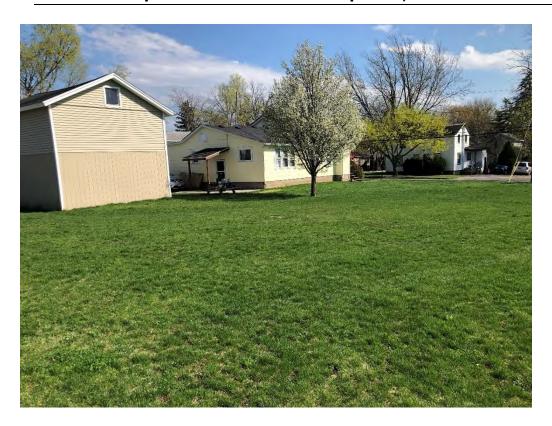
Photo 5 – Looking southeast across the central portion of the Site.

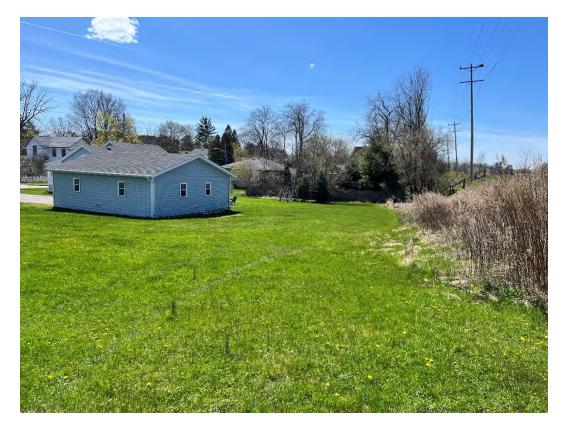
Photo 6 – Looking southwest across the Site.

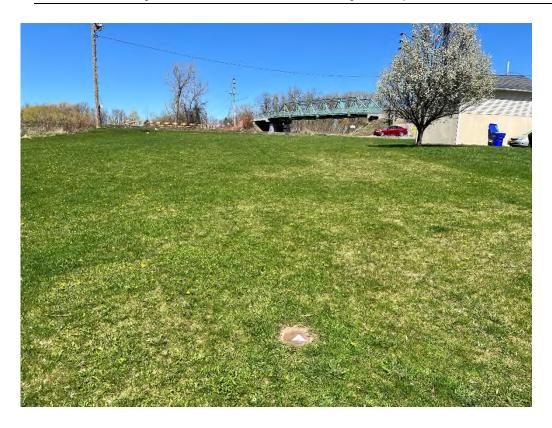
Photo 7 – Looking northeast across central portion of the Site, MW-20 visible in foreground.
