RE: Periodic Review Report for Site No. V00314 & June 2017 Inspections.

**Periodic Review Report for Site No. V00314, Aurubis Buffalo, Inc., located @
Military and Sayre St. Buffalo, NY 14207**

Dated June 27, 2017

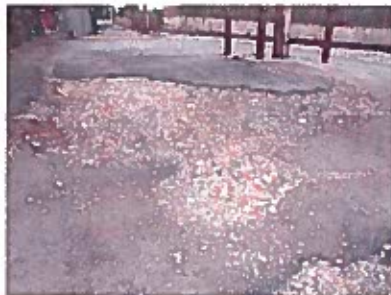
- Area C (west of the boiler house): The two stacks have been removed west of the boiler house. Determine when the boiler house stacks were removed, if possible. Current ground cover includes brick/gravel surface. Possible limited washout of the ground cover was observed north of the northern stack (see photo).

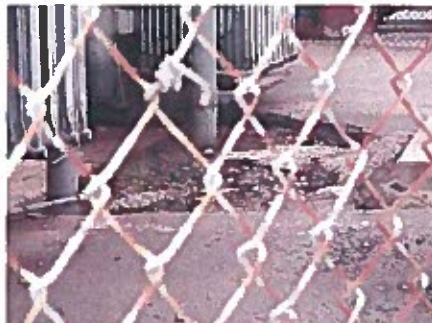
- Area D: The substation area is a dangerous area and the inspectors did not enter the substation for further inspection. Limited areas of asphalt wear were present within the locked fence.

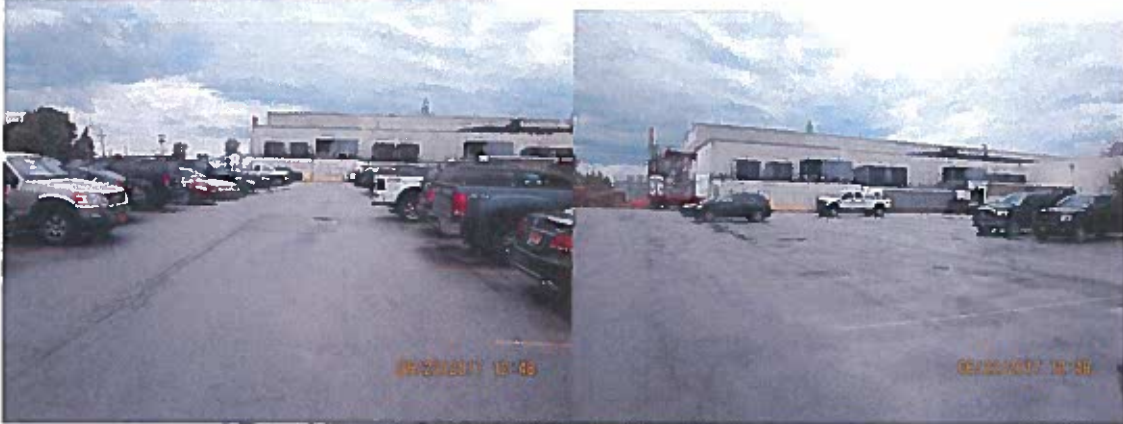
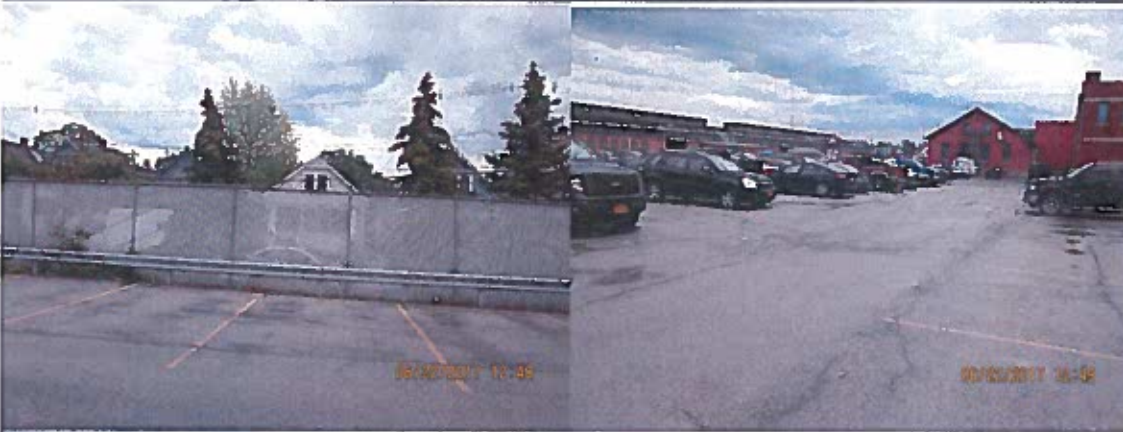
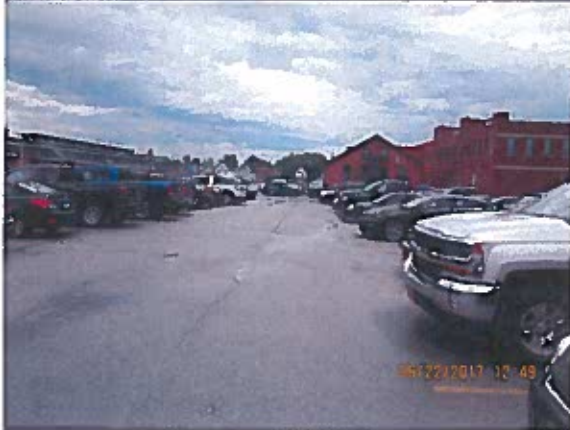
Asphalt covering Area A in good condition.

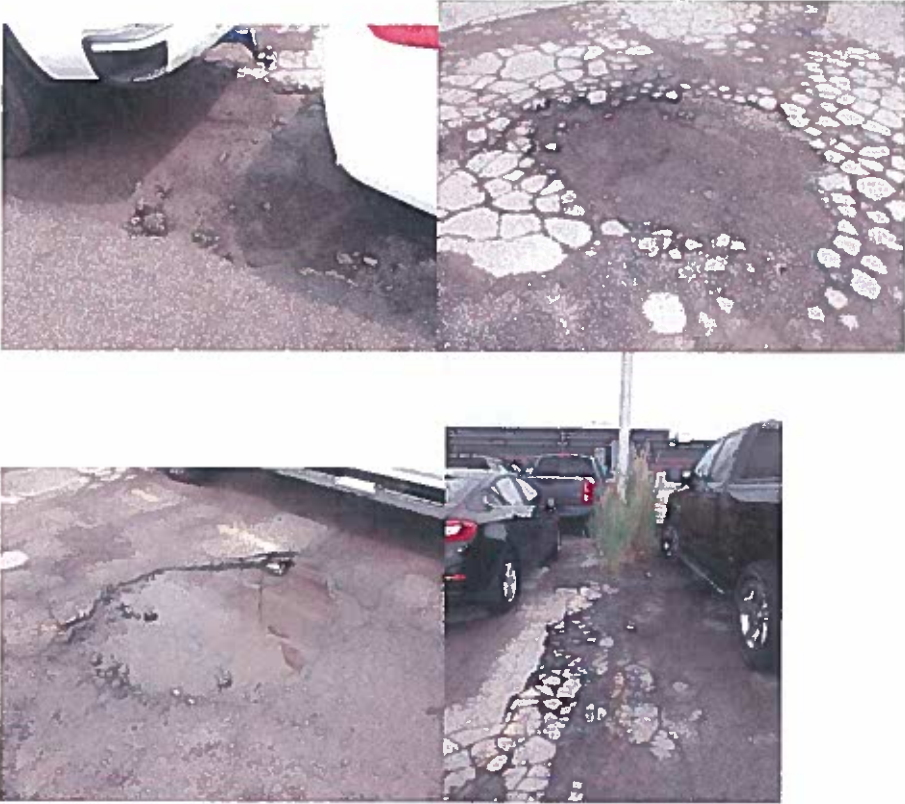
Issues found in Area A: The “pre-existing paved or concrete roadways and parking lots” of the east most employee parking lot had potholes and grass growing. The surface underneath appeared hard, but not sure if soil was exposed.

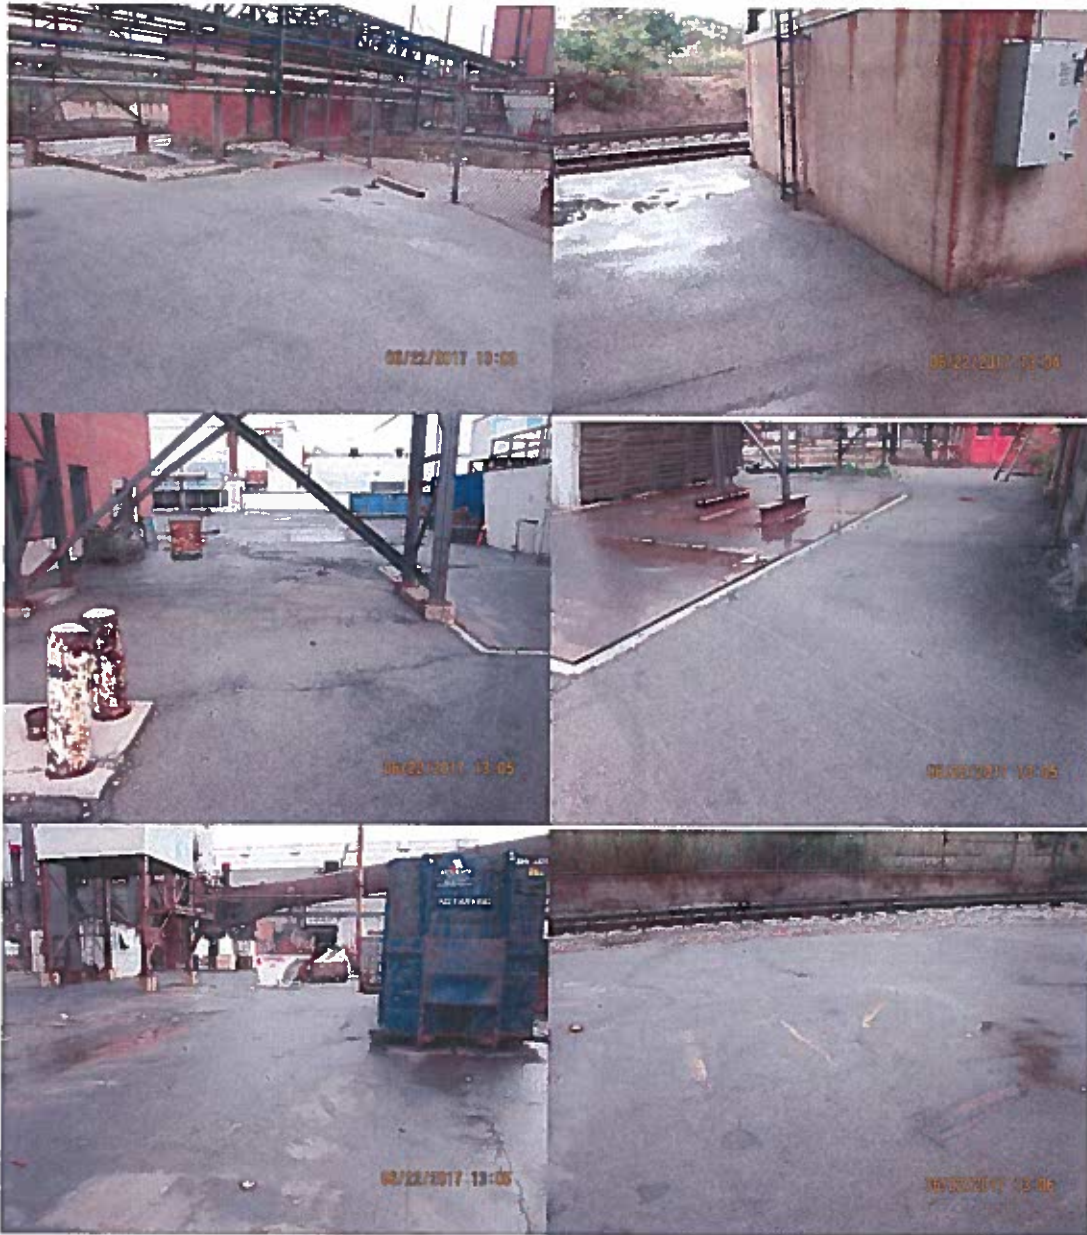
Area C
Asphalt covering Area C in good condition

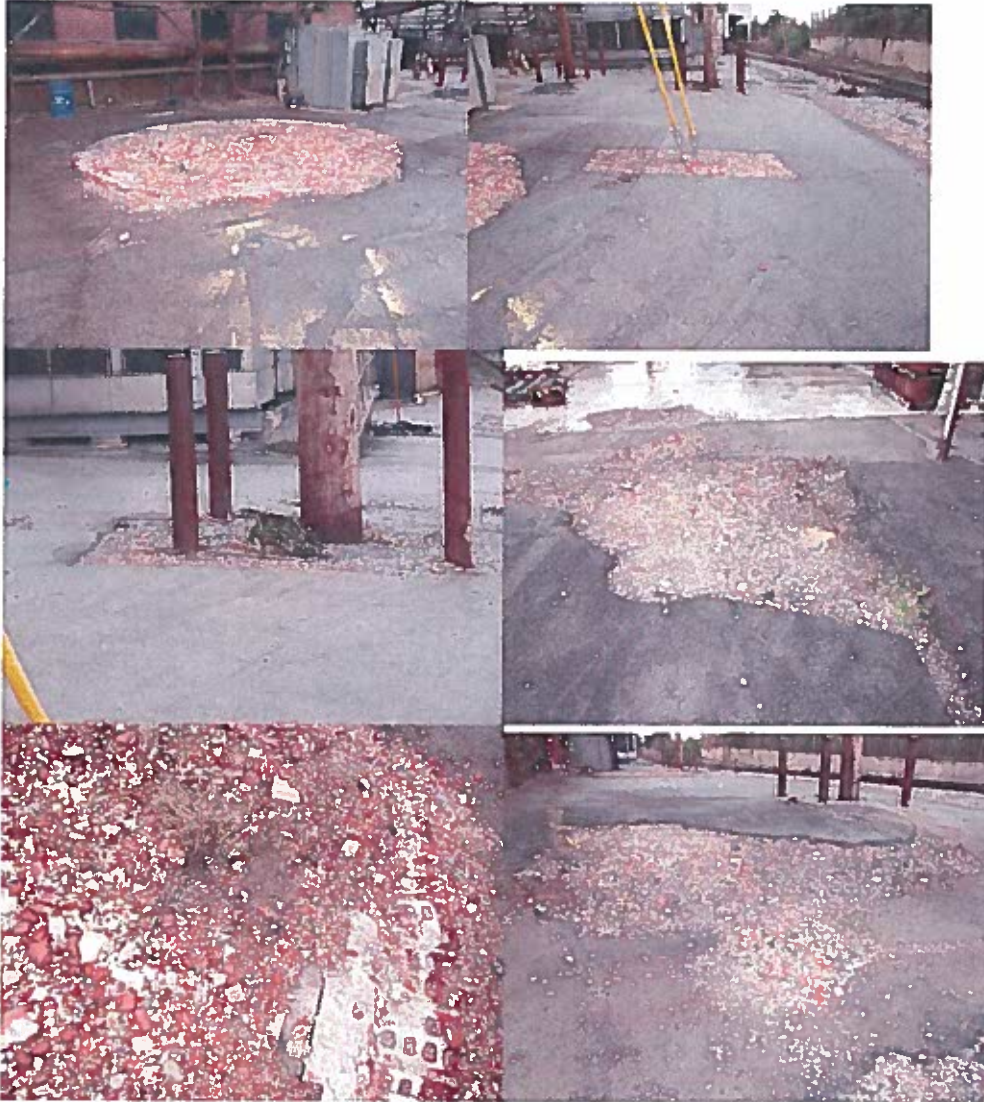
Issues found in Area C (west of the boiler house): Determine when the boiler house stacks were removed (if possible) and if the associated ground cover is appropriate. There appears to be washout of the ground cover towards where the cogeneration plant used to be.

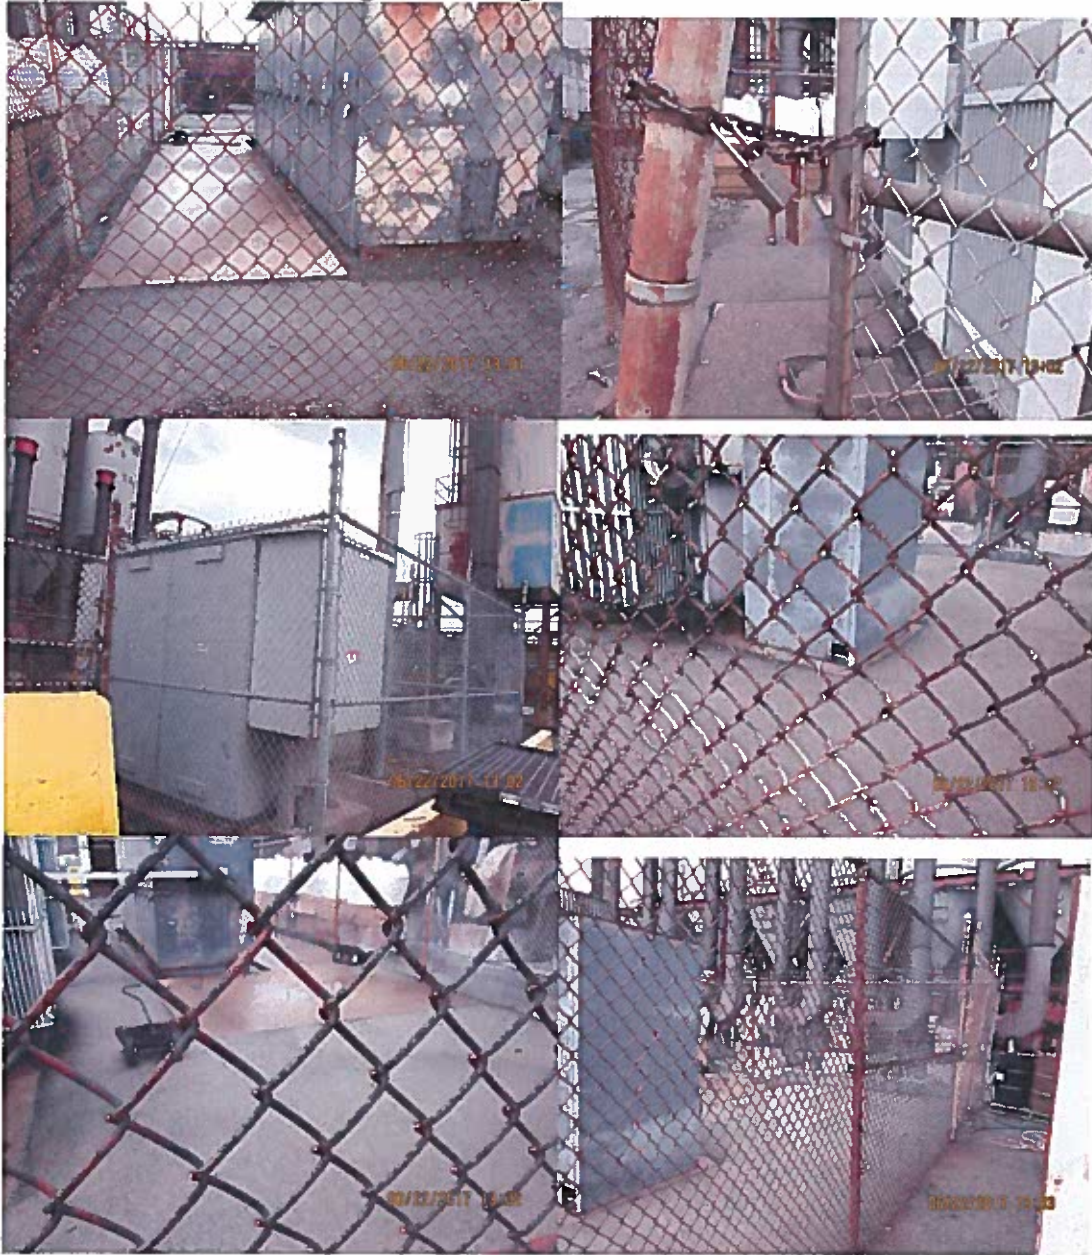
Asphalt & concrete covering Area D in good condition

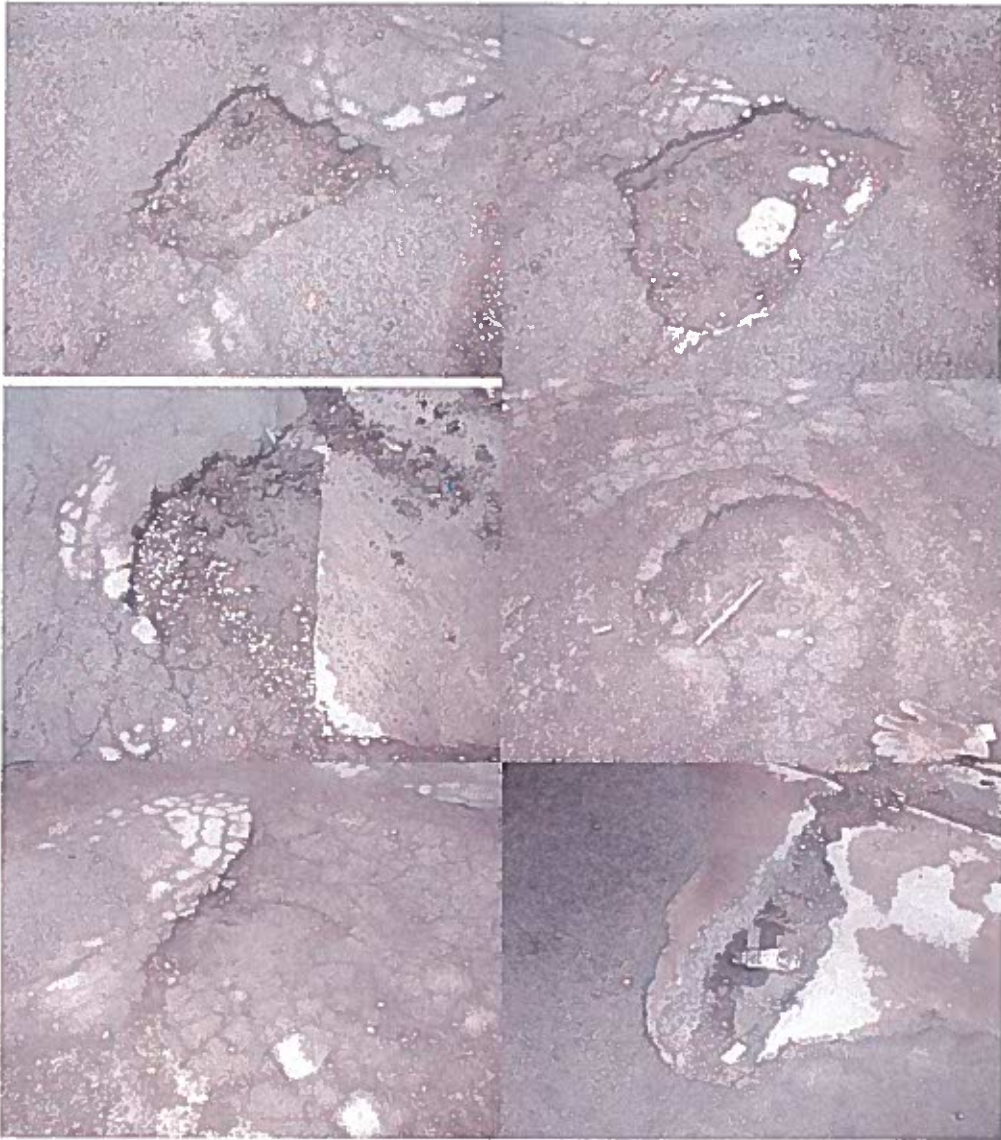
Issues found in Area D:

There were large pot holes in the “pre-existing paved or concrete roadways and parking areas”. Soil appears to potential be exposed in some of these pot holes.

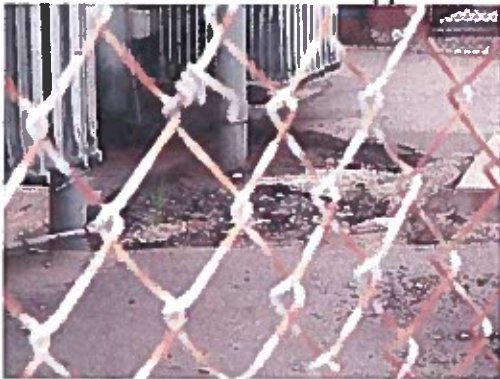
Within the substation there appears to be some potential for soil exposure.

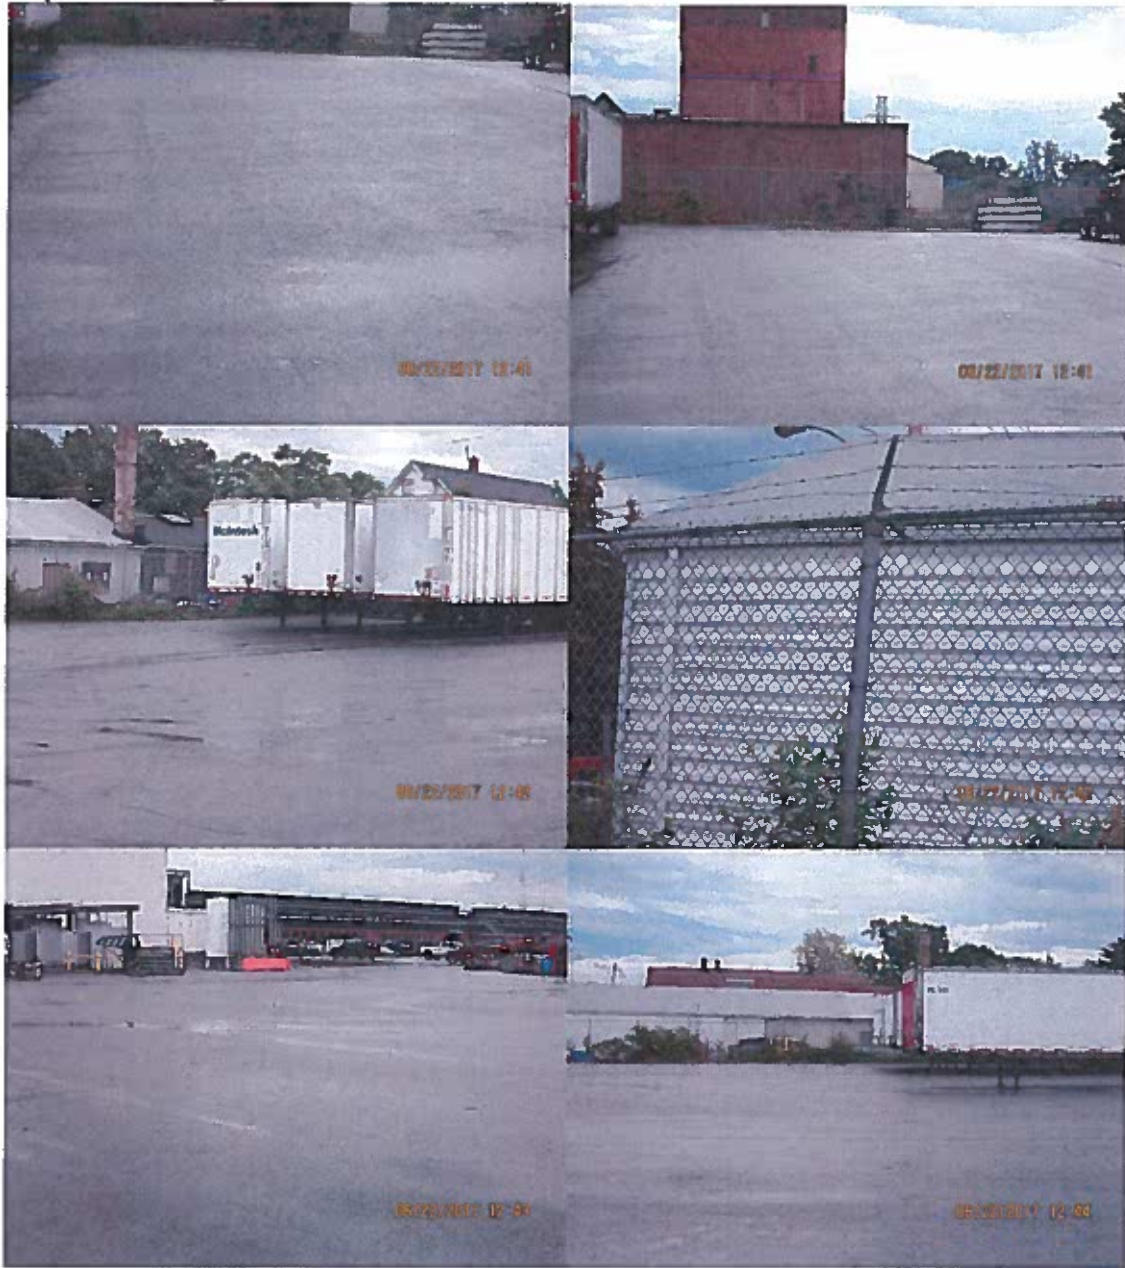
Area M
Asphalt covering Area M

No Issues found in Area M

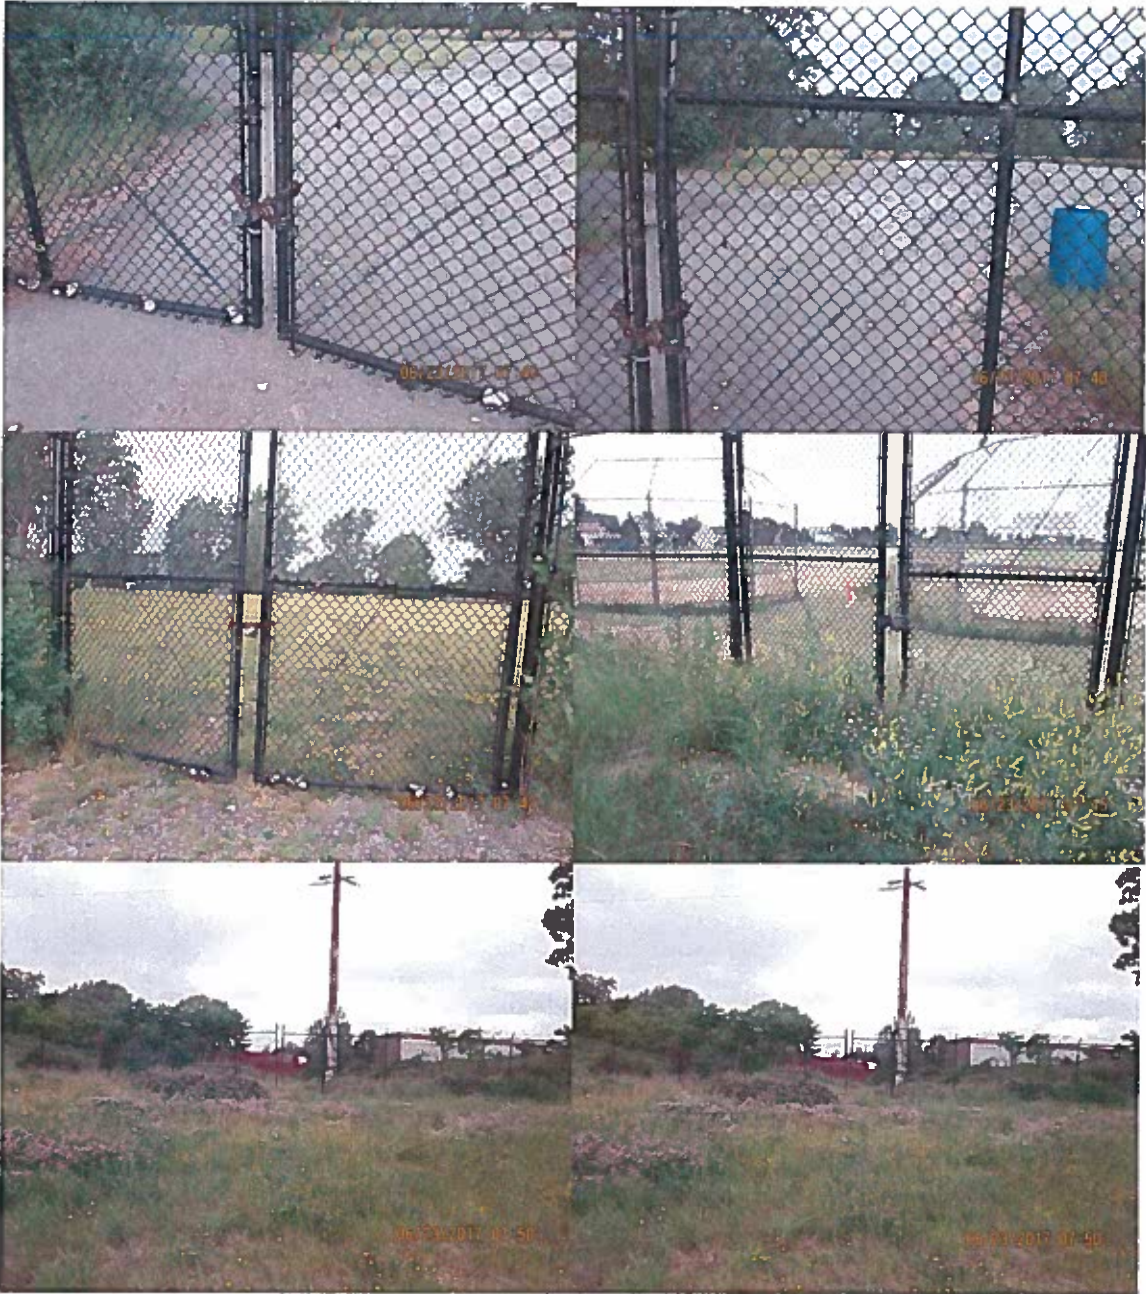
Area J: Fence in good condition

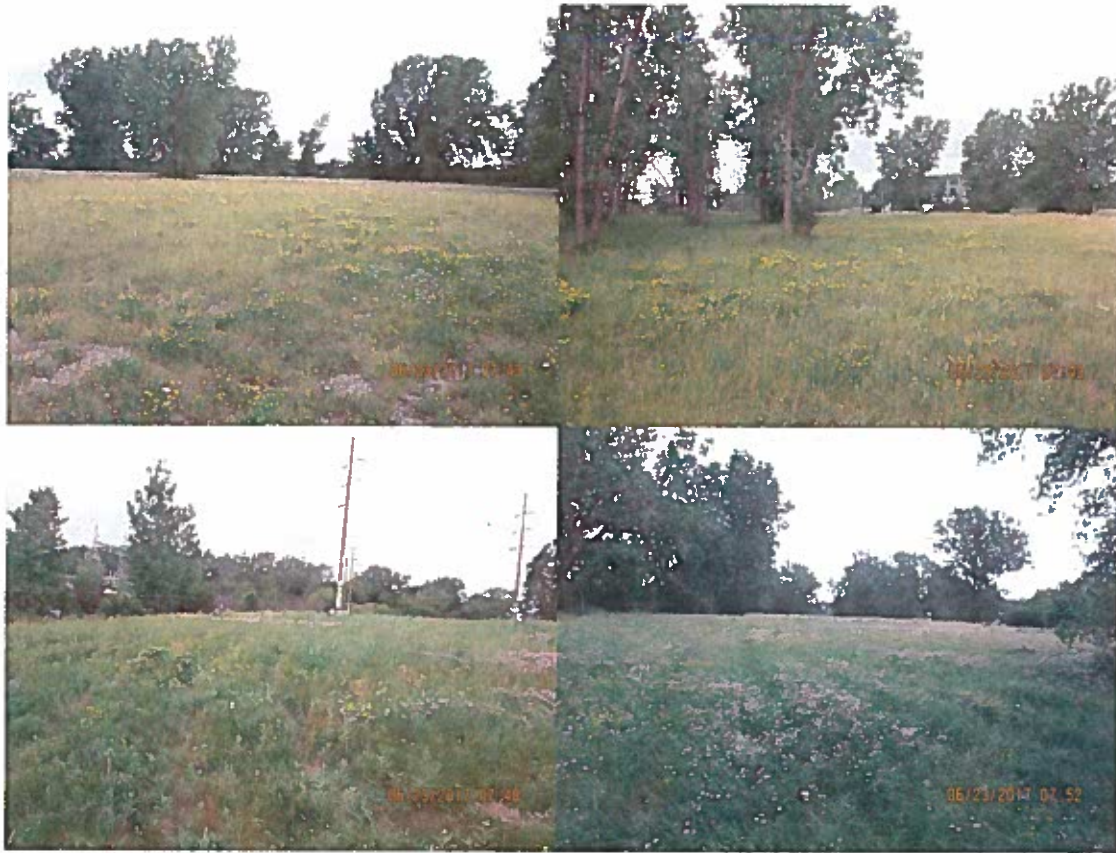
Area J: Vegetation healthy and abundant with no evidence of paths from people or animals.

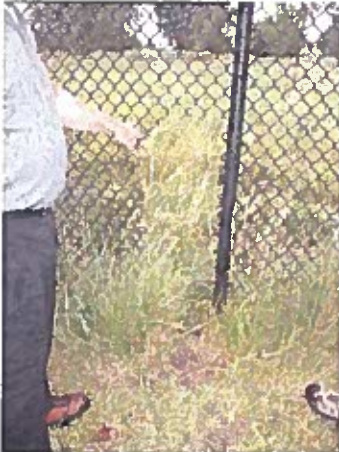
- No breaches of the security fence were observed during the June 21-23 inspection.
- During the June 29, 2017 inspection an area of fence was identified to have been recently cut near the ball fields, like to retrieve softballs. The cut fence area was reported and a work order placed for immediate repair.

Issue found in Area J: New hole in fence observed June 29, 2017 (It was not there on June 23). It looked like someone had entered just a short way past the opening.

damaged or deteriorated to the extent that potential trespassers or other unauthorized personnel could pass through, over, or under the fence without significant effort.	new hole in area J fence has been submitted.
