**Periodic Review Report for Site No. V00314, Aurubis Buffalo, Inc., located @  
Military and Sayre St. Buffalo, NY 14207**

Dated July 27, 2018

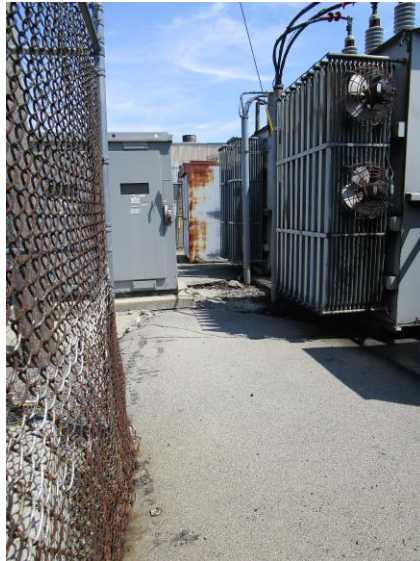
- Area D: The substation area is a dangerous area and the inspectors did not enter the substation for further inspection. Limited areas of asphalt wear were present within the locked fence. However, access to this area is limited due to the locked fence. Repairs within this area will have to be coordinated with an electrical contractor.

| Item # | Recommendation | Target Date |
|---|--|---|
| 2 | Patch pothole in area D substation. | Spring 2019 |

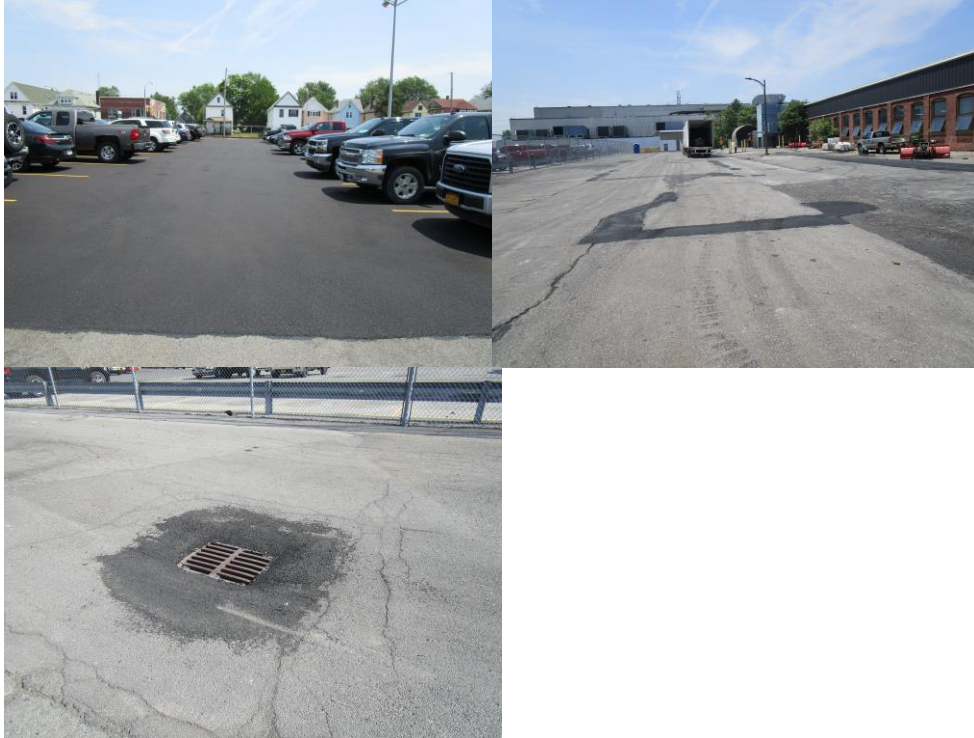
### **Area A**

Asphalt covering Area A in good condition.

Note: Surface repair of Area A parking lot completed Summer 2018

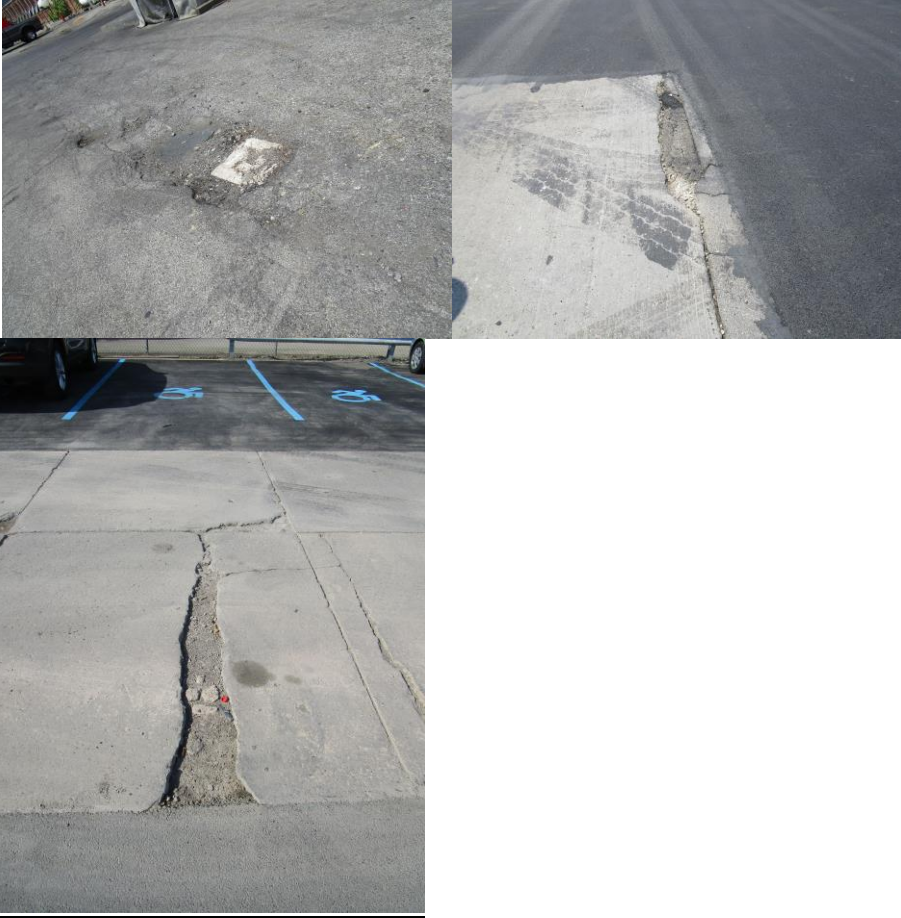
**Concerns** found in Area A: The paved & concrete roadways and parking lots had some minor potholes and areas for future patching.

| Item # | Recommendation | Target Date |
|---|--|---|
| 1 | Patching potholes in Areas A, C, & M. | Fall 2018 |

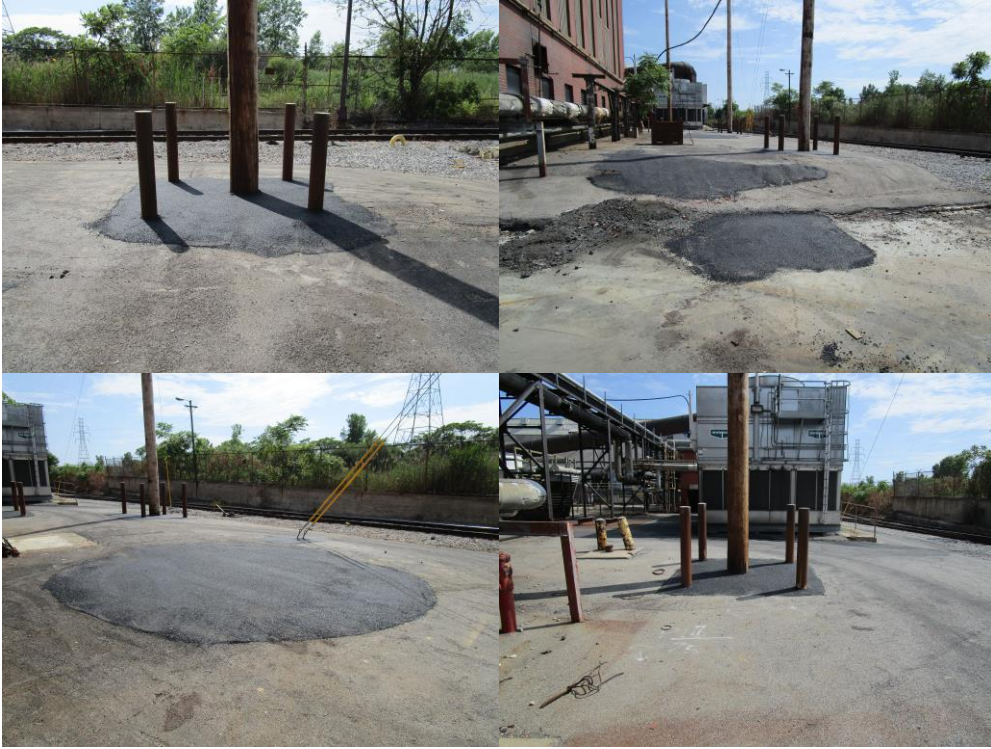
**Area C**

Asphalt covering Area C in good condition

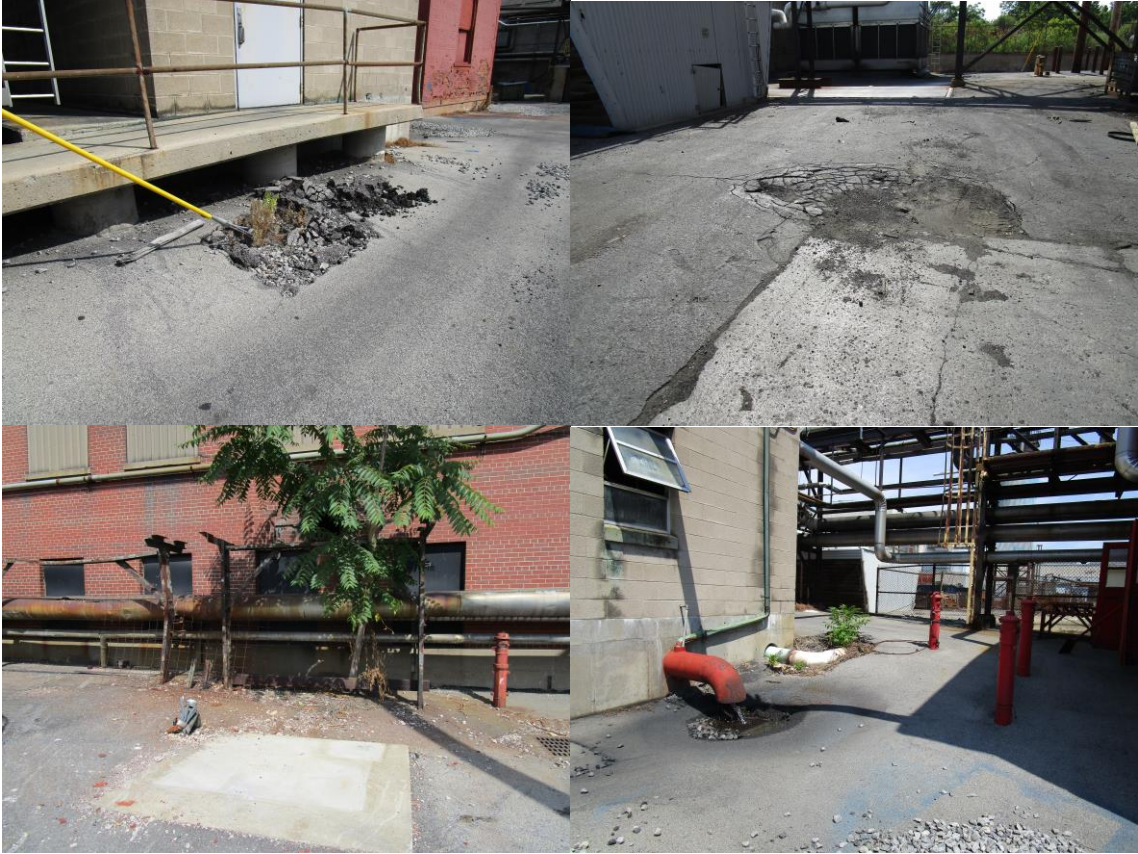
**Concerns found in Area C: Some asphalt needs patching**

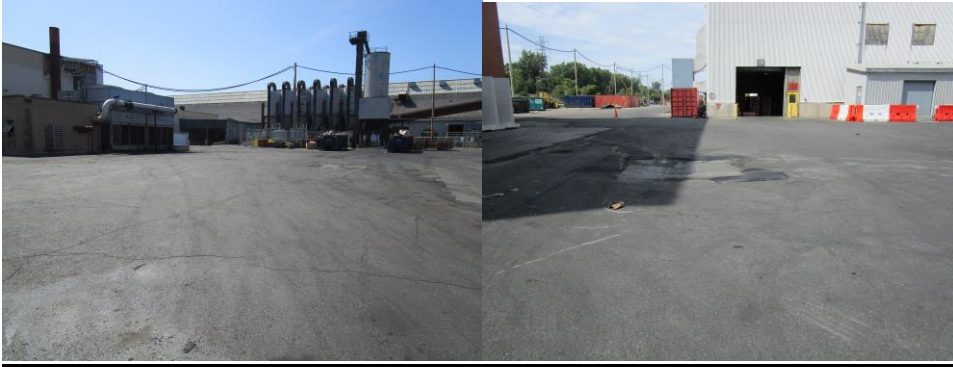
**Area D**

Asphalt & concrete covering Area D in good condition

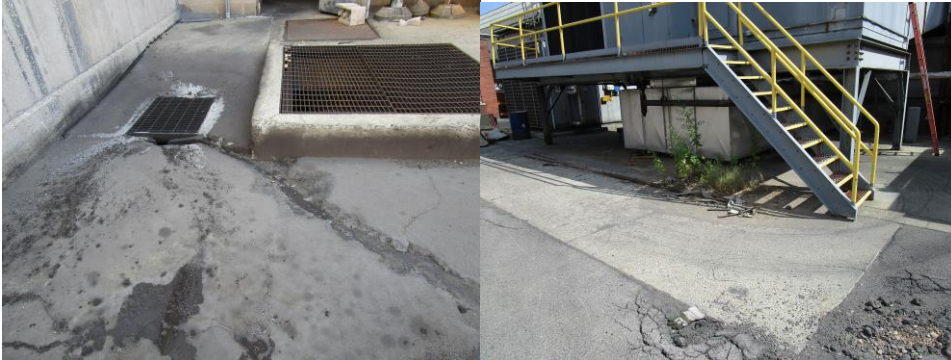
**Concerns found in Area D:**

Limited ruts/potholes in pavement

| Item # | Recommendation | Target Date |
|---|--|---|
| 3 | Patch potholes in area D that are not in the substation. | Fall 2018 |

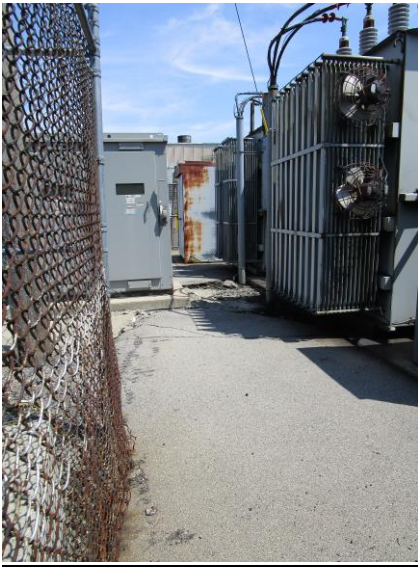
Within the substation there appears to be some potential for soil exposure. However, the substation is located behind a locked gate, limited exposure potential.

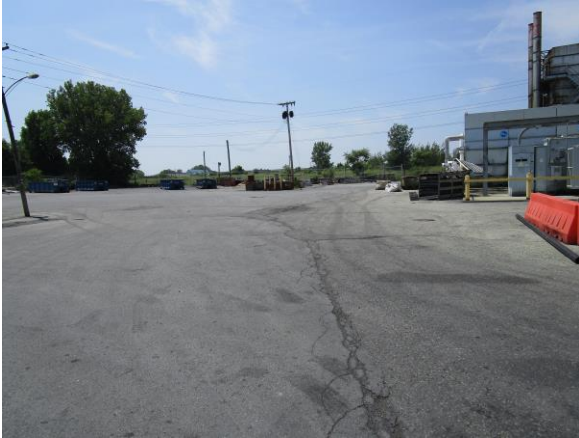
**Area M**

Asphalt covering Area M

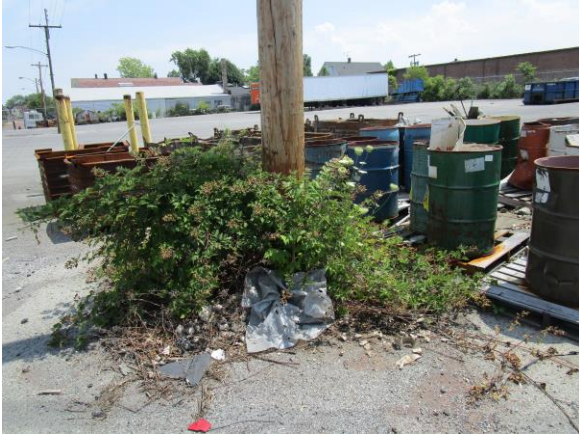
**Concern** found in Area M: Vegetation growth near one utility pole.

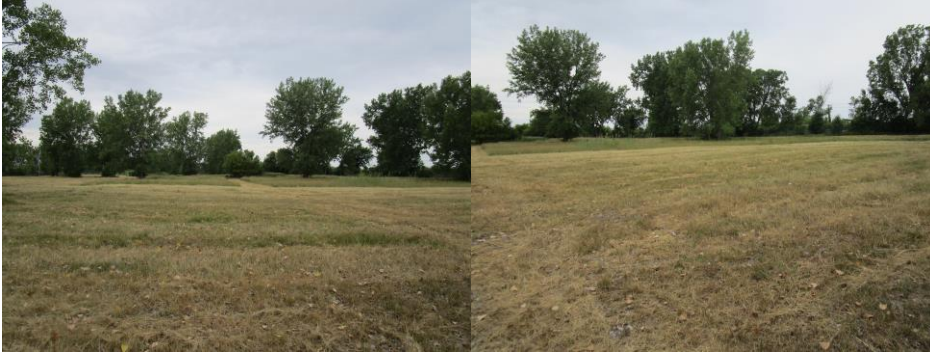
**Area J**

Area J: Vegetation healthy and abundant with no evidence of paths from people or animals.

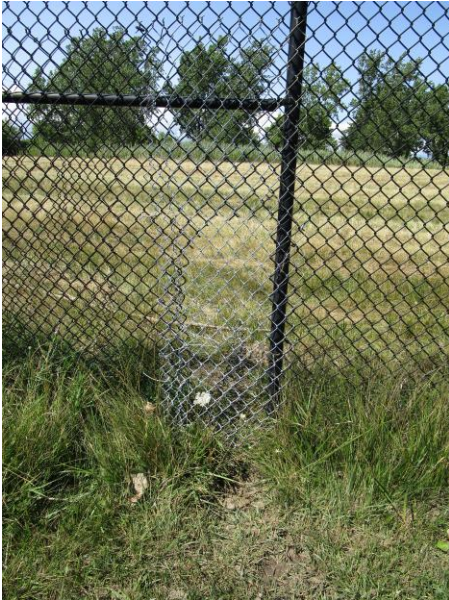
- The vegetation is very healthy.
- There are no ruts or foot print paths through the vegetation that would indicate that people or animals are entering this restricted area.
- During the June 26, 2018 inspection a hole in the fence was identified which has since been repaired.
- Within the bollard area:
  - There were no trees suggesting deep roots breaching the cap nor were there signs of any animal burrows
  - The eight original bollards defining the soil cap perimeter are all present and clearly visible.

The hole in fence has been repaired.
