INSPECTION REPORT

Site Number: V-00334-9/915525

Site Name: Grief Bros. Corporation

Location: 2122 Colvin Blvd, Tonawanda

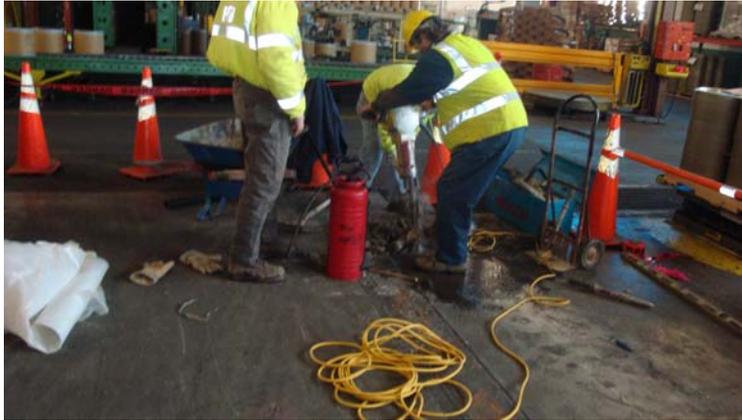
Sub-slab depressurization system running. Area around former varnish pit has problems with short circuiting and vacuum is lost at the joint between the former varnish pit wall and floor slab. Attempts to seal the joint have provided temporary performance improvements but the sealant breaks down over time. Pinto has been hired to remove a section of concrete along the south side of the former varnish pit and replace with new concrete to provide a better seal along wall. Concrete floor removal is slow due to problems with dust control and power outages. Floor slab is approx 6” thick, using jack hammer to bust out floor. Using shop vacuum and water spray to reduce dust. Temp shield fabricated to place over concrete saw to contain dust proved marginally effective. Expect work to take the rest of the week to complete.

030811-01 Removing Floor Slab.jpg

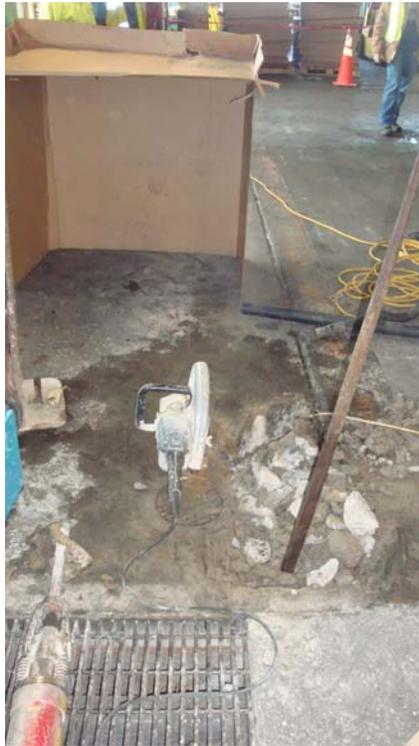
030811-02 Saw Cutting Floor.jpg
