2023 PERIODIC REVIEW REPORT
CLOSED VCA SITE NO. V00357-8
CORNING, NEW YORK

by
Haley & Aldrich of New York
Rochester, New York

for
New York State Department of Environmental Conservation
Avon, New York

File No. 129352-007
January 2024

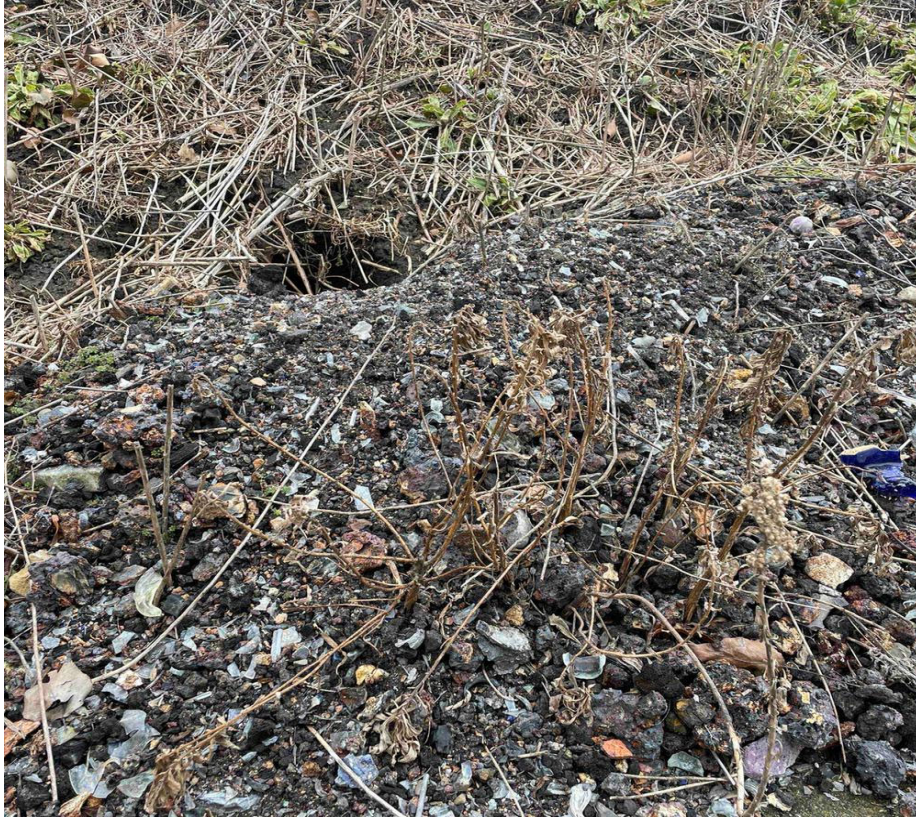
4. In early 2023 an animal burrow was identified on the southeast portion of the site in a landscape area. The animal exposed buried ash and debris. After identification of the breach of cover, a plan was coordinated with the NYSDEC and Corning to repair the cover at the location of the animal burrow. Corning repaired the burrow hole under observation by Haley & Aldrich. The activities to repair consisted of coordination with NYSDEC, removing animal burrow materials, containerizing the material, backfilling the hole with approved material, installing demarcation layer, and top dressing with mulch. The containerized materials were analyzed and determined to be non-hazardous and were subsequently disposed at a Steuben County Landfill by others. NYSDEC was notified of all activities, and it was determined that a Corrective Measures Report was not required for this activity. During the site inspection on 11 January 2024 a new animal burrow in the same general vicinity was observed and will need to be repaired in the same manner as the 2023 animal burrow. It is recommended to provide the NYSDEC with the same notification and also have the repair activities observed by Haley & Aldrich. Photos of the 2023 animal burrow repair are attached in Appendix B.

Photo 1: Animal burrow on southeast side of property and displaced buried materials. Photograph taken 2-17-2023.

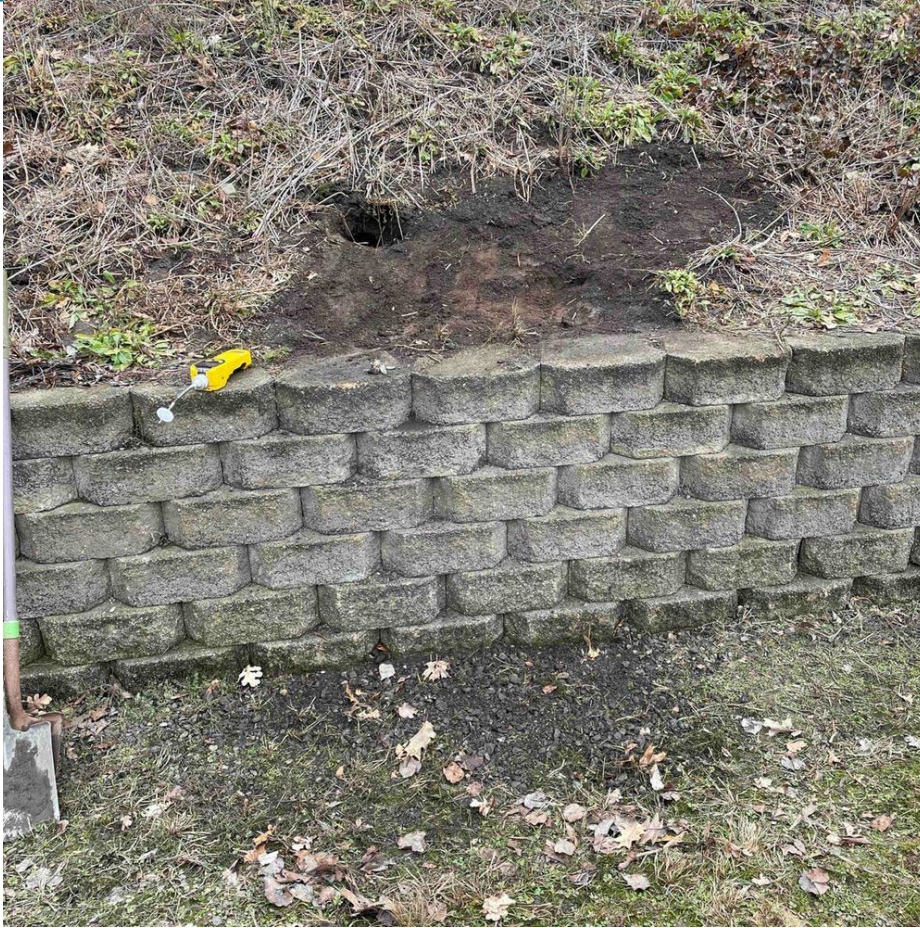
Photo 2: Material removal at animal burrow. Photograph taken 2-17-2023.

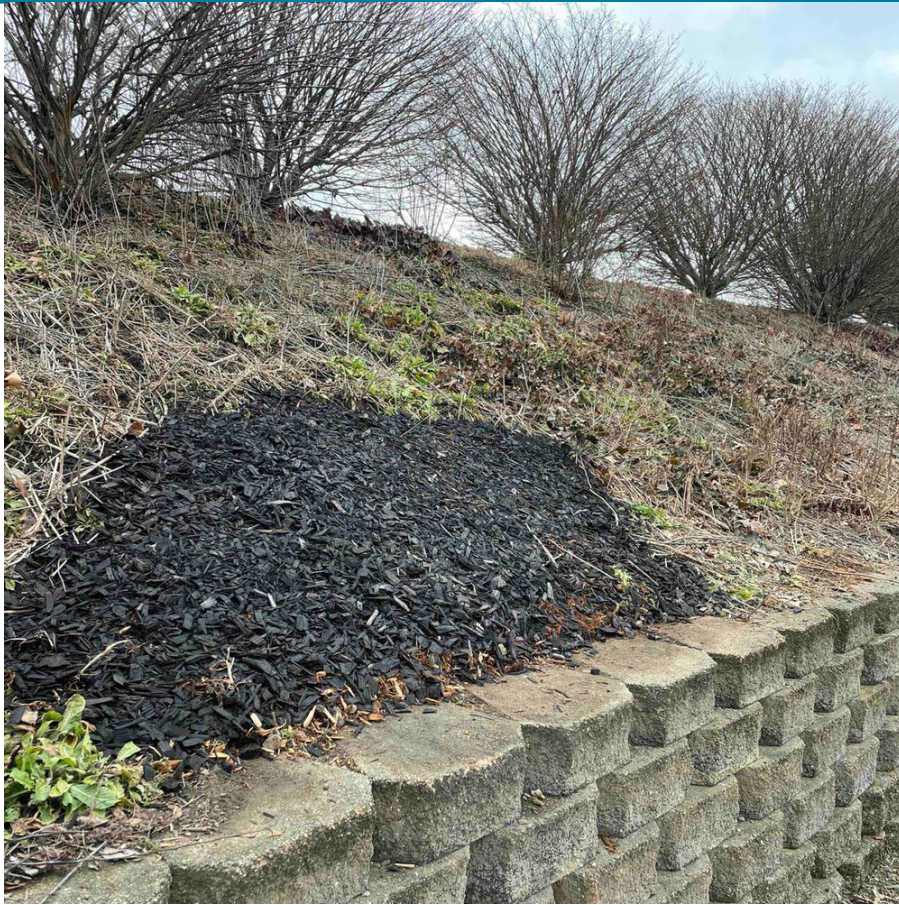
Photo 3: Animal burrow backfilled and area covered with mulch. Photograph taken 2-17-2023.

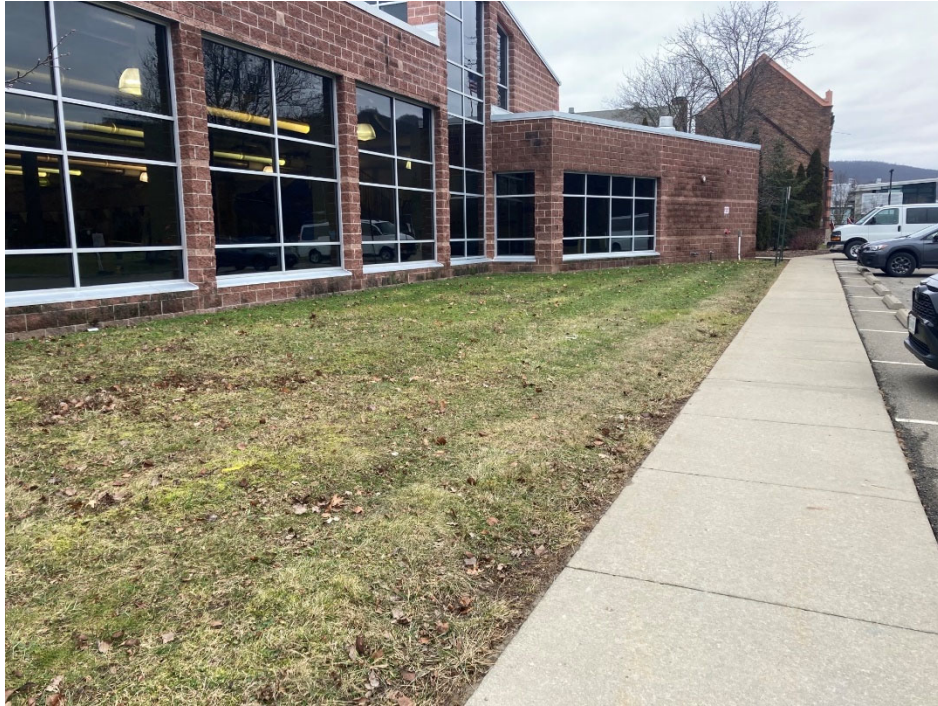
Photo 1: Sidewalk and grass cover.

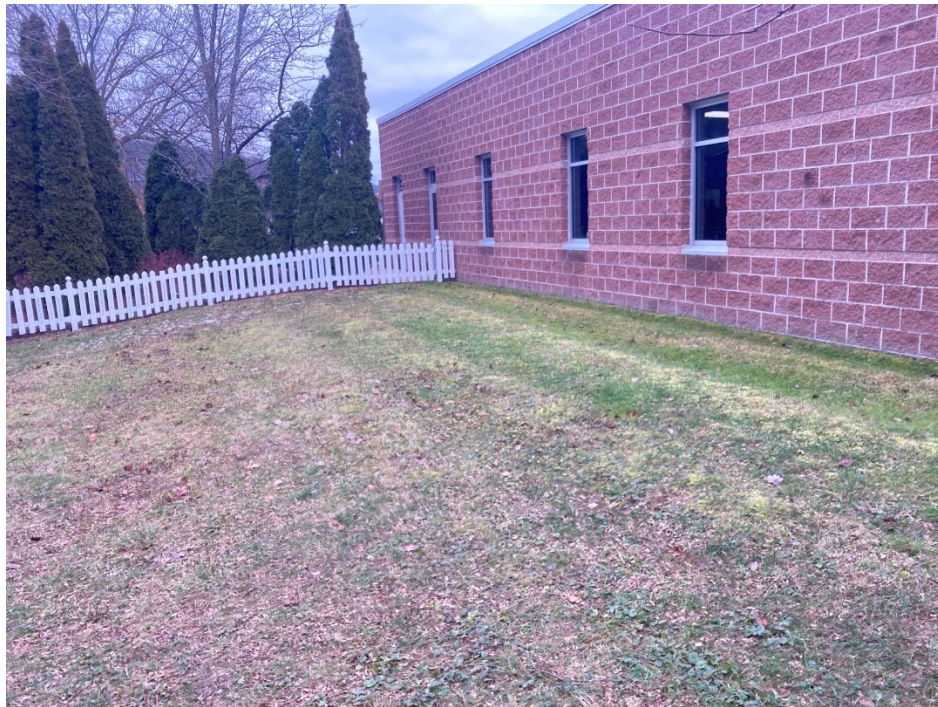
Photo 2: Grass cover.

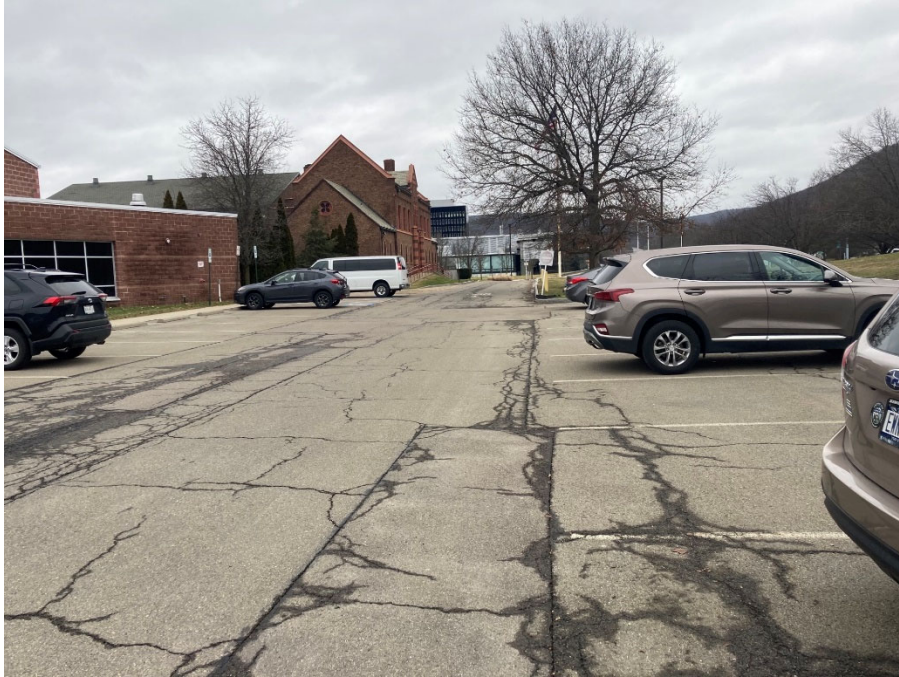
Photo 3: Asphalt cover.

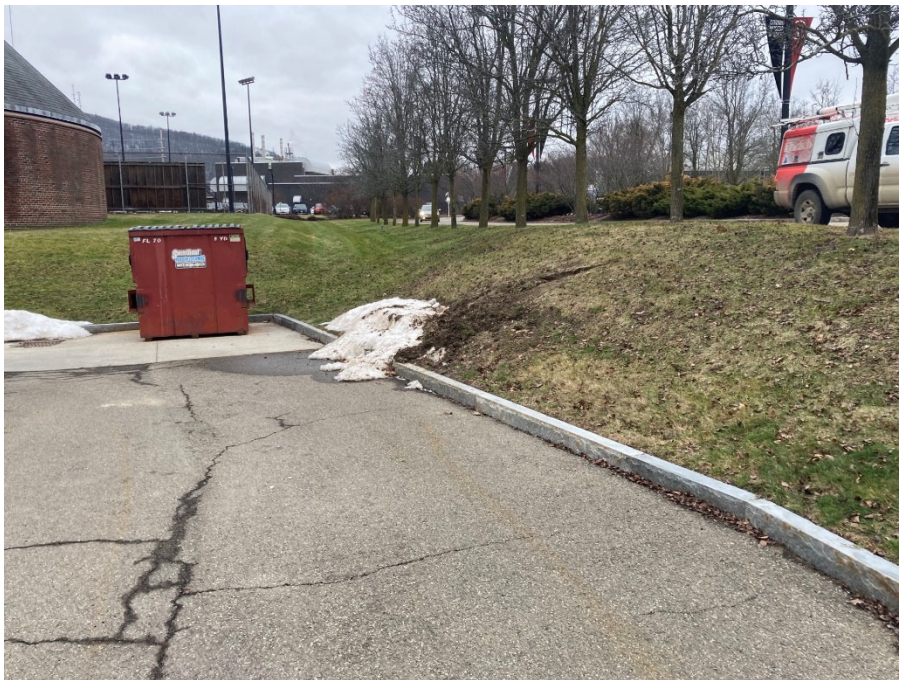
1. There was one area of snowplow disturbance identified during the inspection on the north lawn area of the site, along a slope, immediately adjacent to site's trash facilities. The surficial damage caused by the plow appears to be 2 to 4 inches deep and an area of approximately 9 to 15 square feet. The damage did not appear to breach the site cover system, but rather just disturbed the surficial topsoil. It is recommended to patch the snowplow damage with topsoil using hand tools and to broadcast grass seed in the area when weather permits.

Photo 4: Surficial ground disturbance in north area of property caused by snowplow.

The surficial areas of disturbance associated with the snowplowing activities and the ground depression appear to be minimal, however, to prevent the loss of cover soils, Haley & Aldrich recommends that the areas of disturbance be filled with topsoil and seeded when weather permits. The Annual Inspection Form is attached in Appendix C.

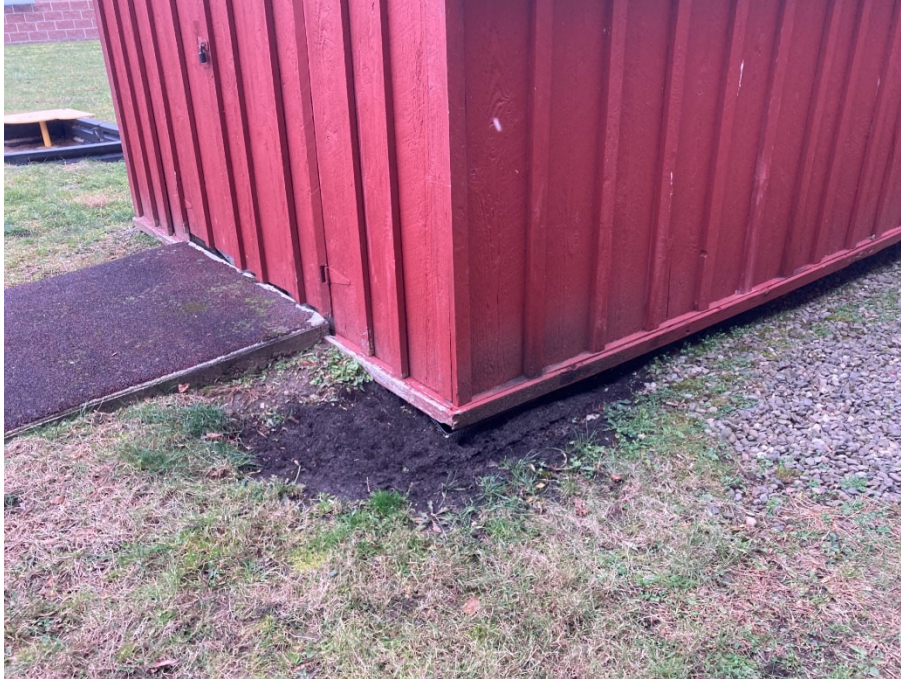
2. In the playground area, around one corner of an existing shed, there was some surficial ground disturbance observed. The maintenance director at the YMCA stated that they installed some hardware cloth as a wildlife deterrent in the corner of the shed. The integrity of the cover system did not appear impacted. It is recommended to cover the disturbed area with grass seed when weather permits.

Photo 5: Surficial ground disturbance around shed caused by installation of wildlife deterrent fencing.

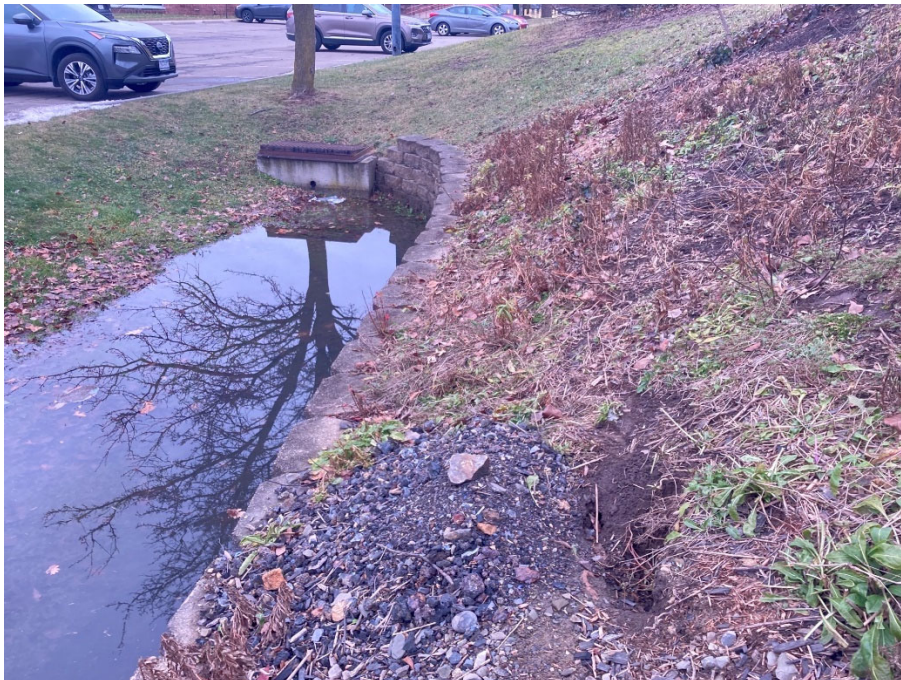
Photo 6: Cover breach in southeast corner of property caused by wildlife.

Repair the disturbed soils noted in Section A to restore cover when weather permits and re-establish grass cover. The animal burrow repair should be coordinated with the NYSDEC and conducted in a similar manner as the 2023 animal burrow in the same location.

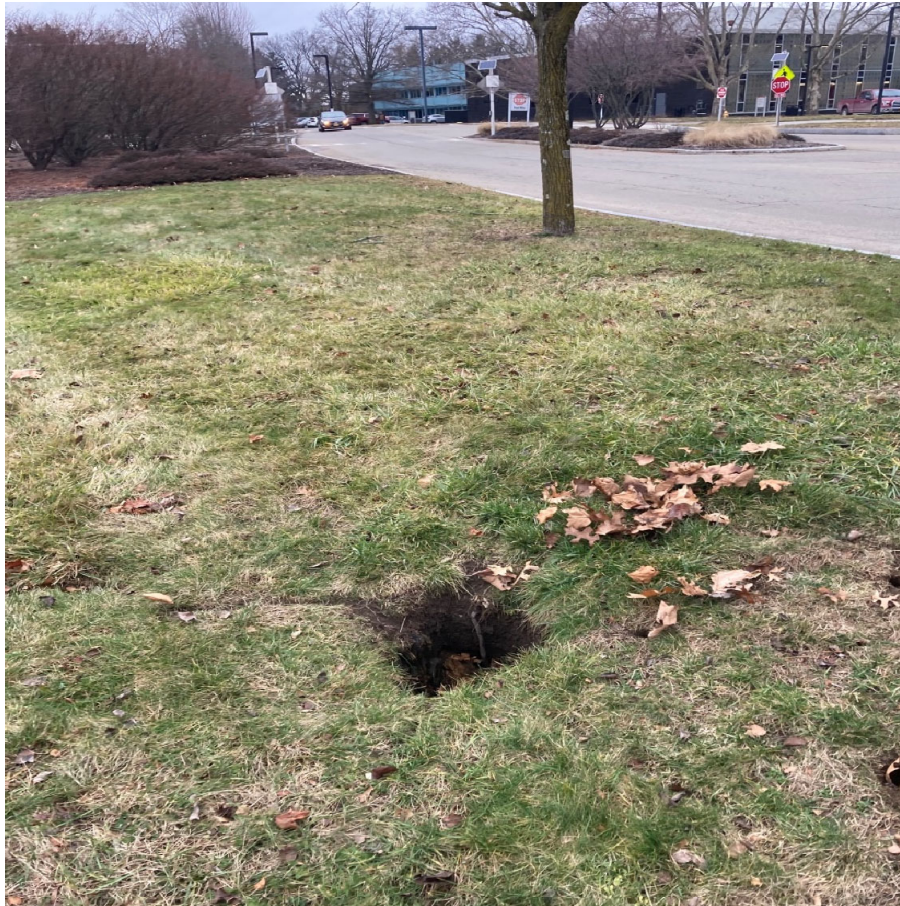
3. In the north lawn there appeared to be a depression in the ground surface cause by animal activity or a tree-root system. The depression appeared to be approximately 18 inches in diameter and 12 to 18 inches in depth. Inspection of the depression showed only topsoil or native soil. It is recommended to patch the depression with topsoil using hand tools and to broadcast grass seed in the area when weather permits.

Photo 7: Surficial ground depression in north area of property.
