## ENGINEERING REPORT

## PERFORMED ON THE GREYSTON BAKERY SITE

104 Ashburton Avenue City of Yonkers Westchester County, New York

> December 2003 (Revised February 2004)

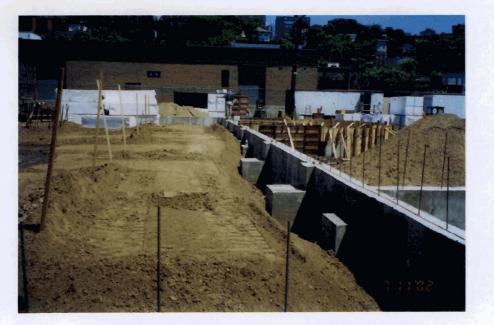
1. Pre building construction. Backfilling of building footprint.

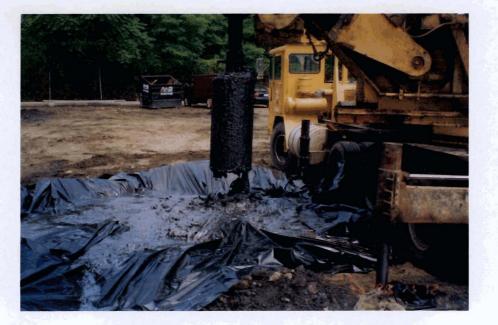
3. Installation of DNAPL/LNAPL – Removal Monitoring System collection of auger spoils for off-site dispensation.

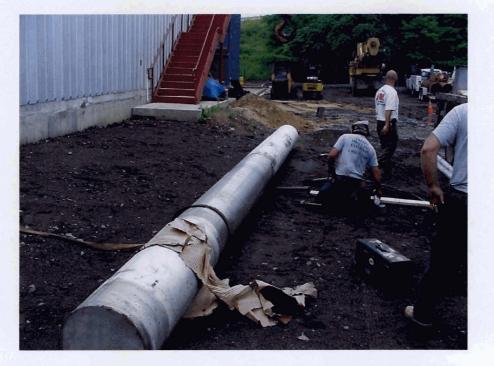
5. 18" diameter DNAPL/LNAPL Removal Monitoring System detail.

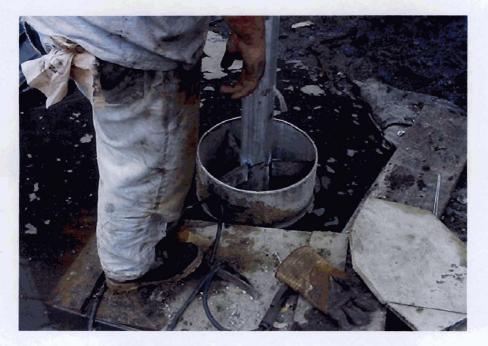
6. 4" diameter DNAPL recovery pipe being inserted into DNAPL/LNAPL Removal Monitoring System.

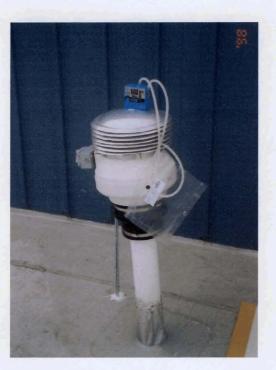
7. Collection of tedlar samples for VOC analysis VES roof discharge.
