RE: Transmittal - Period Review Report
NFG – Buffalo Service Center
95 Fourth Street
Buffalo, New York

Annual Inspection Form
Waterfront School Venting System/Concrete Condition
Buffalo, New York

Date: July 17, 2020

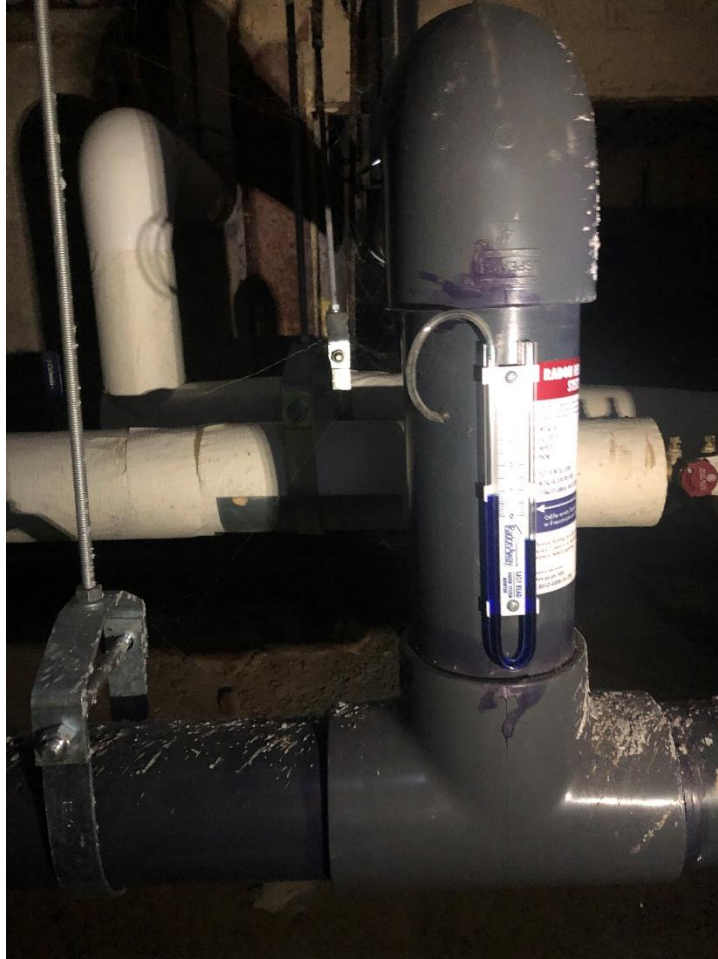
Photograph No. 1

The weather has been very dry in the area for weeks. There had been some rain on Sunday July 15 and there was some standing water in the basement but not nearly as much as most years. The fan was operating and the monometer (Photograph No. 1) showed almost 2-inches of water column vacuum. The alarm was clear in the classroom above the fan (Photograph No. 2). The stack and raincap were in place and clear (Photograph No. 3).

Monometer on Fan Suction Pipe

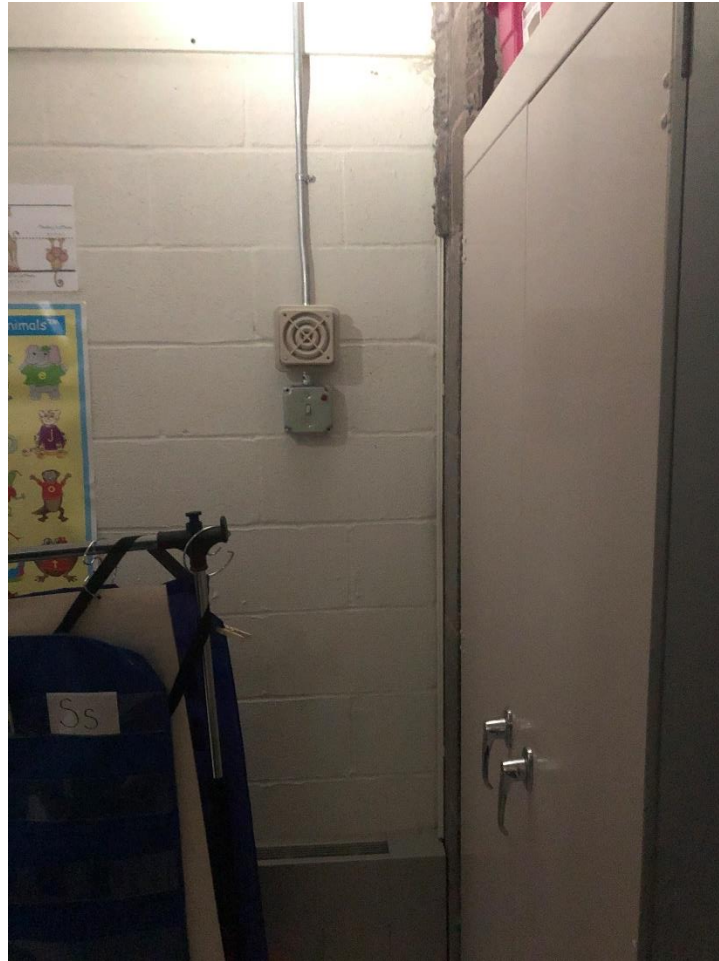
Photograph No. 2
Alarm in Classroom 110

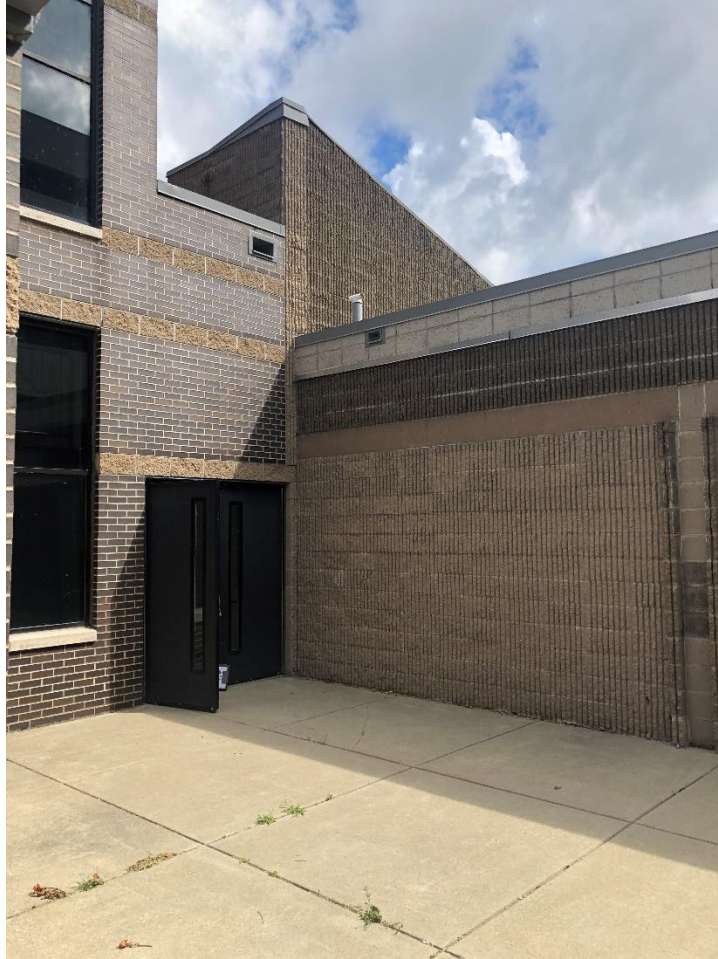
Photograph No. 3

Stack and Rain Cap

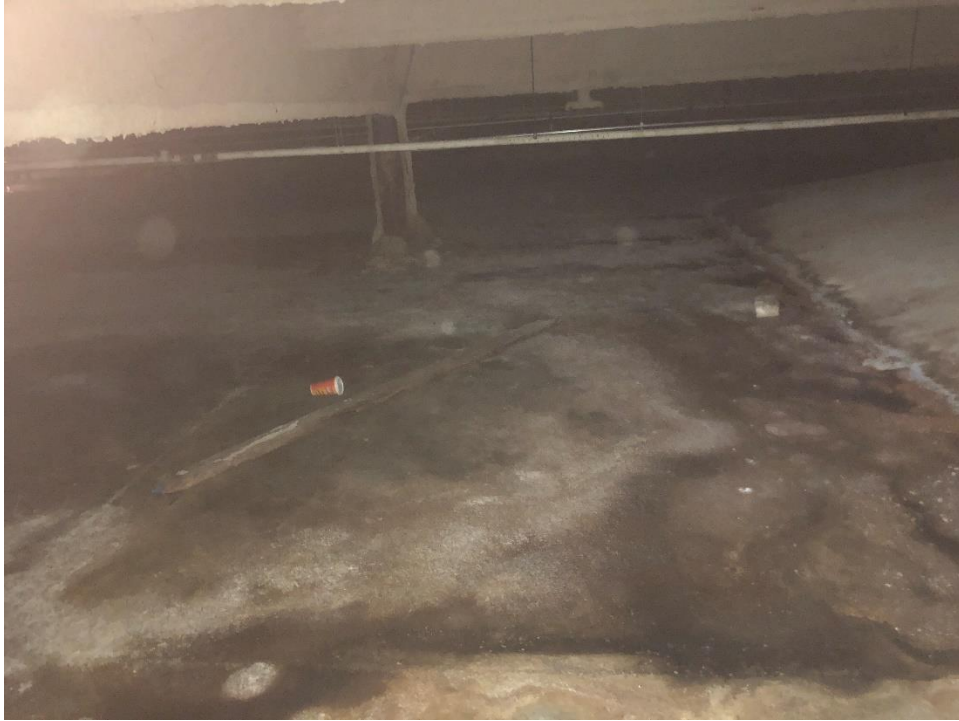
Photograph No. 4

No significant cracking (See Photographs
No. 4 to No. 6)
(hairline cracks are allowable and expected)

The floor is in good condition. There is some material that has fallen from
the overhead beams and other utility piping, but not enough to prevent complete
inspection. There was standing water in areas, but it was clear and did not
obstruct the inspection. The basement was much drier than typical and the area
of the slab over the former excavation was almost completely dry.

Basement Floor

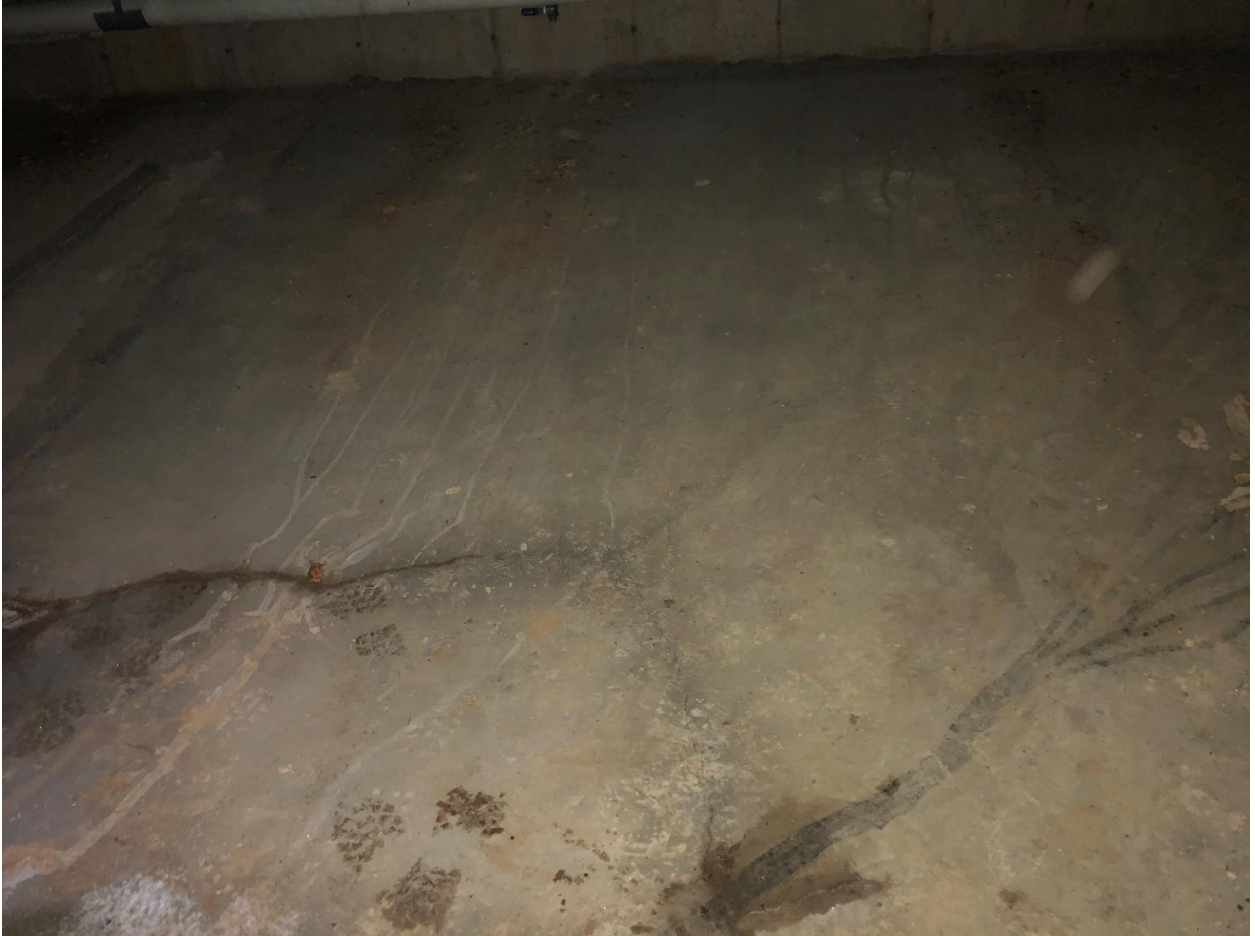
Photograph No. 5

Basement Floor

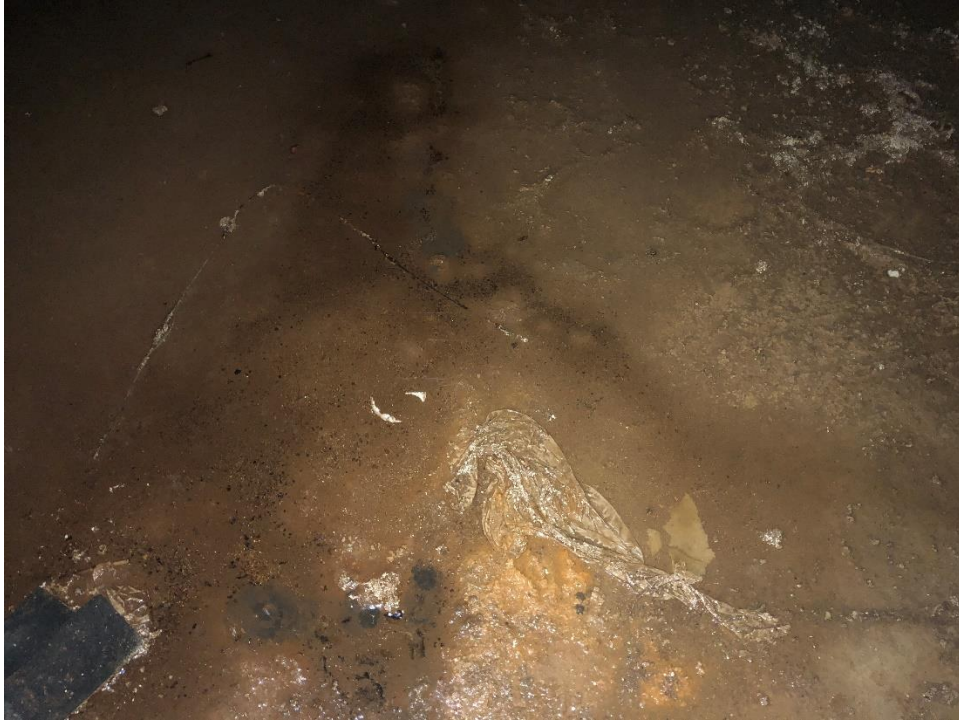
Photograph No. 6

Basement Floor
