INVENTUM ENGINEERING, PC

August 15, 2022

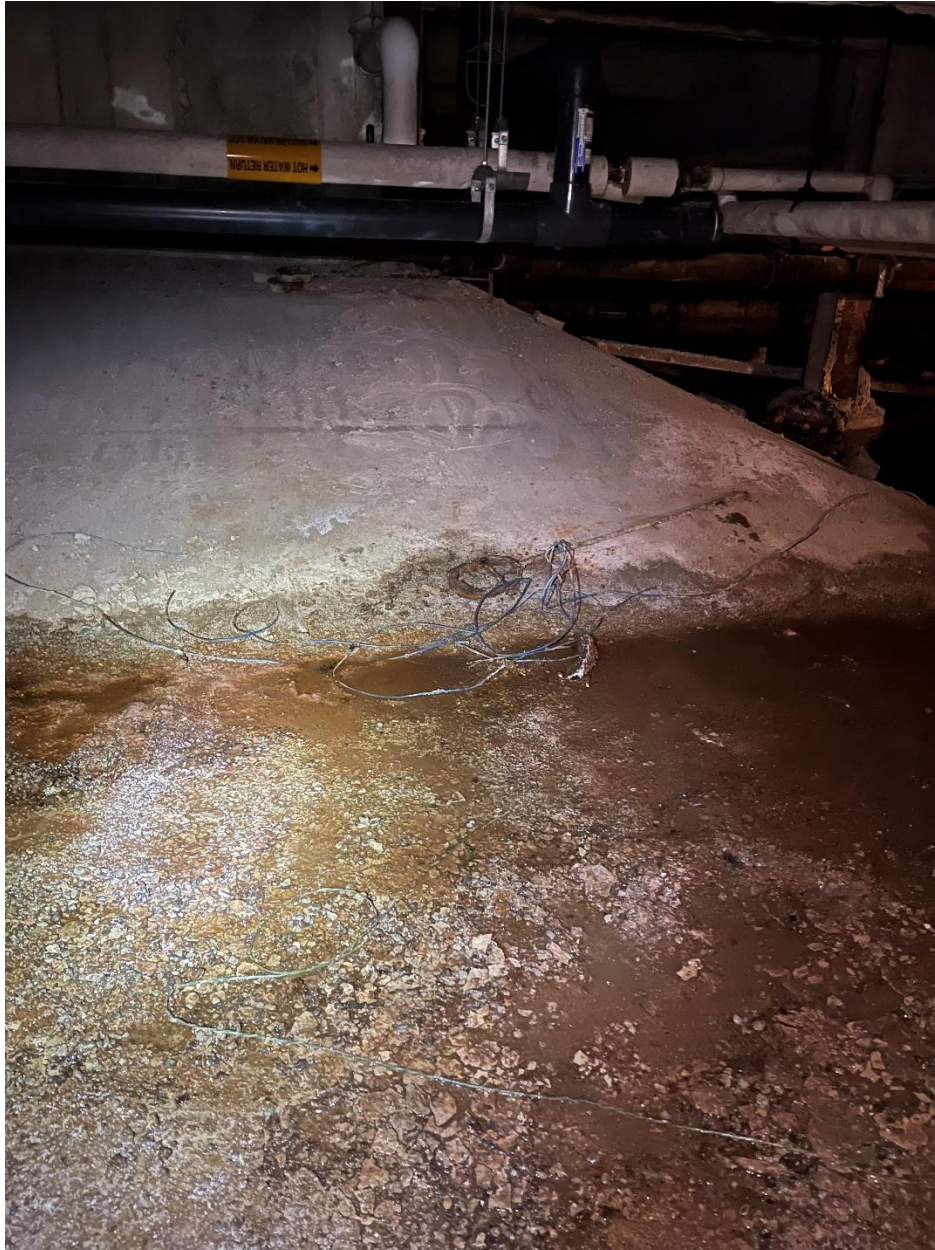
Photograph 4: Floor and sloped wall under manometer
(Note debris is accumulated dust, sediment and spalled concrete)

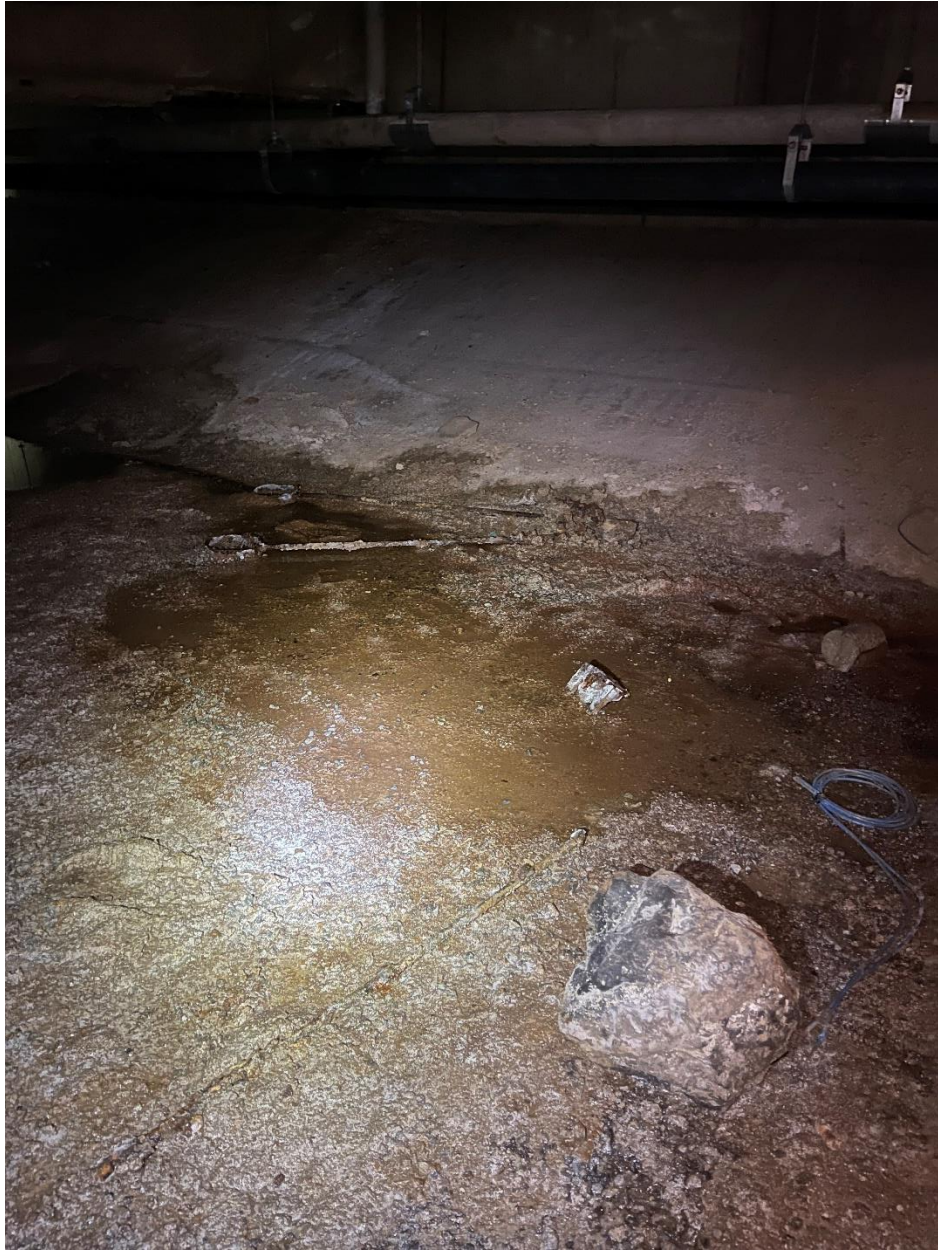
Photograph 5: Typical condition of floor with moisture and debris

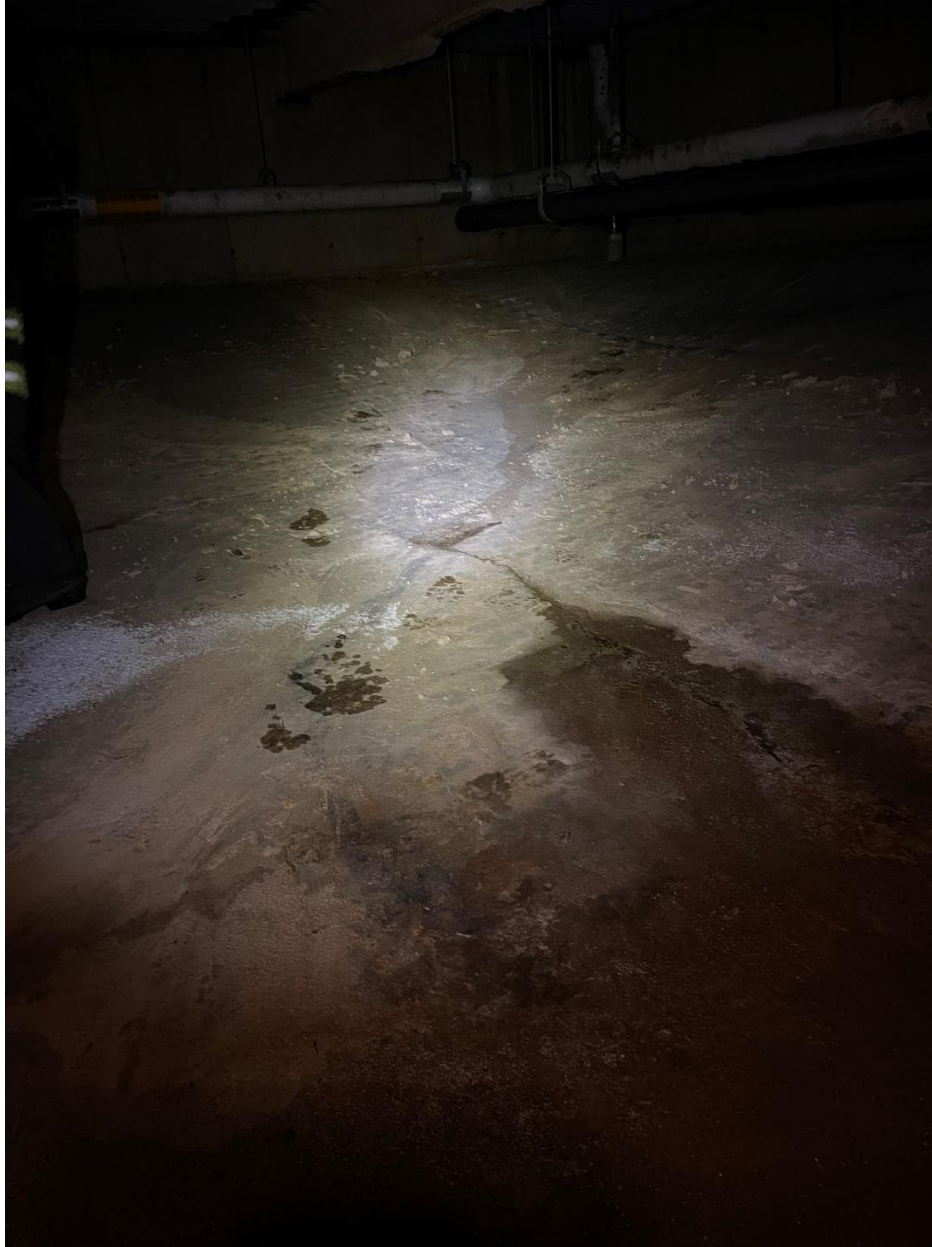
Photograph 6: Corner of floor and sloped wall moving left from manometer.
(Note apparent water path down sloped corner. Potential source in sidewall.)

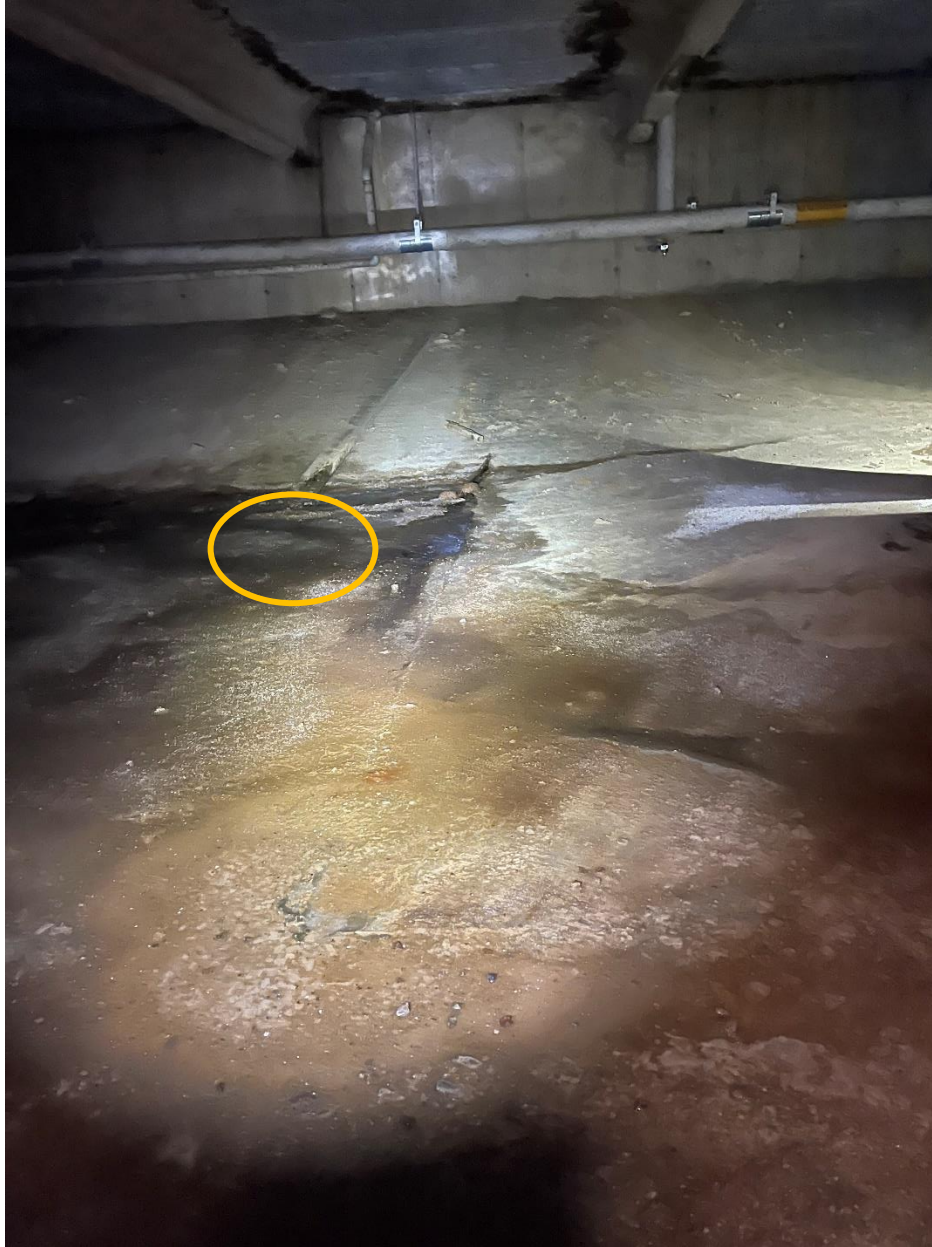
Photograph 7: Floor and sloped wall moving left from corner

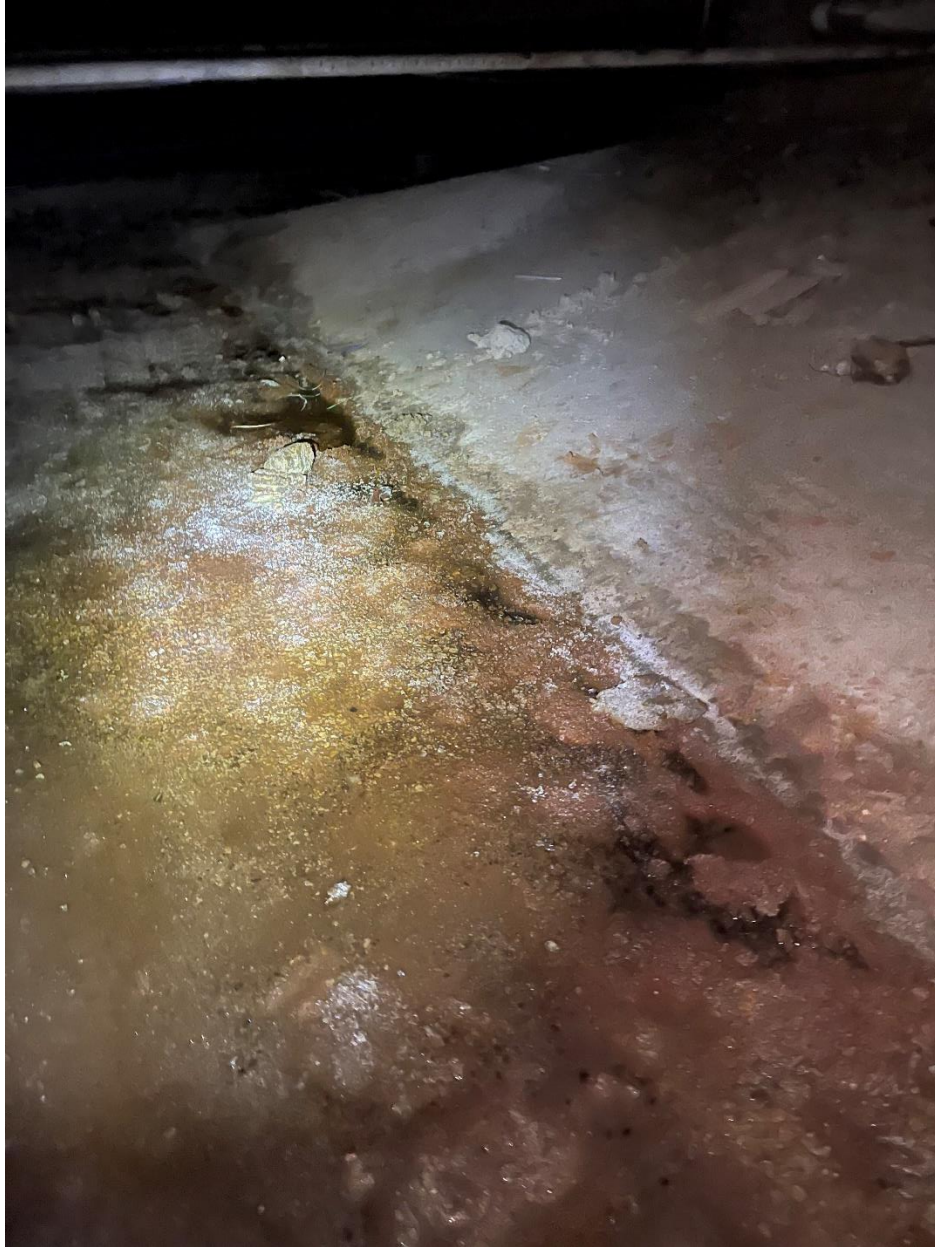
Photograph 8: Floor and sloped wall

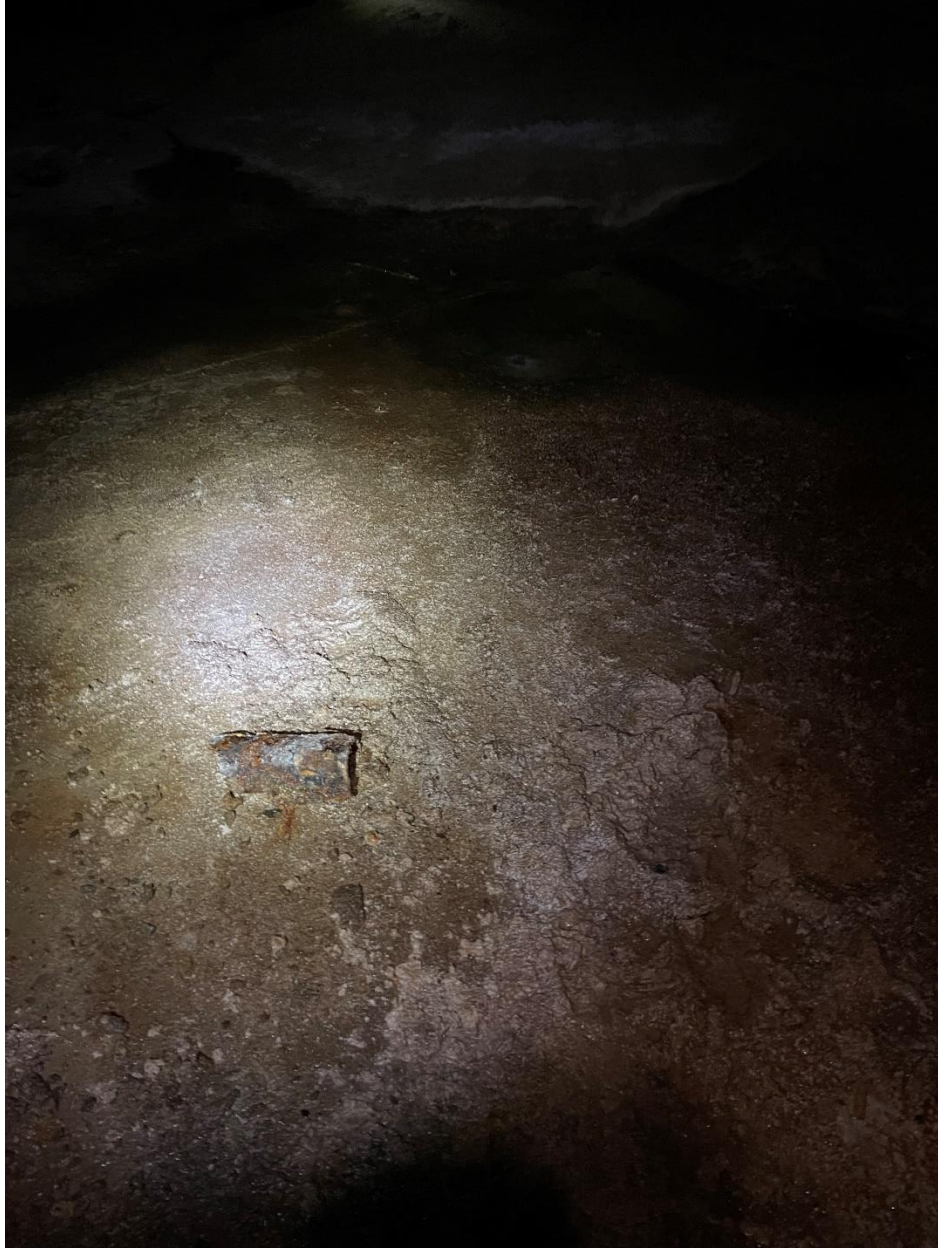
Photograph 9: Debris, typical floor condition.

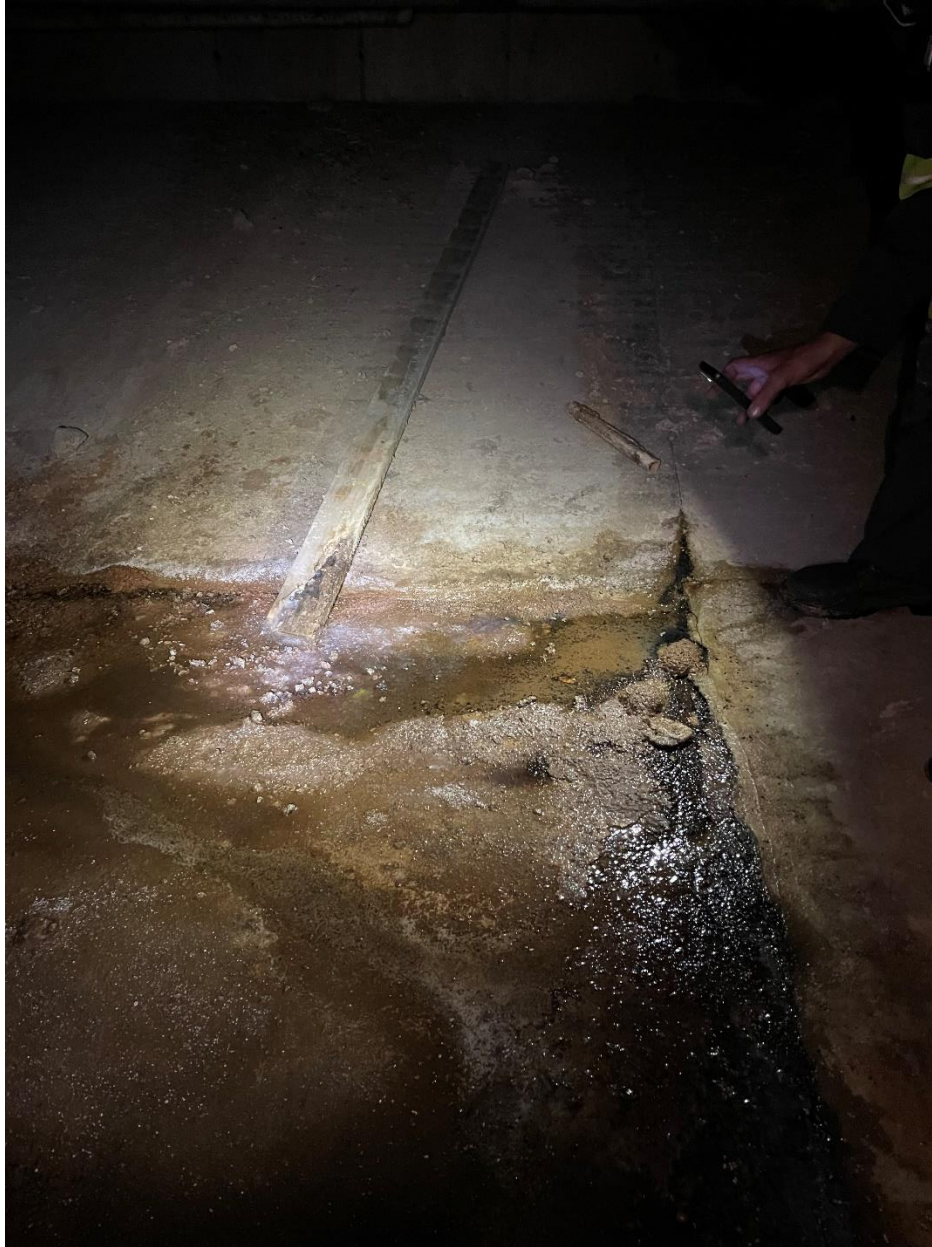
Photograph 10: Floor at corner of sloped wall.
