Construction Closeout Report

2137 Seneca Street Site

March 2012

2137 SENECA STREET SITE
(SITE NO. V-00370)

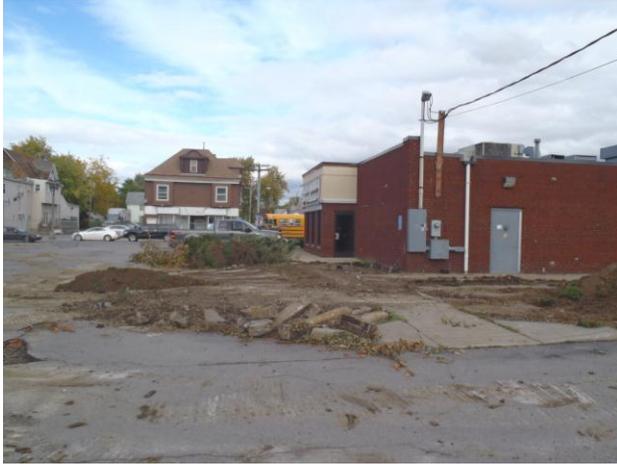
Photo 1: Pre-redevelopment – Waste characterization (looking east)

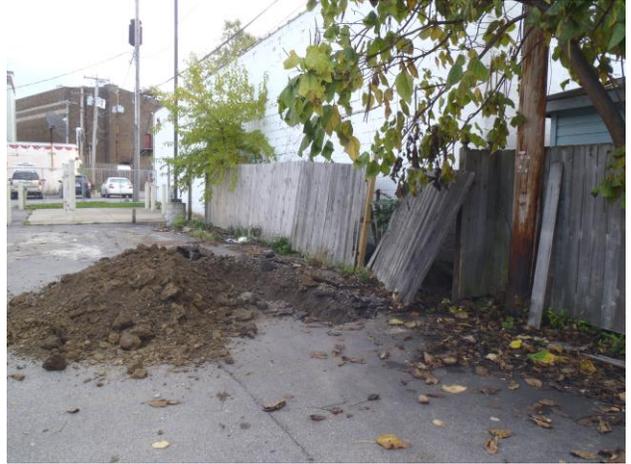
Photo 2: Pre-development – Waste characterization (looking south)

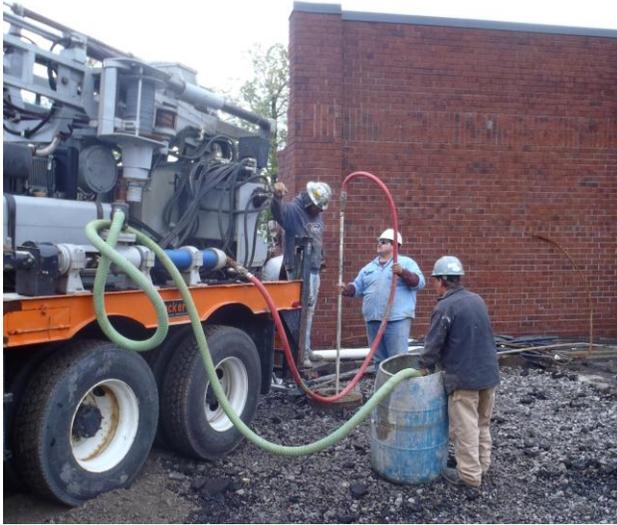
Photo 5: Well decommissioning – grout application (MW-6)

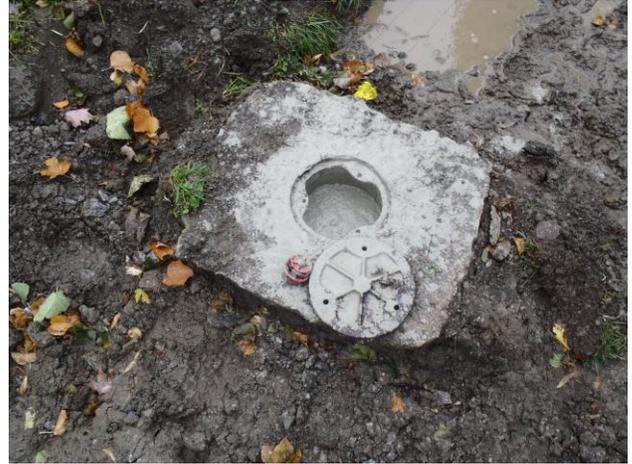
Photo 6: Well decommissioning – (MW-3)

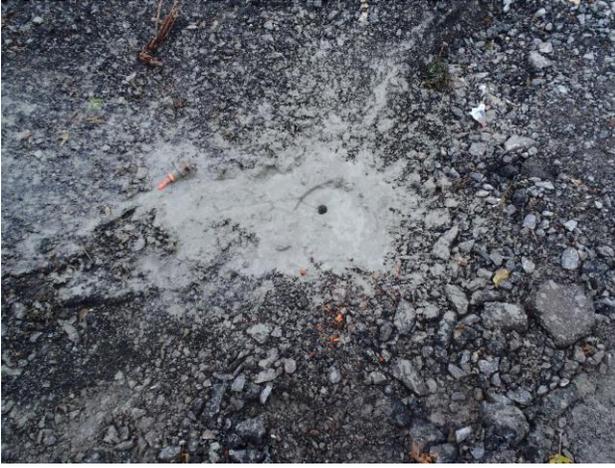
Photo 9: Well decommissioning – (IW-16 S/D)

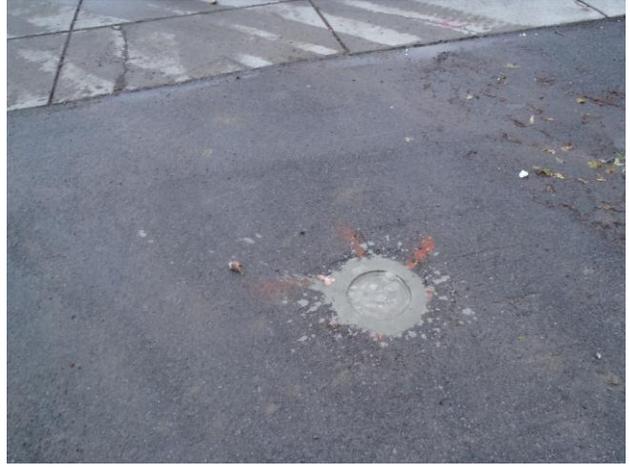
Photo 10: Well decommissioning – (IW-11)

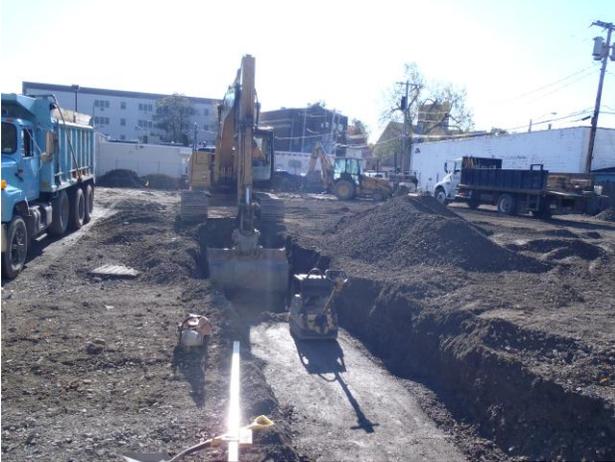
Photo 11: New Building footer/foundation excavation (looking south)

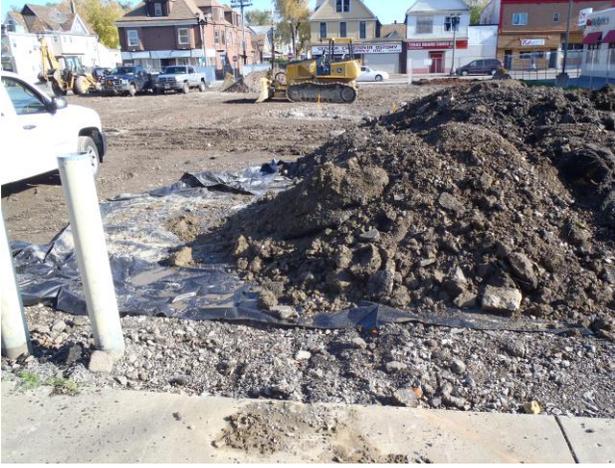
Photo 13: Stockpiled soils prior to off-site disposal

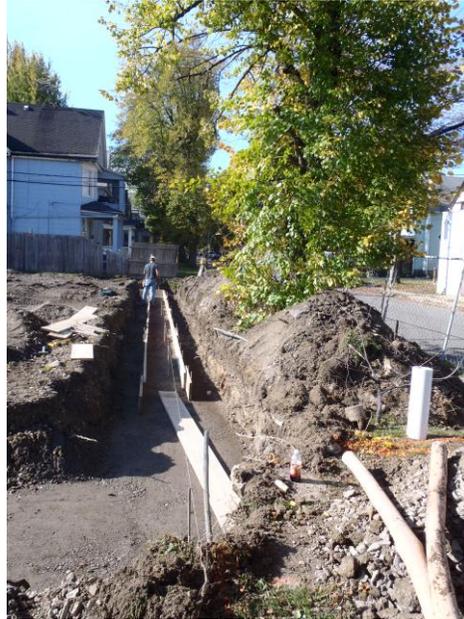
Photo 14: Redevelopment activity -- Foundation framing (looking west)

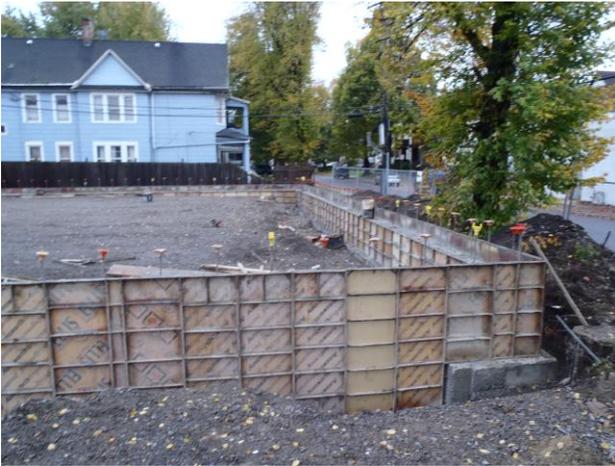
Photo 15: Redevelopment activity -- Foundation framing (looking southwest)

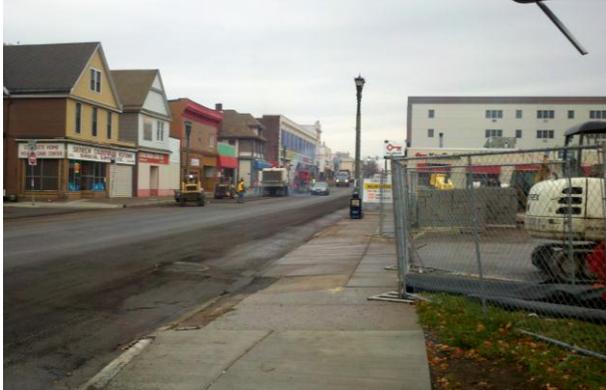
Photo 17: City of Buffalo – Seneca Street resurfacing project

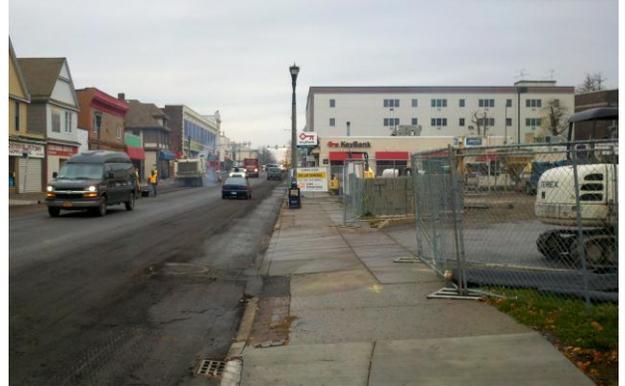
Photo 18: City of Buffalo – Seneca Street resurfacing project

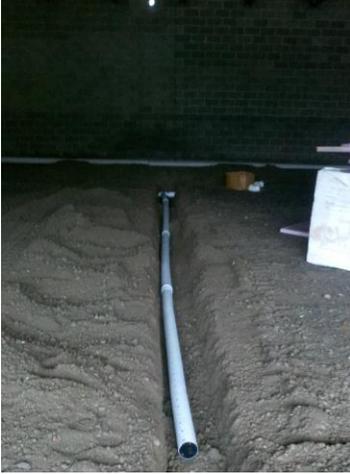
Photo 21: Sub slab depressurization system – Drain pipe layout

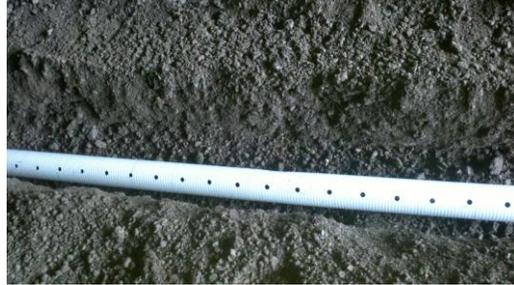
Photo 22: Sub slab depressurization system – Perforated drain pipe

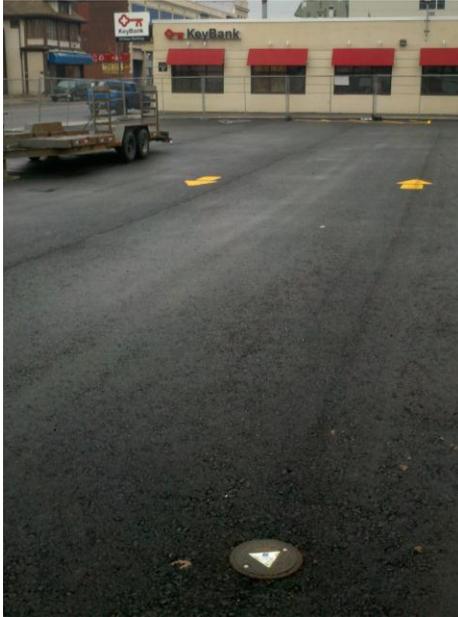
Photo 25: Site condition – Well road box in parking lot (MW-2)

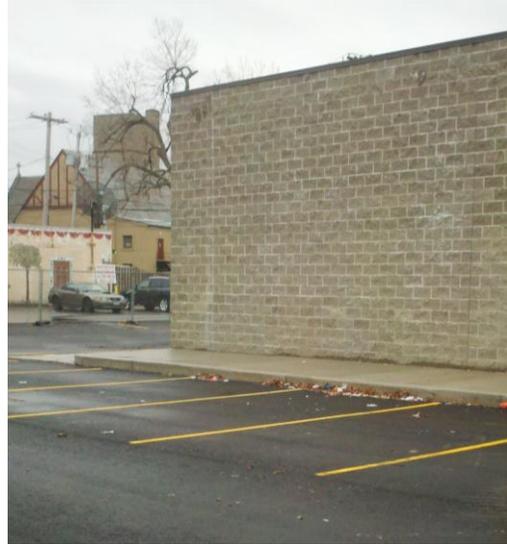
Photo 26: Site condition – Building and sidewalk

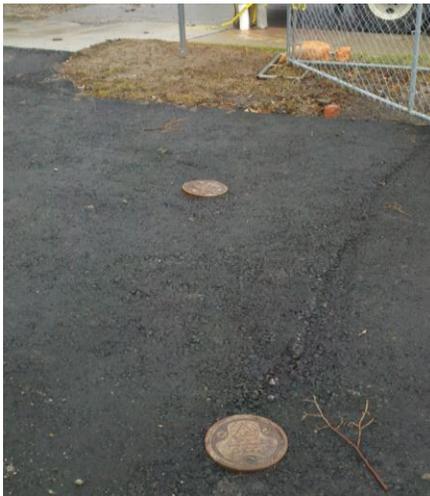
Photo 27: Site condition – Well road boxes (MW-4 and MW-4A)
