**SITE ASSESSMENT OF 20 SUBSTATIONS
FOR MERCURY CONTAMINATION**

**METROPOLITAN TRANSPORTATION AUTHORITY
LONG ISLAND RAIL ROAD**

**DVIRKA AND BARTILUCCI CONSULTING ENGINEERS
(a Division of William F. Cosulich Associates, P.C.)
330 Crossways Park Drive
Woodbury, New York 11797**

DECEMBER 2000

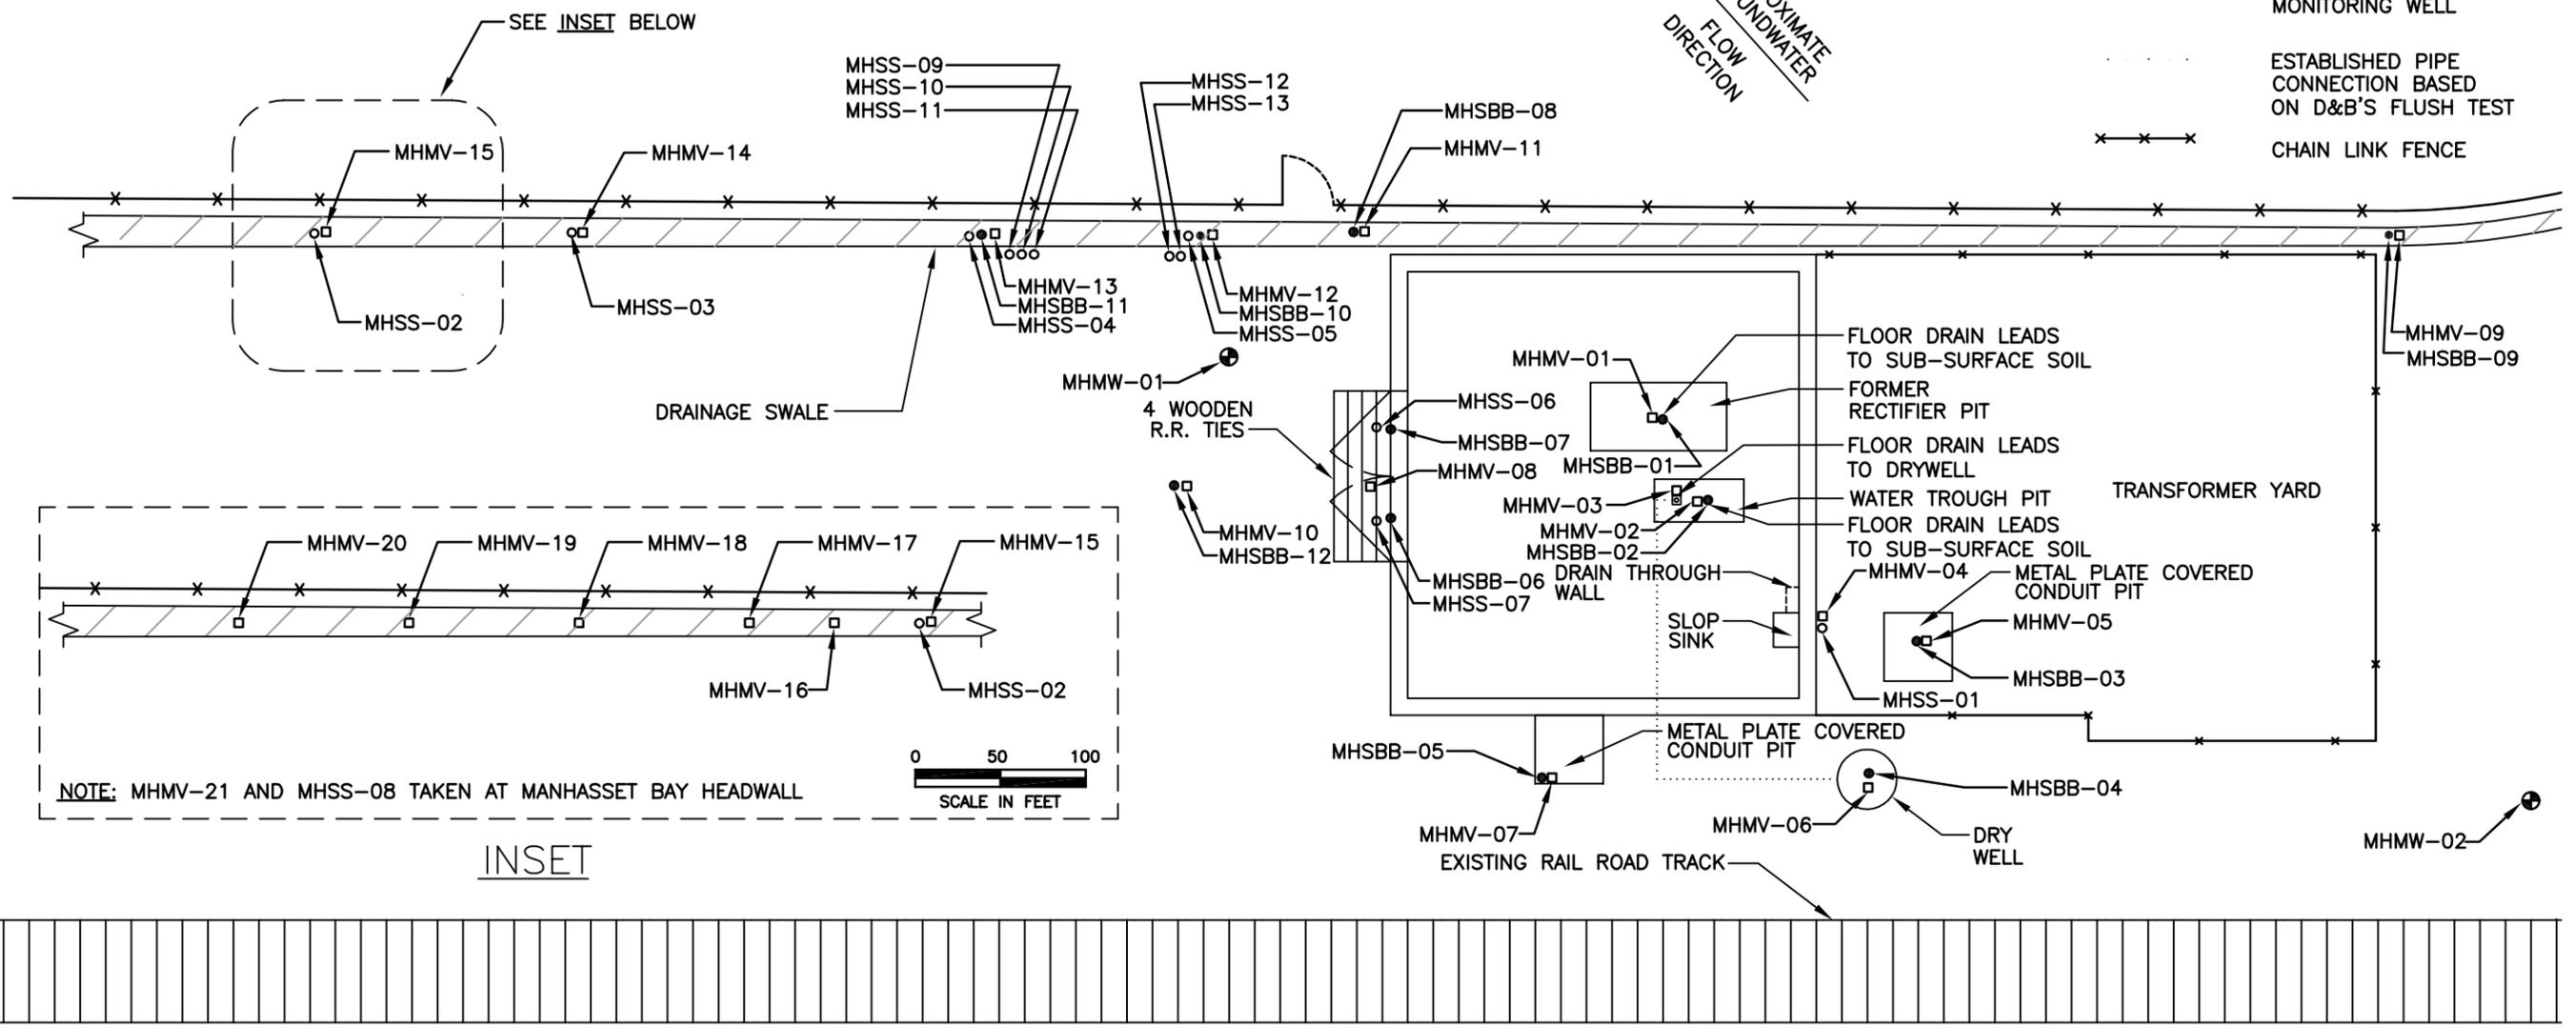
NOTE: MHMV-21 AND MHSS-08 TAKEN AT MANHASSET BAY HEADWALL

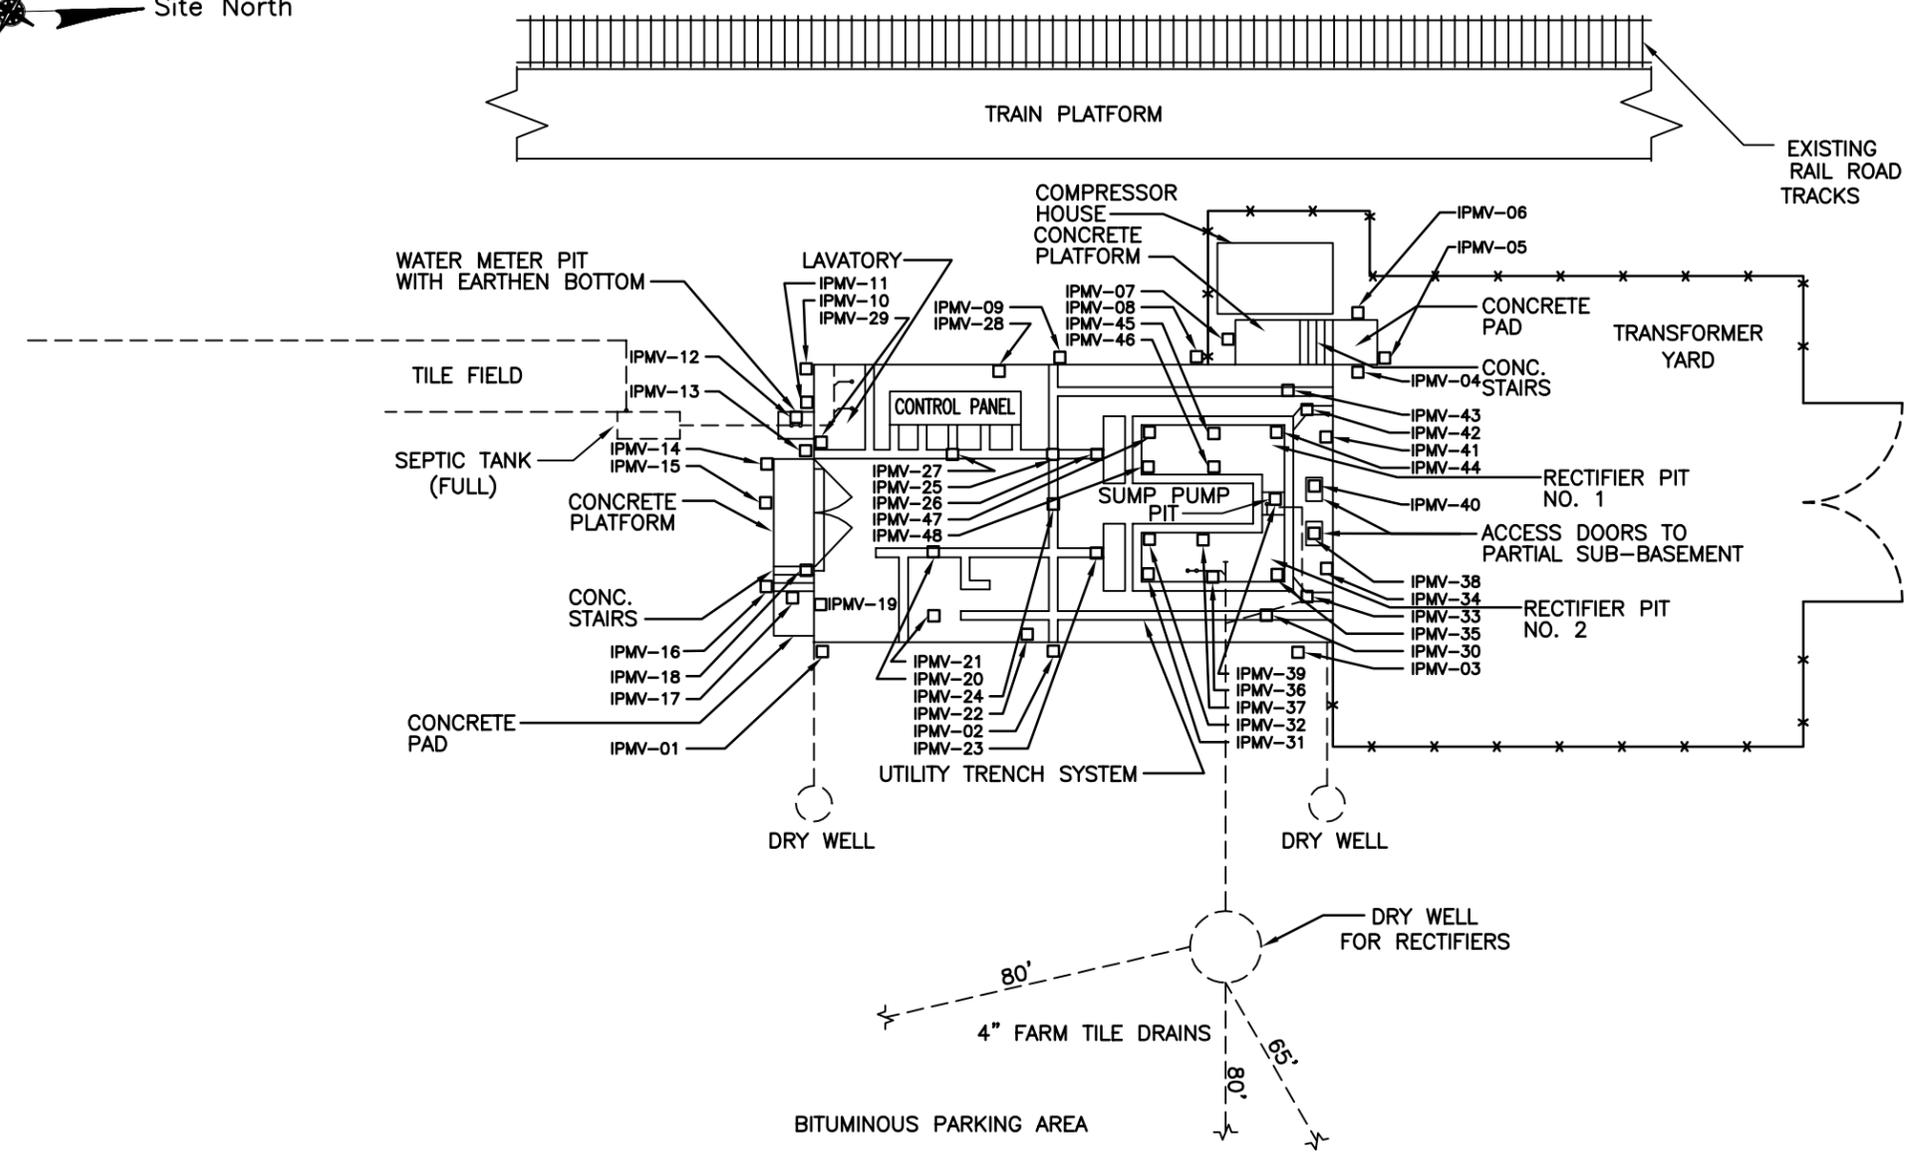
NOTE: DRY WELLS NOT ACCESSIBLE, COVERED WITH ASPHALT FROM GRADE

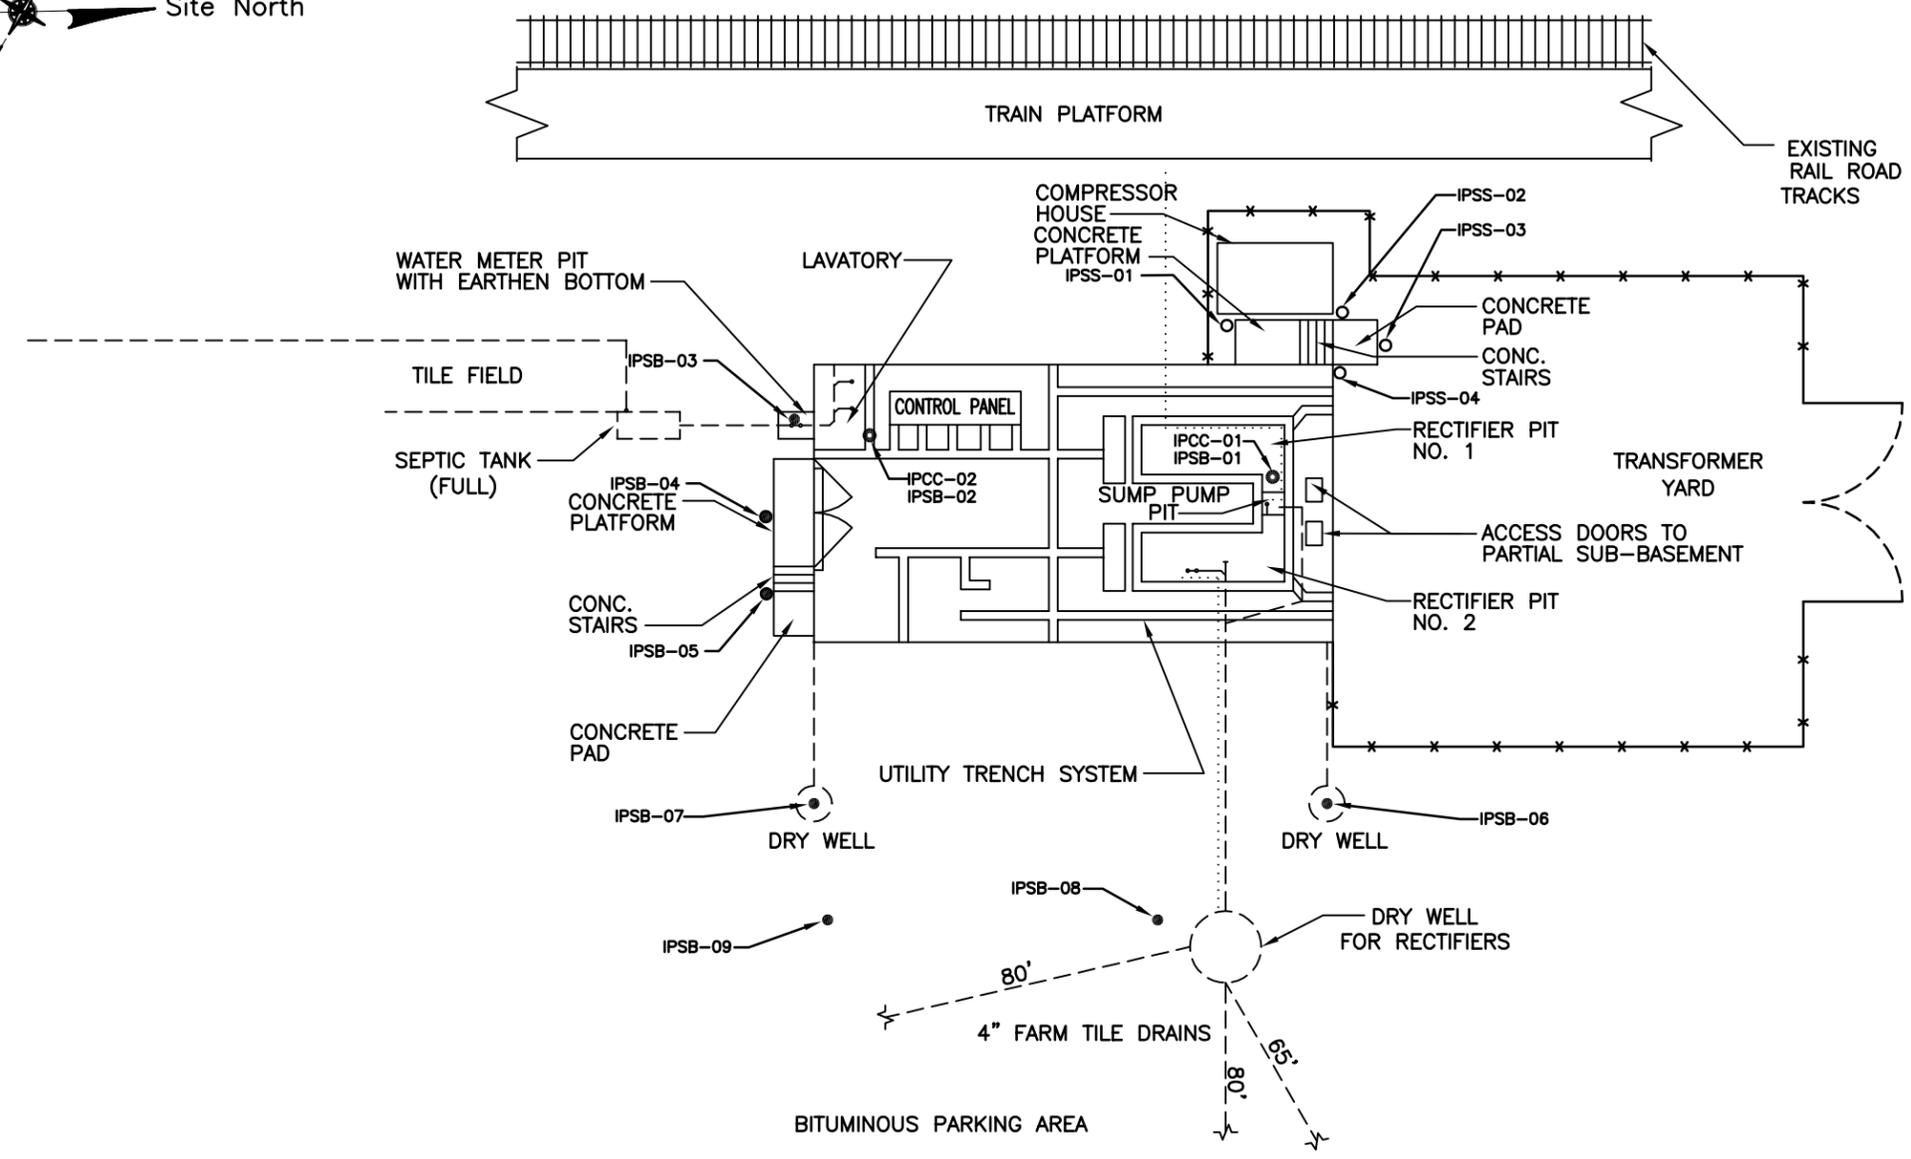
NOTE: DRY WELLS NOT ACCESSABLE, COVERED WITH ASPHALT FROM GRADE

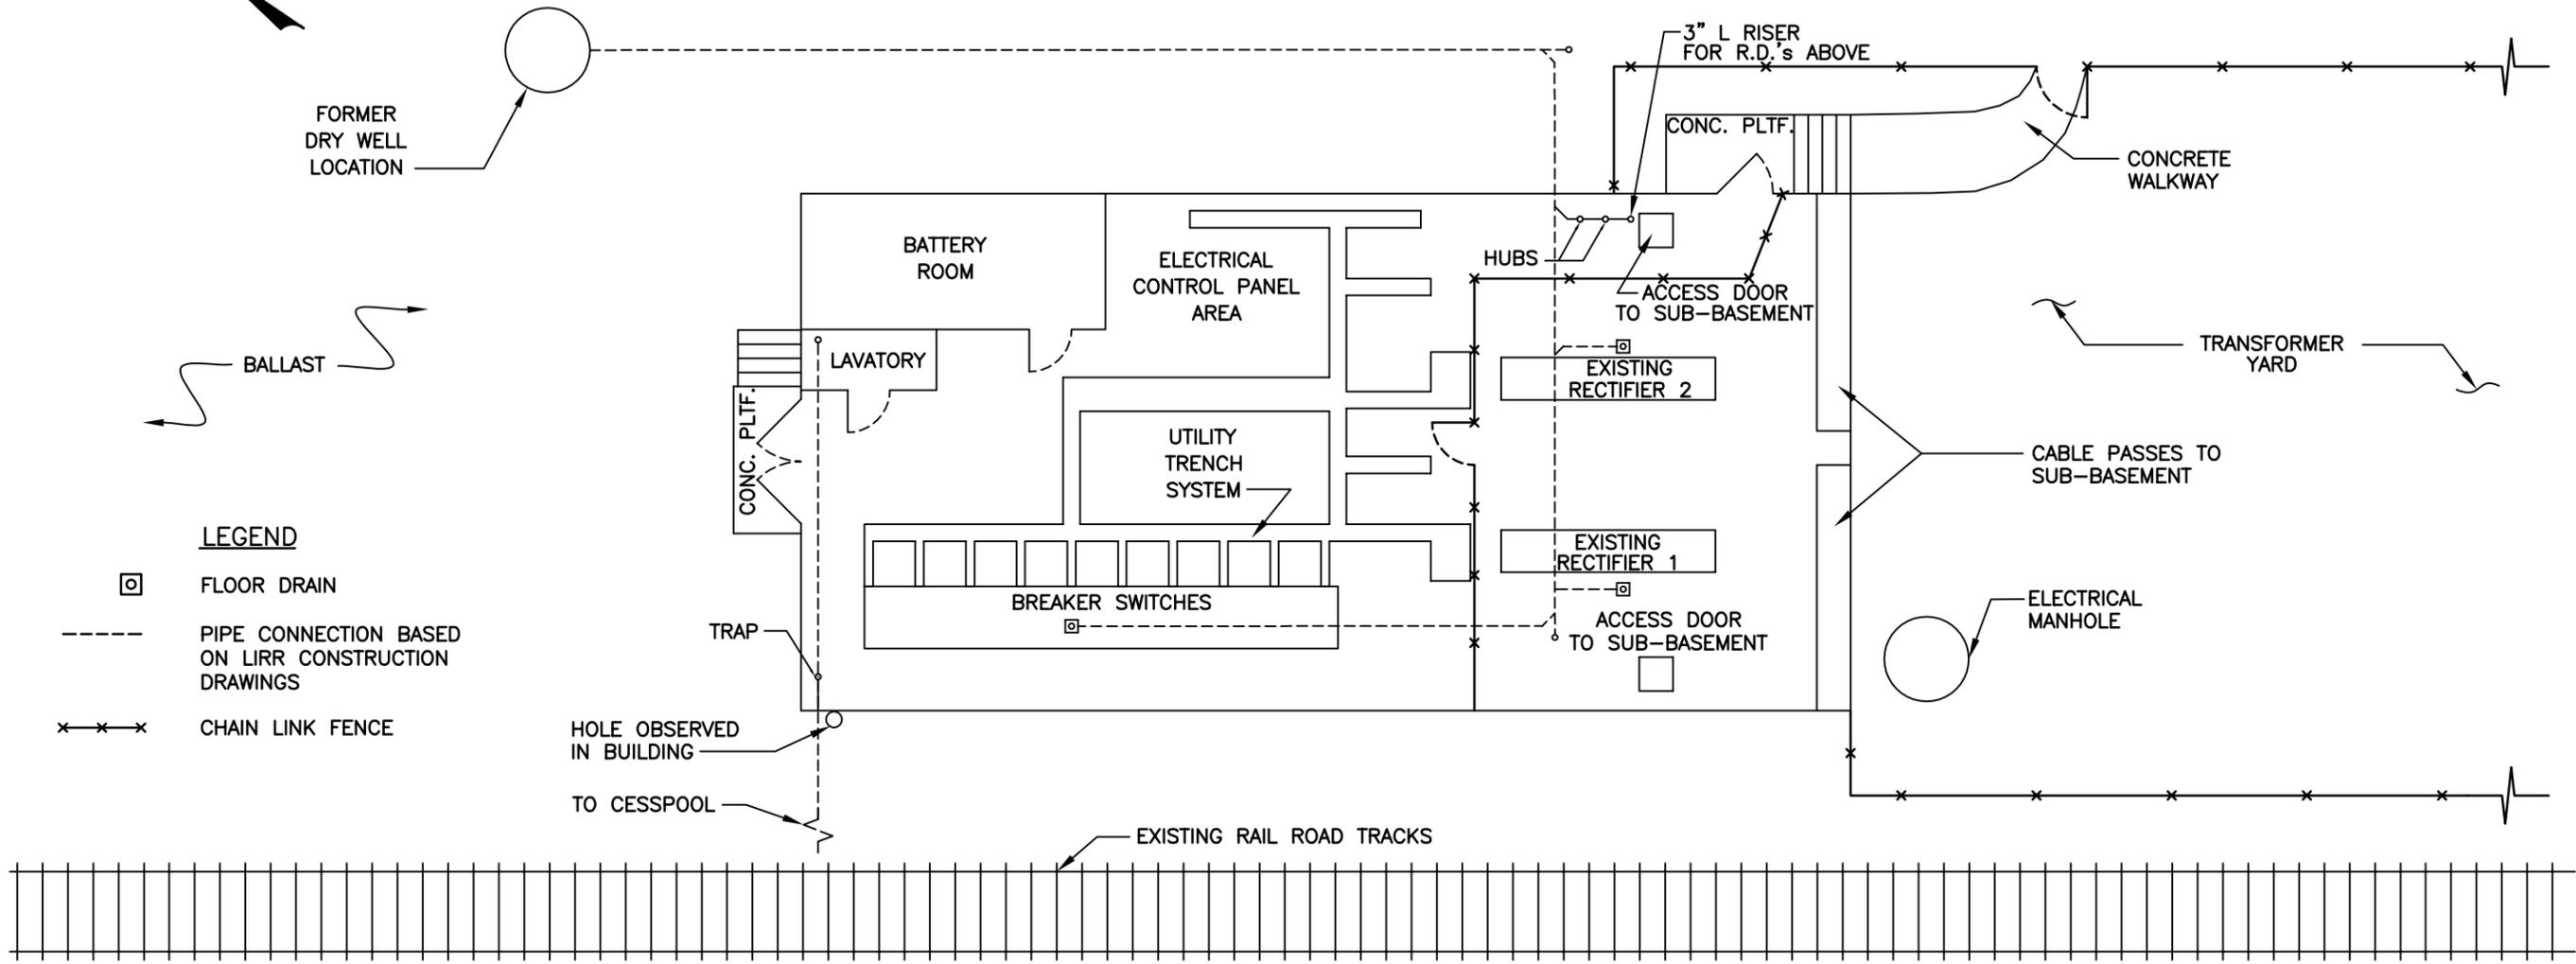
HOLE OBSERVED IN BUILDING TO CESSPOOL
