Periodic Review Report

(July 7, 2021 through July 7, 2022)

Former Dowell Facility

3311 Walden Avenue, Depew, New York

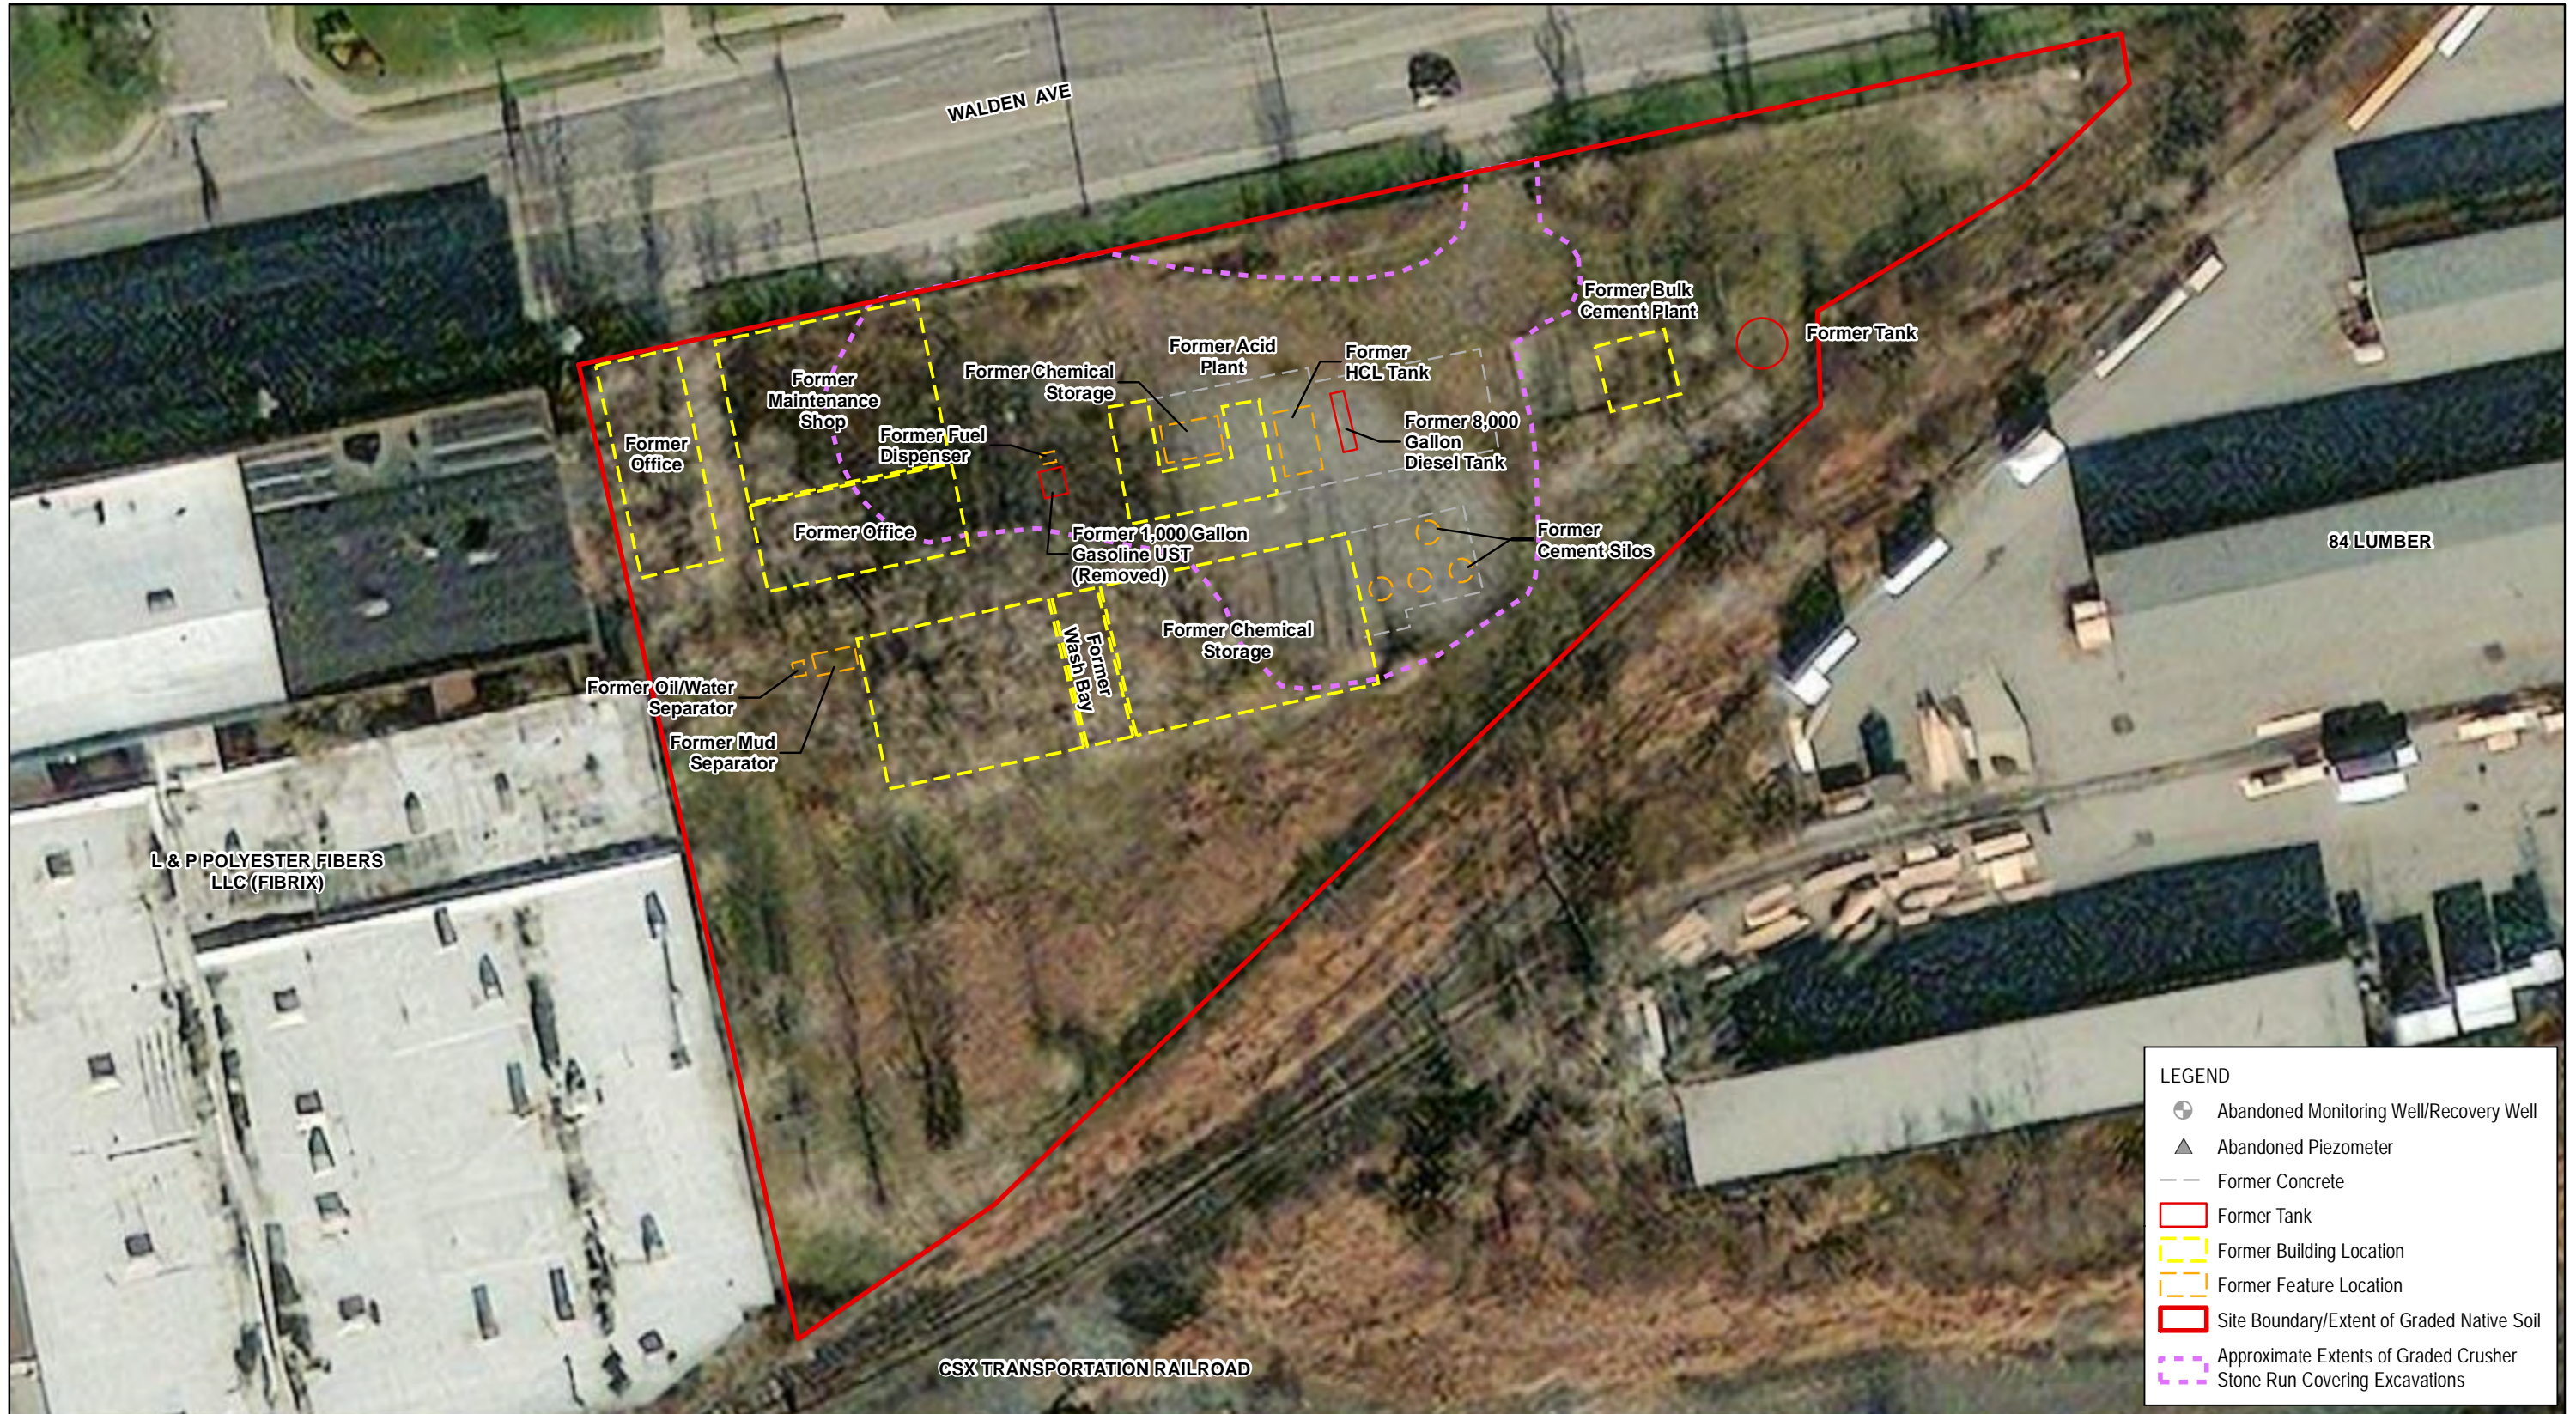
Response: There are two types of cover at the site. The historical excavation and the area of the thermal treatment are covered with graded crusher run stone. The remaining portion of the site is covered in graded native soil. Figure 1-2 was revised to identify the different cover types, and references to Figure 1-2 were added to Sections 1.4 and 2.2.

Exposure to any remaining contamination at the site is prevented by a soil cover placed over the site as shown on Figure 1-2. This soil cover is composed of a minimum of 12 inches of native soil or crusher run stone. The location of the soil cover, which is the site boundary, is described in the metes and bounds site description in Appendix A of the SMP. The Excavation Work Plan (EWP) provided in Appendix F of the SMP outlines the procedures required to be implemented in the event the soil cover is breached, penetrated, or temporarily removed, and any underlying remaining contamination is disturbed. Procedures for the inspection of this cover are provided in the inspection plan included in Section 4 the SMP. Any work conducted pursuant to the EWP must also be conducted in accordance with the procedures defined in a health and safety plan and associated community air monitoring plan that will be prepared for the site and provided as an attachment to the EWP.

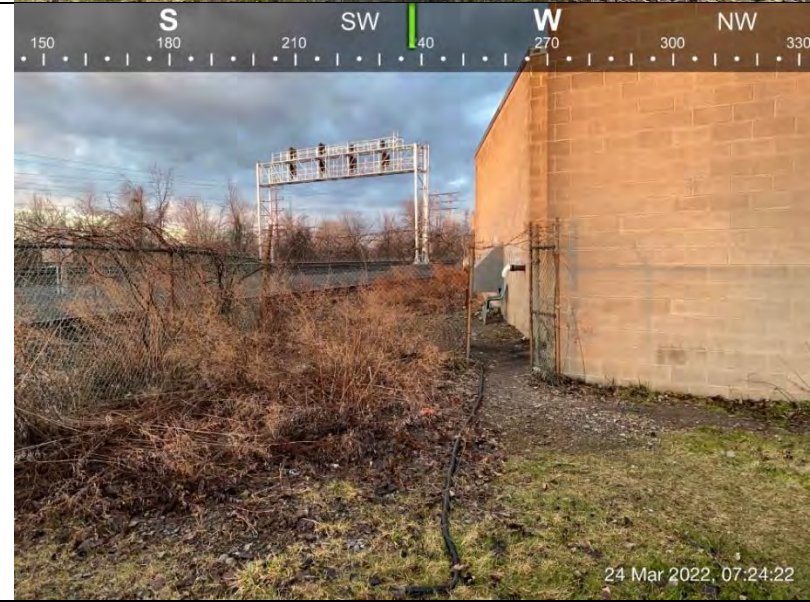
During the inspection, it was found that the neighboring facility (Fibrix) was discharging a liquid by corrugated pipe, through the rear gate, and onto the site. Up until 2022, Fibrix was under a lease agreement for use of the property for parking, which was initiated on August 23, 2017; however, Fibrix has not used the site for parking to date. This lease was terminated in early 2022. Per communication with Fibrix, the compressor room in the Fibrix building was having flooding issues from rain and snow melt water. On or around March 10, 2022, in response to the flooding, Fibrix created a hole through the floor slab in their compressor room and installed a sump pump to pump the water out from under the slab before it flooded the compressor room. Initially, the water was being discharged out of the back of their building to the south, toward the railroad tracks, but sometime between the installation of the pump and the initial site inspection on March 24, the pipe had been diverted through the side gate and discharged on the site. The water was discharged until March 25, 2022, when it was discovered by Fibrix to have been moved. Per the communication with Fibrix, the room was only used to house the compressor and no wastes or chemicals were stored in that room and no contamination is known to reside under the building.

Photograph Number: 8
Subject/Description: Southern corner facing Southwest, corrugated pipe present

The corrugated pipe observed during the initial inspection on March 24, 2022 that was discharging the rain and snow melt water from the Fibrix compressor room was removed. In accordance with the request from NYSDEC in the 2021 PRR approval letter, the gates are now secured with chains and combination locks.

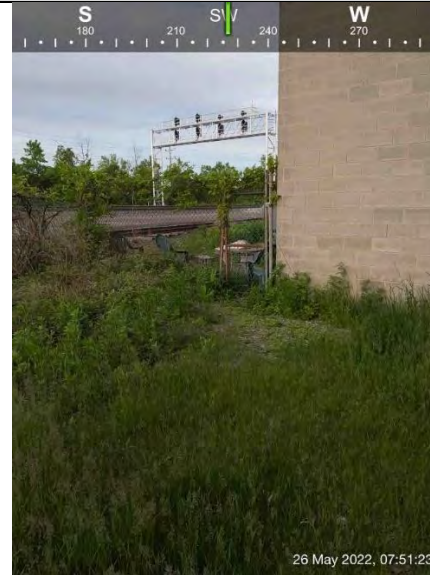
A second site inspection was conducted on May 26, 2022. During this event, soil from around the area where the pipe was discharging was screened with a photoionization detector. No photoionization detector readings, odors, visual staining, or other signs of impacts were noted. The ICs and EC were inspected, and no impacts from this discharge were noted that did or could impact the protectiveness of the remedy. Based on the inspection results and the information that was obtained during communication with Fibrix, the rain and snow melt water beneath the slab being discharged to the site would not be impacted based on the known use of the compressor room.

Photograph Number: 12
Subject/Description: Southern corner facing Southwest, corrugated pipe no longer present during second site inspection

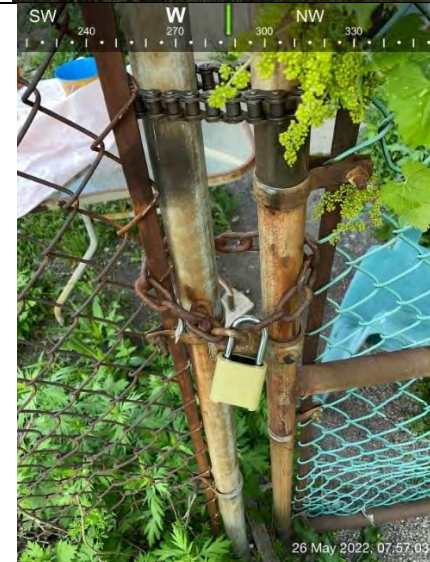
Photograph Number: 13
Subject/Description: Southern corner facing West, new combination lock on gate

The lock was replaced and secured with the chain to the gate to fully secure the site within this PRR reporting period, addressing NYSDEC's comment related to this item on the 2021 PRR. Appendix C contains the photographs from the sitewide inspections.

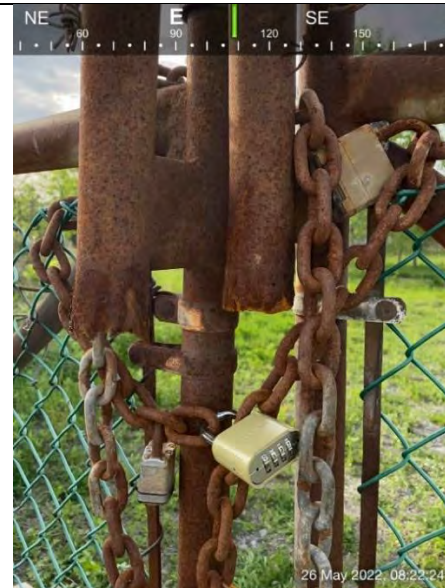
Subject/Description: Site entrance gate facing East-southeast, new combination lock on gate
