Re: White Plains Former Manufactured Gas Plant Site
White Plains, New York
NYSDEC Site #V00438-3

PERIODIC REVIEW REPORT
WHITE PLAINS FORMER MGP SITE
White Plains, Westchester, New York

APRIL 2014

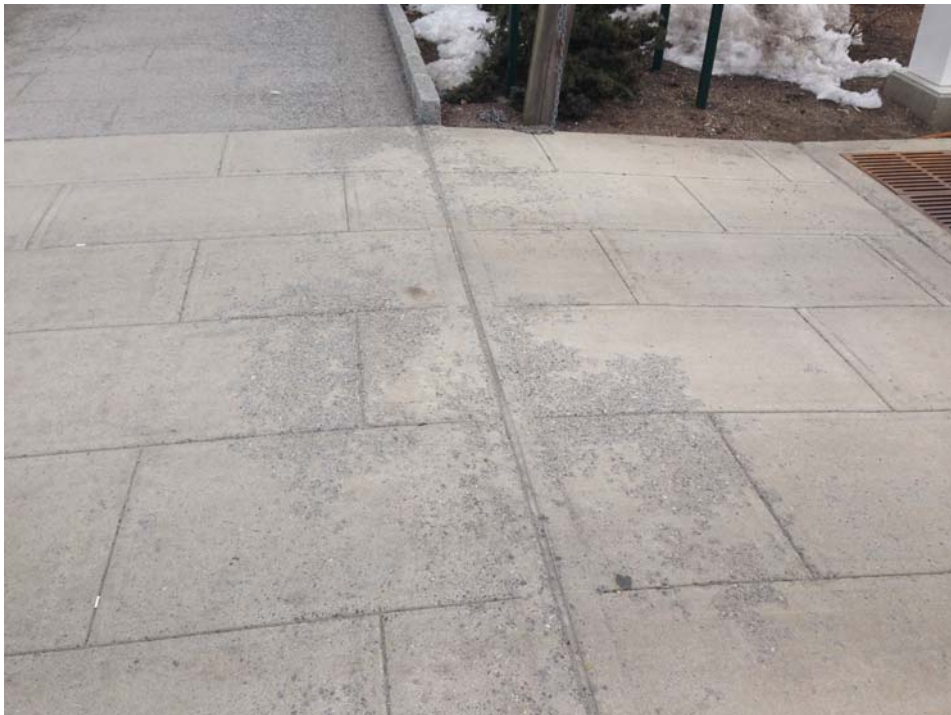
Observed concrete flaking in the sidewalk located along Water Street in the northeast corner of the Site.

Photo 7: Spalling of Concrete in Sidewalk Near Northeast Entrance

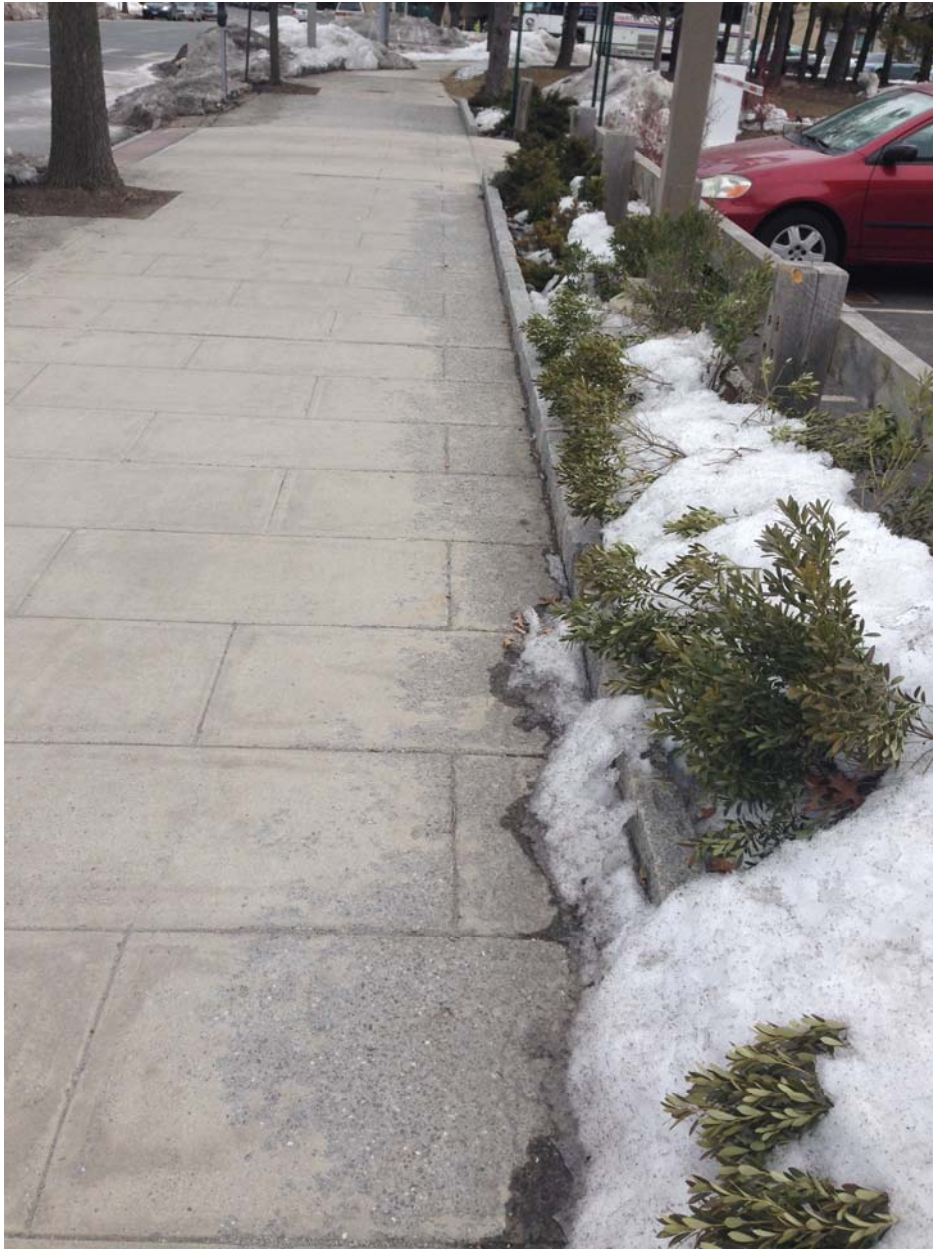
Photo 8: Spalling of Concrete along Water Street
