Re: White Plains Former Manufactured Gas Plant Site
White Plains, New York
NYSDEC Site #V00438-3

Enclosed for filing with the Department is the 2014 Periodic Review Report for the above-referenced site.

PERIODIC REVIEW REPORT
WHITE PLAINS FORMER MGP SITE
White Plains, Westchester, New York

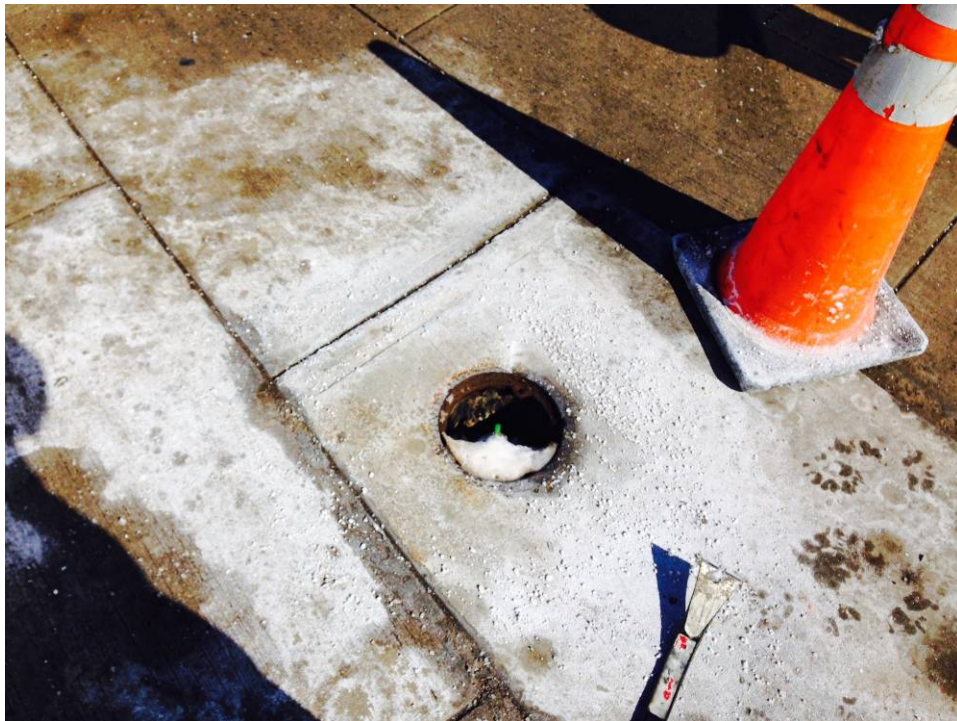
During the Site inspection on March 6, 2015, monitoring well, MW-18 was observed to be missing its well cover but its well plug was intact. As requested by Con Edison, Parsons subsequently installed a replacement cover at MW-18 on March 12, 2015 and this issue has been corrected.

Photo 8: MW-18 Missing Cover on 3/6/15

Observed concrete flaking in the sidewalk located along Water Street in the northeast corner of the Site. Monitoring well, MW-18 was missing its well cover. A well cover was installed at MW-18 on March 12, 2015.

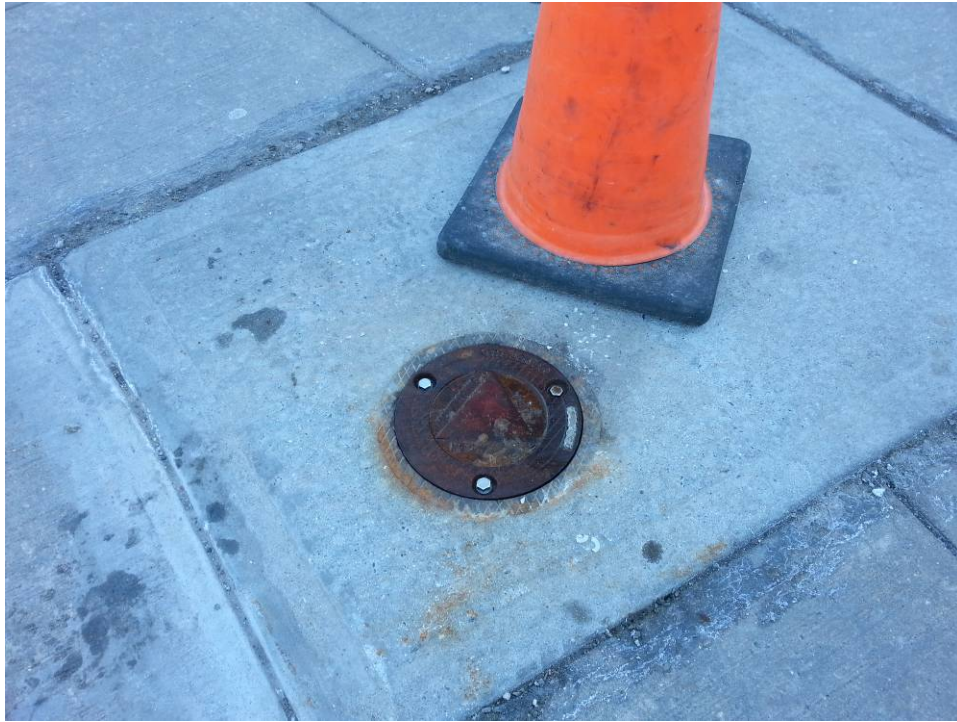
Photo 9: MW-18 Well Cover Replaced on 3/12/15
