**Re: Consolidated Edison Company of New York, Inc.  
White Plains Former Manufactured Gas Plant Site Periodic Review Report  
NYSDEC Site #V00438-3**

**PERIODIC REVIEW REPORT**  
**WHITE PLAINS FORMER MGP SITE**  
**White Plains, Westchester, New York**  
**(NYSDEC SITE NO: V00438-3)**

**JULY 2016**

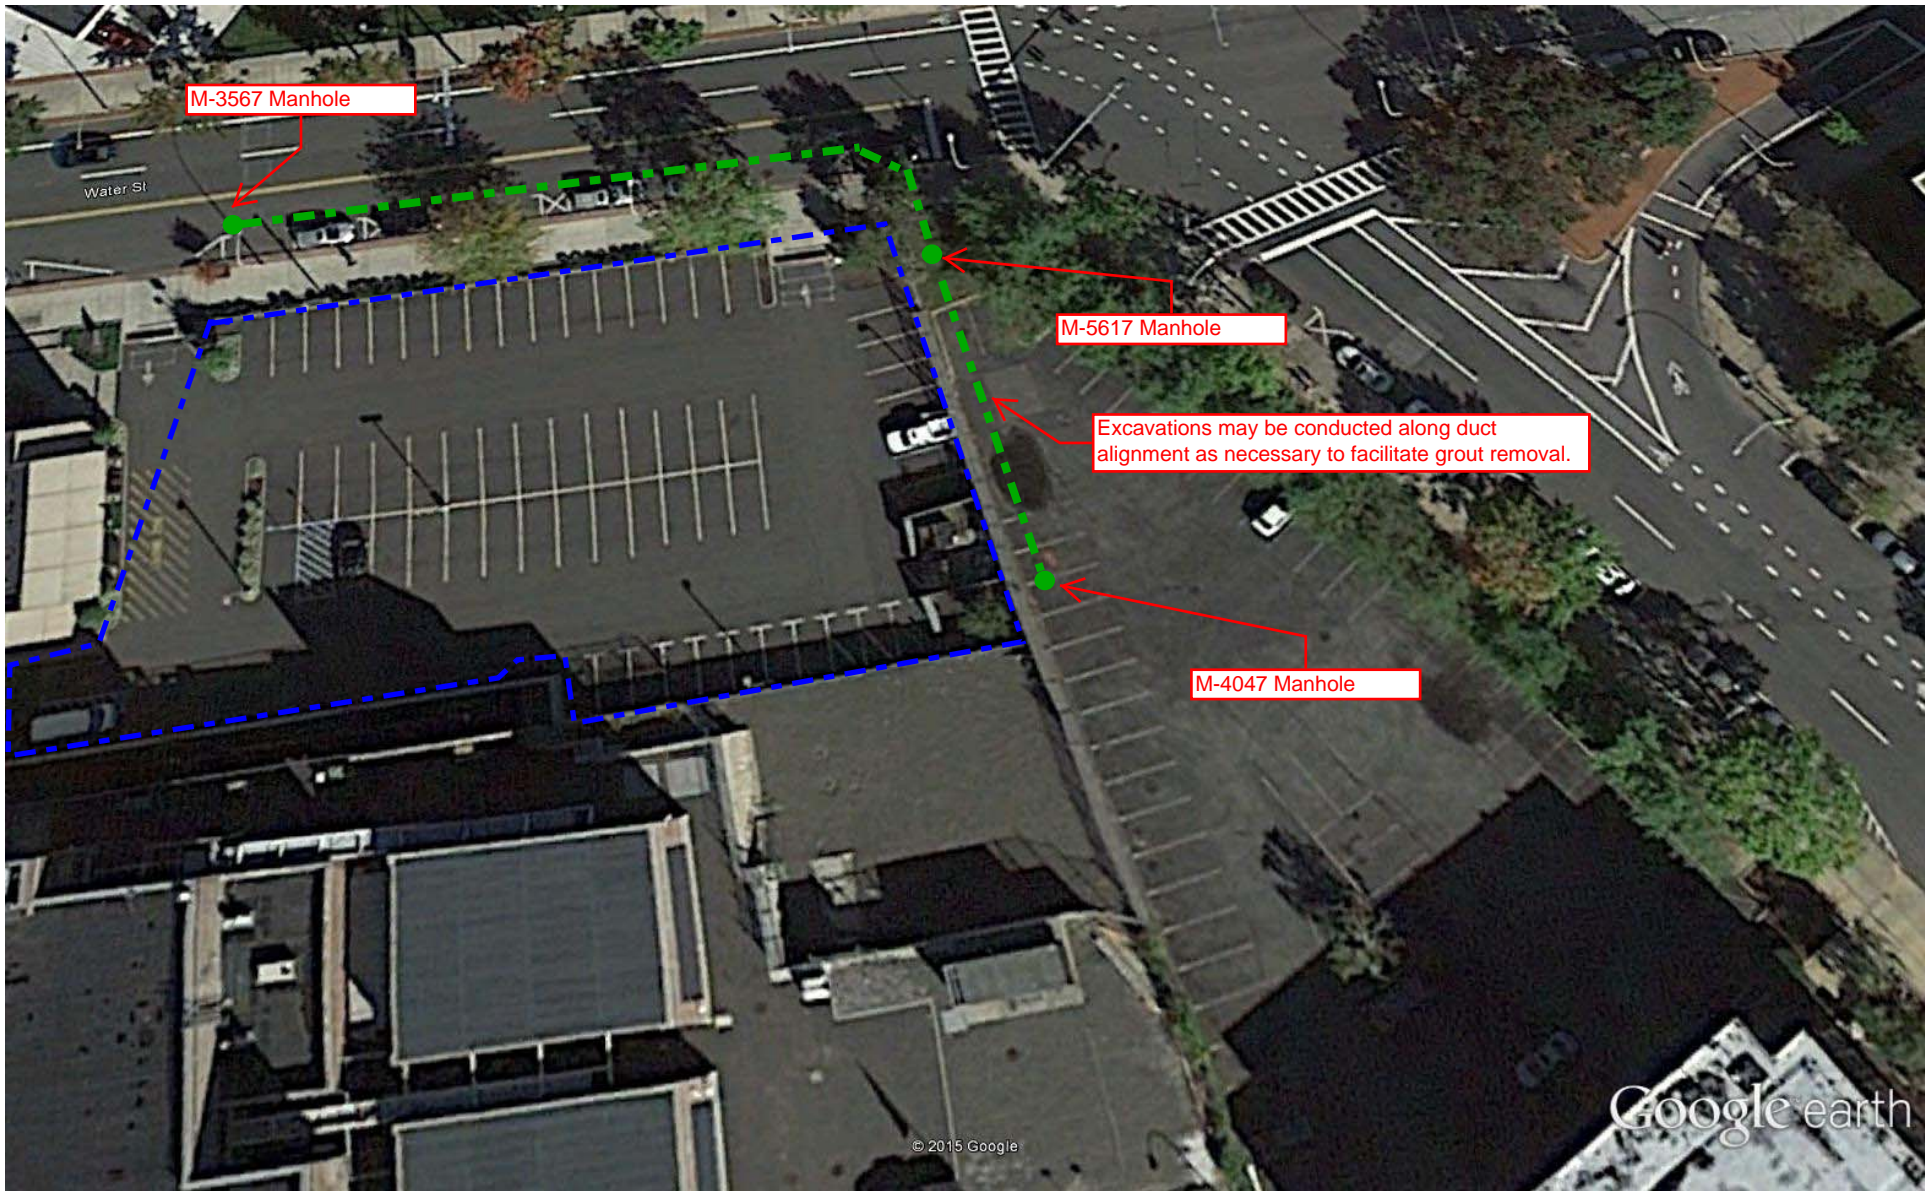
**Figure 3: Electric Ductbank Repair Location**

Con Edison retained the services of J Fletcher Creamer & Son, Inc. to conduct maintenance activities along the existing electric duct bank alignment located outside the northern and eastern boundaries of the OU-2 portion of the Site ([Figure 3](#)). The intrusive activities included excavating overburden soil to an average depth of approximately six feet below ground surface (bgs) to expose the electric duct bank alignment and allowing for repair and maintenance work. Con Edison contracted Parsons to conduct oversight and perform Community Air Monitoring Plan (CAMP) monitoring. Excavation trenching extended from manhole M-4047 towards Water Street and then west within Water Street before ending at manhole M-3567. All excavated soil was temporarily placed on polyethylene sheeting and covered. No observed impacts or sustained CAMP exceedances were recorded. The excavated trenches were backfilled and covered with asphalt upon completion. The excavated portion of the sidewalk north of the OU-2 portion of the Site was backfilled and resurfaced with concrete.

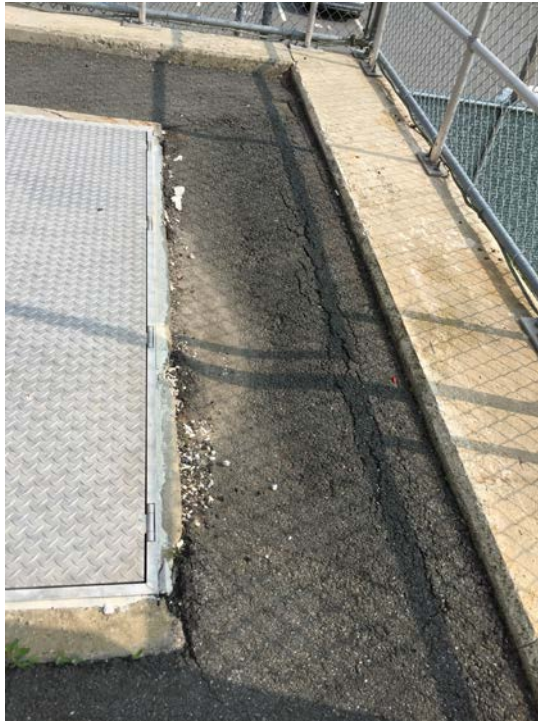
**Photo 1: Substation Parking Lot depression along equipment vault (facing North)**

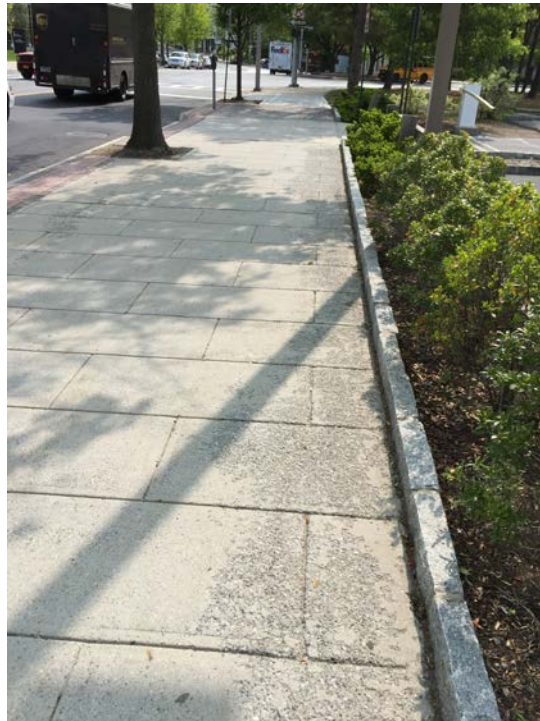
Observed concrete flaking in the sidewalk located along Water Street in the northeast corner of the Site.

**Photo 16: Sidewalk immediately north of Water Street Parking Lot (facing East)**

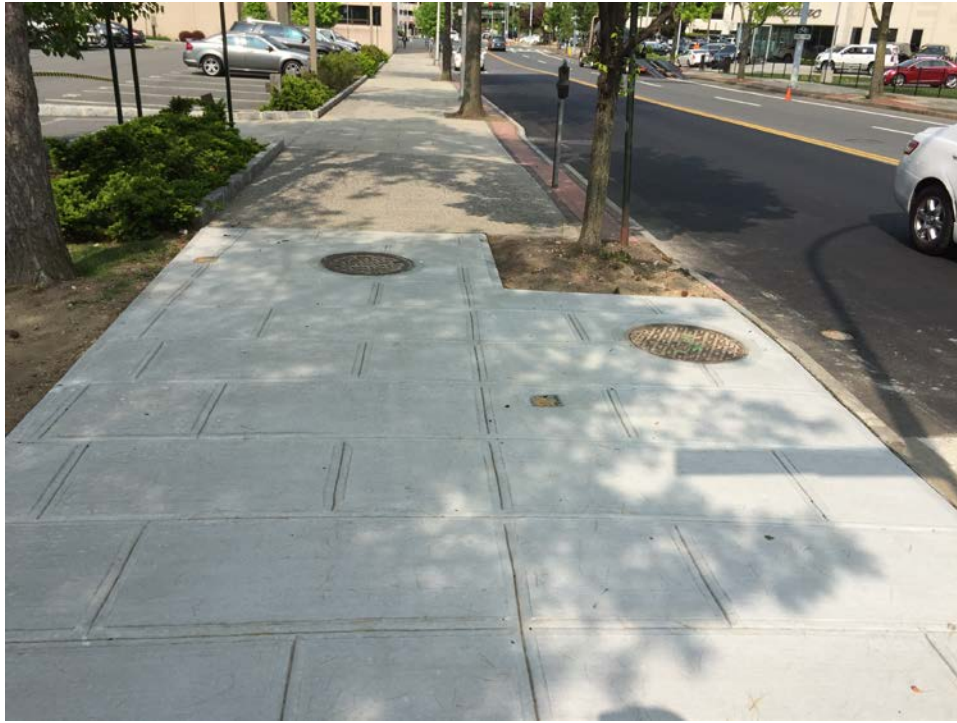
**Photo 17: Newly Poured Sidewalk Along Water Street Parking (facing West)**
