**Re: Consolidated Edison Company of New York, Inc.
White Plains Former Manufactured Gas Plant Site Periodic Review Report
NYSDEC Site #V00438-3**

PERIODIC REVIEW REPORT
WHITE PLAINS FORMER MGP SITE
White Plains, Westchester, New York
(NYSDEC SITE NO: V00438-3)

JULY 2017

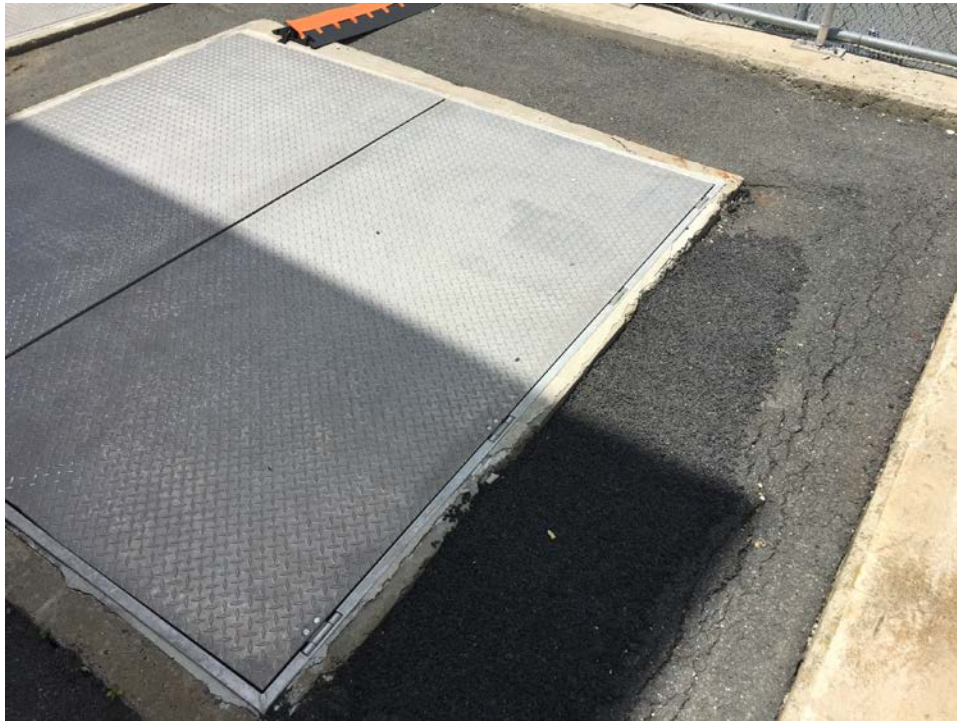
Photo 1: Substation Parking Lot filled in depression along equipment vault (facing North)

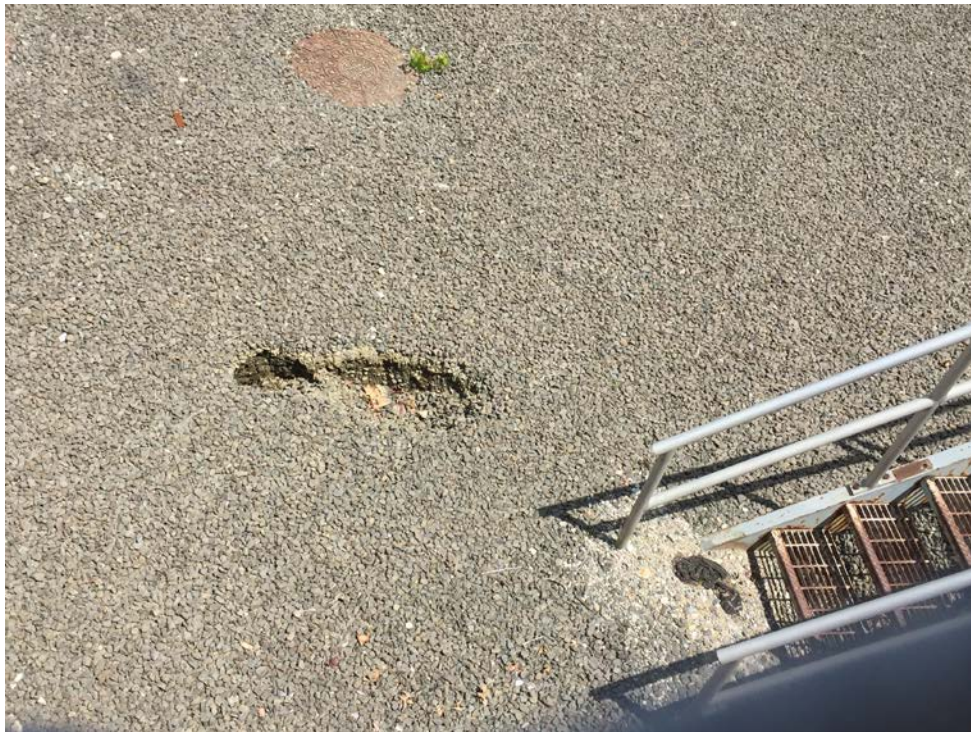
Photo 2: Sink hole in gravel cover area near Transformer Vault No. 3 (facing East)

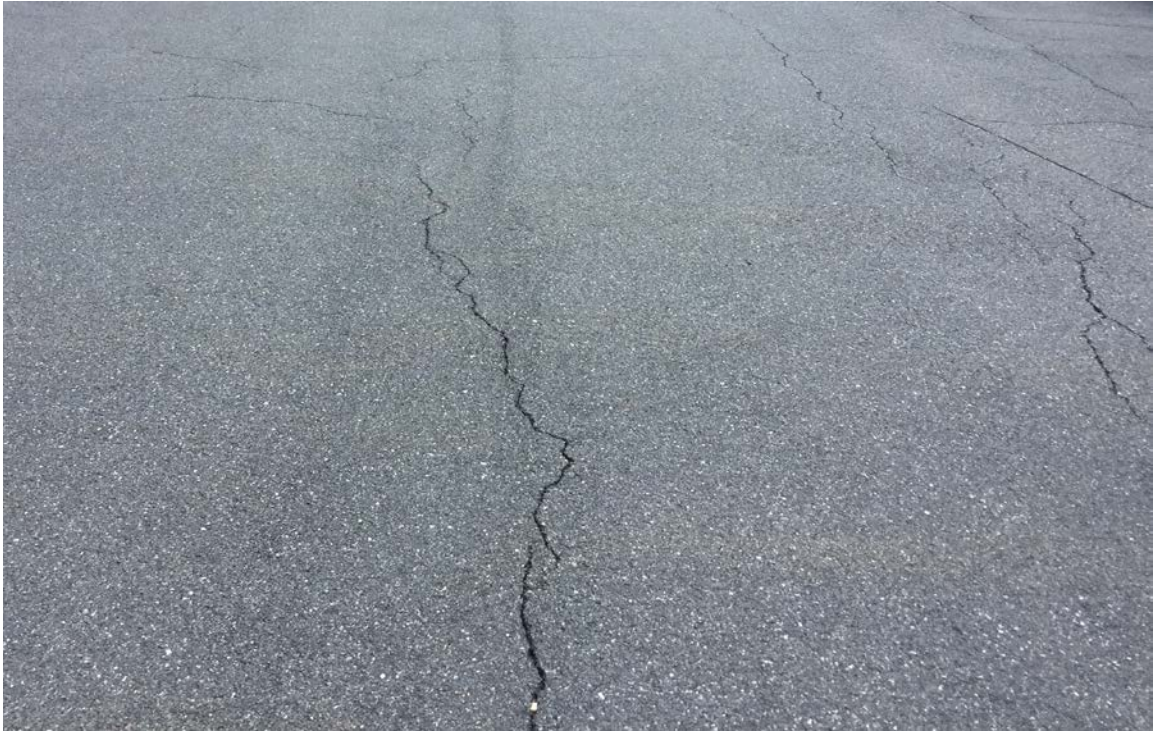
Photo 3: Substation Parking Lot (facing South)

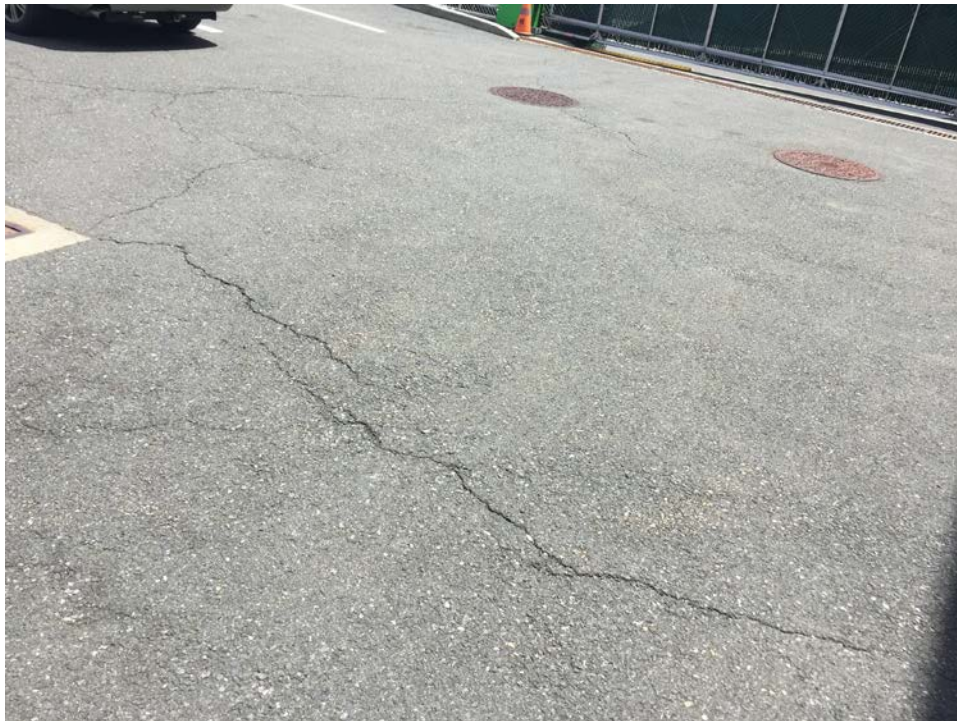
Photo 4: Substation Parking Lot (facing South)

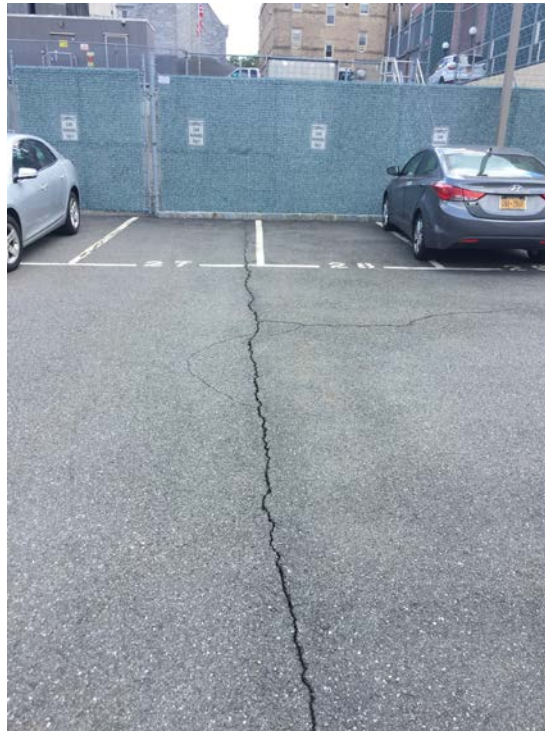
Observed cracks in the asphalt cover of the parking lot composite cover system which appear to be due to the harsh winter conditions of past seasons. Cracks do not appear to have gotten worse since last year's inspection.

Photo 5: Water Street Parking Lot (facing South)

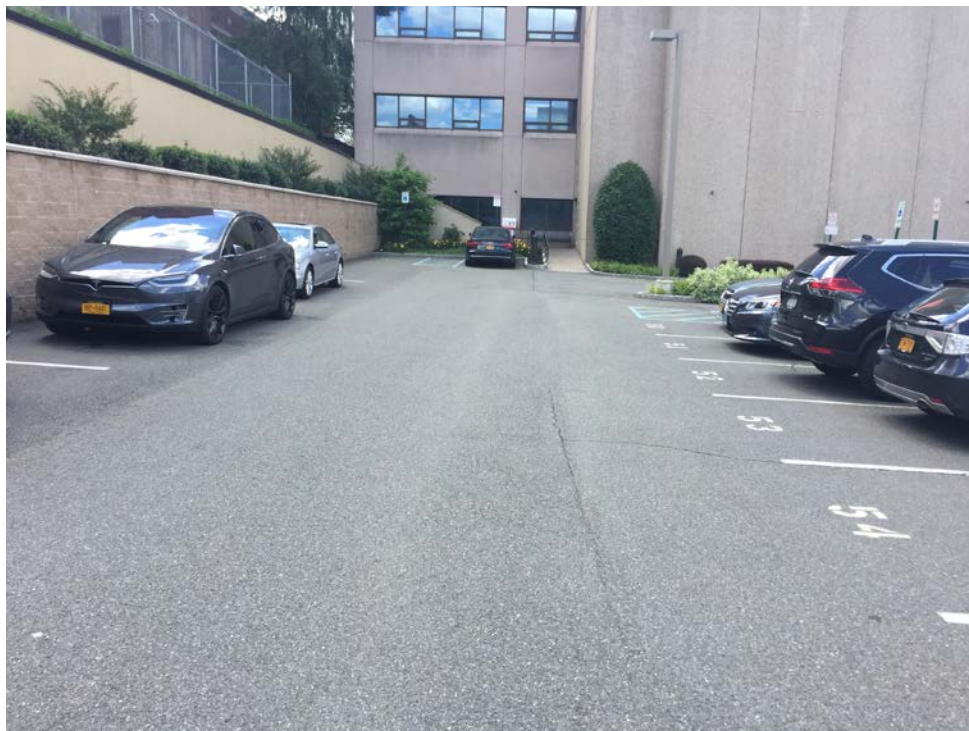
Photo 6: Water Street Parking Lot (facing West)

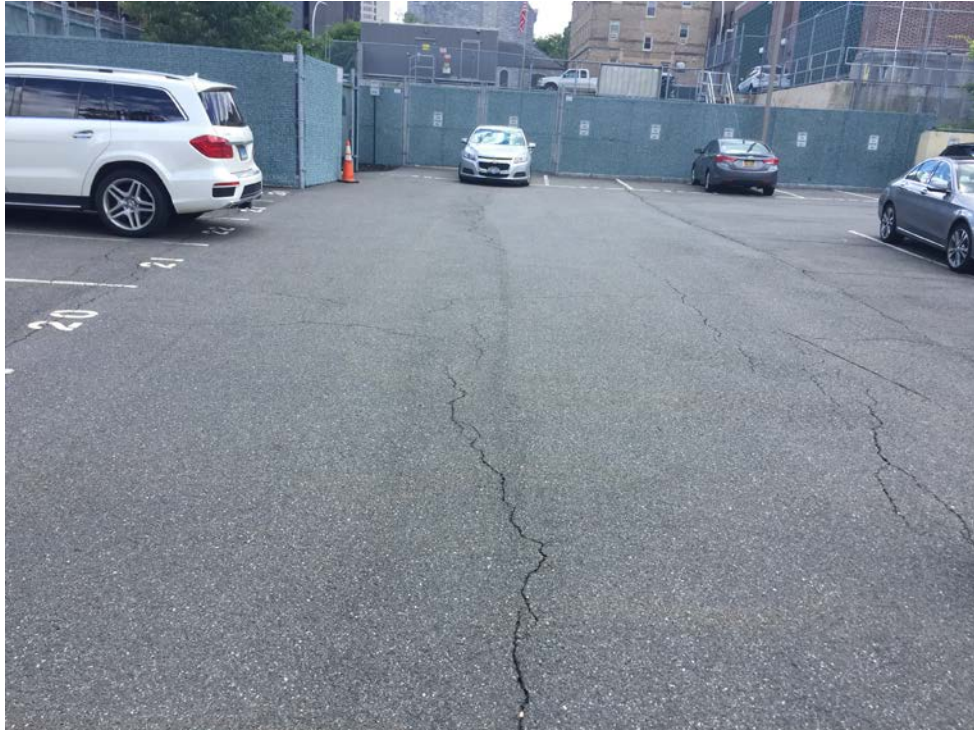
Photo 7: Water Street Parking Lot (facing South)

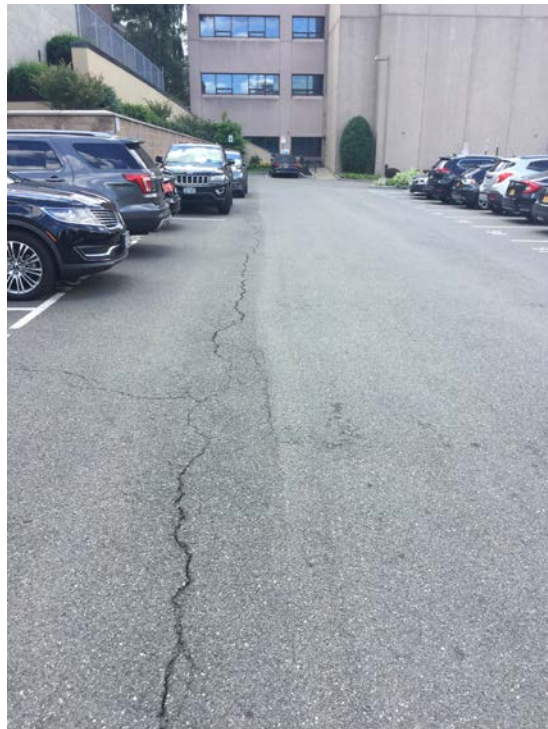
Photo 8: Water Street Parking Lot (facing West)

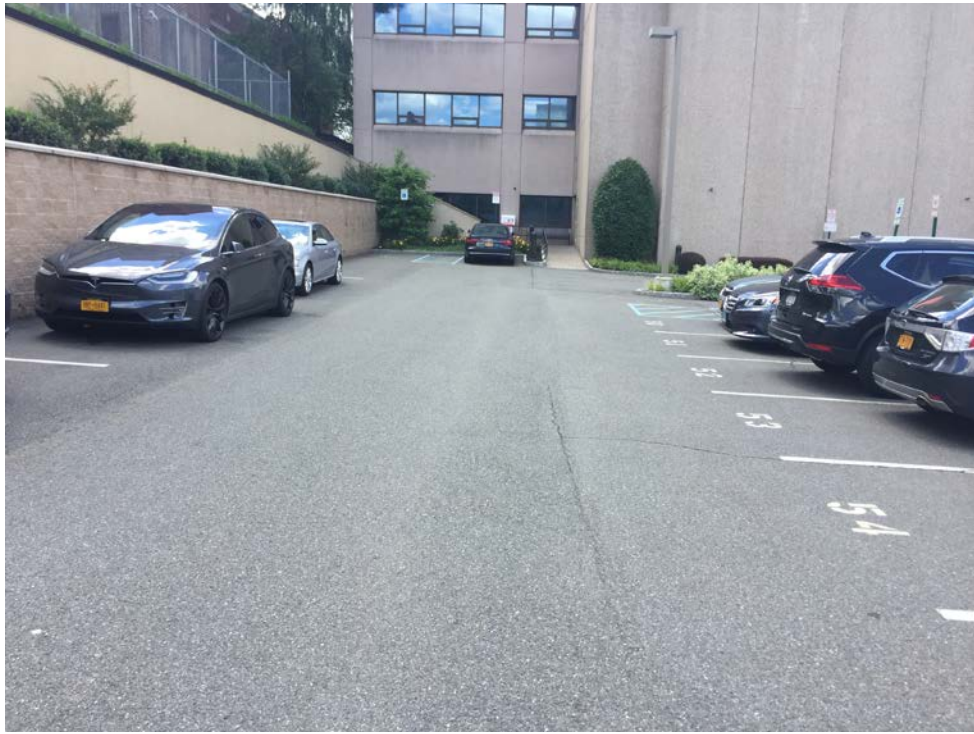
Photo 9: Water Street Parking Lot (facing West)

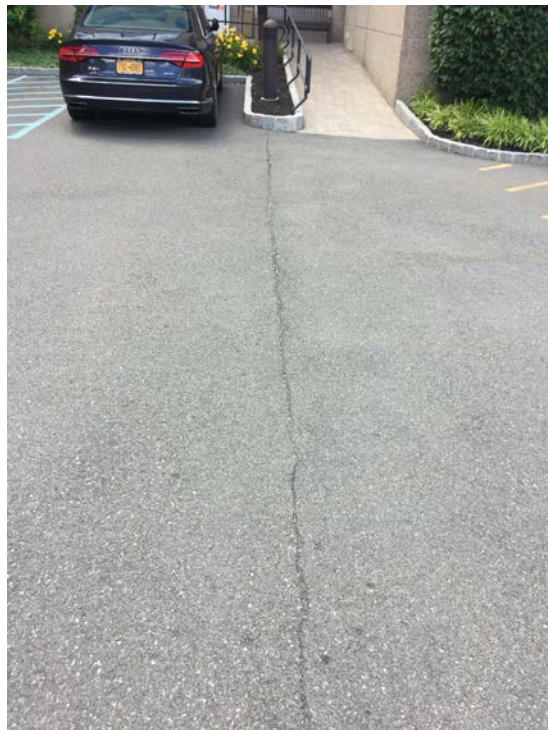
Photo 10: Water Street Parking Lot (facing West)

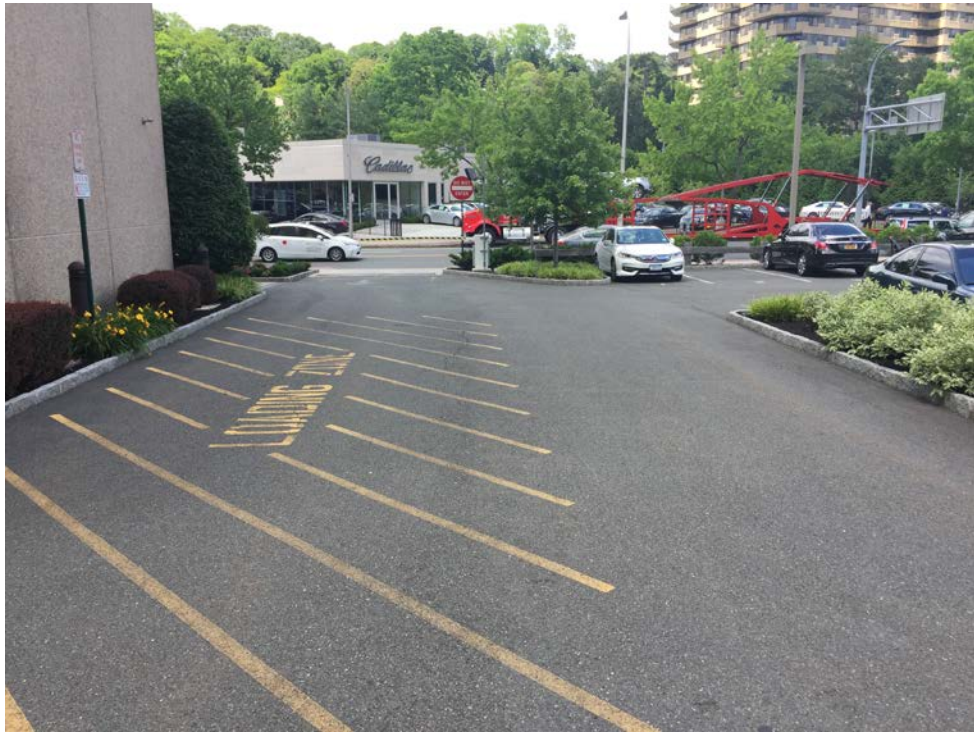
Photo 11: Water Street Parking Lot (facing North)

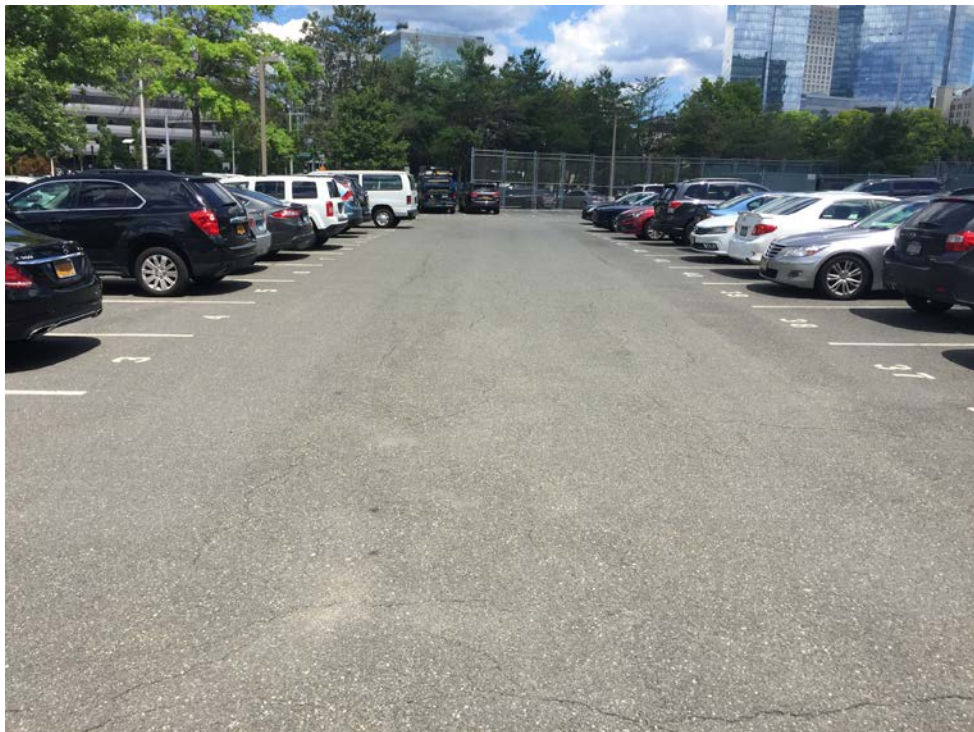
Photo 12: Water Street Parking Lot (facing East)

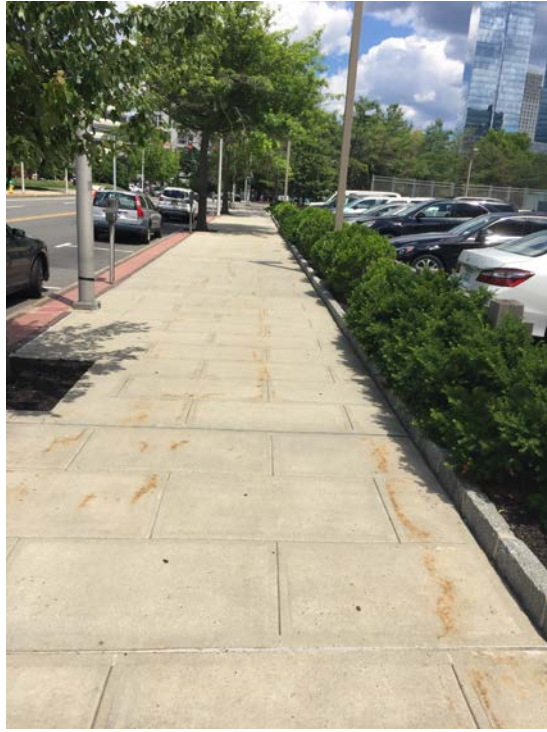
Observed concrete flaking in the sidewalk located along Water Street in the northeast corner of the Site.

Photo 13: Sidewalk immediately north of Water Street Parking Lot (facing East)

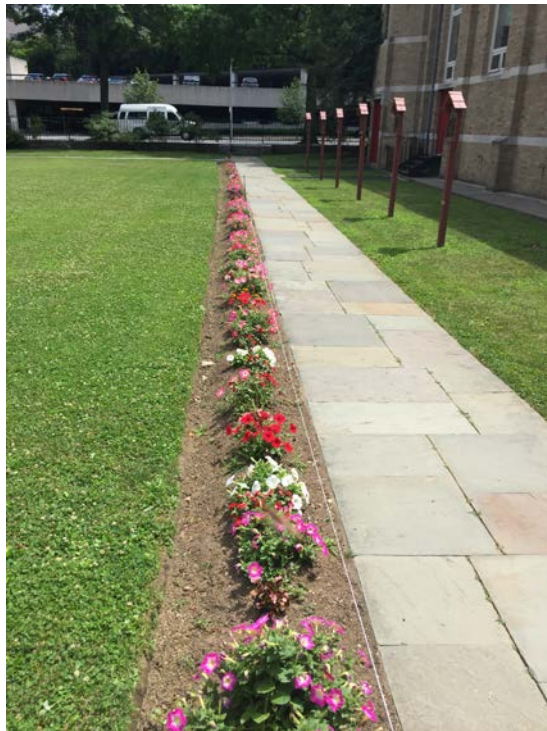
None observed except for the flower beds established in the courtyard of the Saint John the Evangelist Roman Catholic Church property.

Photo 14: Newly installed flowerbed in St John's Courtyard (facing South)
