**Re: Consolidated Edison Company of New York, Inc.  
White Plains Former Manufactured Gas Plant Site Periodic Review Report  
NYSDEC Site #V00438-3**

**PERIODIC REVIEW REPORT**  
**WHITE PLAINS FORMER MGP SITE**  
**White Plains, Westchester, New York**  
**(NYSDEC SITE NO: V00438-3)**

**SITE WIDE INSPECTION FORM**  
**WHITE PLAINS FORMER MGP SITE**

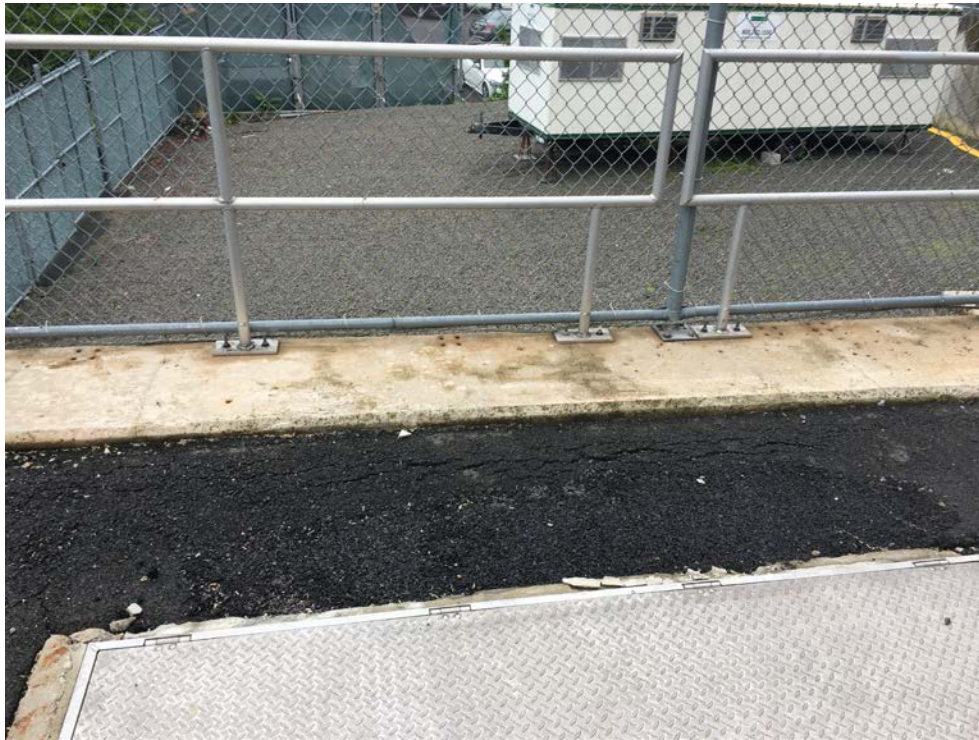
**Photo 1: Substation Parking Lot equipment vault (facing East)**

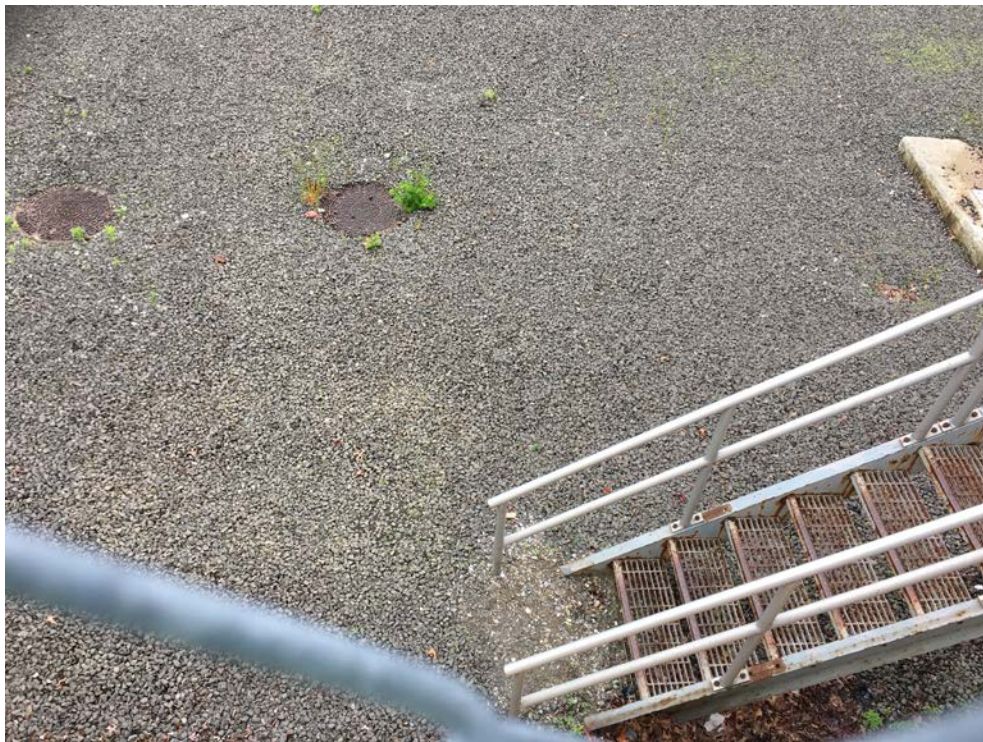
**Photo 2: Sink hole no longer in gravel cover area near Transformer Vault No. 3 (facing East)**

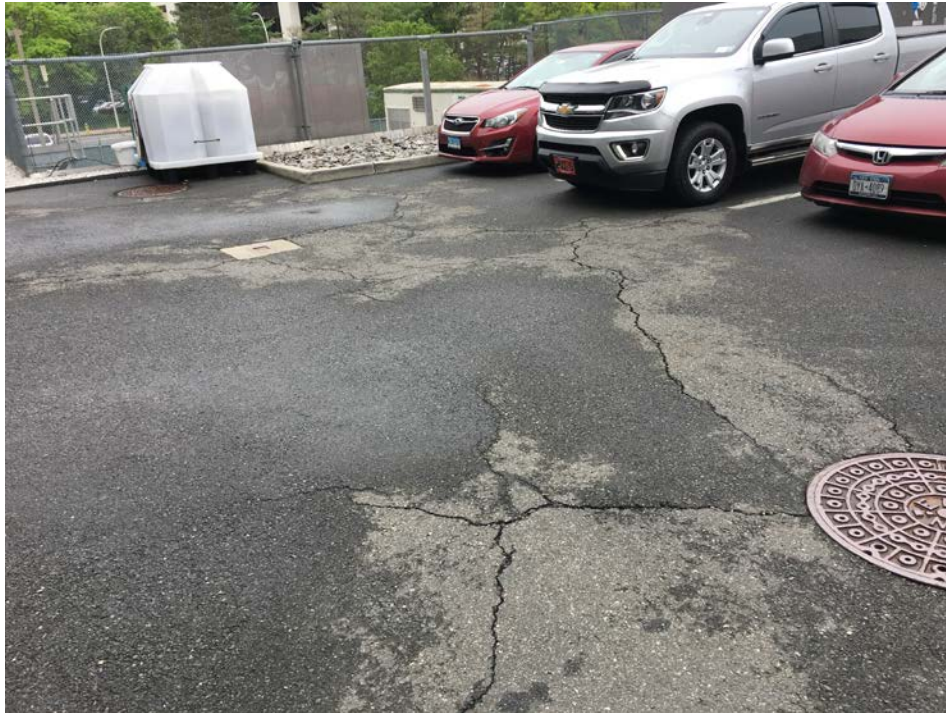
**Photo 3: Substation Parking Lot (facing North)**

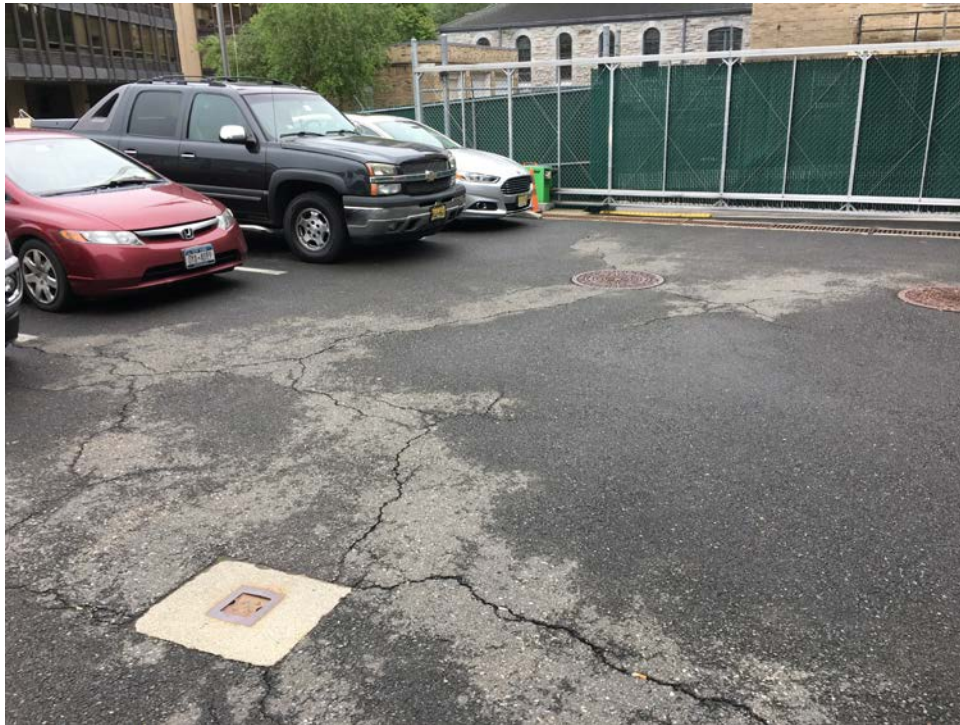
**Photo 4: Substation Parking Lot (facing South)**

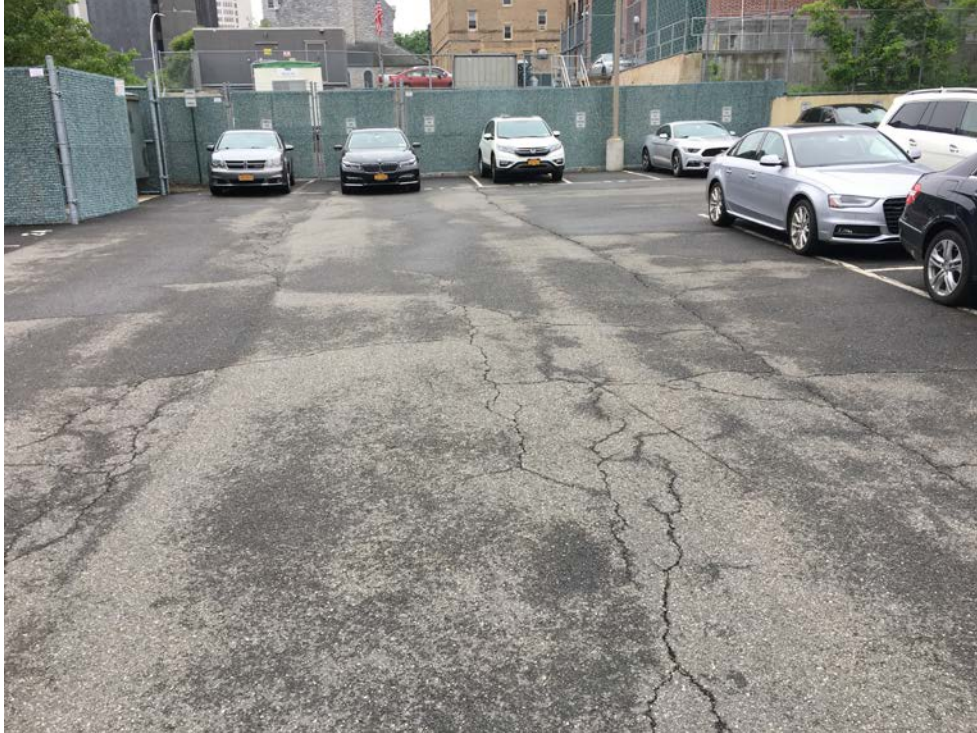
**Photo 5: Water Street Parking Lot (facing South)**

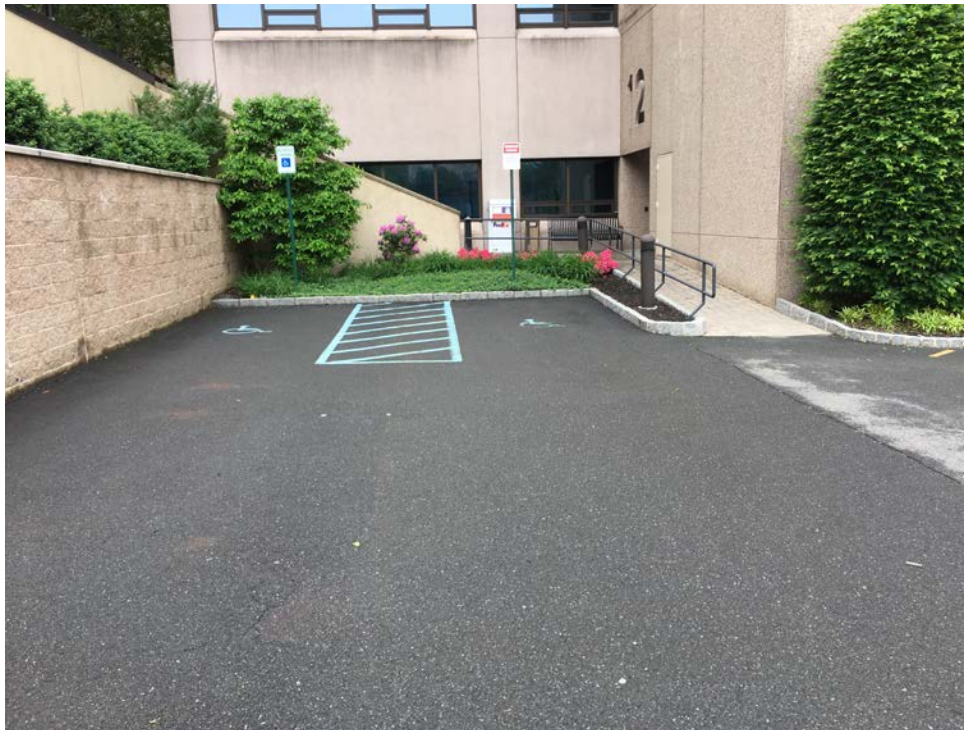
**Photo 6: Water Street Parking Lot (facing West)**

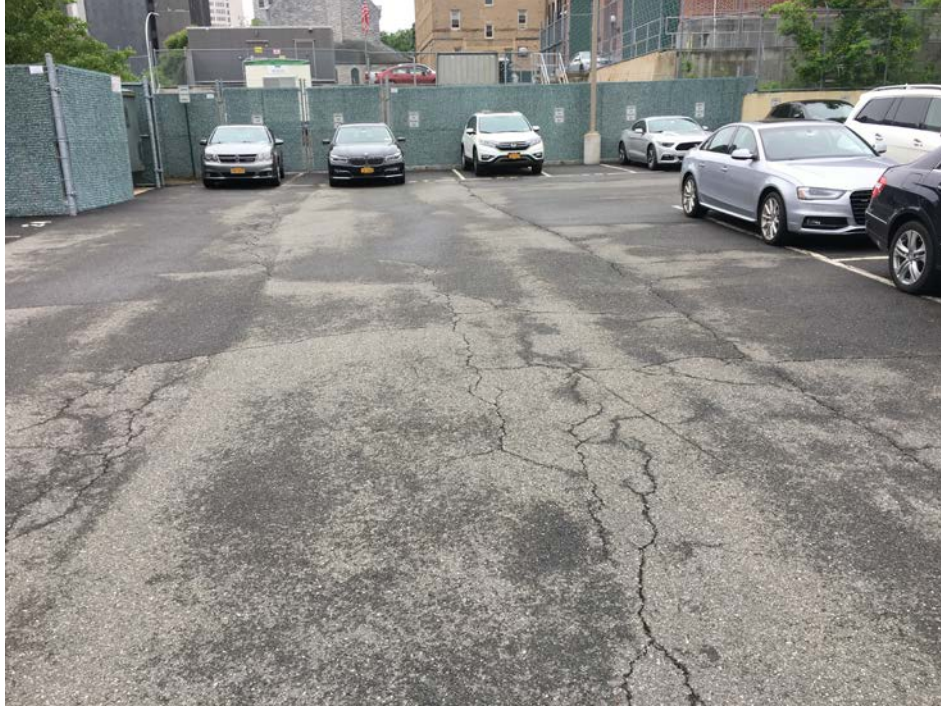
**Photo 7: Water Street Parking Lot (facing South)**

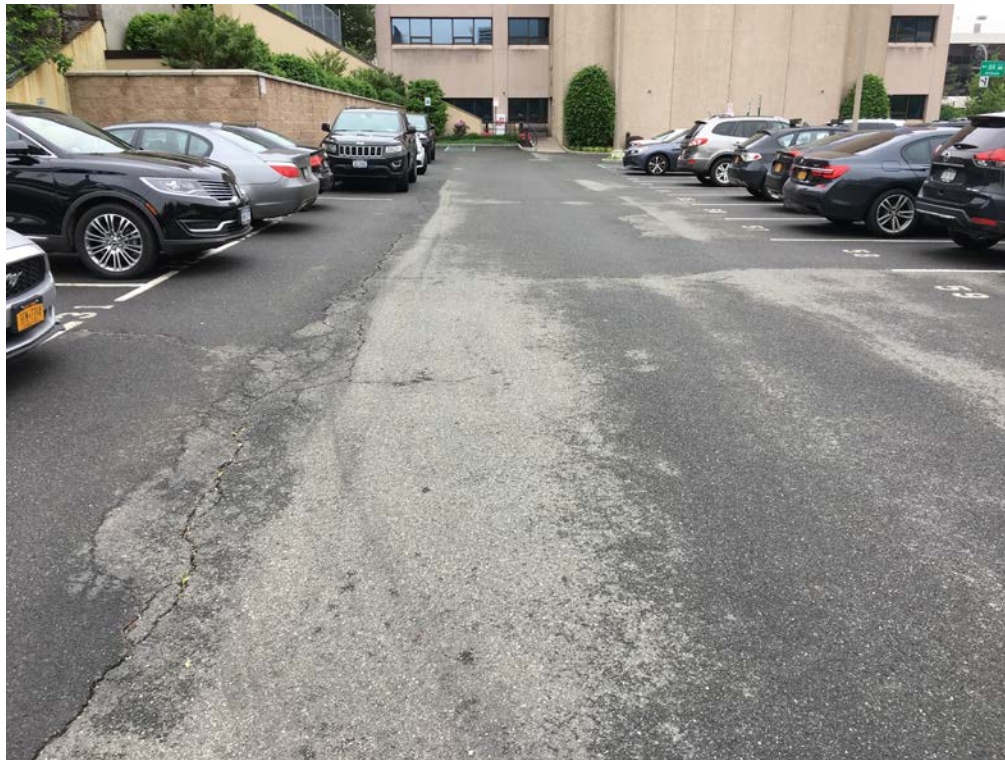
**Photo 8: Water Street Parking Lot (facing West)**

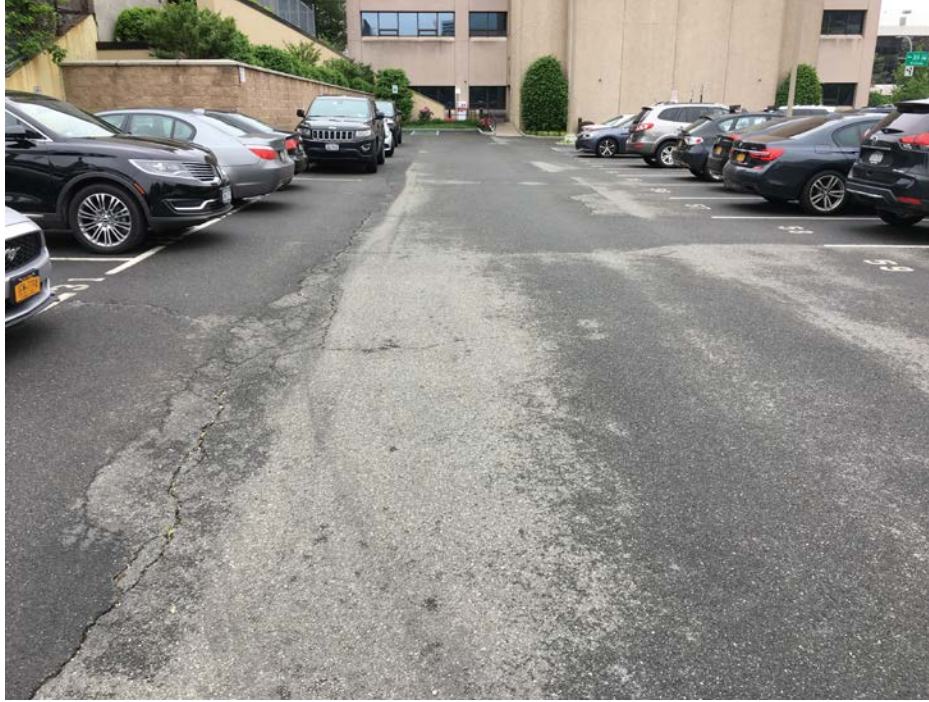
**Photo 9: Water Street Parking Lot (facing West)**

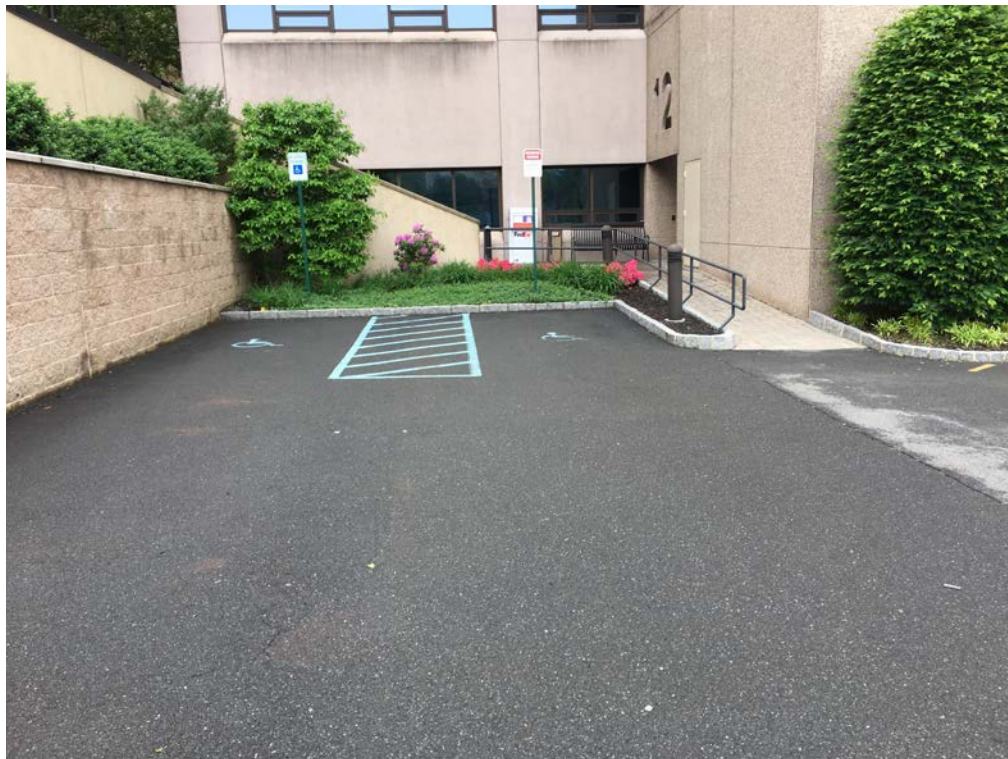
**Photo 10: Water Street Parking Lot (facing West)**

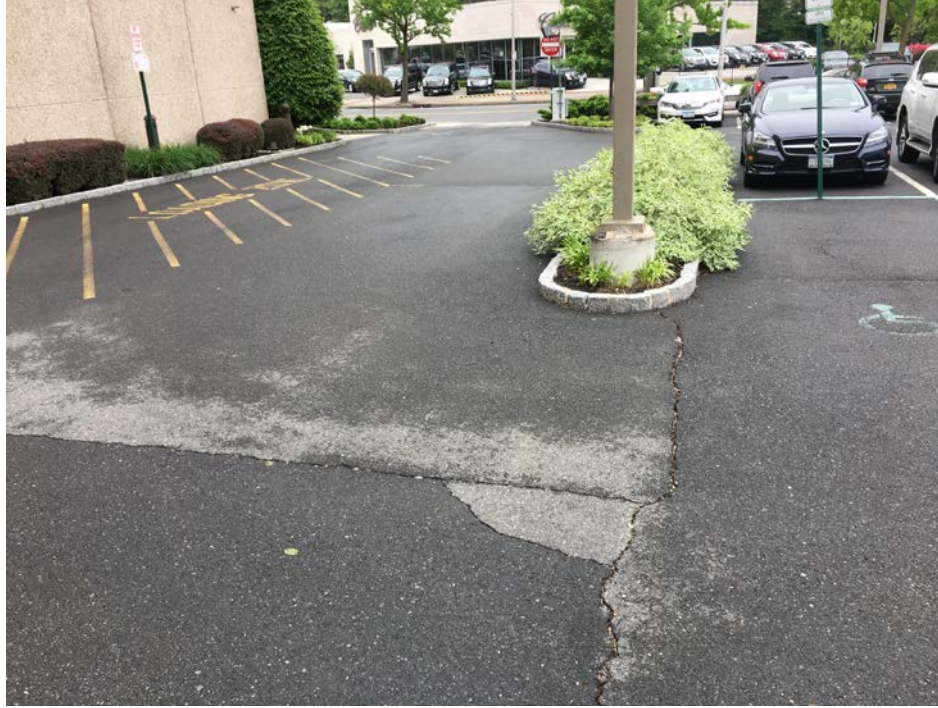
**Photo 11: Water Street Parking Lot (facing North)**

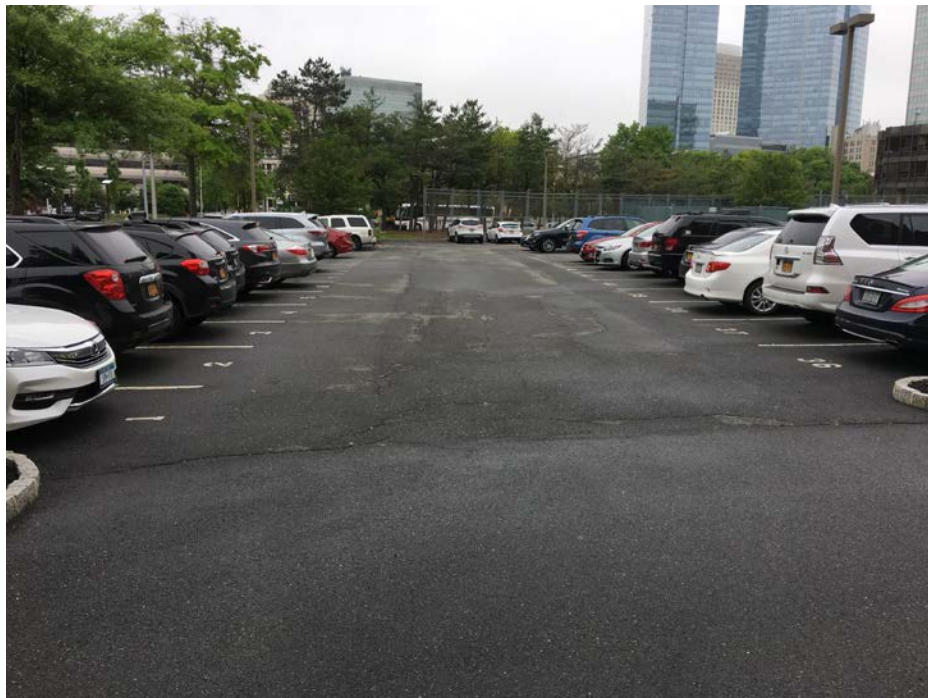
**Photo 12: Water Street Parking Lot (facing East)**

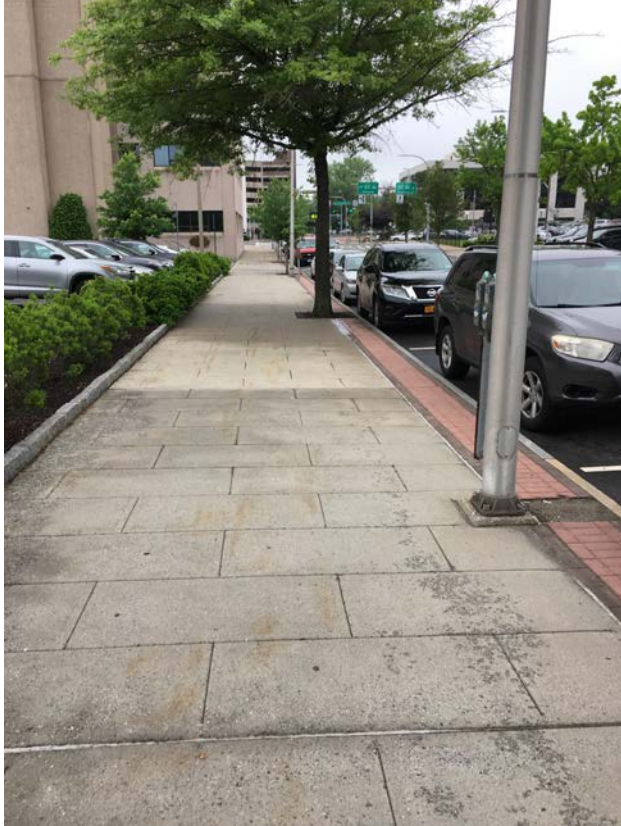
Observed concrete flaking in the sidewalk located along Water Street in the northeast corner of the Site.

**Photo 13: Sidewalk immediately north of Water Street Parking Lot (facing West)**

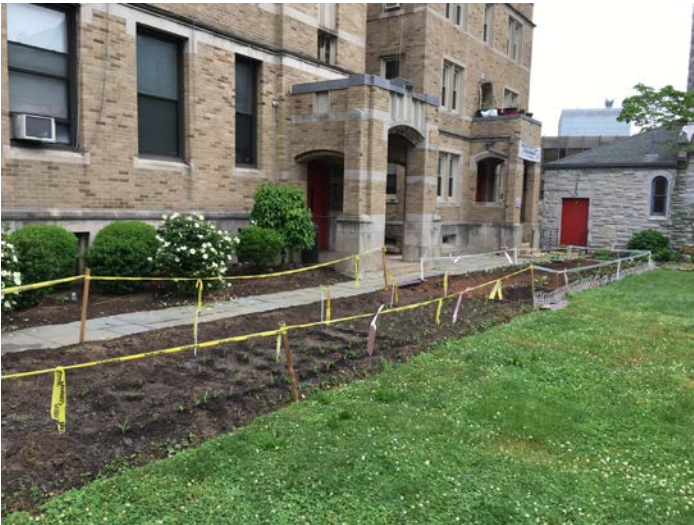
None observed except for the new flower/vegetable beds established in the courtyard of the Saint John the Evangelist Roman Catholic Church property.

**Photo 14: Newly installed flower/vegetable bed in St John’s Courtyard (facing Northeast)**

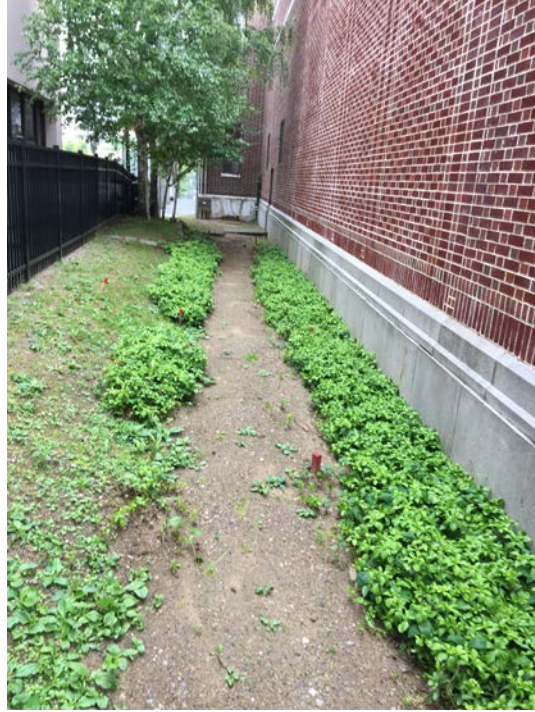
In addition, trenching associated with telecommunications repair work for the Con Edison electric substation was reportedly conducted within the past year, but the trenching was located between the 12 Water Street office building and the substation's Transformer Vault #1 and thus outside the areas of the Site requiring NYSDEC notification. Based on conversations with Con Edison substation personnel during the June 1, 2018 Site inspection, the width of the trench was approximately 2 feet or less and the depth of the trench varied from less than 5 feet on the Con Edison substation property to an approximate depth of 7 ½ feet within the North Lexington Avenue eastern sidewalk.

**Photo 15: Location of Trenching for Telecommunications Repair Work (facing East)**

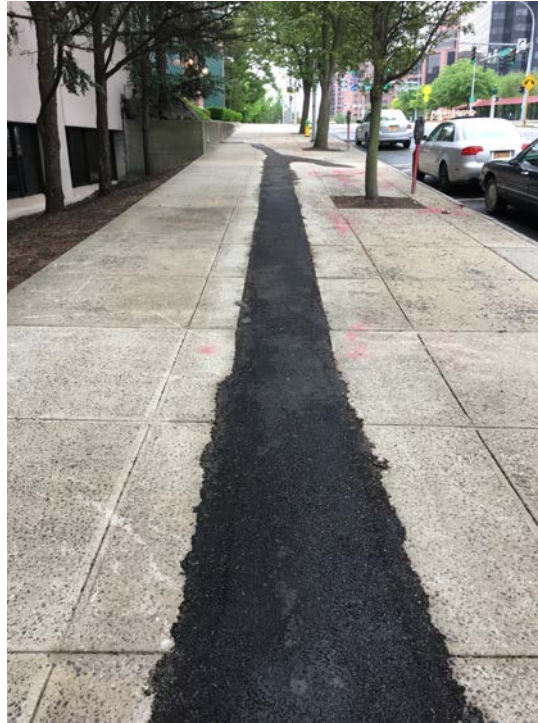
**Photo 16: Telecommunications Repair Trenching along North Lexington Avenue (facing South)**
