**Re: Consolidated Edison Company of New York, Inc.  
White Plains Former Manufactured Gas Plant Site Periodic Review Report  
NYSDEC Site #V00438-3**

**PERIODIC REVIEW REPORT**  
**WHITE PLAINS FORMER MGP SITE**  
**White Plains, Westchester, New York**  
**(NYSDEC SITE NO: V00438-3)**

**JULY 2018**

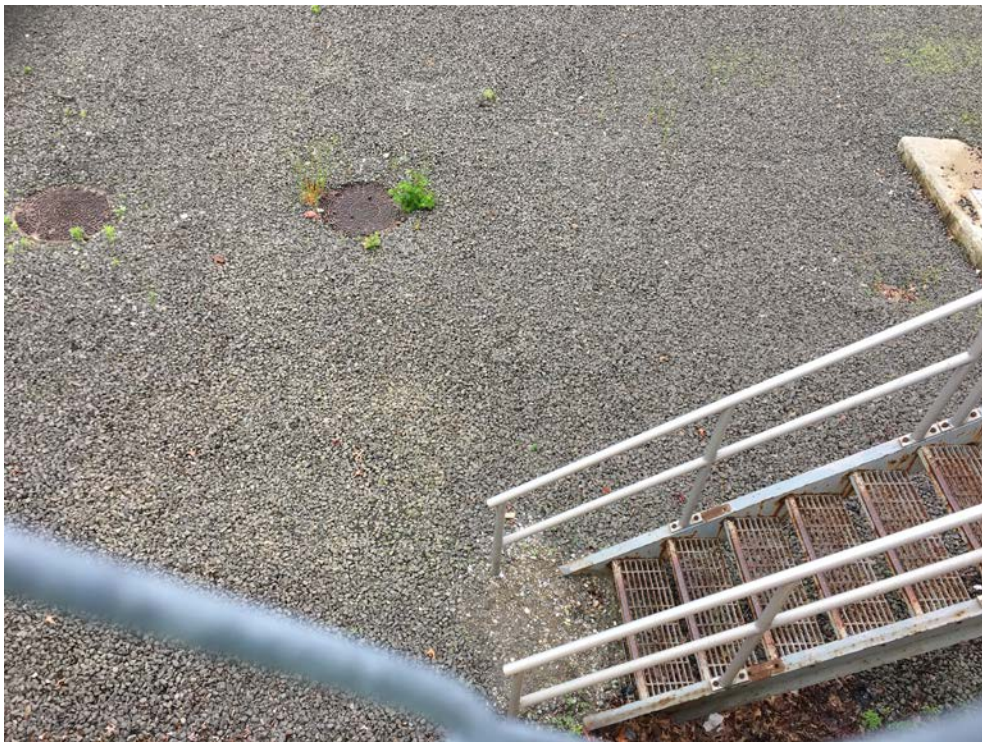
**Photo 2: Sink hole no longer in gravel cover area near Transformer Vault No. 3 (facing East)**

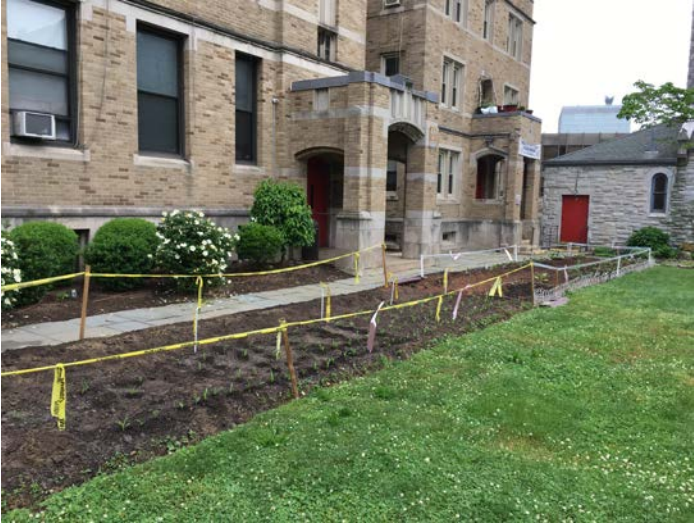
None observed except for the new flower/vegetable beds established in the courtyard of the Saint John the Evangelist Roman Catholic Church property.

**Photo 14: Newly installed flower/vegetable bed in St John’s Courtyard (facing Northeast)**

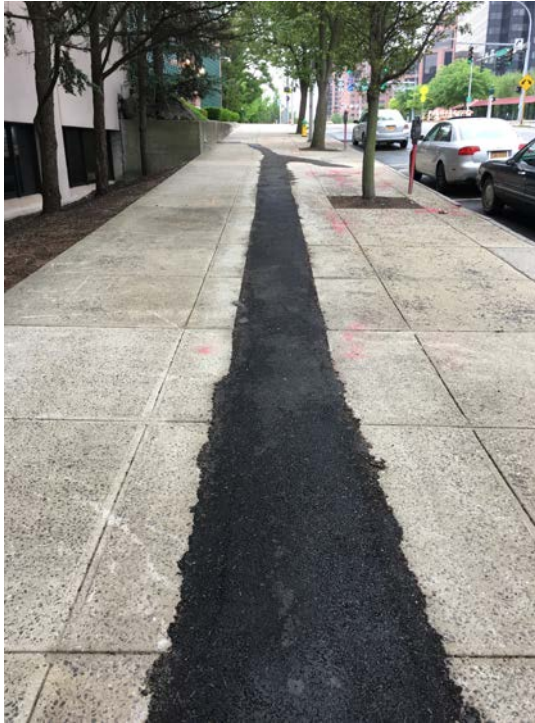
In addition, trenching associated with telecommunications repair work for the Con Edison electric substation was reportedly conducted within the past year, but the trenching was located between the 12 Water Street office building and the substation's Transformer Vault #1 and thus outside the areas of the Site requiring NYSDEC notification. Based on conversations with Con Edison substation personnel during the June 1, 2018 Site inspection, the width of the trench was approximately 2 feet or less and the depth of the trench varied from less than 5 feet on the Con Edison substation property to an approximate depth of 7 ½ feet within the North Lexington Avenue eastern sidewalk.

**Photo 16: Telecommunications Repair Trenching along North Lexington Avenue (facing South)**
