**Re: Consolidated Edison Company of New York, Inc.
White Plains Former Manufactured Gas Plant Site Periodic Review Report
NYSDEC Site #V00438-3**

PERIODIC REVIEW REPORT
WHITE PLAINS FORMER MGP SITE
White Plains, Westchester, New York
(NYSDEC SITE NO: V00438-3)

SITE WIDE INSPECTION FORM
WHITE PLAINS FORMER MGP SITE

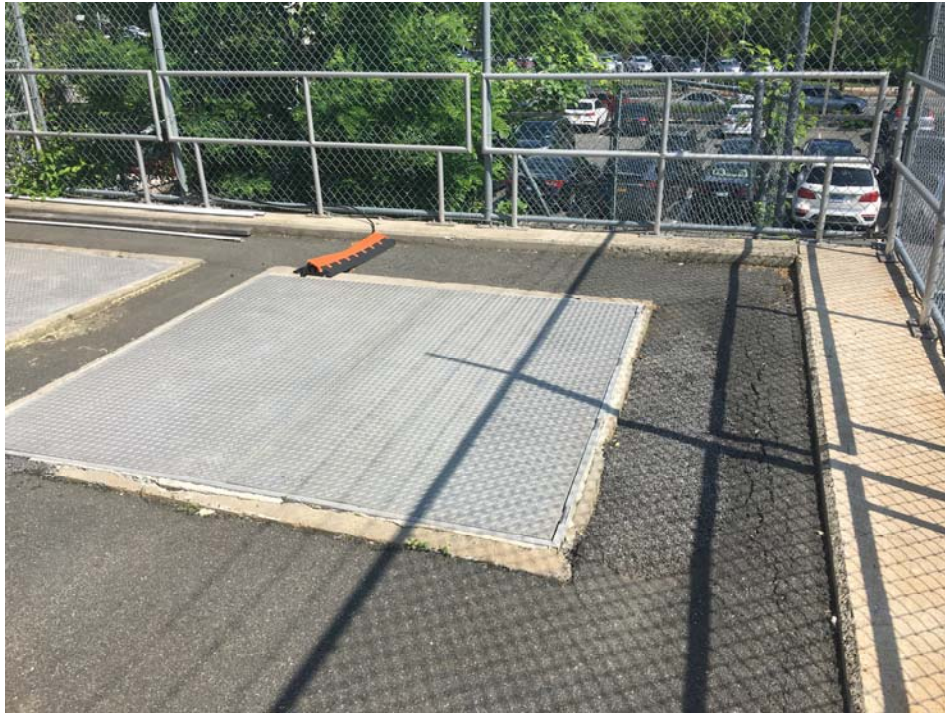
Photo 1: Alley between Transformer Vaults No. 3 and 4 (facing North)

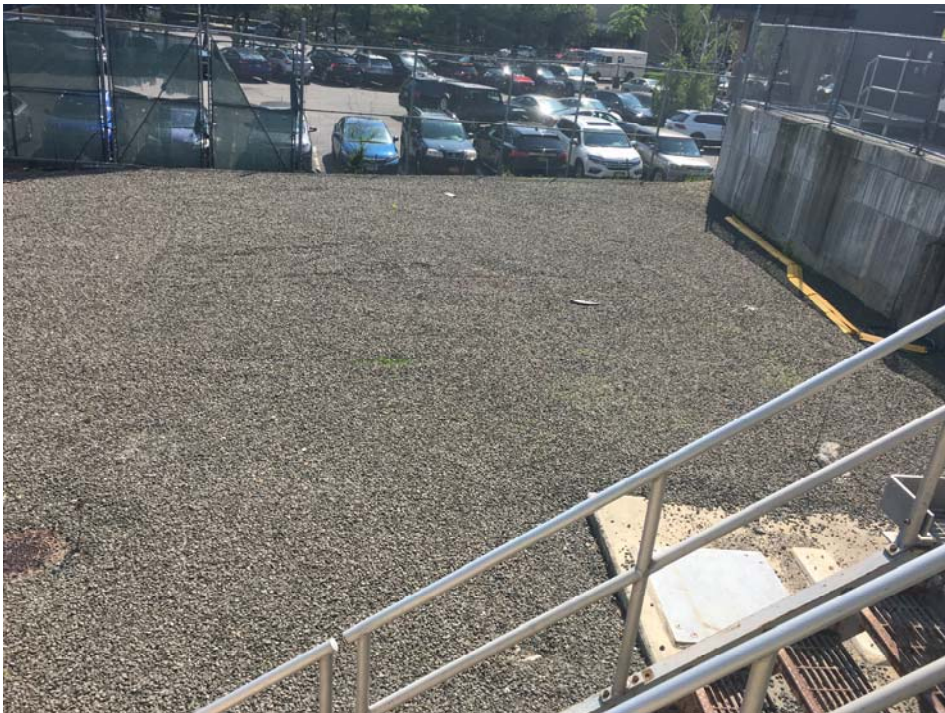
Photo 2: Gravel cover area near Transformer Vault No. 3 (facing East)

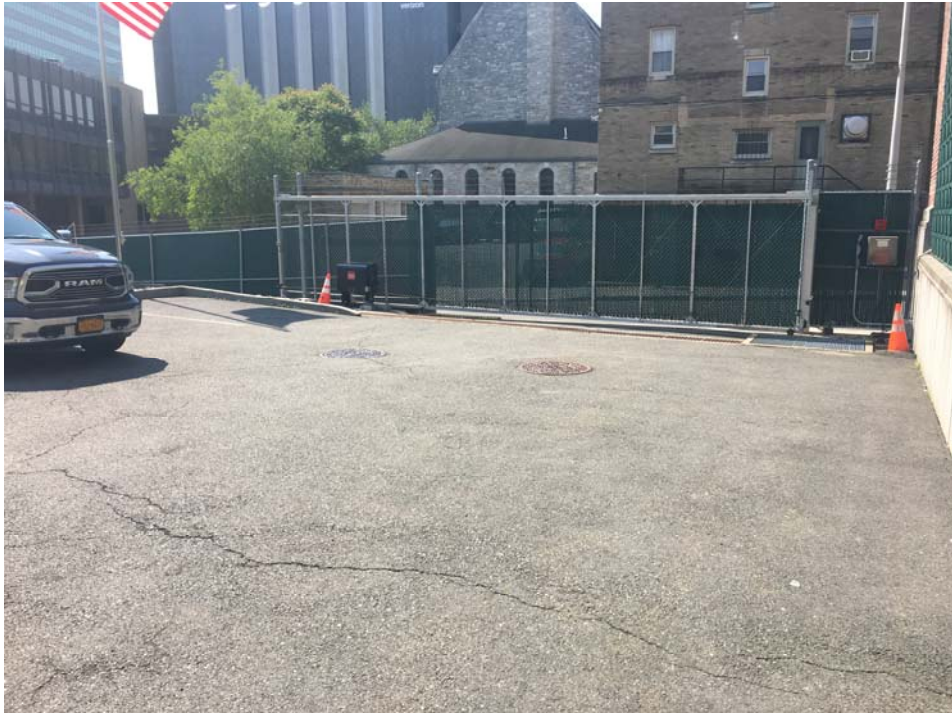
Observed cracks in the asphalt cover of the parking lot composite cover system which appear to be due to the harsh winter conditions of past seasons. Cracks do not appear to have gotten worse since last year's inspection.

Photo 3: Substation Parking Lot (facing South)

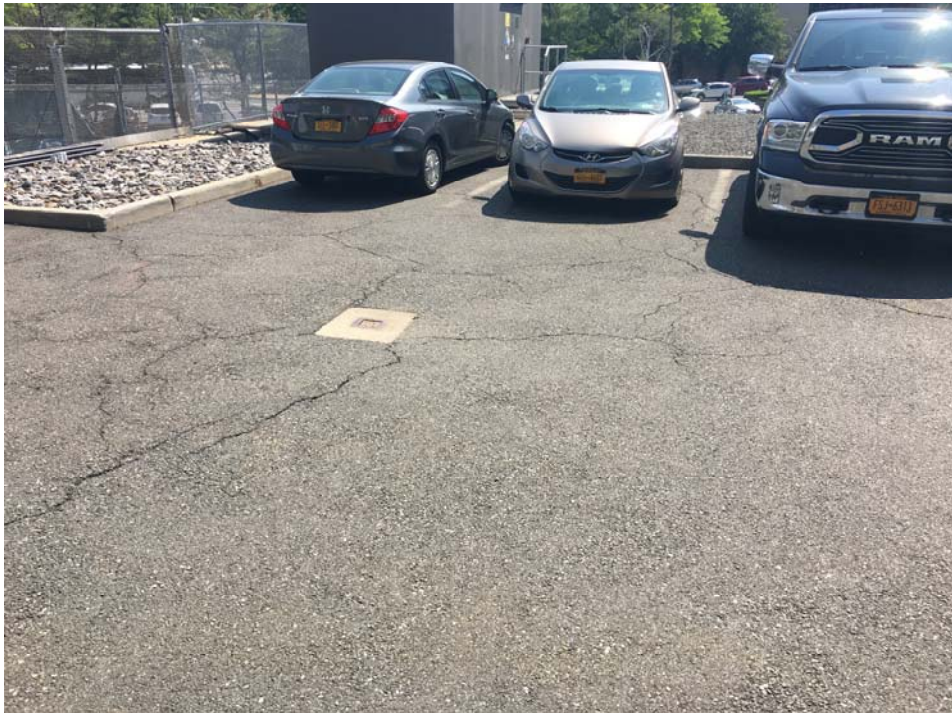
Photo 4: Substation Parking Lot (facing Northeast)

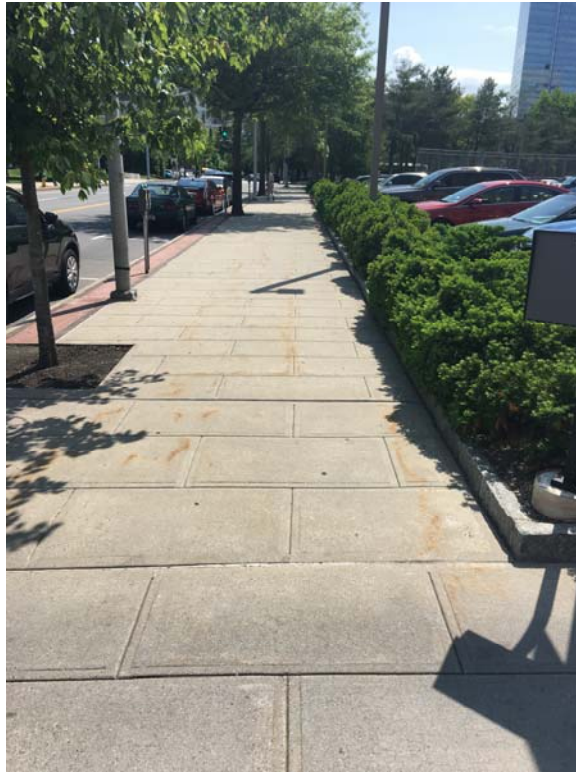
Observed concrete flaking in the sidewalk located along Water Street in the northeast corner of the Site.

Photo 13: Sidewalk immediately north of Water Street Parking Lot (facing East)

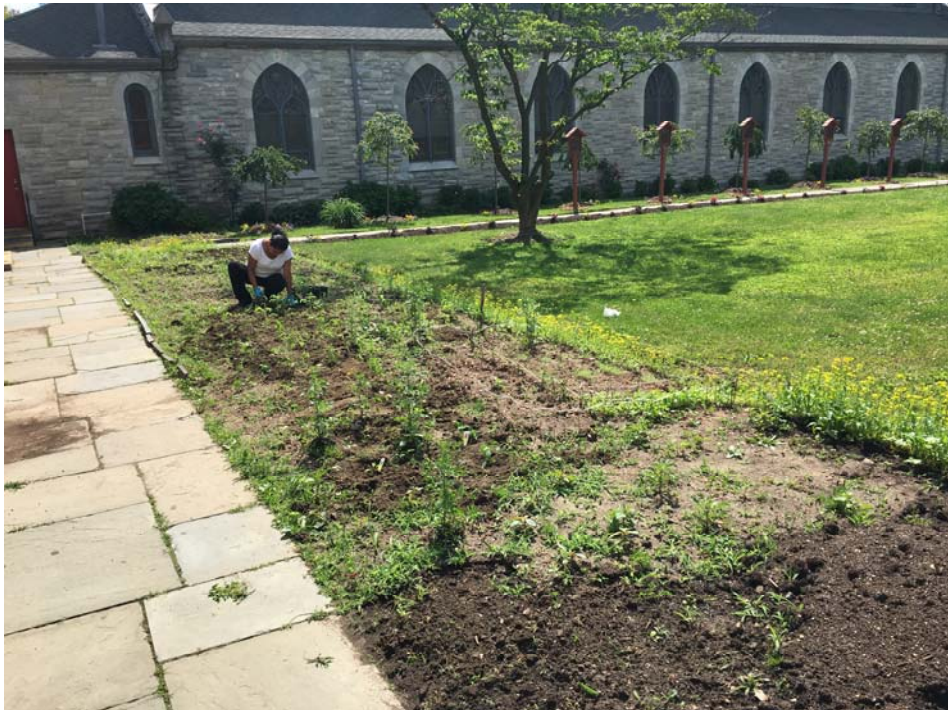
A flower/vegetable bed was observed in the courtyard of the Saint John the Evangelist Roman Catholic Church property which appears to be above grade.

Photo 14: Flower/vegetable bed in St John's Courtyard (facing East)

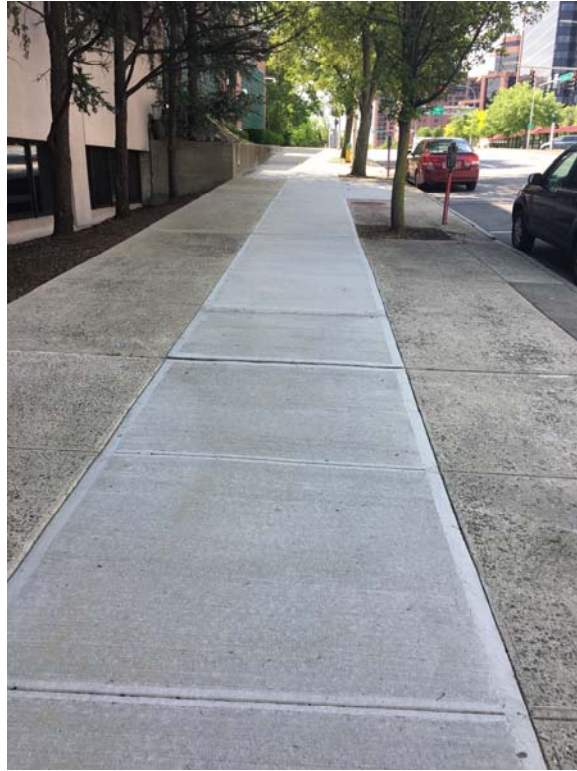
Photo 15: Trenching Sidewalk Repair along North Lexington Avenue (facing South)
