PERIODIC REVIEW REPORT
WHITE PLAINS FORMER MGP SITE
White Plains, Westchester, New York
(NYSDEC SITE NO: V00438-3)

JULY 2024

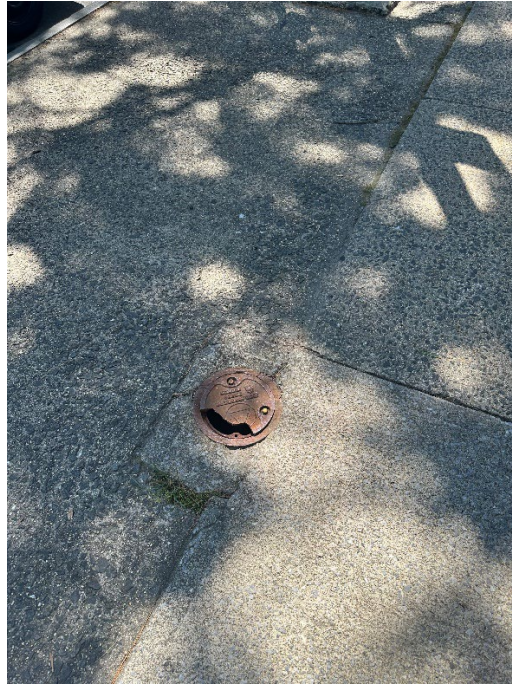
During the site inspection, it was noted that a new cover is needed for MW-19. It was additionally observed during the recent groundwater sampling event that the pvc riser at monitoring well MW-18 was crimped. Based on failed attempts to lower the sampling equipment within monitoring well MW-18, a repair will be necessary for the top portion of riser within this monitoring well.

Photo 9: Monitoring Well MW-19 well cover is broken

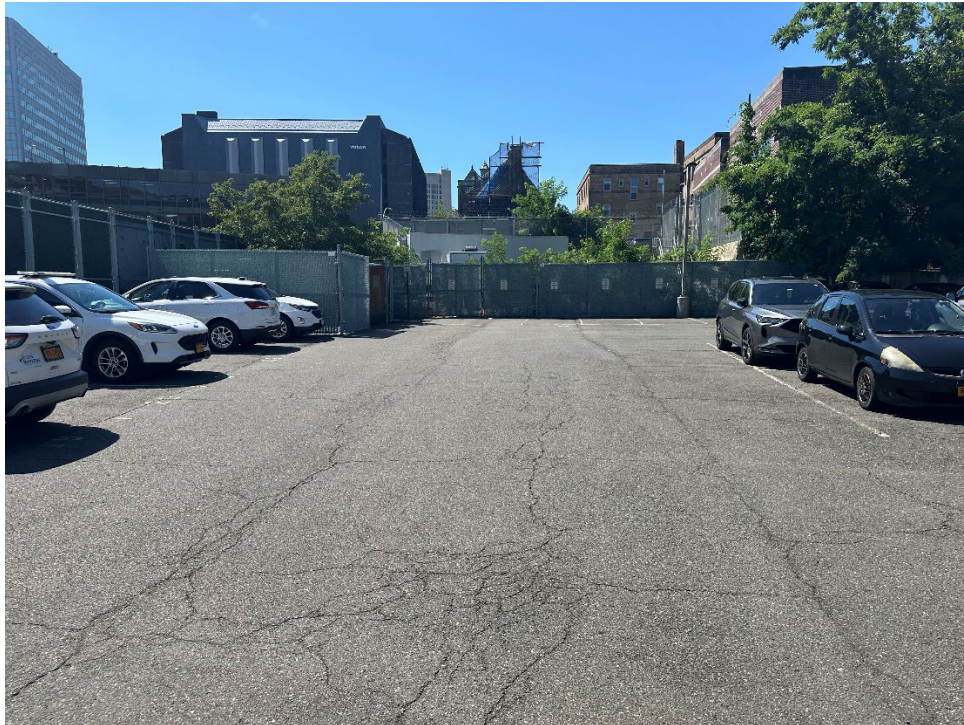
The results of the inspection also indicated the continued presence of cracks in the asphalt cover of the Water Street parking lot composite cover system which appear to be due to the winter conditions of the past seasons. In addition, concrete flaking was again observed in the sidewalk along Water Street in the northeast corner of the Site. These conditions are not currently resulting in exposure pathways through the cover systems. However, it is recommended that these features be closely monitored during future Site inspections in the event that conditions worsen.

OU-2: Observed cracks in the asphalt cover of the parking lot composite cover system in which appear to be due to the harsh winter conditions of past seasons. Cracks do not appear to have gotten worse since last year's inspection.

Photo 10: Water Street parking lot (facing South)

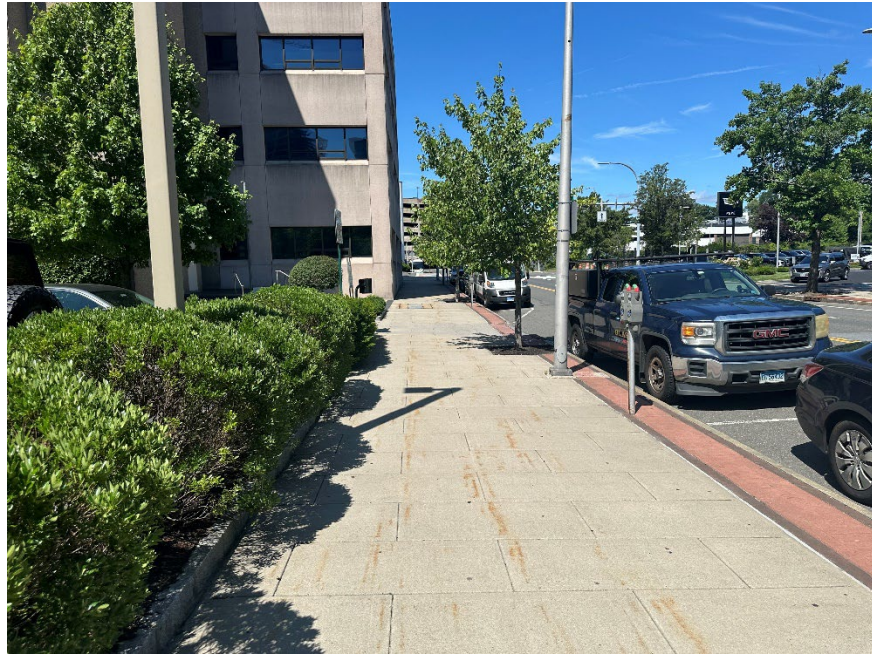
OU-2: Observed concrete flaking in the sidewalk located along Water Street in the northeast corner of the Site.

Photo 11: Sidewalk Immediately North of Water Street Parking Lot (facing West)

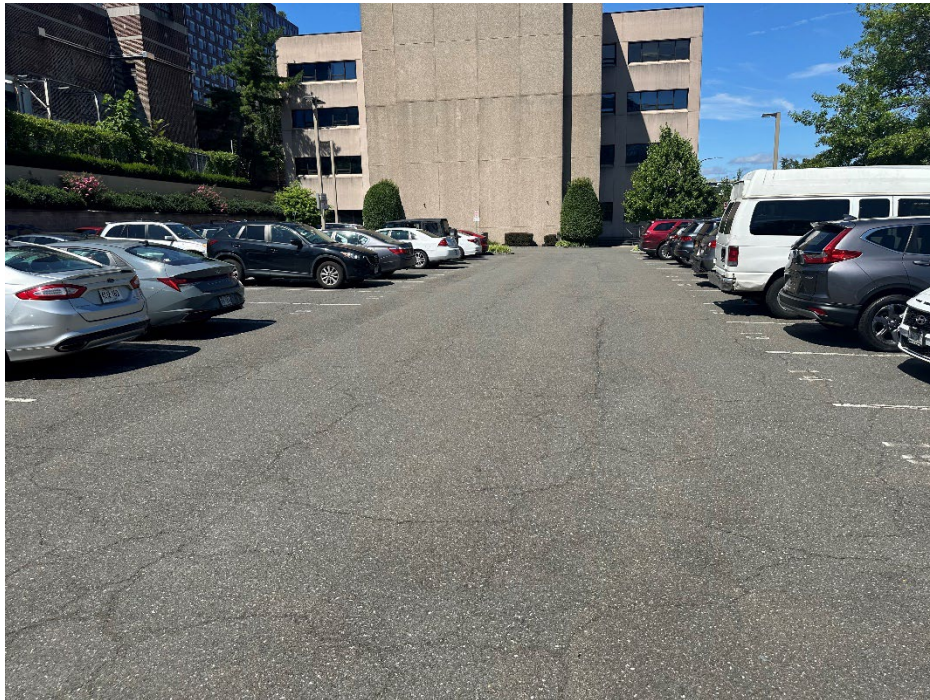
Photo 12: Water Street Parking Lot (facing West)

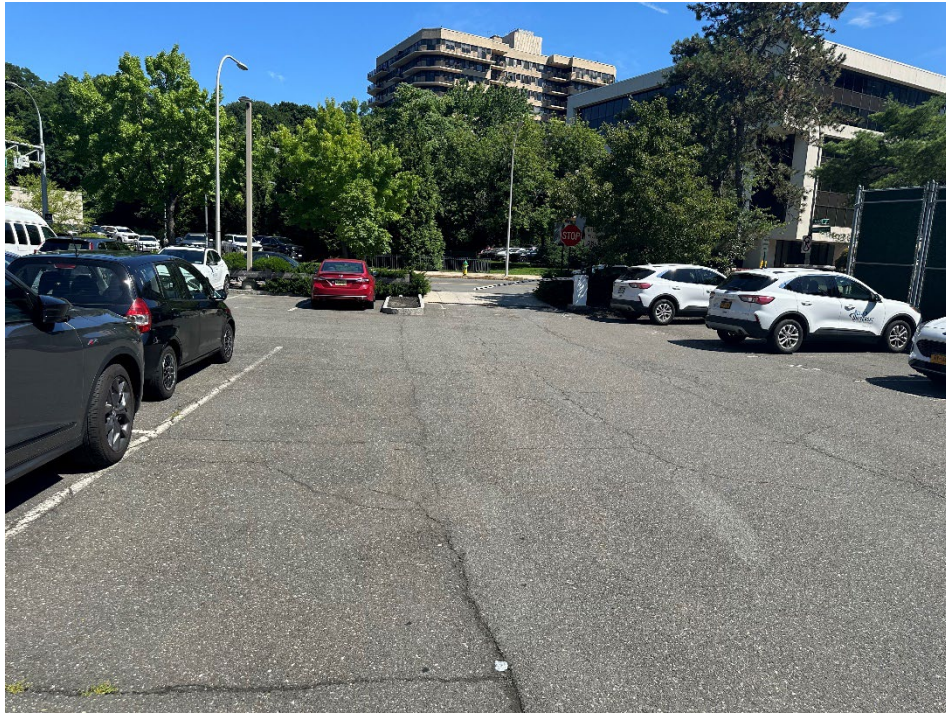
Photo 13: Water Street Parking Lot (facing North)

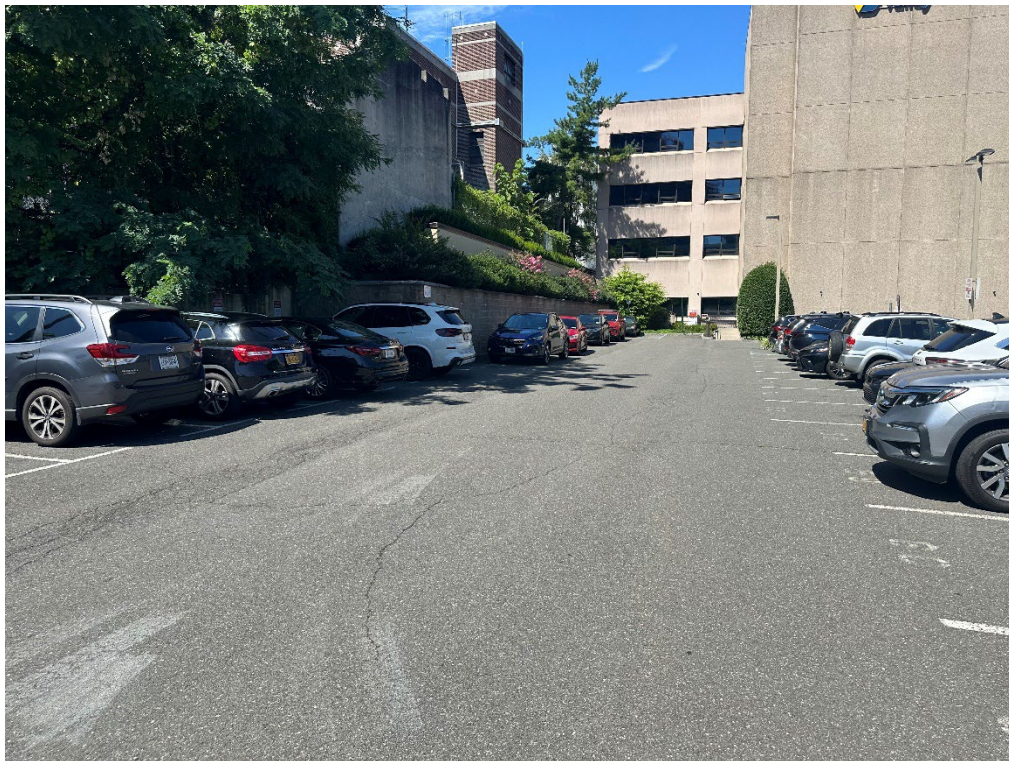
Photo 14: Water Street Parking Lot (facing Southwest)

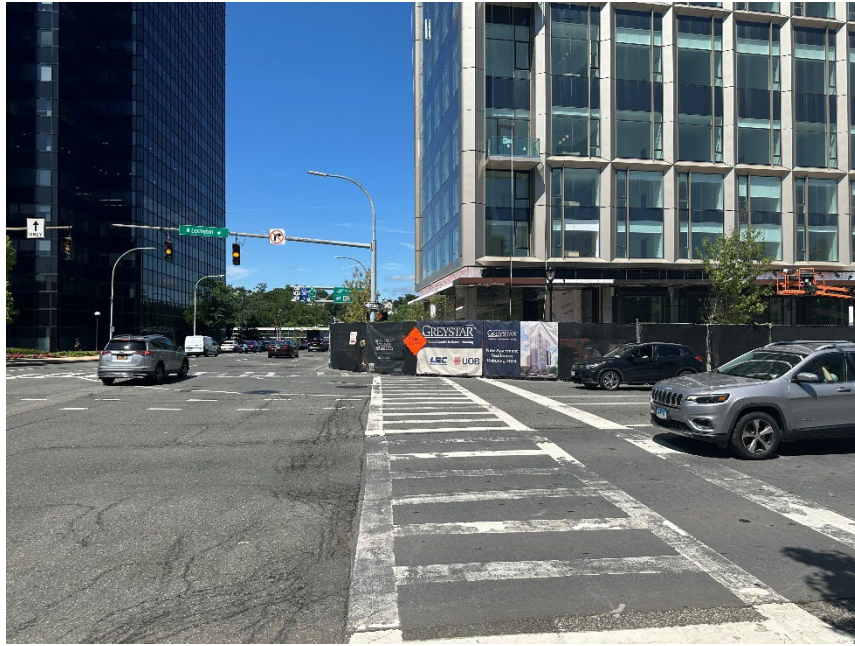
Photo 22: Building construction in progress across North Lexington Avenue from St. Johns western parking lot; MW-18 is behind construction fencing (facing Northwest)
