BRENNAN ENVIRONMENTAL, INC.
ENVIRONMENTAL CONSULTING SERVICES

Periodic Review Report

Congers Colonial Plaza
285 Route 303
Congers, Town of Clarkstown, Rockland County, New York
Section 35.19 Block 2 Lot 11
April 2016
DEC Case # V00456
BEI Job # 060141

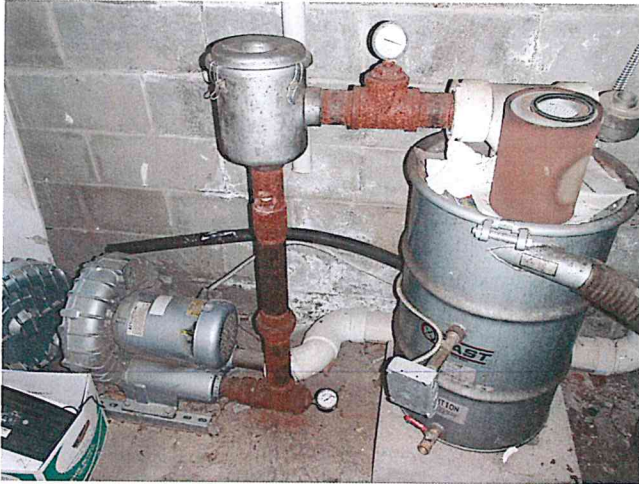
Photo 1: View of the VES-1.

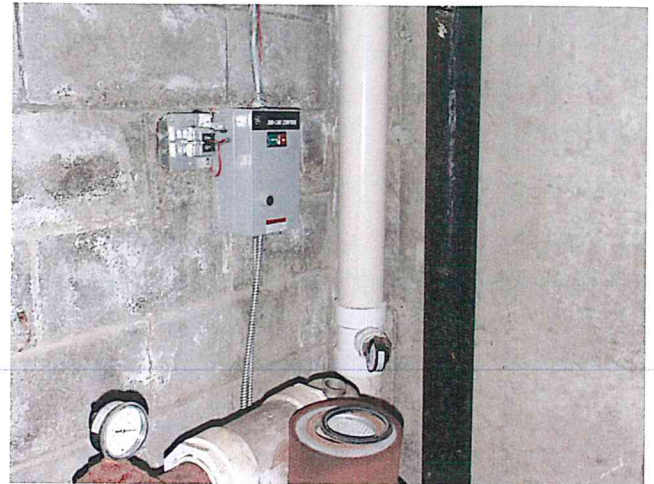
Photo 2: View of the PVC pipe that vents exhaust from VES-1 to the roof.

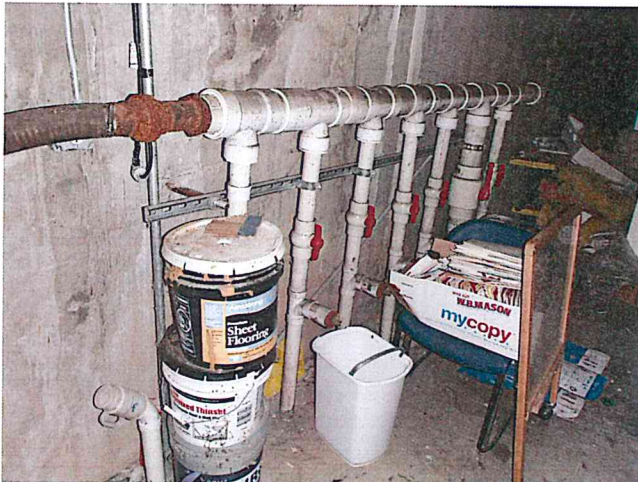
Photo 3: View of the suction points for VES-1.

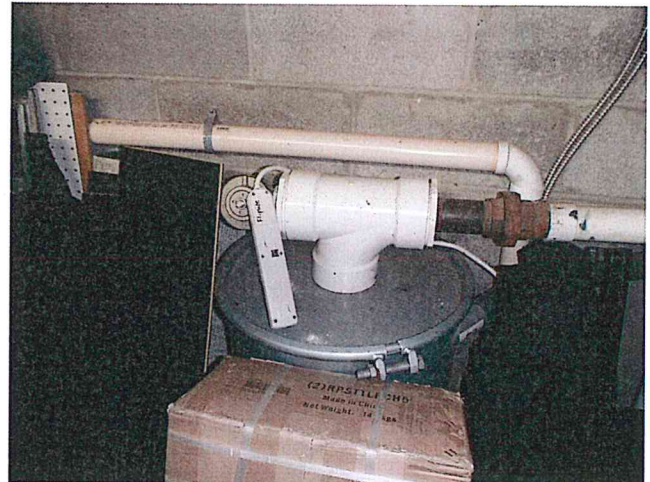
Photo 4: View of the VES-2.

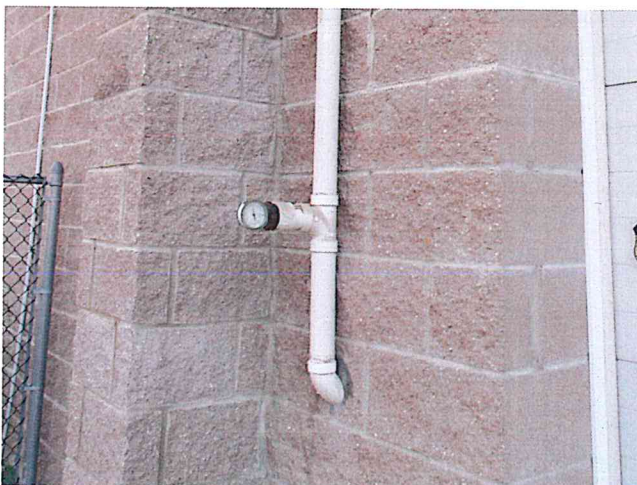
Photo 5: View of the PVC pipe that vents exhaust from VES-2 to the roof.

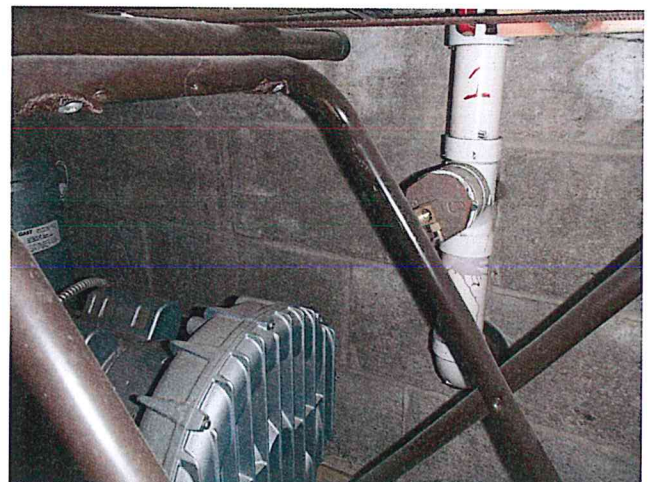
Photo 6: View of the suction point for VES-2.
