October 18, 2005

The following provides a summary of methods and findings associated with the field reconnaissance performed by National Grid on August 24, 2005 at our Malone (Amsden St.) former manufactured gas plant (MGP) site (Site). Specifically, in accordance with an addendum to the draft Remedial Investigation Work Plan (RIWP), dated July 21, 2005, a reconnaissance survey was performed along the section of the Salmon River that extends from the southern property boundary of the Site, approximately 2 miles down stream north to the Macomb Hydroelectric facility on Lamica Lake. The reconnaissance work was conducted jointly by National Grid, TRC, and NYSDEC personnel. This letter summarizes the nature of the field inspection and the findings of that effort.

**TABLE 1: SUMMARY OF OBSERVATIONS
Salmon River, Malone, NY**

FORMER MGP SITE
MALONE, NEW YORK

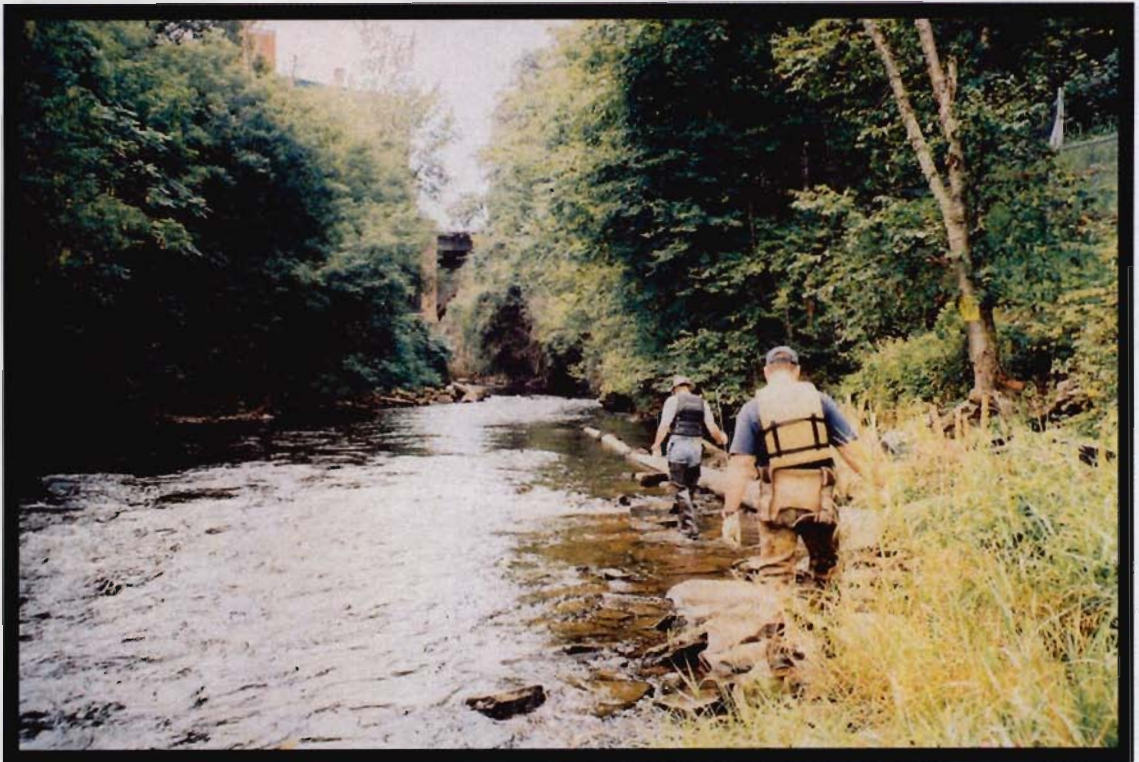
Location	Map Location	Distance from Site	Photos	Observations
Site (southern end)	Location 2 to Location 3	NA	Photo 1 Photo 2	Noted exposed bedrock along western portion of riverbank. Orange-colored iron staining noted along some exposed areas of rock. No odor noted. Only small amount of coarse sand noted around boulders and cobbles comprising the shallow river bottom (west bank). No significant deposition along embankment. Relatively high energy river flow in vicinity; maximum depth estimated at 4-feet. Weathered tar-like material noted on exposed bedrock below former area of coal bunkers. Brown silt and sand with black staining and tar-like odor observed between boulders on river bank further north; stained/odorless material exposed below upper clean sediment layer.
Site (between lower fence and storm sewer outfall)	Location 2 to Location 4	NA	Photo 3	Limited black-stained soil/sediments along the eastern edge of the floodplain; slight tar-like odor noted.

PHOTO 1
Western river bank adjacent to site (looking south).

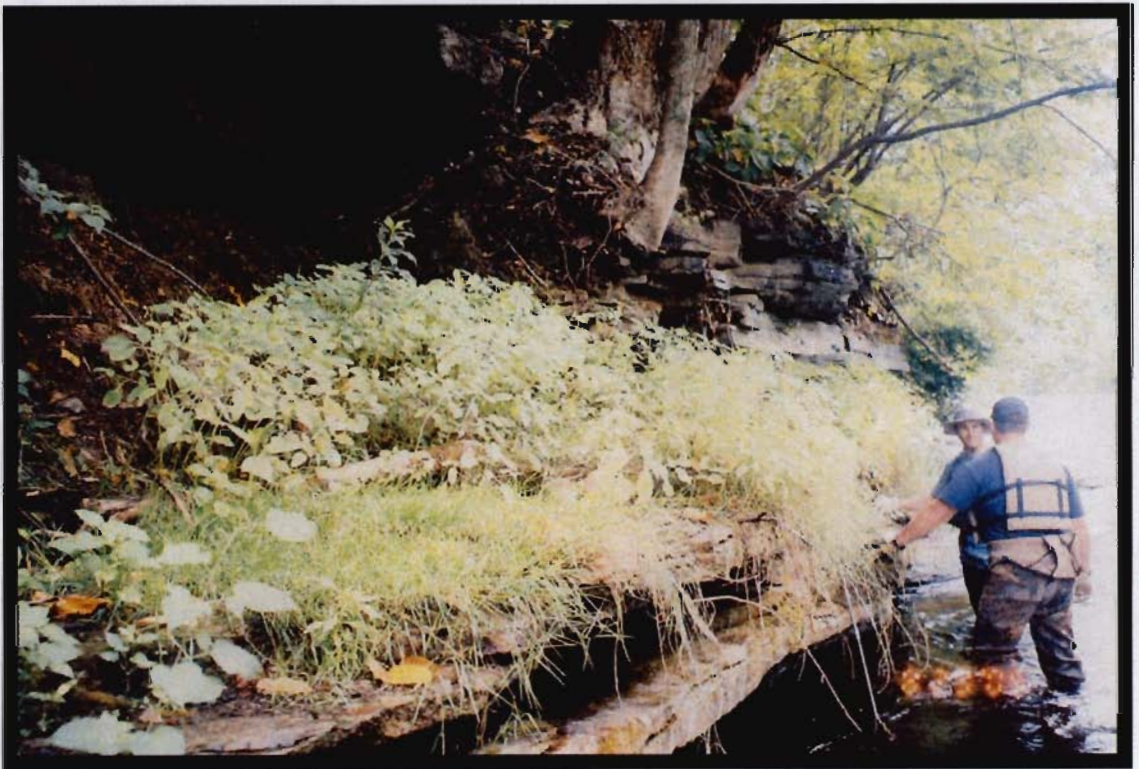
PHOTO 2
Bedrock outcrop adjacent to site.

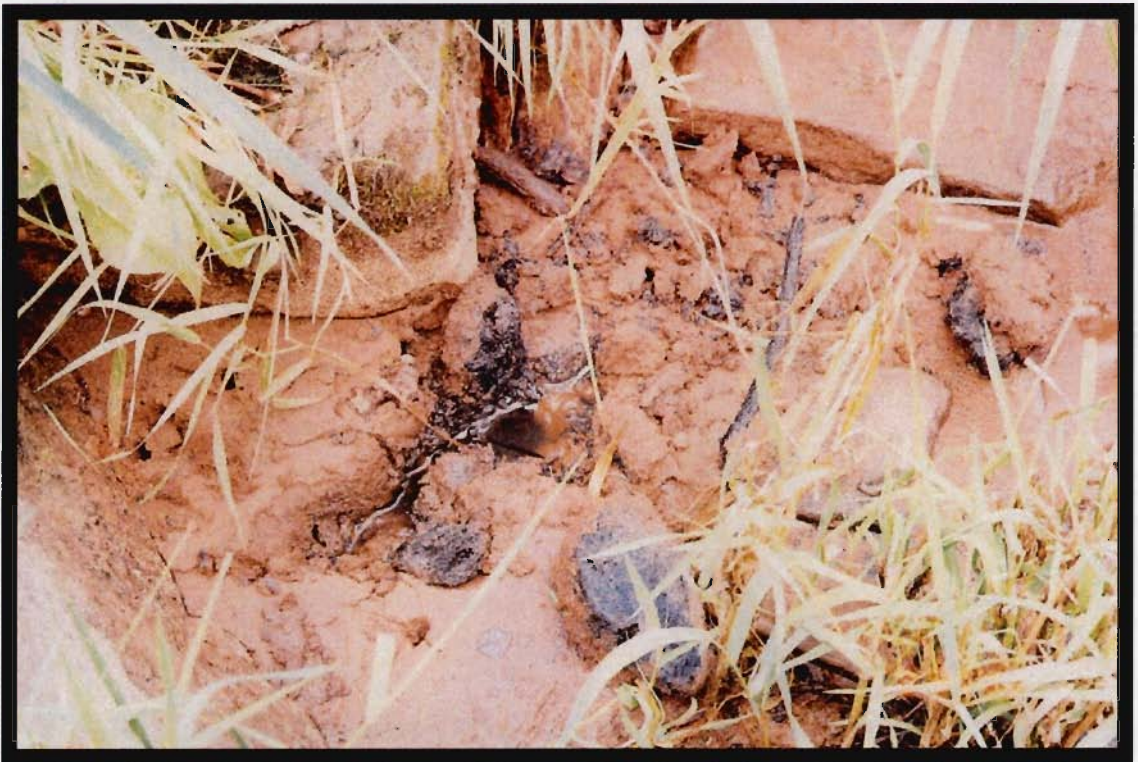
Inspection of the sediments/soils observed in proximity to the Site indicated some evidence of MGP-type impacts (staining and slight to moderate naphthalene-type odors) in the vicinity of the lower site access gate (see Location 2 to 4, and Photo 3). In addition, similar impacted material was noted in the vicinity of a surface swale which runs parallel to the river (see Location 5 to 7, and Photos 5 and 6).

PHOTO 3
Stained soil on bank adjacent to site.

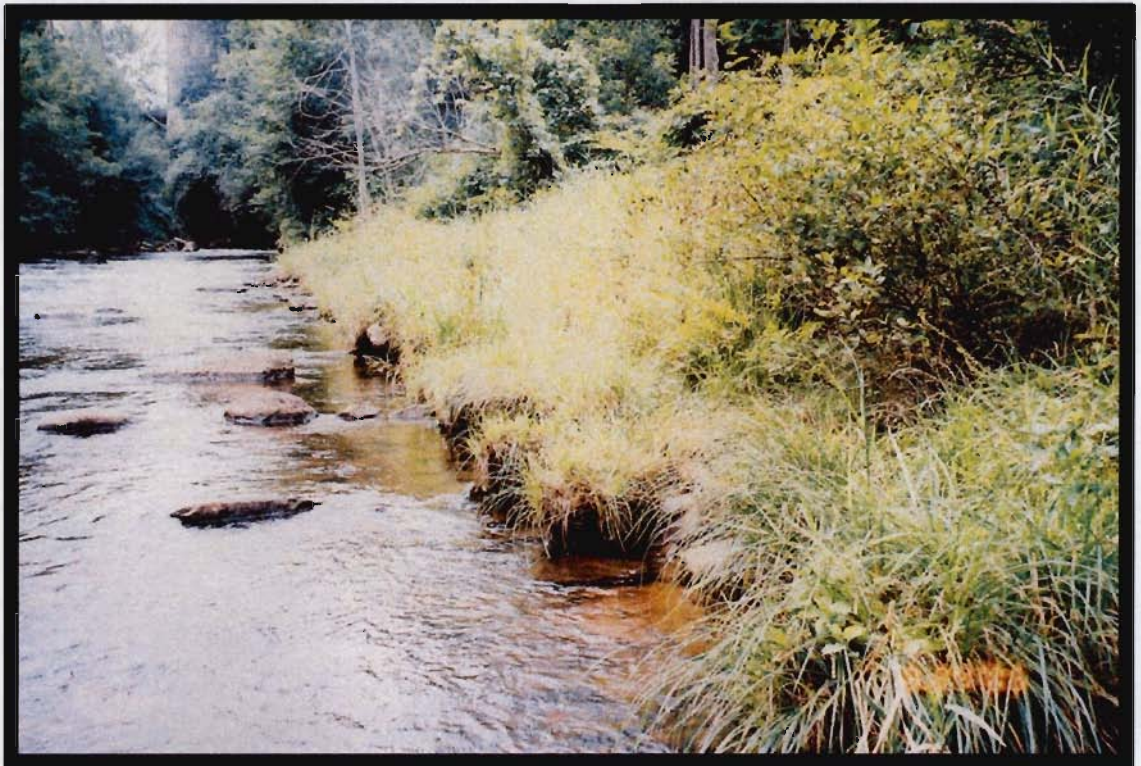
Overall, no evidence was detected to indicate a continuous significant source of site-related contamination (i.e., seeps or sheens). The prominent iron staining observed in the surface swale (see Photos 4 through 8) is believed to be attributable, at least in part, to naturally occurring iron concentrations in the ground water. Quantitative characterization of the sediments will be completed during the upcoming remedial investigation (RI).

Vicinity of sewer outfall	Location 5	NA	Photo 4	Black-stained sediments with slight-to-moderate MGP odor detected in deeper sediments (2 to 3 feet of sediment) adjacent to the on-site storm sewer pipe outfall. Maximum river depth approximately 3 feet. Medium to coarse sand noted around downstream side of exposed cobbles/boulders.
Swale north of storm sewer	Location 5 to Location 6	NA	Photo 5	Inundated area along surface swale; wet, soft sediments with heavy sheens, odor and staining. Moderate odor noted in vicinity of swale. Heavy iron staining also noted on exposed surface of soils.

PHOTO 4
Western river bank near storm sewer outfall.

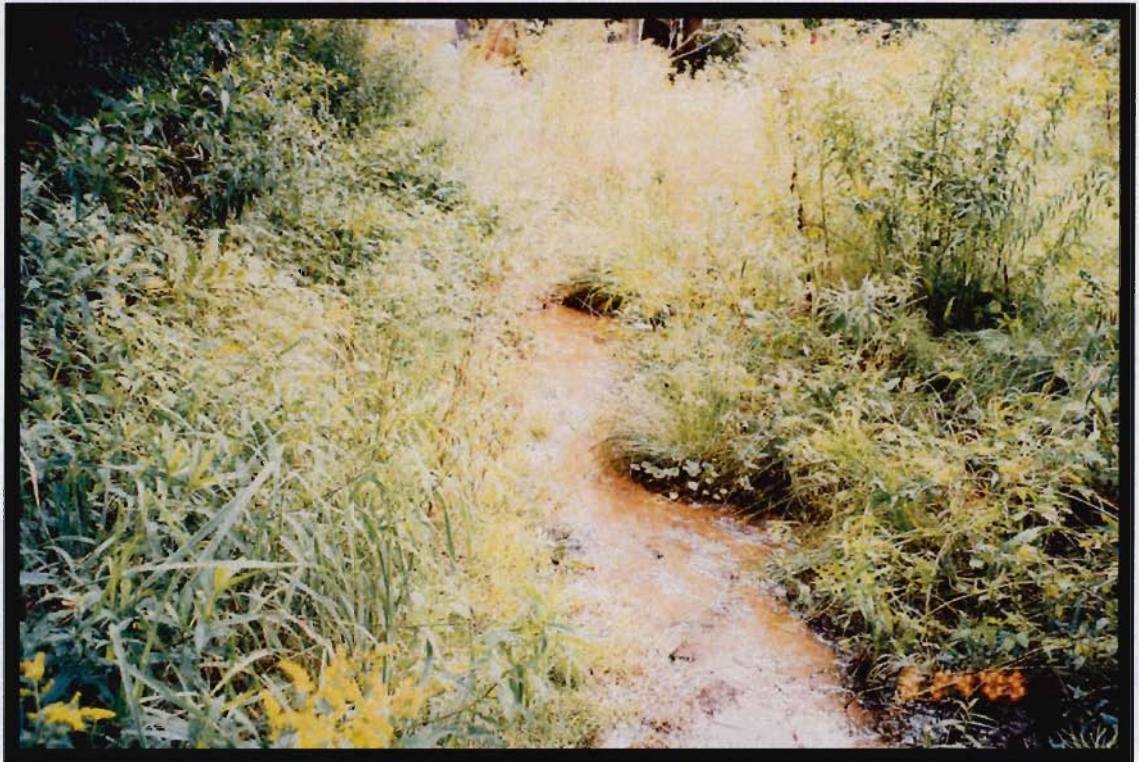
PHOTO 5
Surface swale located near storm sewer pipe (looking north).

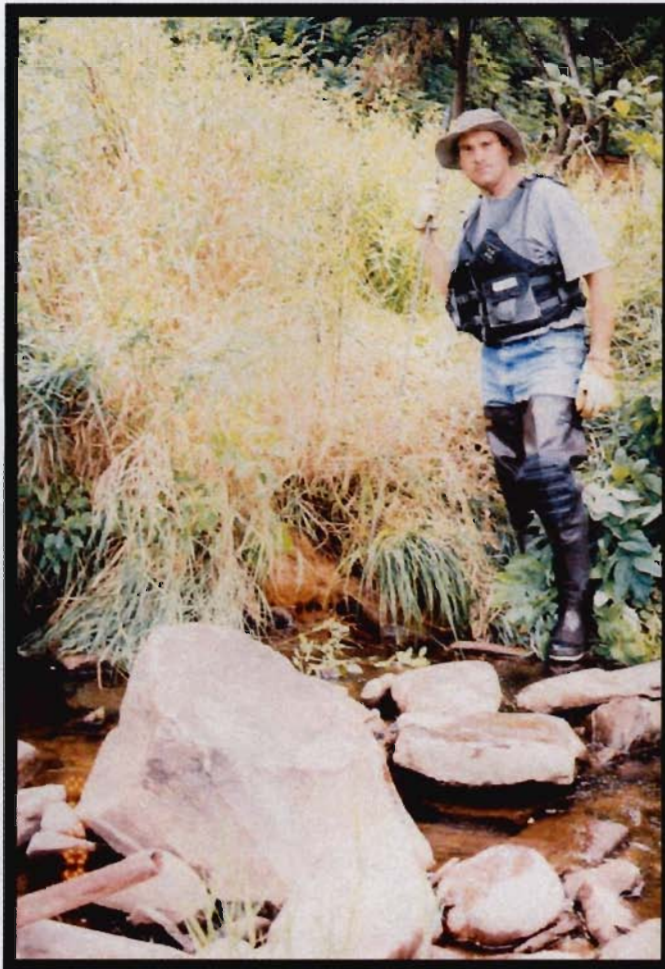
Location	Map Location	Distance from Site	Photos	Observations
Confluence of surface swale and river	Location 6 to Location 7	NA	Photo 6	River in vicinity of swale drainage outfall to river is shallow (1 to 2 feet). River bottom and bank is predominantly covered with cobbles, with occasional boulders; little to no indications of accumulated sediments. No notable impacts observed along riverbank in vicinity of confluence of storm sewer outfall and river.
Swale drainage to Coffee Street cul-de-sac	Location 7 to Location 8	300 feet	Photo 7	First indications of notable sediment deposition since swale drainage outfall. Soft, fine to coarse sand; no odors or sheens noted.
Coffee Street to Factory Street cul-de-sac	Location 8 to Location 9	300 feet to 0.25 mile	Photo 8	Quiescent section of river immediately downstream of cul-de-sac, with up to 1.5 feet of soft sediments along river bank. No sheens or odors observed. Remainder of segment yielded limited evidence of accumulated sediments. No indications of contamination noted.

PHOTO 6
Location of surface swale discharge to river.

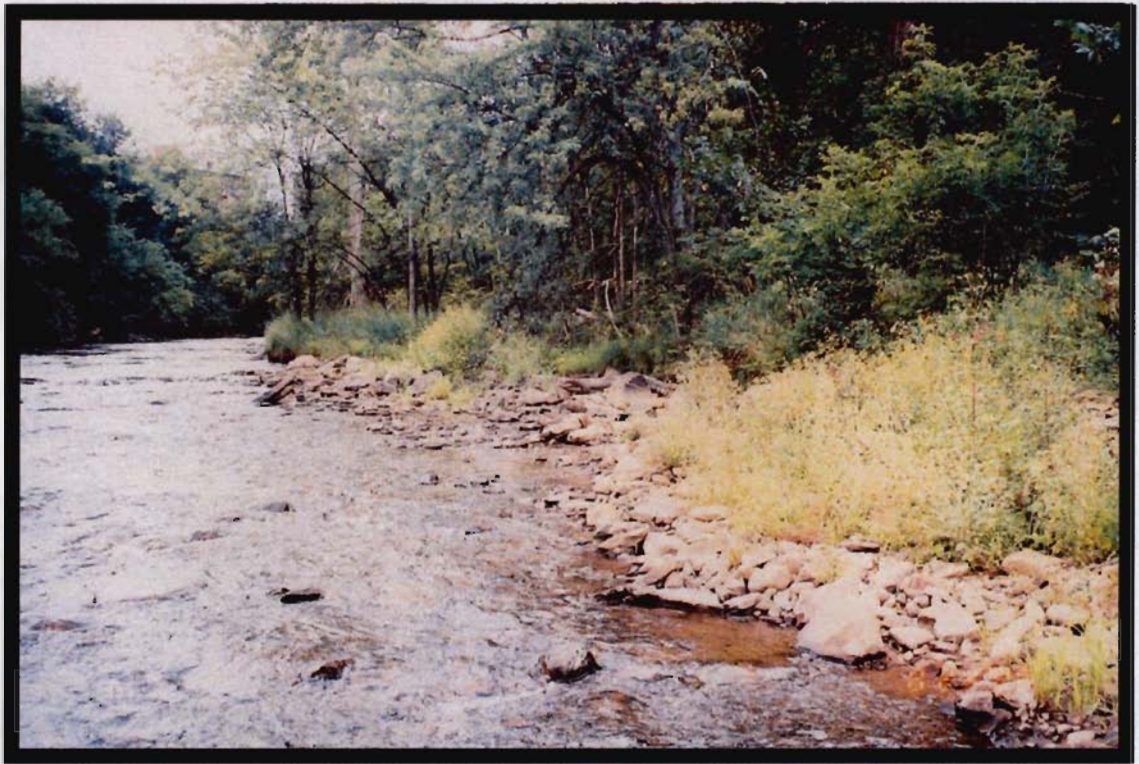
PHOTO 7
Western river bank near Coffee Street cul-de-sac.

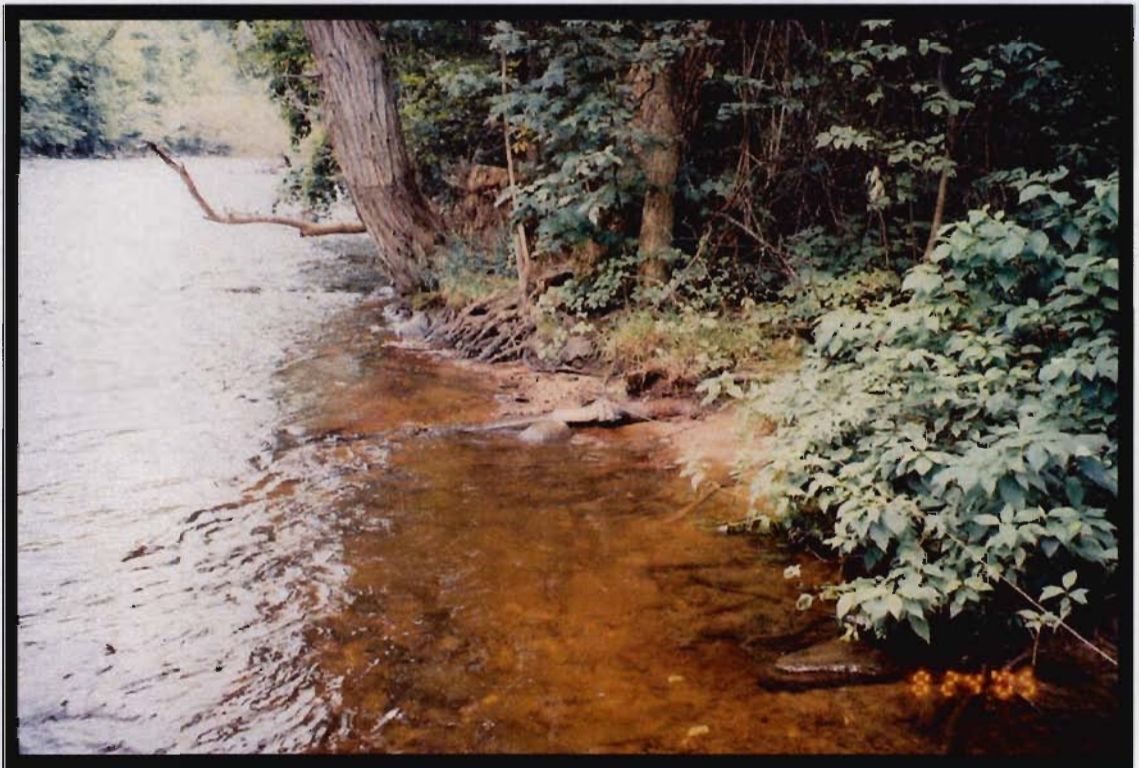
PHOTO 8
Western river bank near Factory Street cul-de-sac.

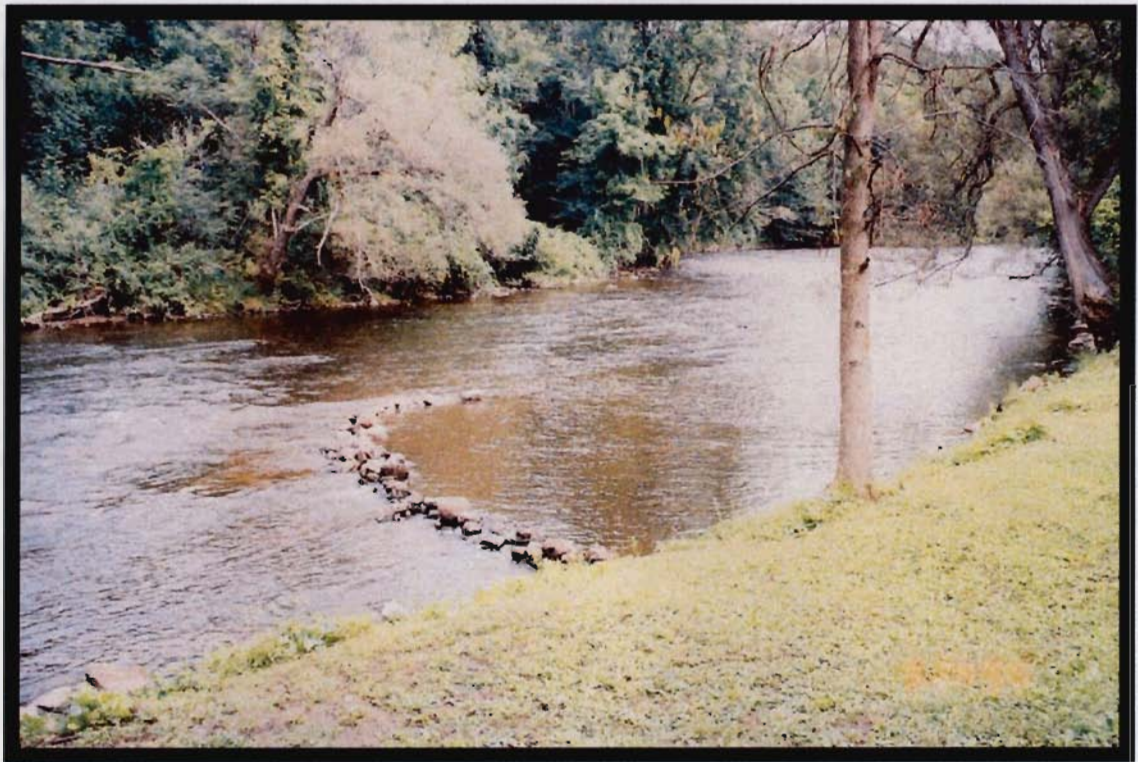
Factory Street to river bend/ Amsden St.	Location 9 to Location 10	0.4 miles	Photo 9	River segment is 2 to 4 feet deep. Some sand deposition observed along west river bank. No physical indications of contamination noted. River becomes wider and shallower (approximately 1-foot deep), with limited accumulation of sand and gravel noted between boulders and small quantities of sand sediment along west river bank. No indications of contamination noted.

PHOTO 9
Cleared section of river bank off Amsden Street (looking southeast).

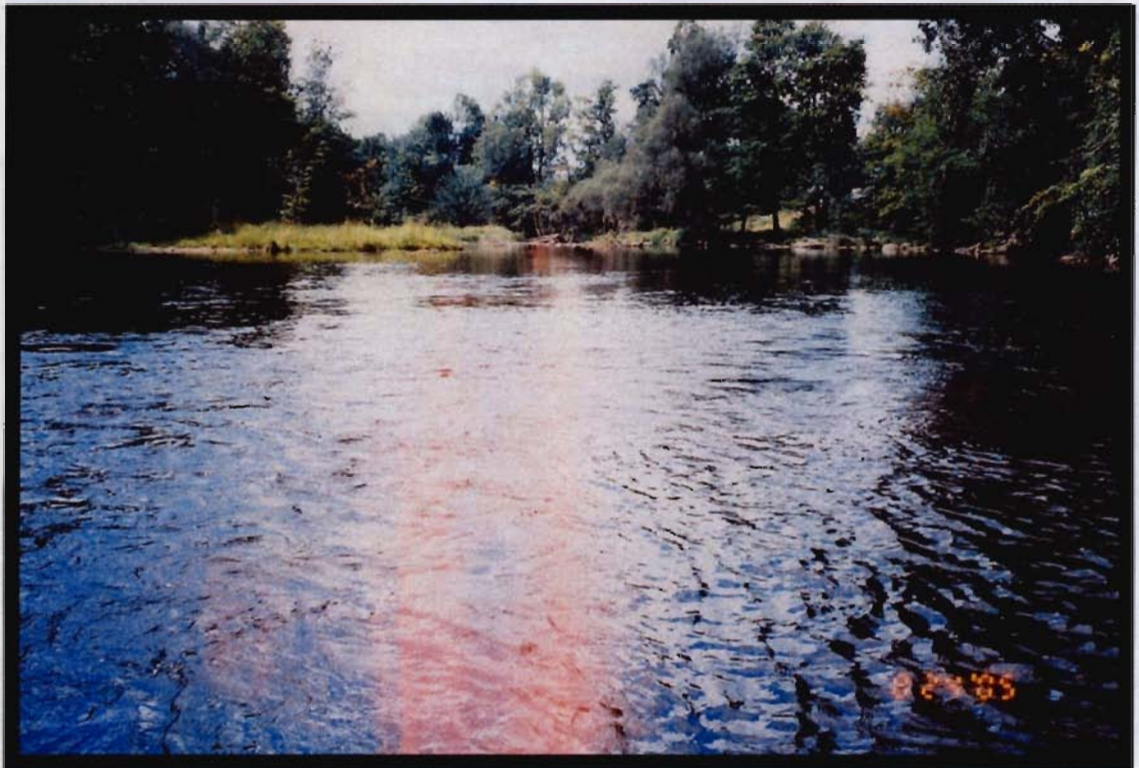
Location	Map Location	Distance from Site	Photos	Observations
Amsden St./river bend to Lamica Lake	Location 10 to Location 11	1.4 miles	Photo 10	Inaccessible for detailed inspection. River appears to be consistent with previous inspected section; generally shallow with relatively high velocity and little potential for sediment deposition. At location 011, river widens and slows after passing through a section of exposed bedrock. Areas of deposited fine to coarse sand sediments were noted resting on the bedrock river bottom, with additional sand deposition noted along the river bank. Water depth ranges from approximately two to five feet (estimated) at initial pool area. No indications of contamination noted.
Lamica Lake section	Location 11 to Location 12	2 miles	Photo 11 Photo 12	Quiescent section of river, from location 011 to the hydroelectric dam. Depth of lake is unknown but the impoundment adjacent to the dam is approximately 7 to 8 feet deep due to siltation, according to BRASCAN.

PHOTO 10
Head of Lamica Lake (looking north).

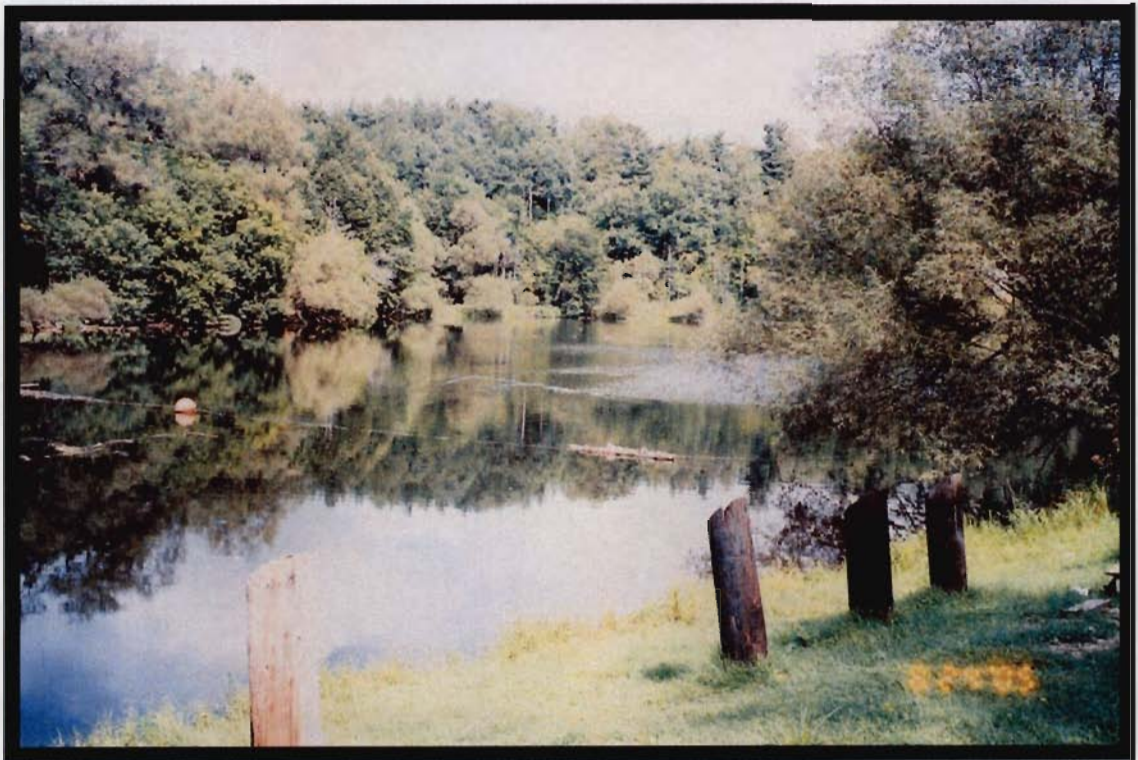
PHOTO 11
Lamica Lake, near hydroelectric facility (looking east).

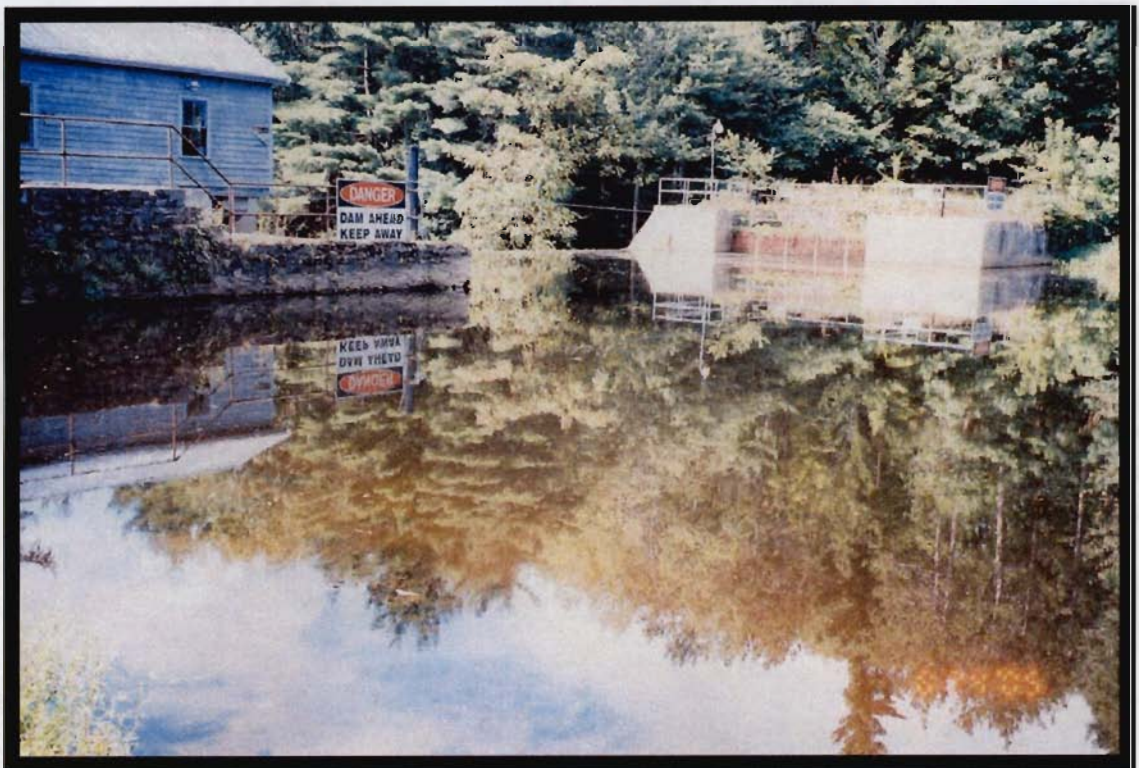
PHOTO 12
Brascan Hydroelectric Facility dam.
