Subject: Technical Memorandum - Adjacent Property Test Pit Investigation
Interim Remedial Measure (IRM)
Fort Edward (Canal St.) Non-Owned Former MGP Site
Fort Edward, Washington County, Site #V00472

Memorandum

**RE: Canal Street Fort Edward MGP Site IRM
Adjacent Property Test Pit Investigation**

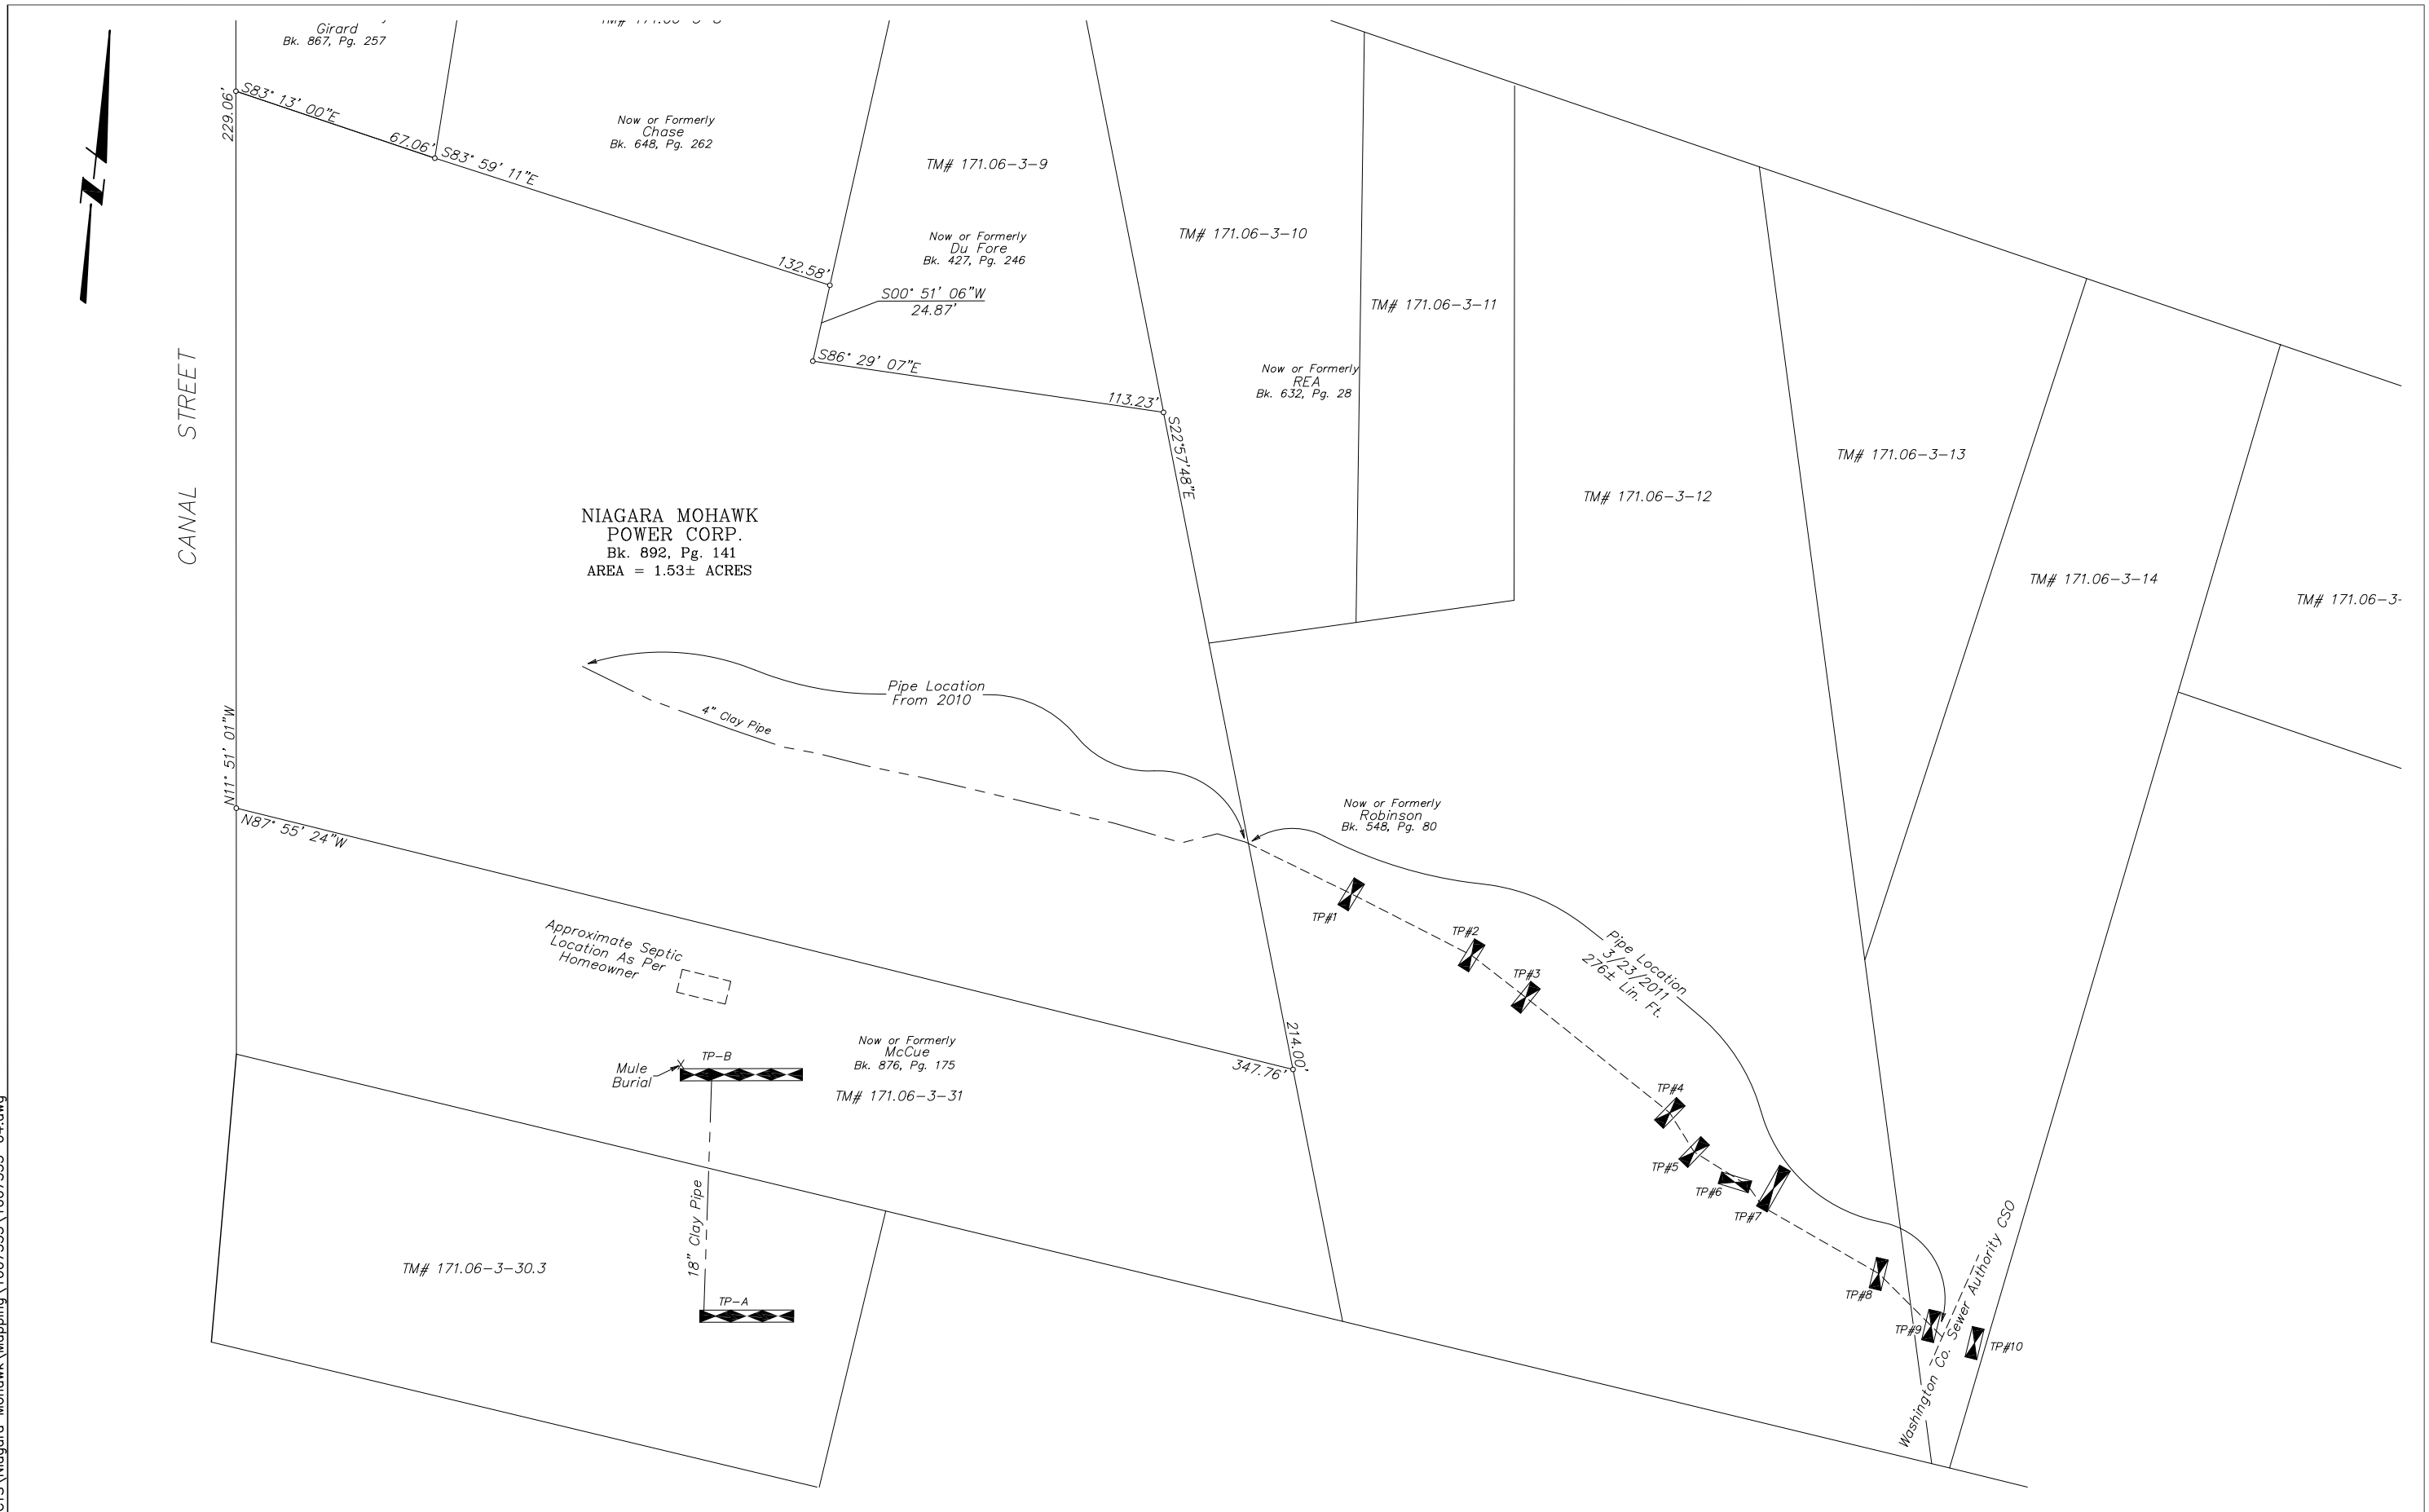
Investigation of the clay tile pipe to determine the extent of travel and approximate route on the adjacent properties to the east was conducted by excavating test pits from March 21, 2011 through March 23, 2011. **Figure 1** depicts test pit locations on the adjacent properties and a Washington County Sewer Authority combined sewer overflow (CSO) drain line. **Attachment 1** contains a photographic log of test pit activities.

The known terminus of the pipe at the eastern boundary of the National Grid property served as a starting location. Ten test pits were advanced sequentially from west to east at distances varying between ten and fifty feet, depending upon vegetation, topography, and other obstructions. The test pits were excavated perpendicular to the expected path of travel of the clay tile pipe and ranged in depth from six inches below grade at the eastern end (TP#9) to approximately 4'-6" below grade in the center portion (TP#4 and TP#5). TP#6 was completed parallel to the path of travel because the pipe direction changed unexpectedly in that location, returning to a more easterly flow. A large diameter reinforced concrete pipe was identified running north to south between TP#9 and TP#10, bisecting the anticipated route of the clay tile pipe. This pipe was identified as a Washington County Sewer Authority CSO discharge. After locating the clay tile pipe in TP#9, approximately three feet west of the CSO, TP#10 was excavated on the east side. The clay tile pipe was not located on the eastern side of the CSO pipeline, although coal ash was observed in the excavation. The clay tile pipe traverses approximately 276 linear feet from the National Grid property to TP#9, adjacent to the CSO.

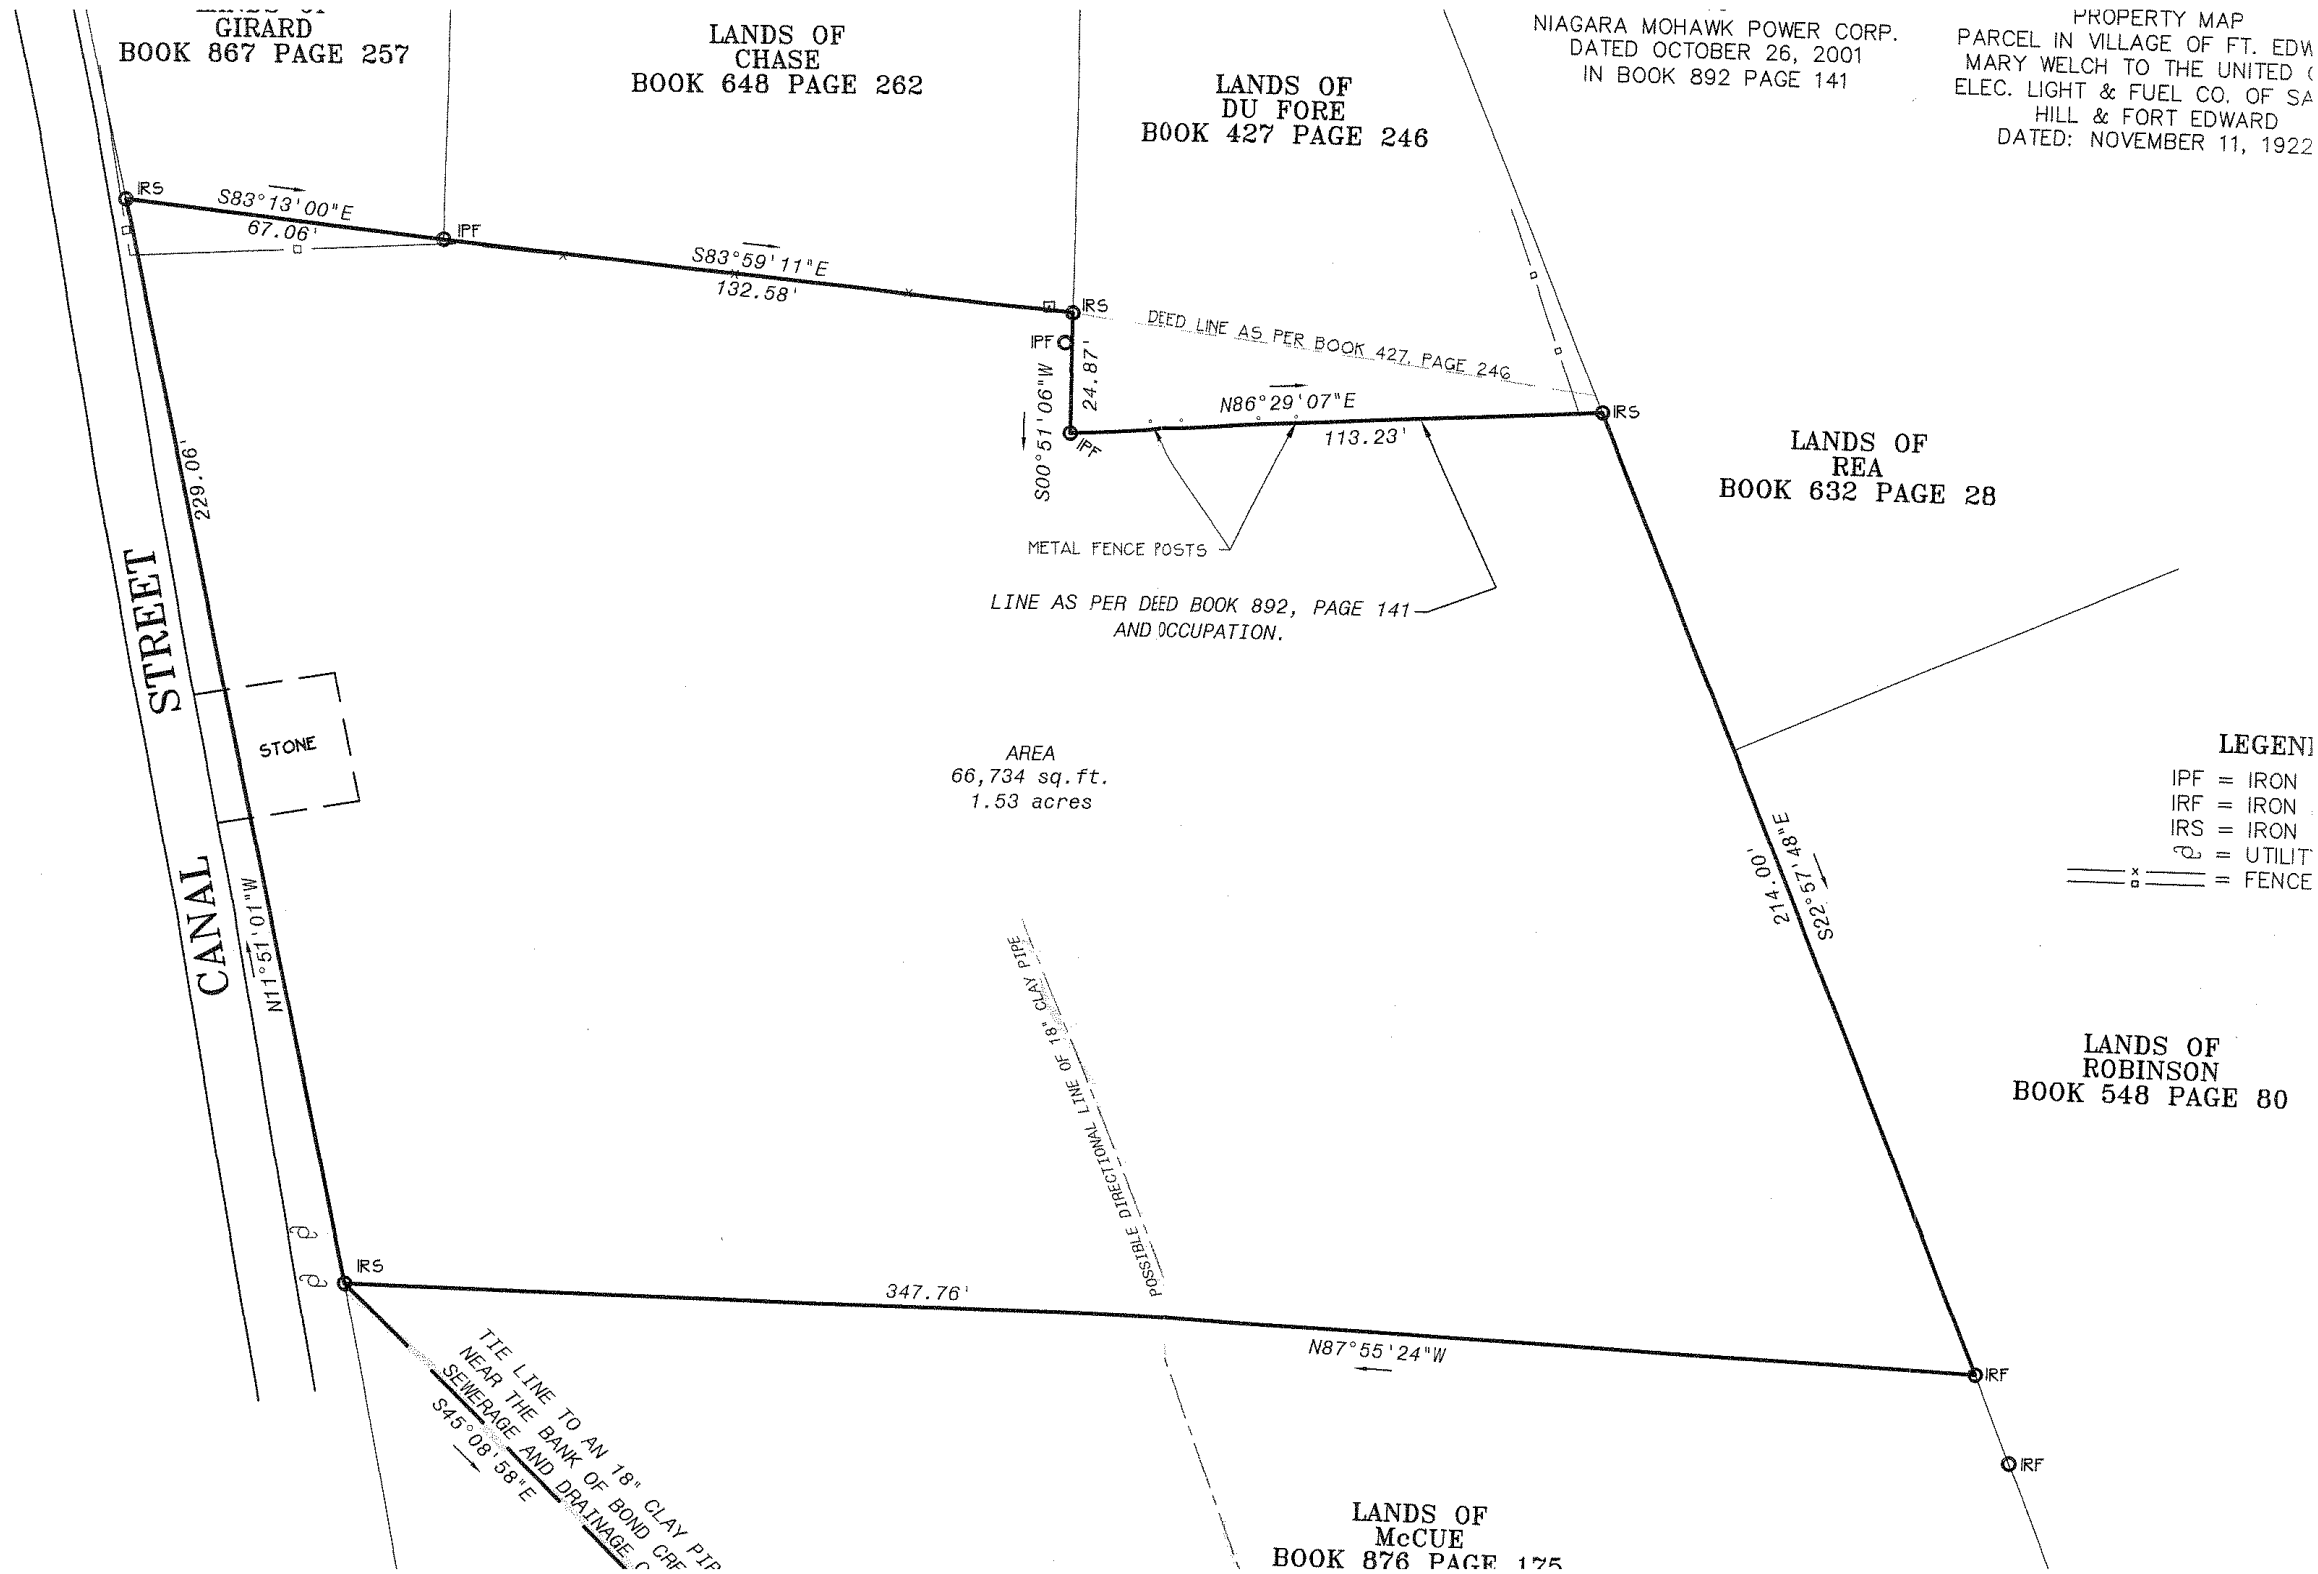
The 18" clay tile pipe appears to coincide with a suspected pipe route identified on an easement diagram for the National Grid property (**Figure 2**). Neither the easement diagram, nor the field investigation of this pipe indicates a correlation to the peat-lined trench. No coal tar, ash, or other evidence of MGP impact was noted anywhere in the excavations completed for TP-A and TP-B. **Table 2** below summarizes the observations from the two test pits. Spoils for each test pit were placed on a piece of HDPE liner at the side of the excavation. Upon completion of observation and documentation, each test pit was backfilled immediately by returning the spoils to the excavation and compacting the material with the bucket of the backhoe or mini-excavator.

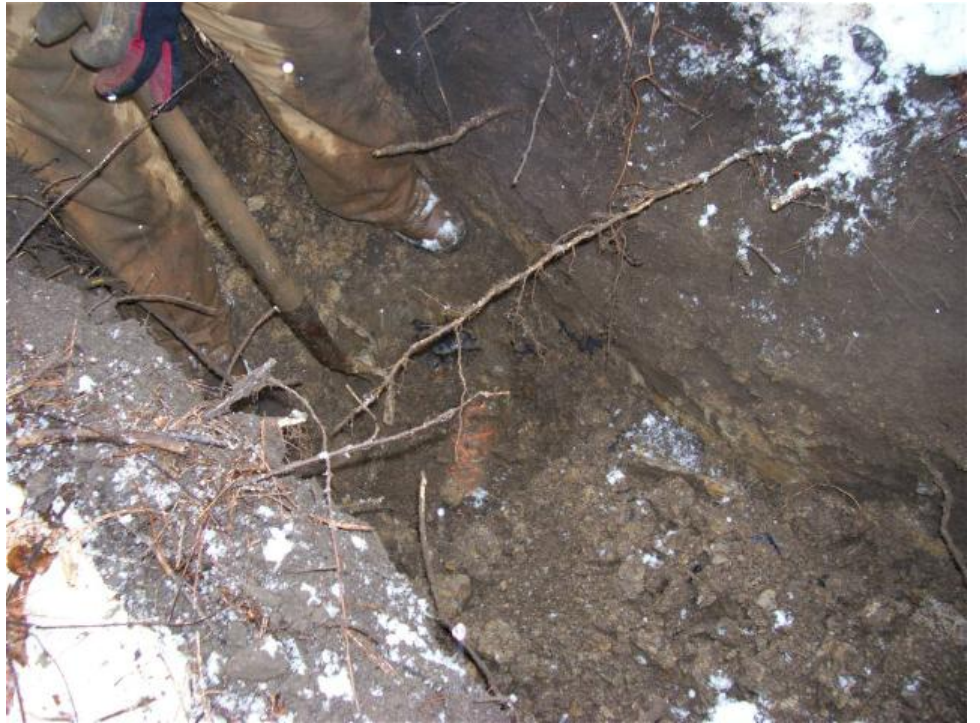
Date: Mar 24, 2011			
Location: TP#2 - Eastern Properties			
Direction: E			
Comments: Pipe with tar in vicinity (above pipe). Approximately three feet below grade.			
Photograph ID: 4

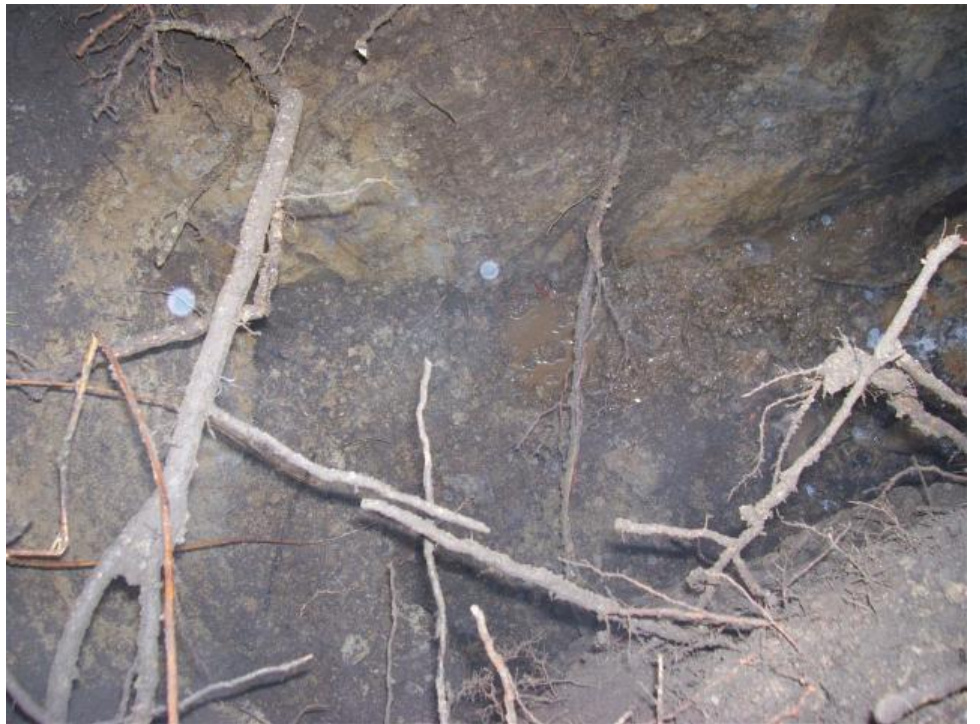
Date: Mar 24, 2011			
Location: TP#3 - Eastern Properties			
Direction: E			
Comments: Pipe found approximately four feet below grade.

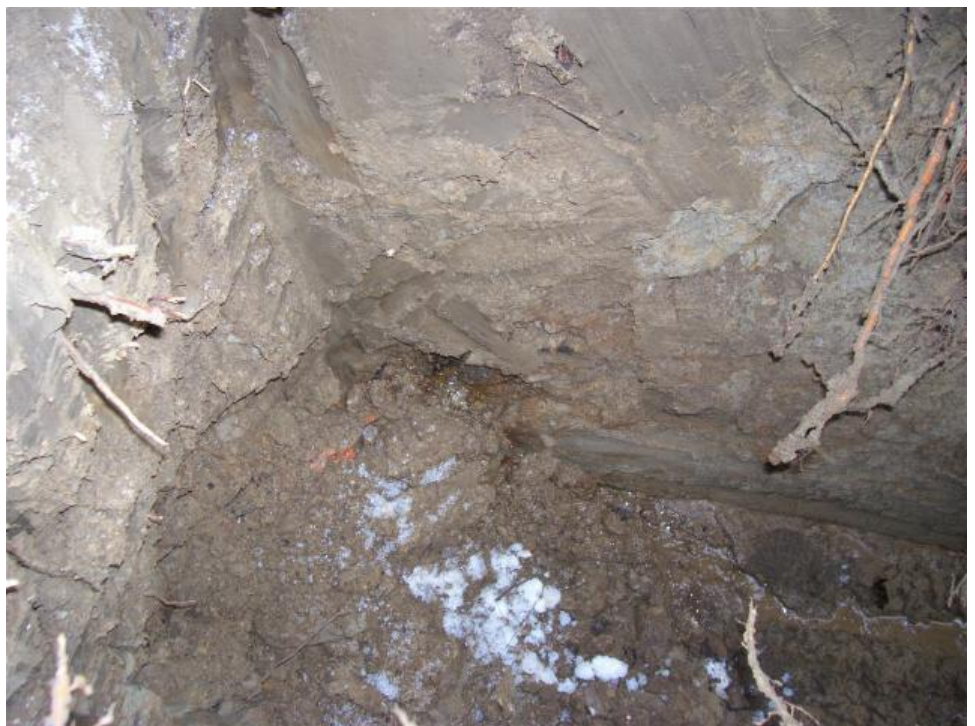
Date: Mar 24, 2011			
Location: TP#4 - Eastern Properties			
Direction: SW			
Comments: Pipe found approximately 4'-6" below grade. The pipe turned south between TP#3 and TP#4.			
Photograph ID: 6

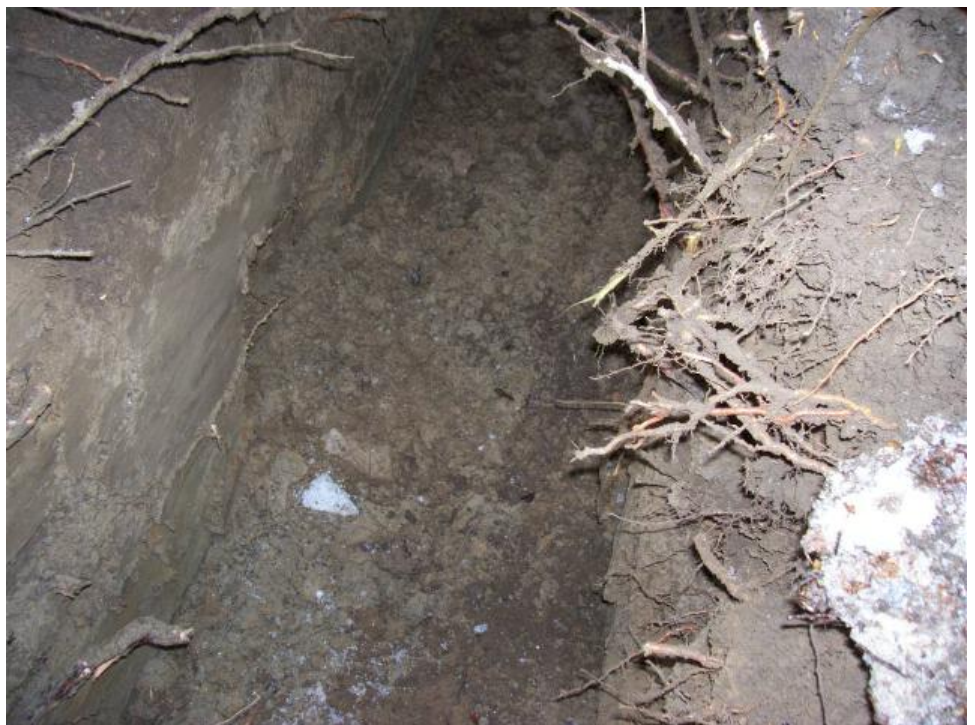
Date: Mar 24, 2011			
Location: TP#5 - Eastern Properties			
Direction: S			
Comments: Pipe found approximately 4'-6" below grade. Visible in photo just above chunk of ice.

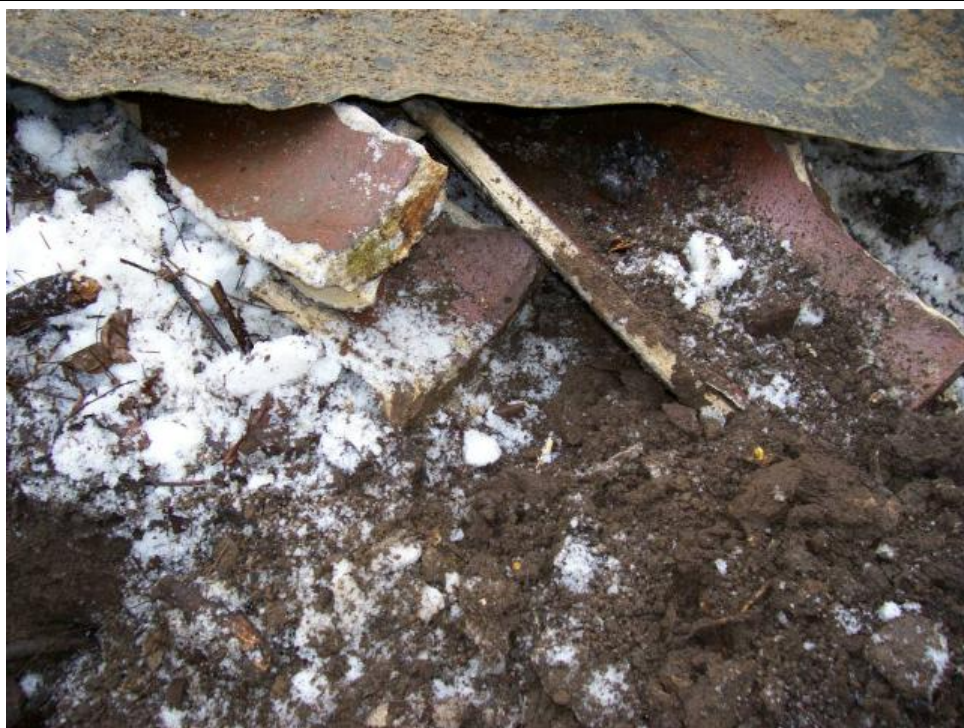
Date: Mar 24, 2011			
Location: TP#6 - Eastern Properties			
Direction: NE			
Comments: Large diameter clay pipe unearthed at surface in area of Test Pit 6. No tar or MGP residue associated with this pipe.			
Photograph ID: 8

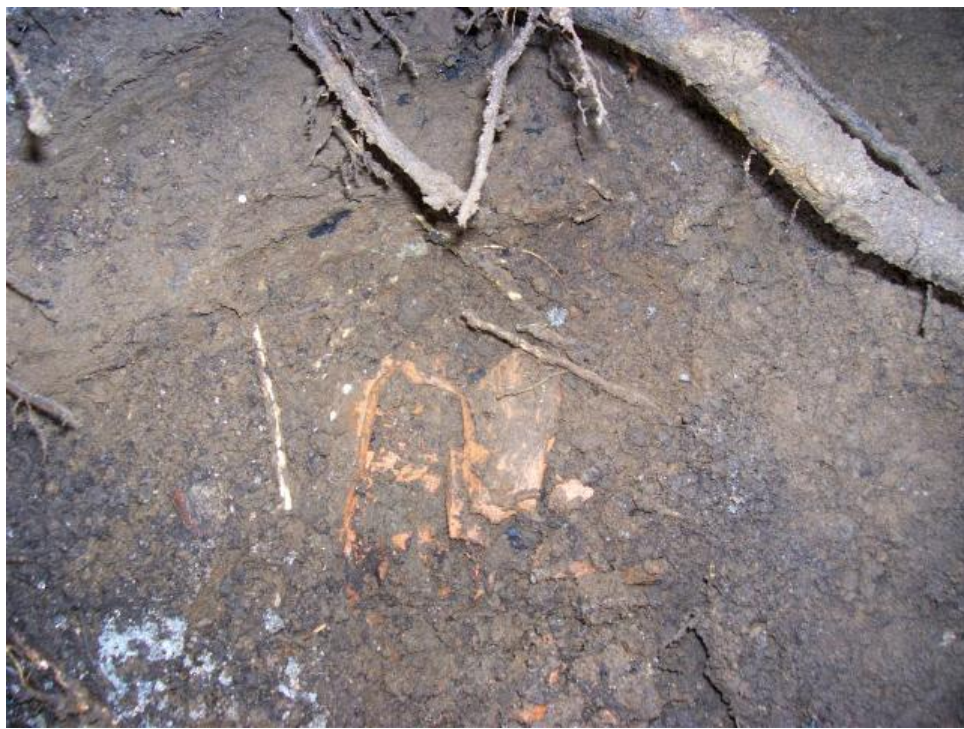
Date: Mar 24, 2011			
Location: TP#6 - Eastern Properties			
Direction: E			
Comments: Pipe with tar in vicinity. No tar inside pipe.

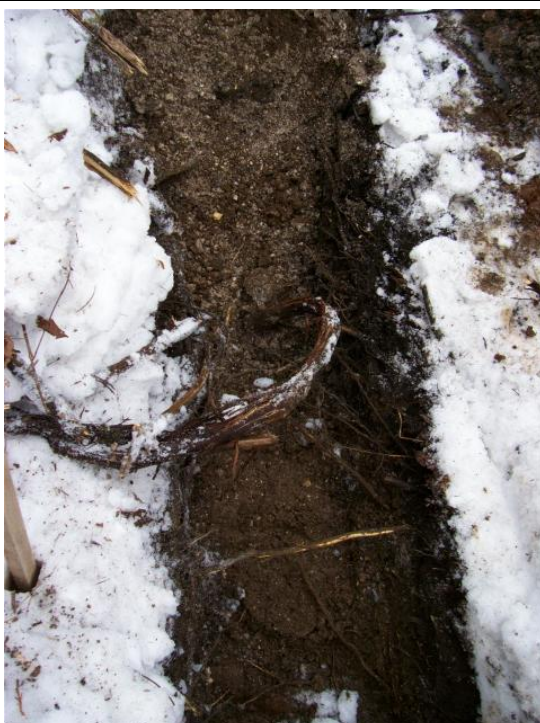
Date: Mar 24, 2011			
Location: TP#7 - Eastern Properties			
Direction: N			
Comments: Double pipes laid side-by-side. Coal ash above pipes, but little to no tar. Pipe located approximately one foot below grade.			
Photograph ID: 10

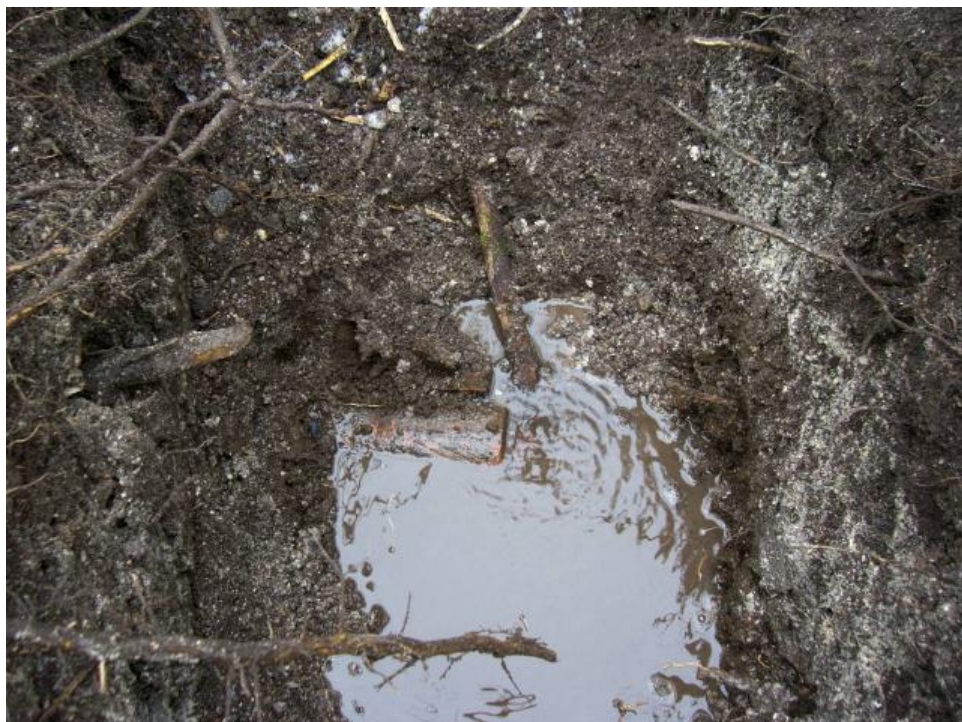
Date: Mar 24, 2011			
Location: TP#8 - Eastern Properties			
Direction: S			
Comments: Double pipes laid side-by-side. Coal ash above pipes, but little to no tar. Pipe located approximately 6" below grade.

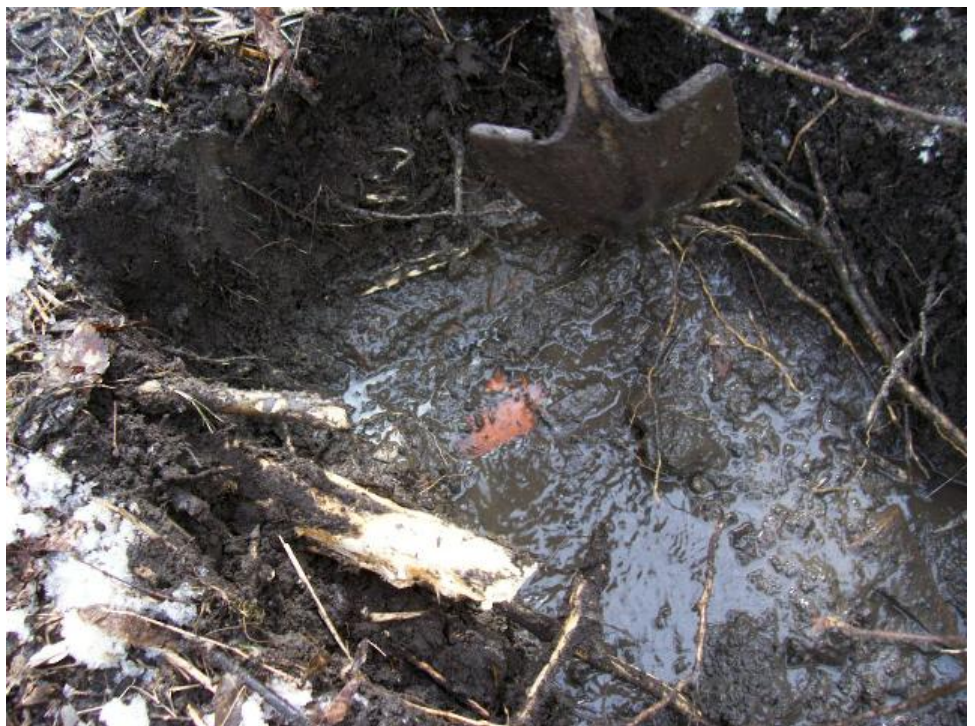
Date: Mar 24, 2011			
Location: TP#9 - Eastern Properties			
Direction: S			
Comments: Double pipes laid side-by-side. Coal ash above pipes, but little to no tar. Pipe located approximately 6" below grade.			
Photograph ID: 12

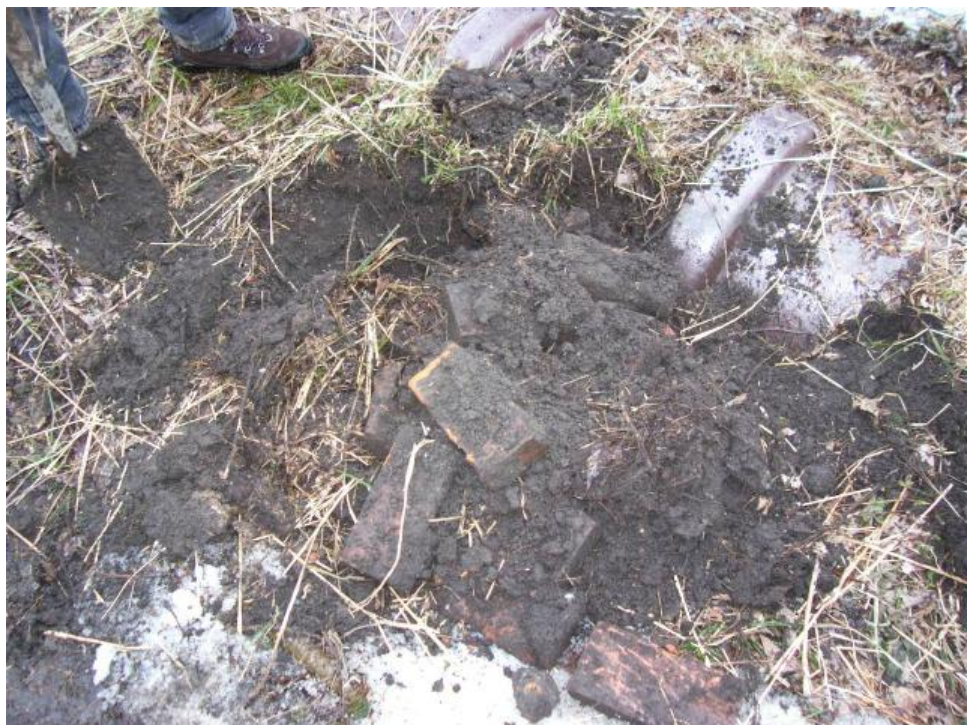
Date: Mar 24, 2011			
Location: Brick structure at CSO Pipe			
Direction: E			
Comments: Bricks alongside CSO pipe in area where clay tile pipe would have intersected.

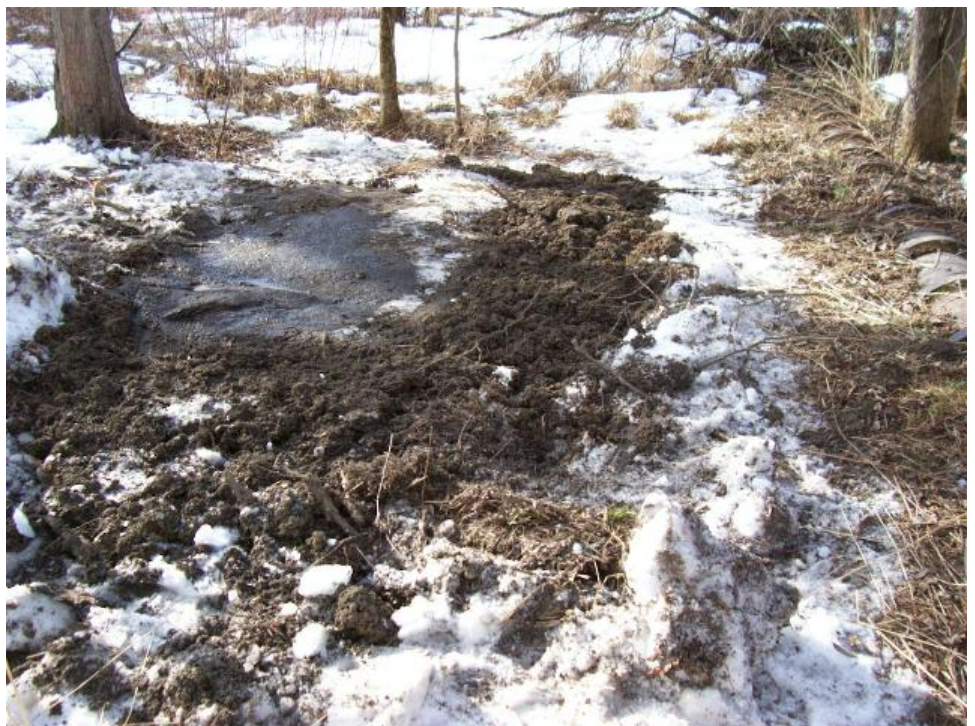
Date: Mar 24, 2011			
Location: TP#10 - east of CSO Pipe			
Direction: S			
Comments: Test pit excavation area on east side of CSO pipe. Coal ash found in this test pit, but no clay tile pipe or coal tar.			
Photograph ID: 14

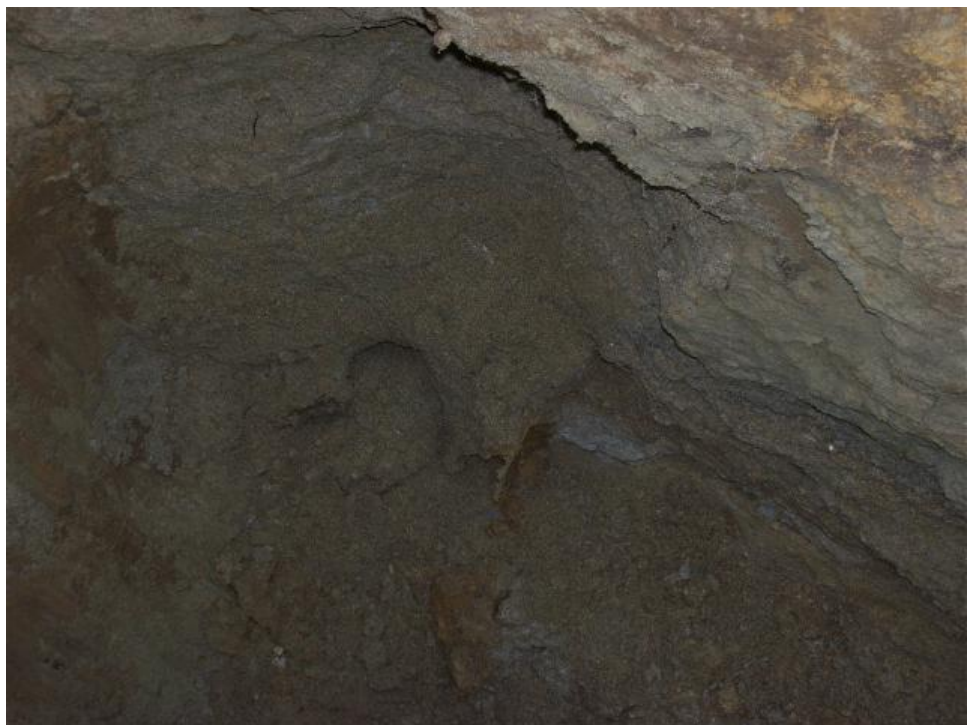
Date: Mar 24, 2011			
Location: TP-A - Southern Properties			
Direction: NW			
Comments: 18" clay tile pipe discovered approximately 7 feet below grade. No coal tar, MGP residue, or odors associated with the pipe.

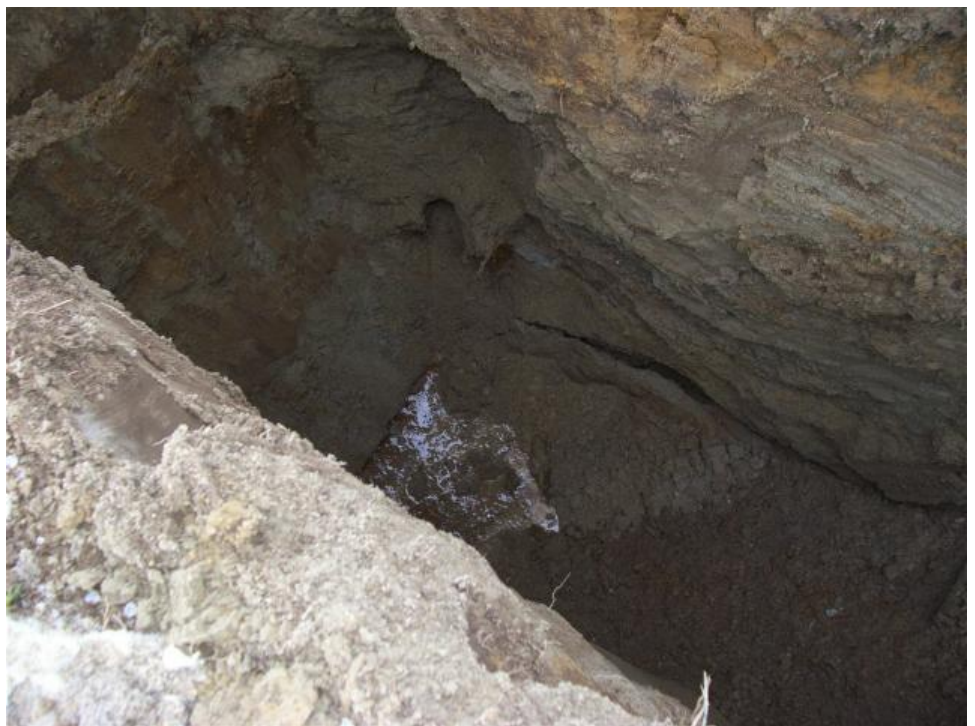
Date: Mar 24, 2011			
Location: TP-A - Southern Properties			
Direction: NW			
Comments: Clay tile pipe approximately one foot above water table.			
Photograph ID: 16

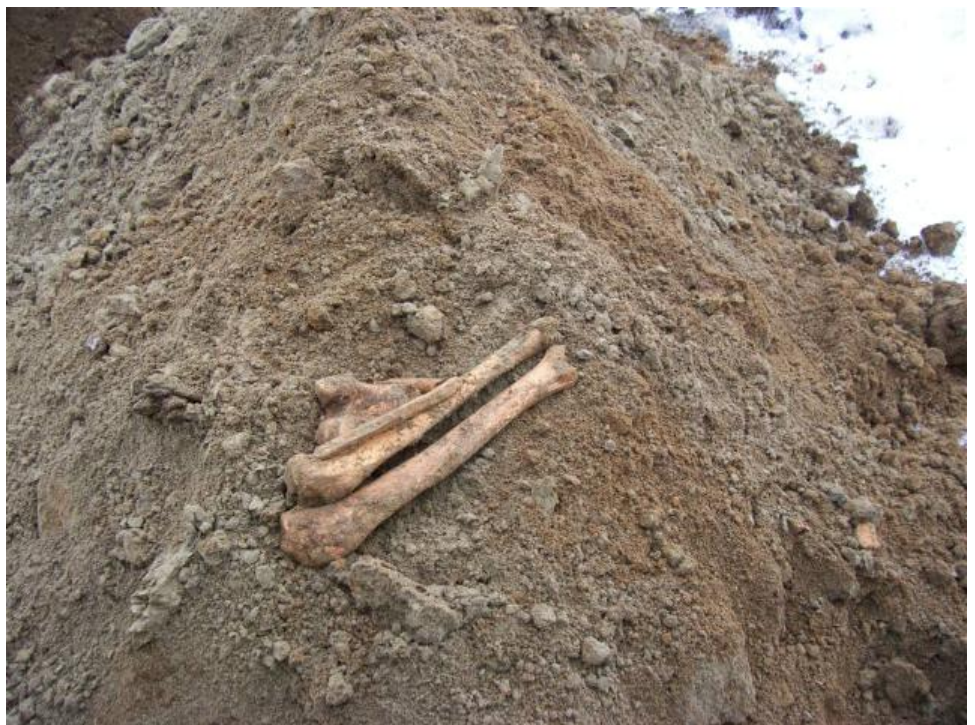
Date: Mar 24, 2011			
Location: TP-B - Southern Properties			
Direction: E			
Comments: Animal bones discovered during test pit activities on McCue property.

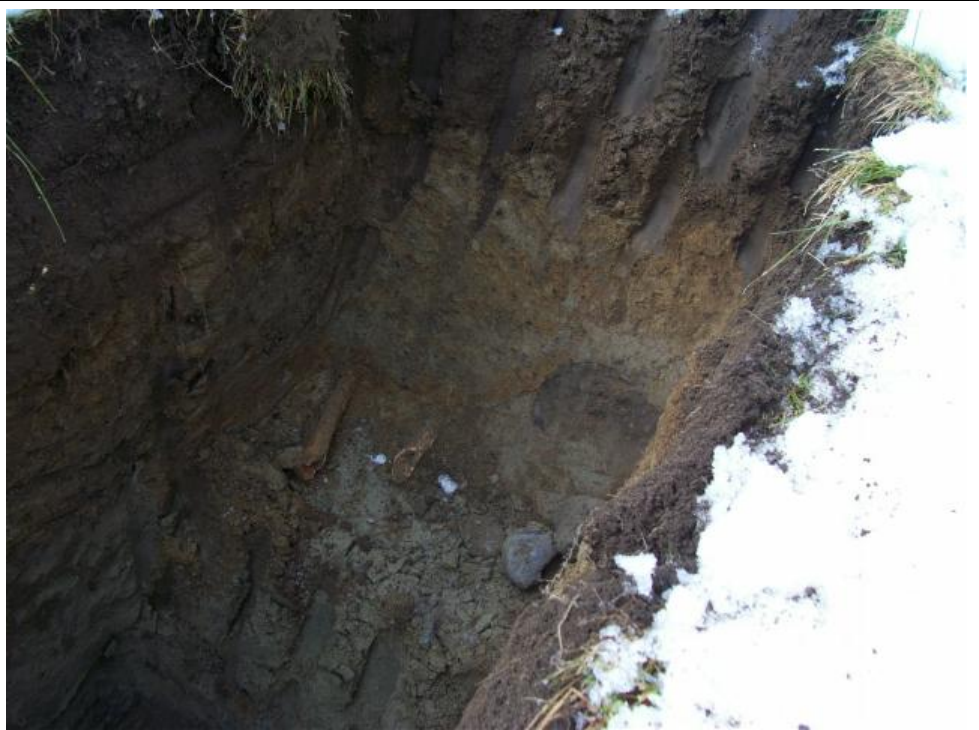
Date: Mar 24, 2011			
Location: TP-B - Southern Properties			
Direction: W			
Comments: Animal bones discovered during test pit activities on McCue property. Bones discovered approximately three feet below grade.			
Photograph ID: 18

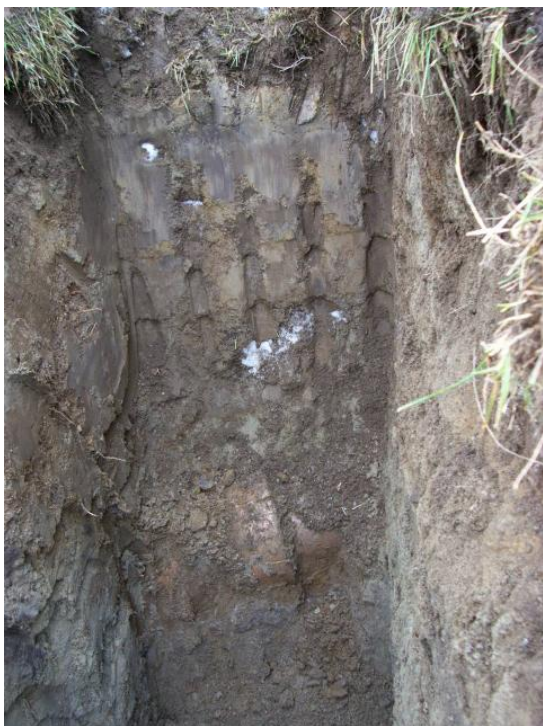
Date: Mar 24, 2011			
Location: TP-B - Southern Properties			
Direction: W			
Comments: 18" clay tile pipe discovered approximately 7 feet below grade. No coal tar, MGP residue, or odors associated with the pipe.

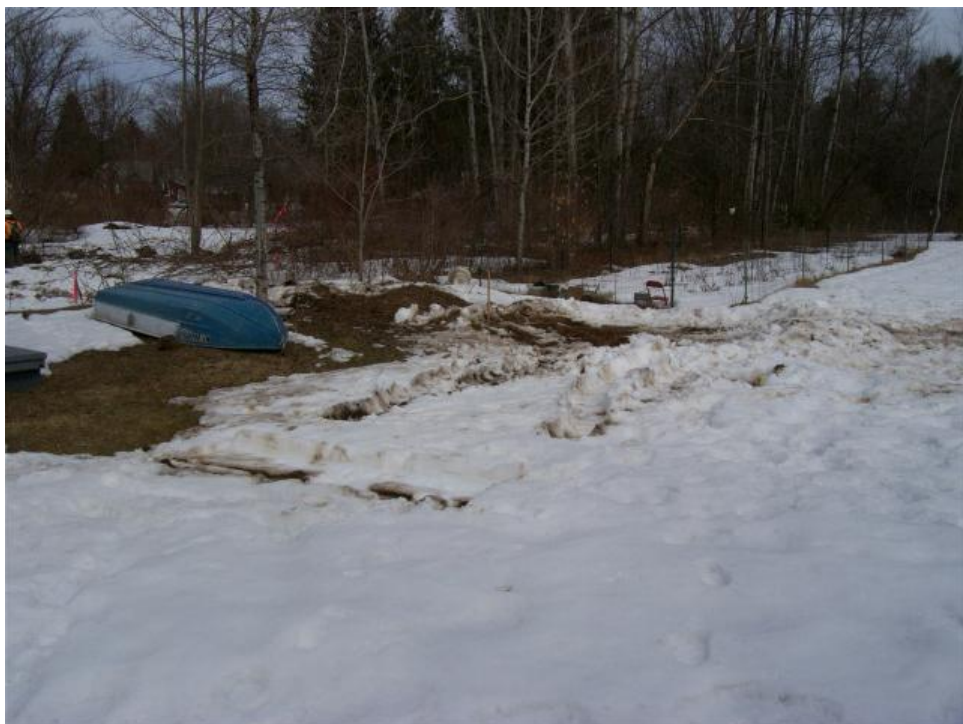
Date: Mar 24, 2011			
Location: Southern Properties			
Direction: NE			
Comments: McCue property where original test pit planned prior to relocation.

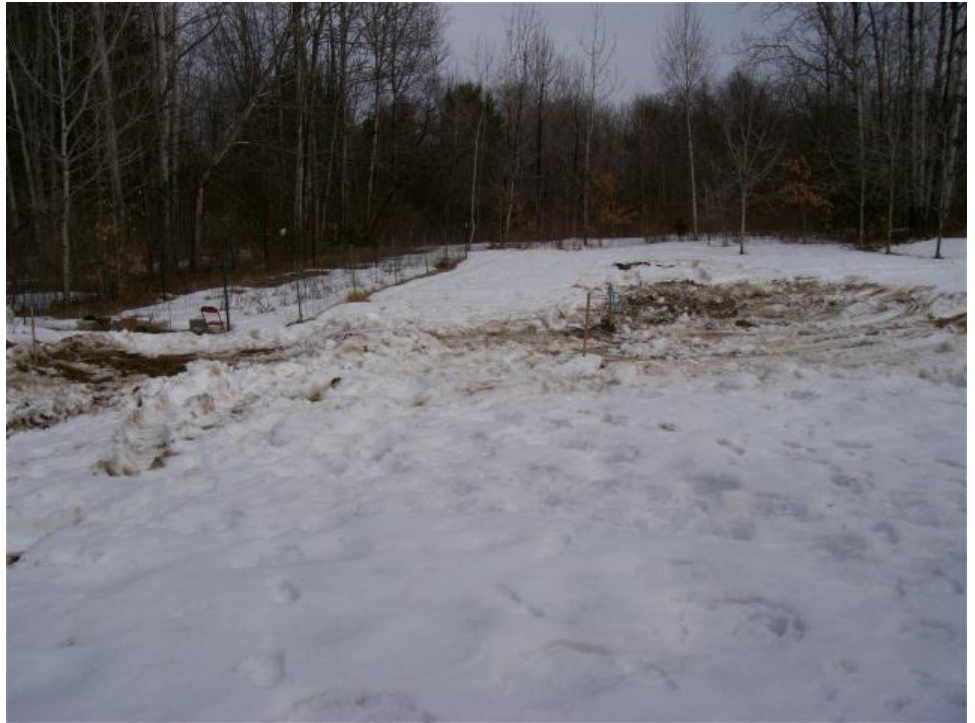
Date: Mar 24, 2011			
Location: Southern Properties			
Direction: E			
Comments: McCue property after backfill and clean-up at Test Pit "B."			
Photograph ID: 22

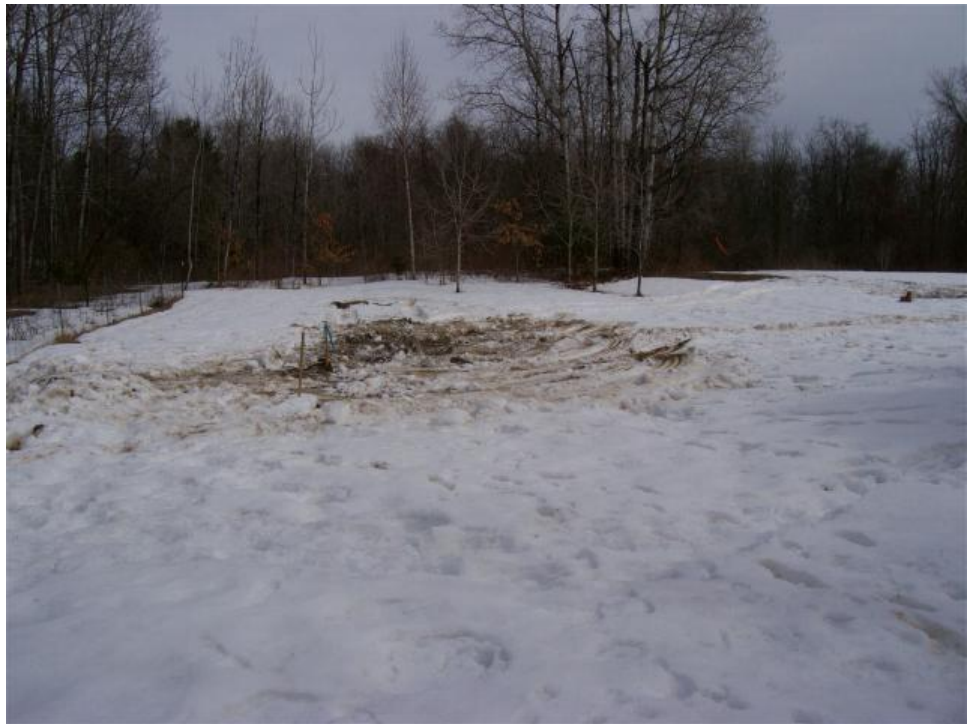
Date: Mar 24, 2011			
Location: Southern Properties			
Direction: E			
Comments: Test Pit "B" after backfill and clean-up.

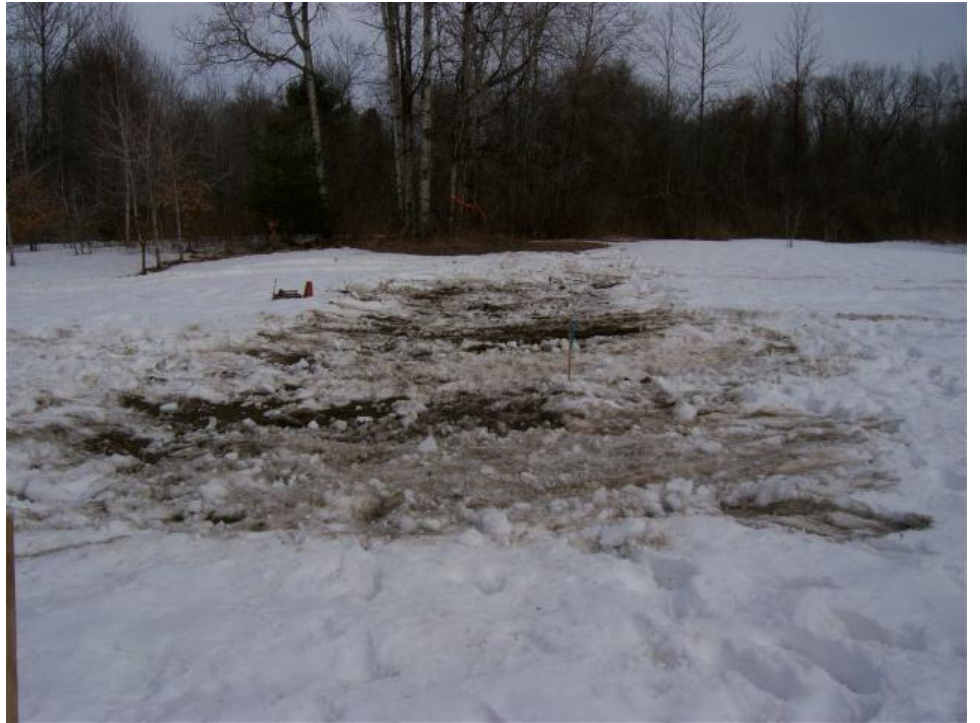
Date: Mar 24, 2011			
Location: Southern Properties			
Direction: E			
Comments: Test Pit "A" after backfill and clean-up.			
Photograph ID: 24
