Subject: Technical Memorandum - Adjacent Property Test Pit Investigation
Interim Remedial Measure (IRM)
Fort Edward (Canal St.) Non-Owned Former MGP Site
Fort Edward, Washington County, Site #V00472

Memorandum

**RE: Canal Street Fort Edward MGP Site IRM
Adjacent Property Test Pit Investigation**

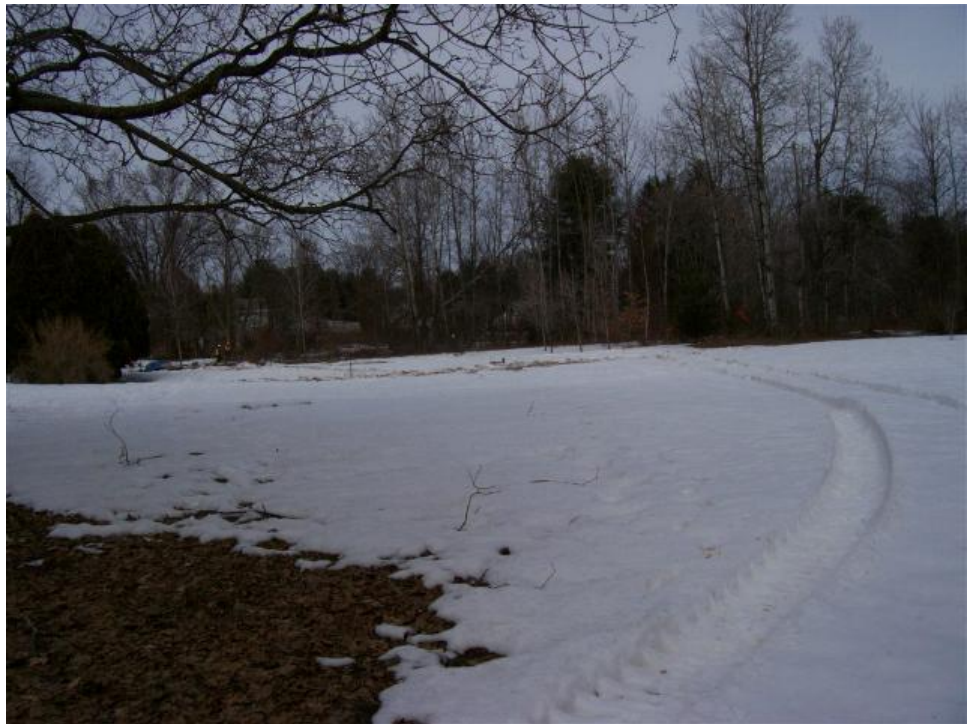
Date: Mar 24, 2011			
Location: Southern Properties			
Direction: NNE			
Comments: Southern properties where backhoe tracked out after completion of test pits.
