Re: Corrective Measures Work Plan/Letter
Metropolitan Avenue Campus (Q686)
92-34 Metropolitan Avenue
Forest Hills, New York
VCP Agreement # V-00550-2
ATC Project No. Z214YI2603

Corrective Measures
Metropolitan Avenue Campus
91-30 Metropolitan Avenue
Forest Hills, New York 11375

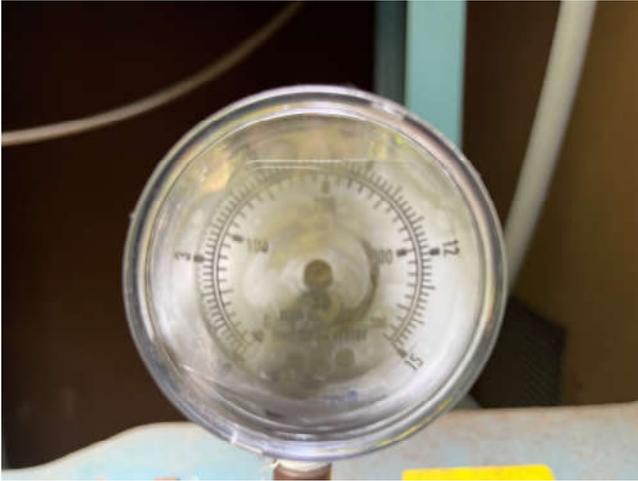
- Broken blower output pressure gauge;
- Portions of the cover system are beginning to become compromised.

Photo 1: View of the old malfunctioned blower outlet pressure gauge.

During the August 18, 2022 inspection, ATC observed that the existing cracks on the tennis courts had deteriorated even further since the last inspection in February 2022. Following this inspection, the custodial staff sealed/patched these cracks to prevent further deterioration. It should also be noted that on September 13, 2022, the blower output pressure gauge was replaced and is functional.

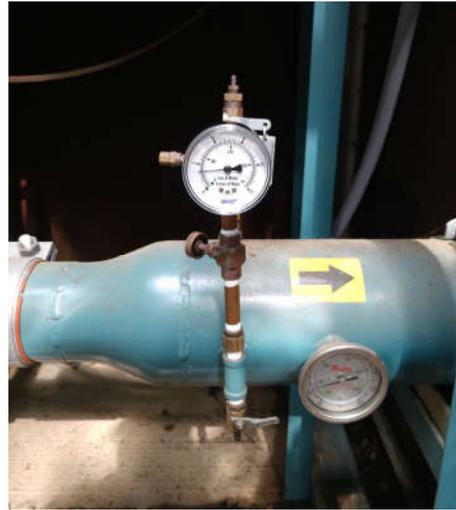
Photo 2: View of the newly installed blower outlet pressure gauge.

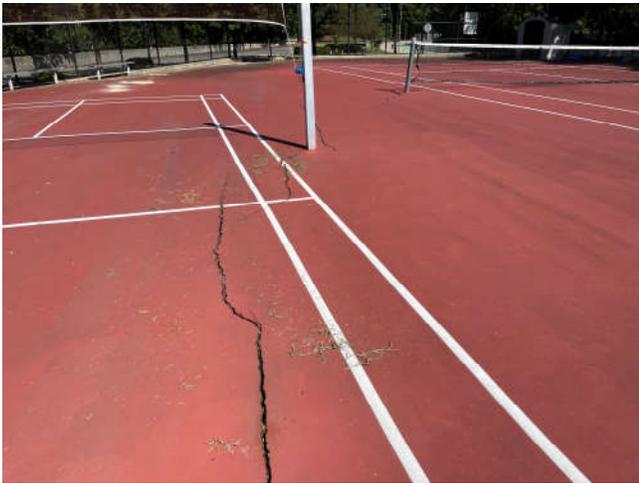
Photo 3: View of a typical previously existing crack on the tennis court.

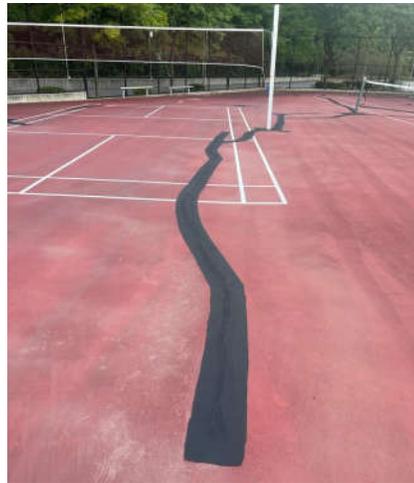
Photo 4: View of the recently sealed cracks on the tennis court.

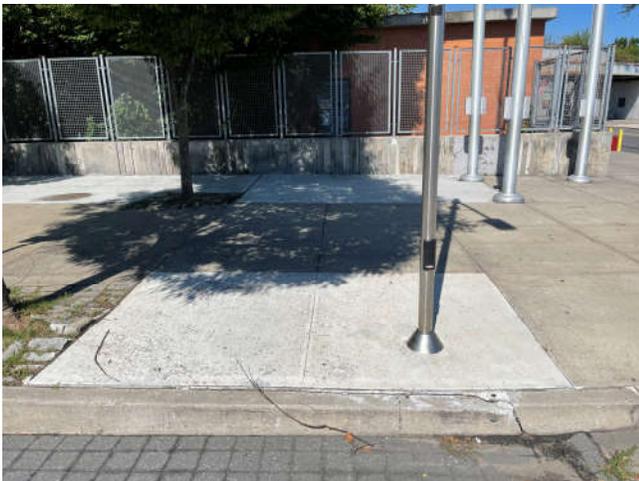
Photo 5: View of the repaired previously sinking light pole concrete pad.

Following receipt of this letter, Mr. Gilbert Gedeon, PE with ATC and Denise Cosenza, Project Manager with ATC conducted a return site visit to assess the cover system on August 18, 2022. ATC met with and was accompanied by Mr. Eric Jackson, the school's Fireman. At that time, ATC requested to inspect areas that had been reported in the monthly inspection documents as "pavers by the blue side of the auditorium are very loose" and "light pole sinking in." The area of the light pole had the concrete slab repaired in June 2021. In addition, the pavers identified as

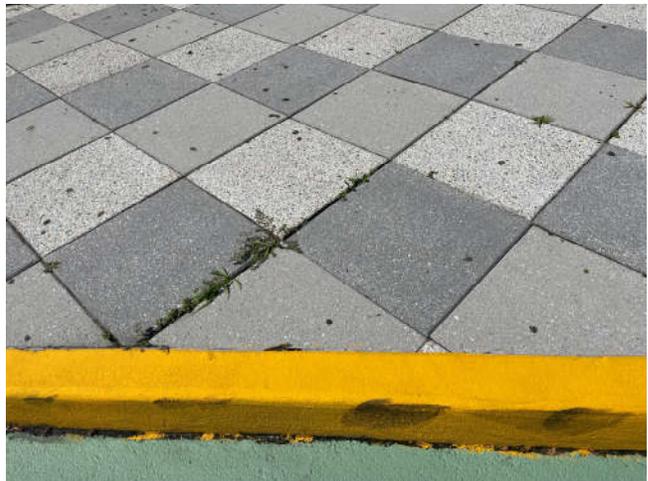
“loose” appeared to be not level with some of the surrounding pavers, but the cover system did appear to be intact.

Photo 6: View of area identified as "loose pavers" with no cover compromised.
