May 5, 1998

Re: Edgewood Warehouse and Former Roblin Steel Sites 320 South Roberts Road, Dunkirk, New York CHA Project No. 6801.07.04.

WATERFRONT VILLAGE
40 LA RIVIERE DRIVE, SUITE 136
BUFFALO, NEW YORK 14202
TEL: 716-847-6310 • FAX: 716-847-0123
www.cha-lip.com
October 30, 1997

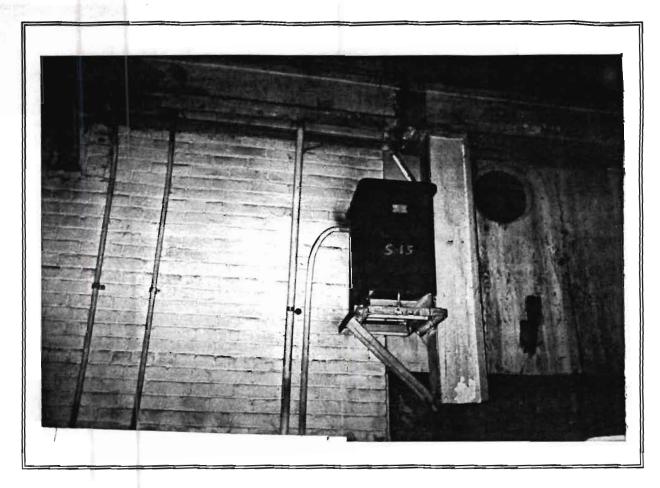
Photo #9: Column-mounted 25 KVA transformer located within warehouse building.

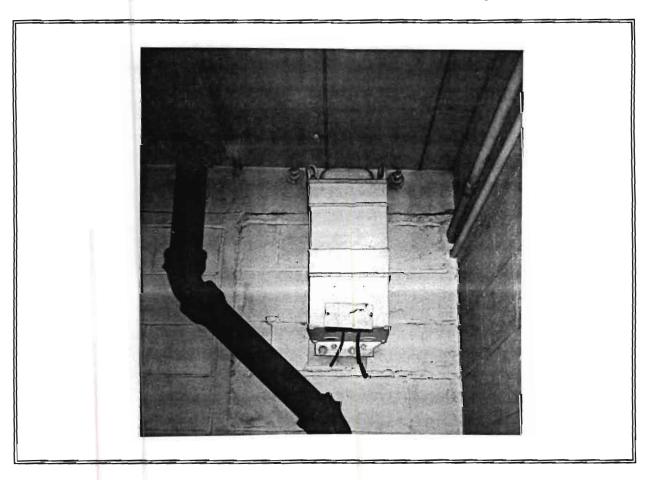
Photo #10: Wall mounted transformer located in former scale house building.

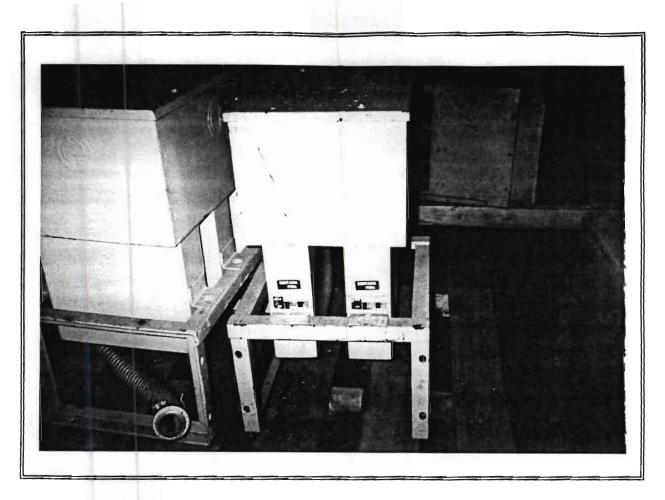
Photo #11: Pallet holding two capacitor assemblies labeled as PCB-containing stored within warehouse.

Furthermore, prior to the acquisition of the subject property, CHA would recommend that all PCB-containing electrical equipment; solid waste; hazardous waste; and friable or damaged ACMs be removed from the site for disposal in accordance with all State and Federal Regulations.

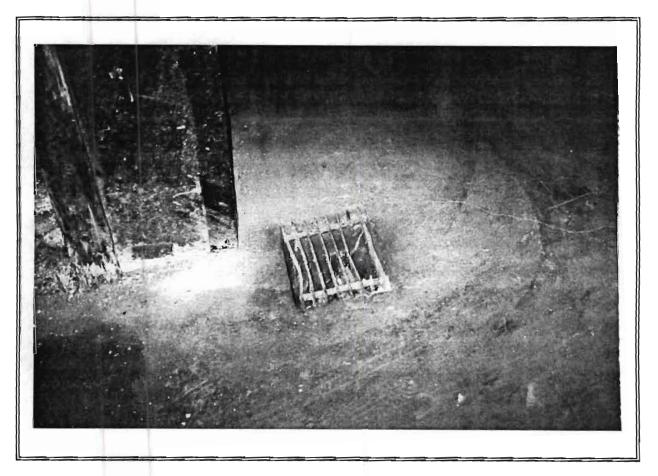
Photo #12: Floor drain located within former maintenance room of warehouse building.

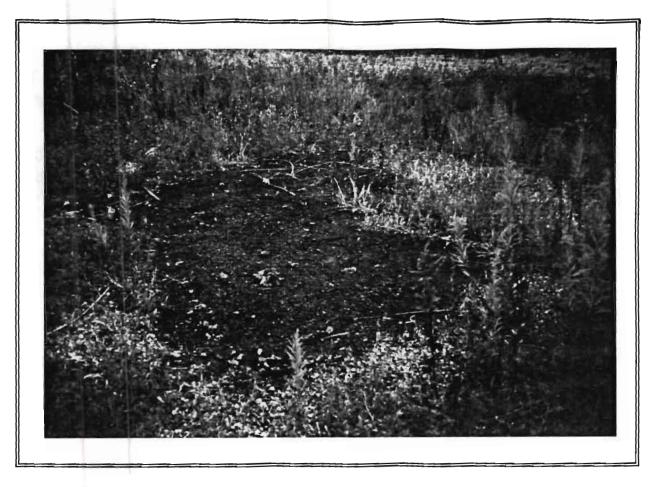
Photo #13: Area of stained soil located along northern property margin between warehouse and scale house.

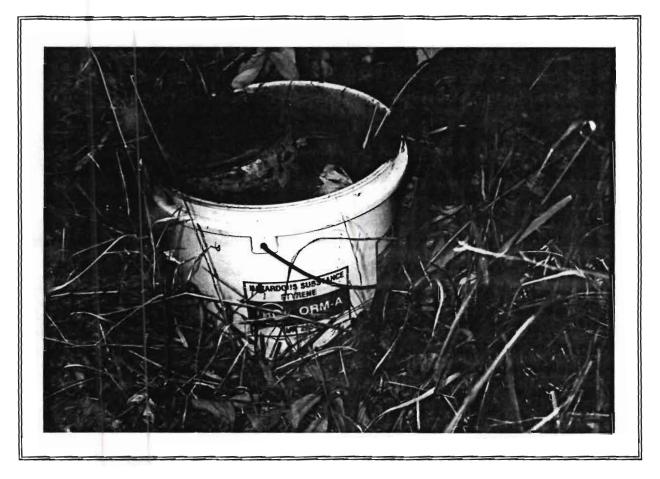
Photo #14: Discarded container observed near former scale house building (labeled as originally containing hazardous substance).

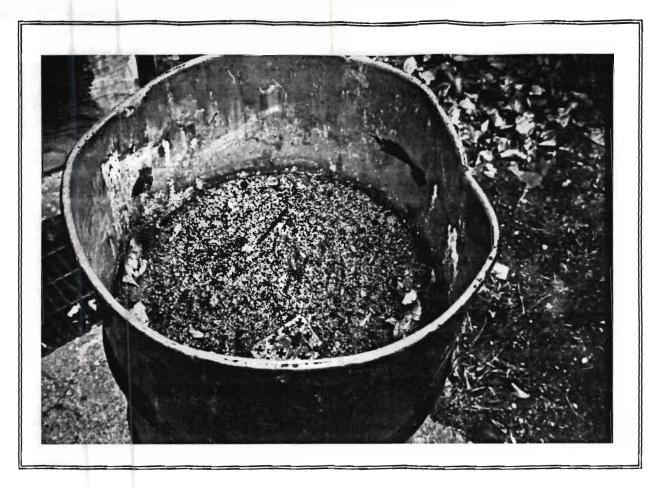
Photo #15: One of three uncovered 55-gallon drums containing a solid substance resembling ash observed on the east side of the warehouse building.

Samples of potential hazardous waste materials contained within the three 55-gallon drums located on the Edgewood Warehouse Site will be collected for the purpose of completing waste characterization analyses. Any suspect liquid and/or solid materials occurring within other containers present on the Former Roblin Site will also be sampled for this purpose. Samples will be analyzed for Ignitability, Reactivity, Corrosivity and Toxicity. The latter analysis will be performed using the Toxicity Characteristic Leaching Procedure (TCLP) with the resulting sample extracts analyzed for volatile and semi-volatile organic compounds and metals. CHA has assumed that 1 composite sample will be collected from the three drums and submitted for waste characterization.

- Disposal characterization of the solid substance observed within three uncovered drums extant on the subject property; and
- Evaluation of the condition of asbestos containing materials (ACMs) identified within the warehouse building.

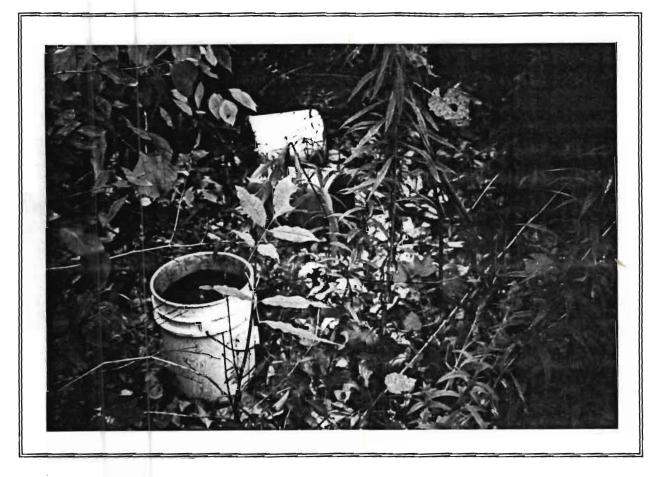
Photo #16: 5-gallon pails containing roofing-tar residues observed along northern side of warehouse building.

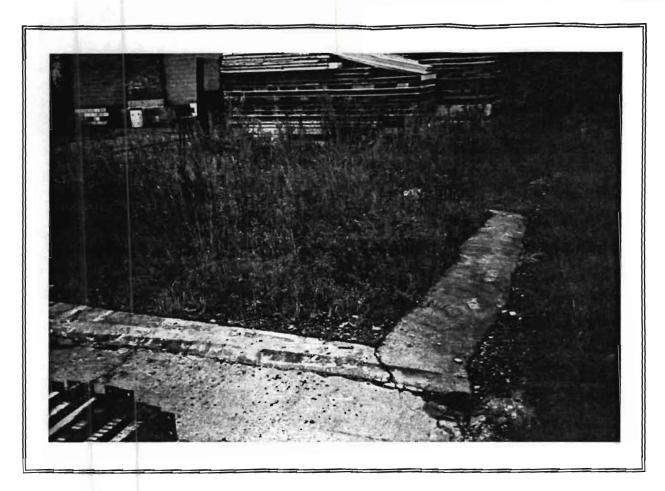
Photo #17: Former pit filled with soil/fill on the east side of warehouse building in the vicinity of the former pickling house.

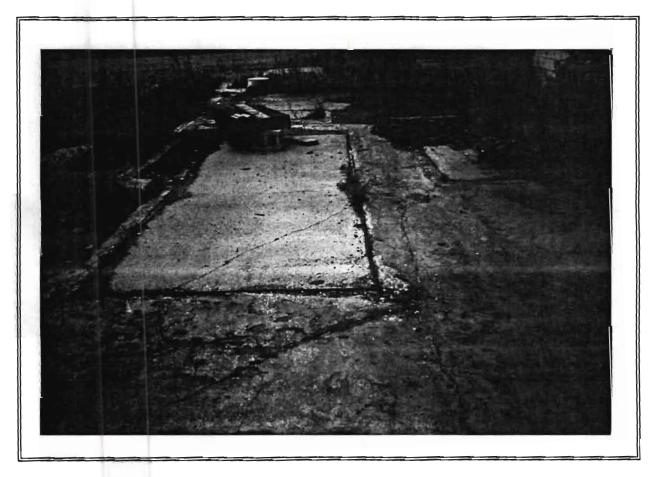
Photo #18: Former pits filled with concrete located near east end of warehouse building in vicinity of former lime storage room.

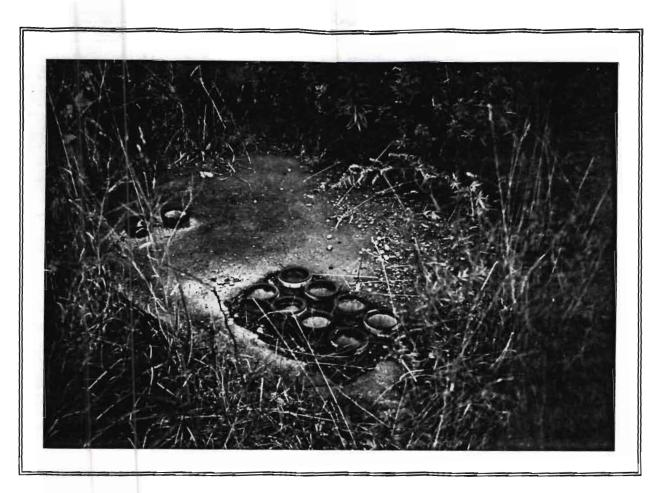
Photo #19: Potential former transformer pad located near southeastern corner of warehouse.

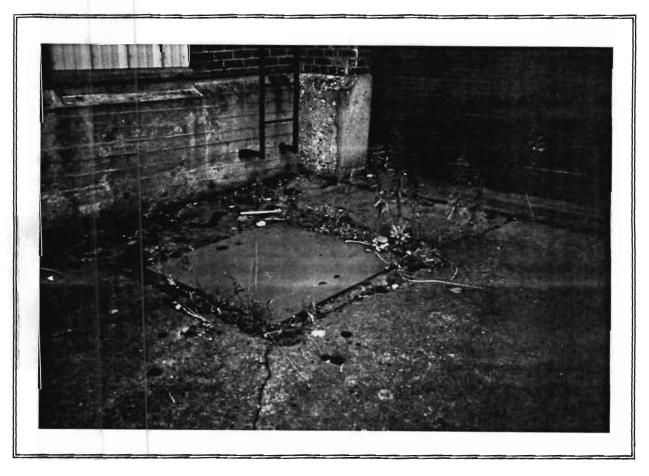
Photo #20: Covered pit located along northern side of warehouse building.

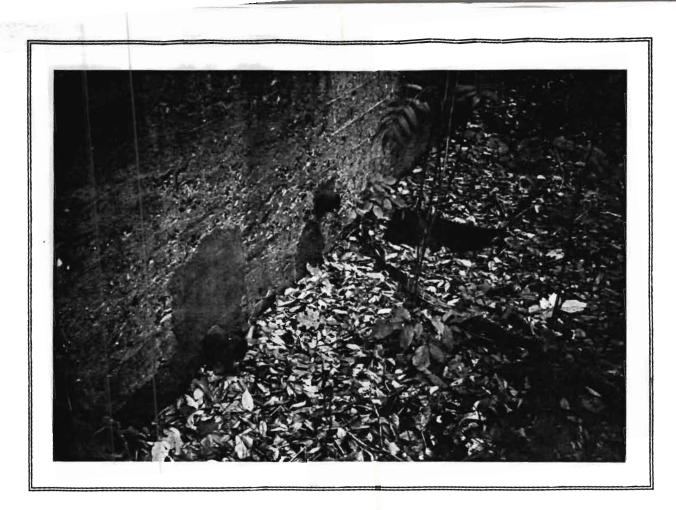
Photo #21: Pipes protruding from base of northern wall of the warehouse building.

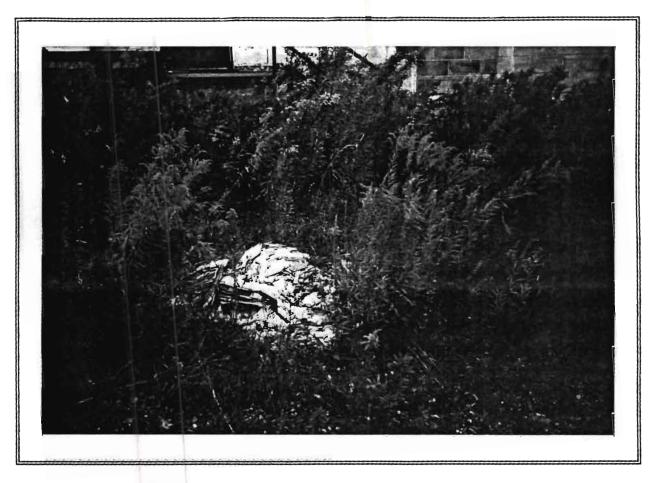
Photo #22: Pile of demolition debris potentially containing ACMs located near former scale house building.

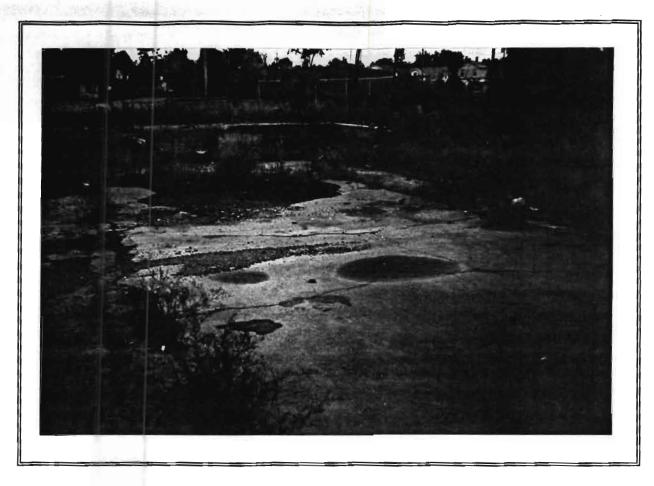
Photo #23: Former pit filled with concrete located along south side of warehouse building in the vicinity of the former neutralizing room (potential stained surface shown in background).

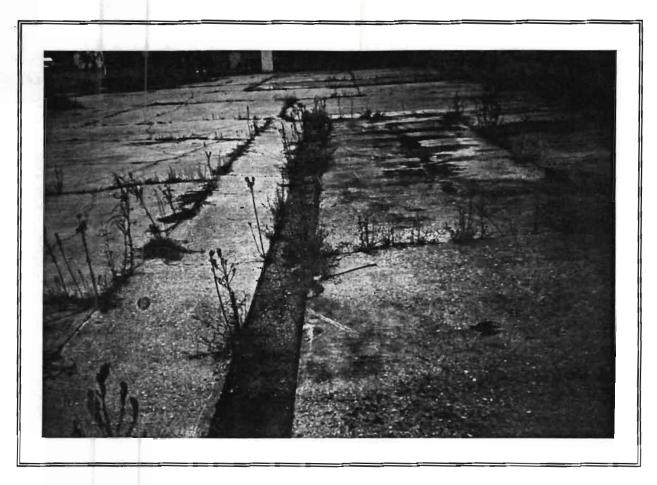
Photo #25: Trench drain filled with sediment observed in fenced yard located along south side of warehouse building.

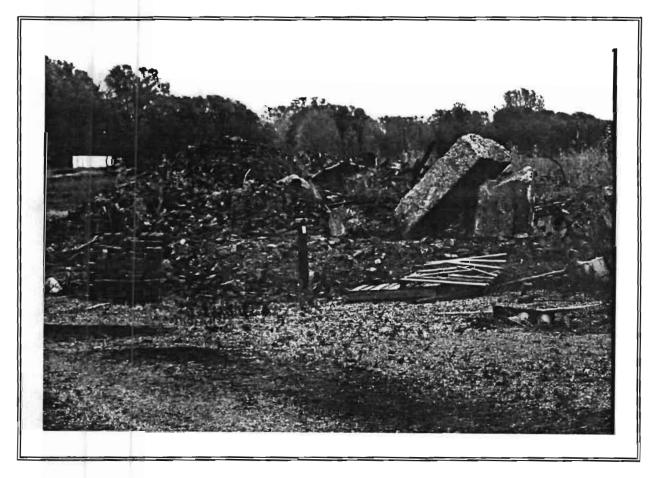
Photo #26: Demolition debris located on former Roblin Steel site just east of the subject property's eastern boundary (note groundwater monitoring well in foreground).
