**American Cleaners Kingston  
Ulster County, New York**

**Interim Remedial Measures  
Construction Completion Report:**

**Sub-Slab Soil Vapor Extraction and  
Bioremediation of Groundwater  
NYSDEC Site Number: V-00601-3**

**SEPTEMBER 2017**

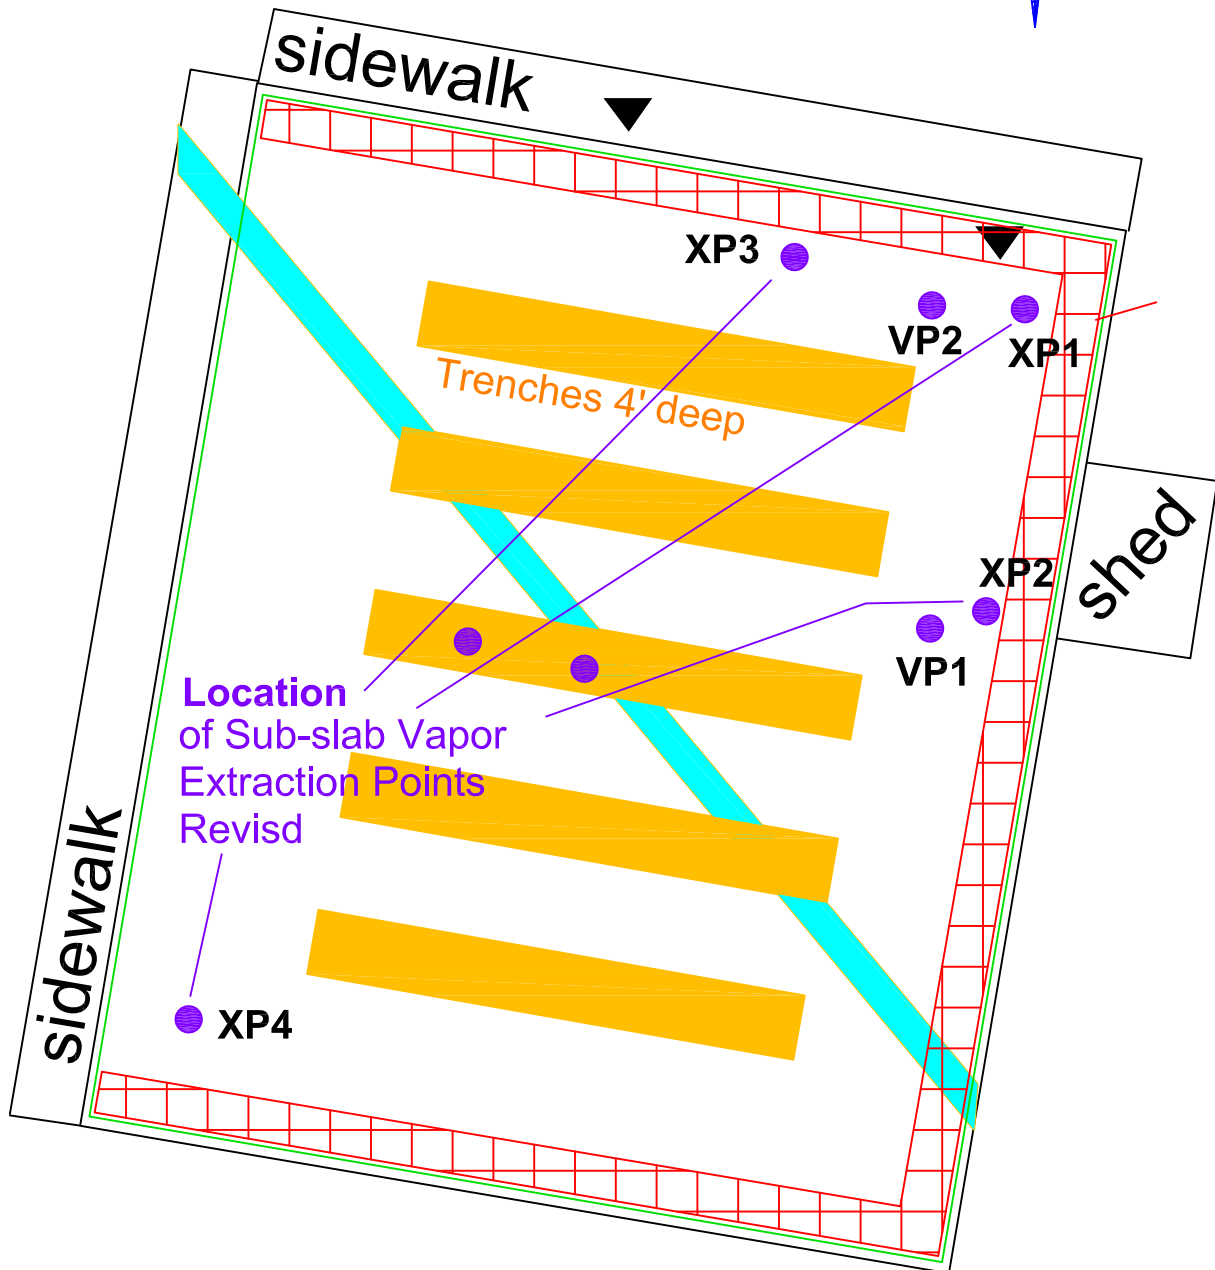
**VP1 & VP2 were temporary vacuum measuring points**

Figure 2A. Location of Vacuum and Sub-Slab Vapor Extraction Points on Site Plan of Building showing Features Constructed for Dry-Cleaning Operations American Cleaners Inc, 734 Ulster Avenue, Kingston, NY  
NYSDEC DER VCP Site V-00601-3 December 31, 2009  
Revised November 2013

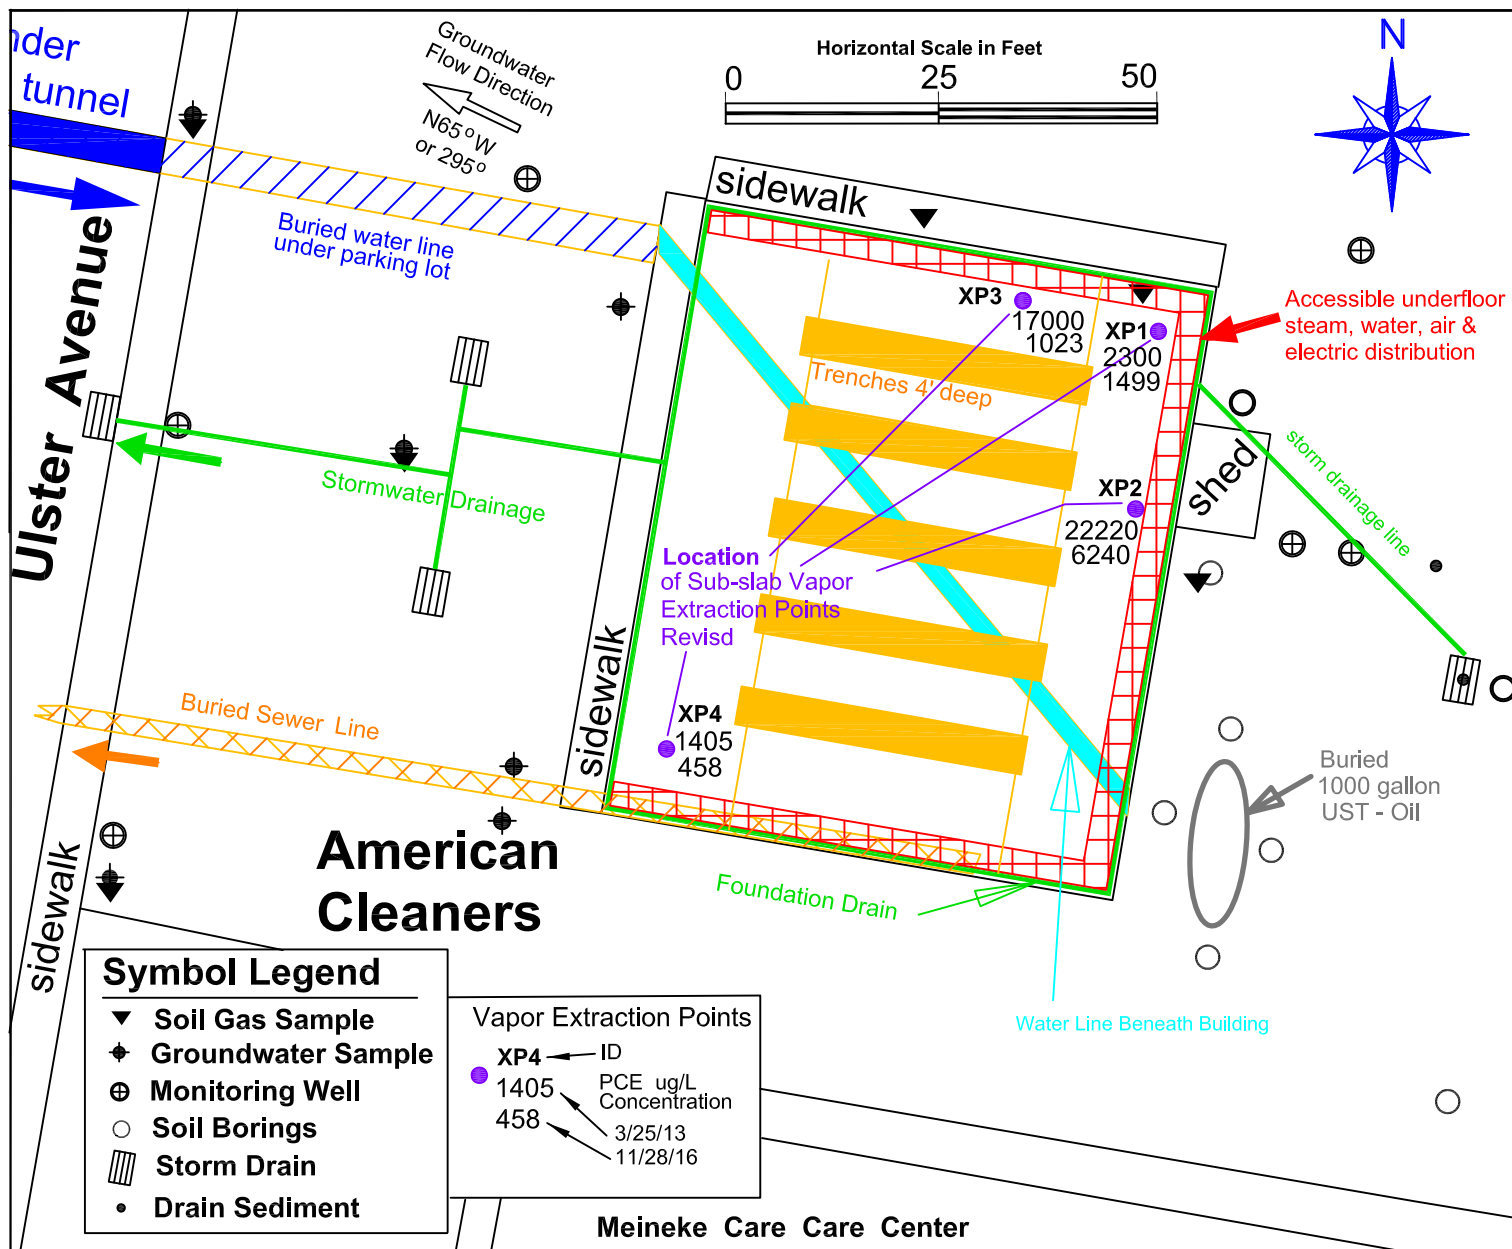
Figure 2B. Location of Sub-Slab Vapor Extraction Points with PCE concentrations in ug/L sampled in 2013 and 2016 on building site plan showing utilities and Features Constructed for Dry-Cleaning Operations

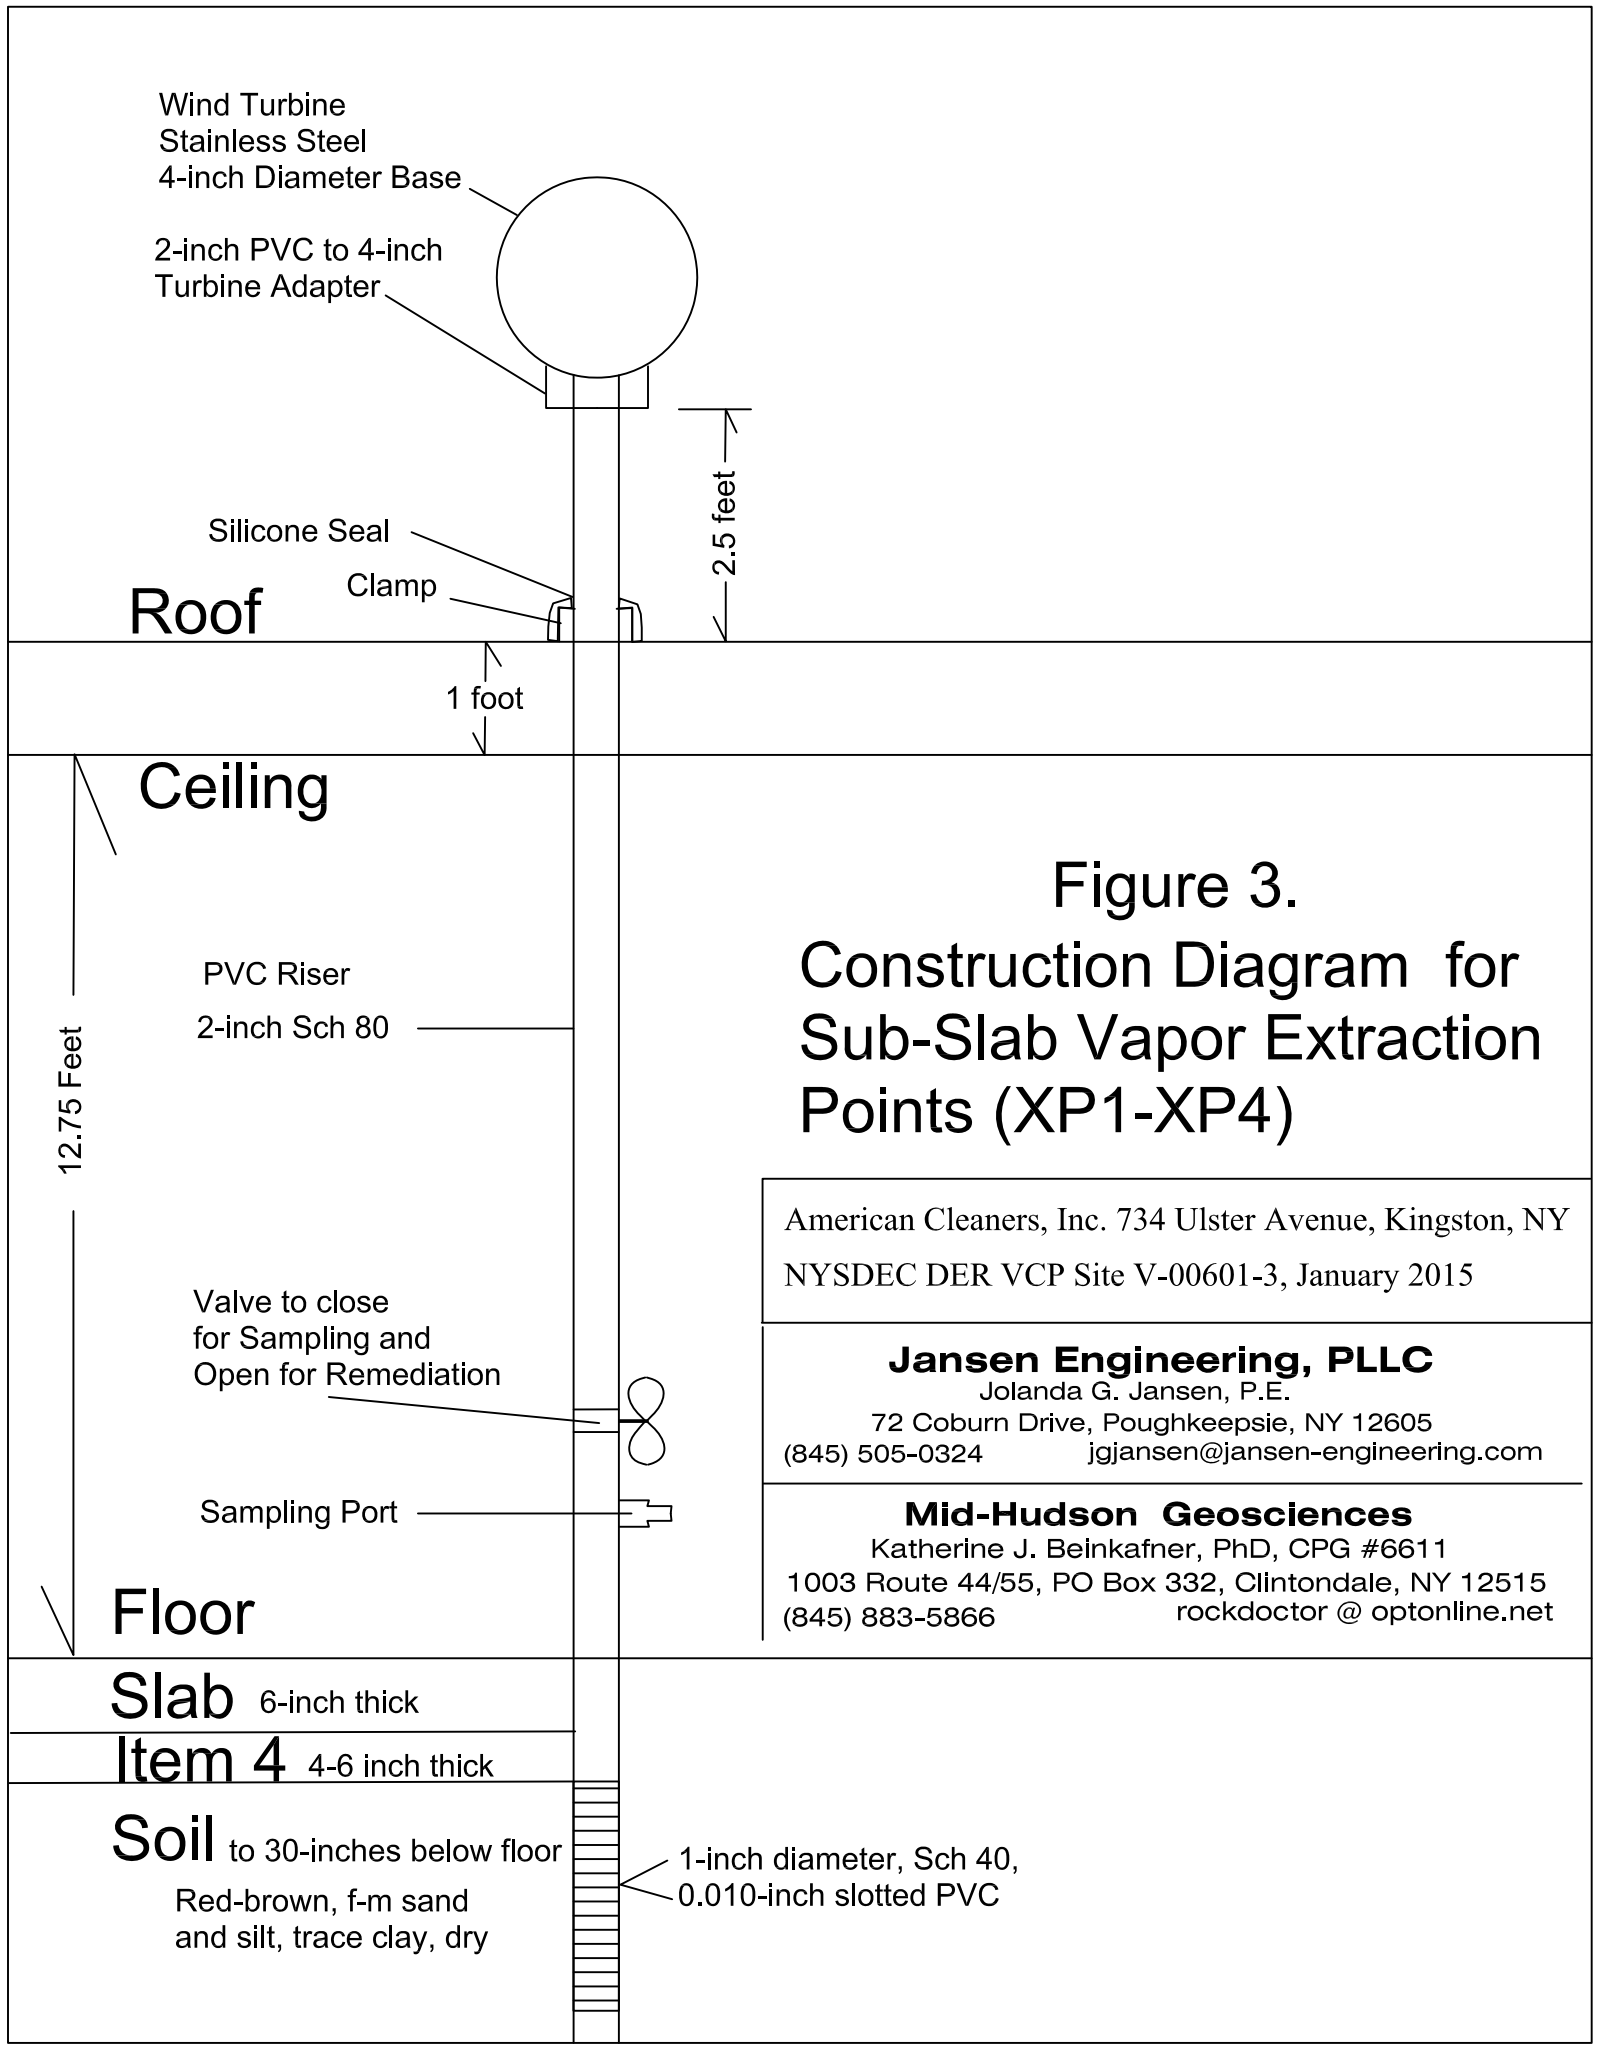
Figure 3.  
Construction Diagram for  
Sub-Slab Vapor Extraction  
Points (XP1-XP4)

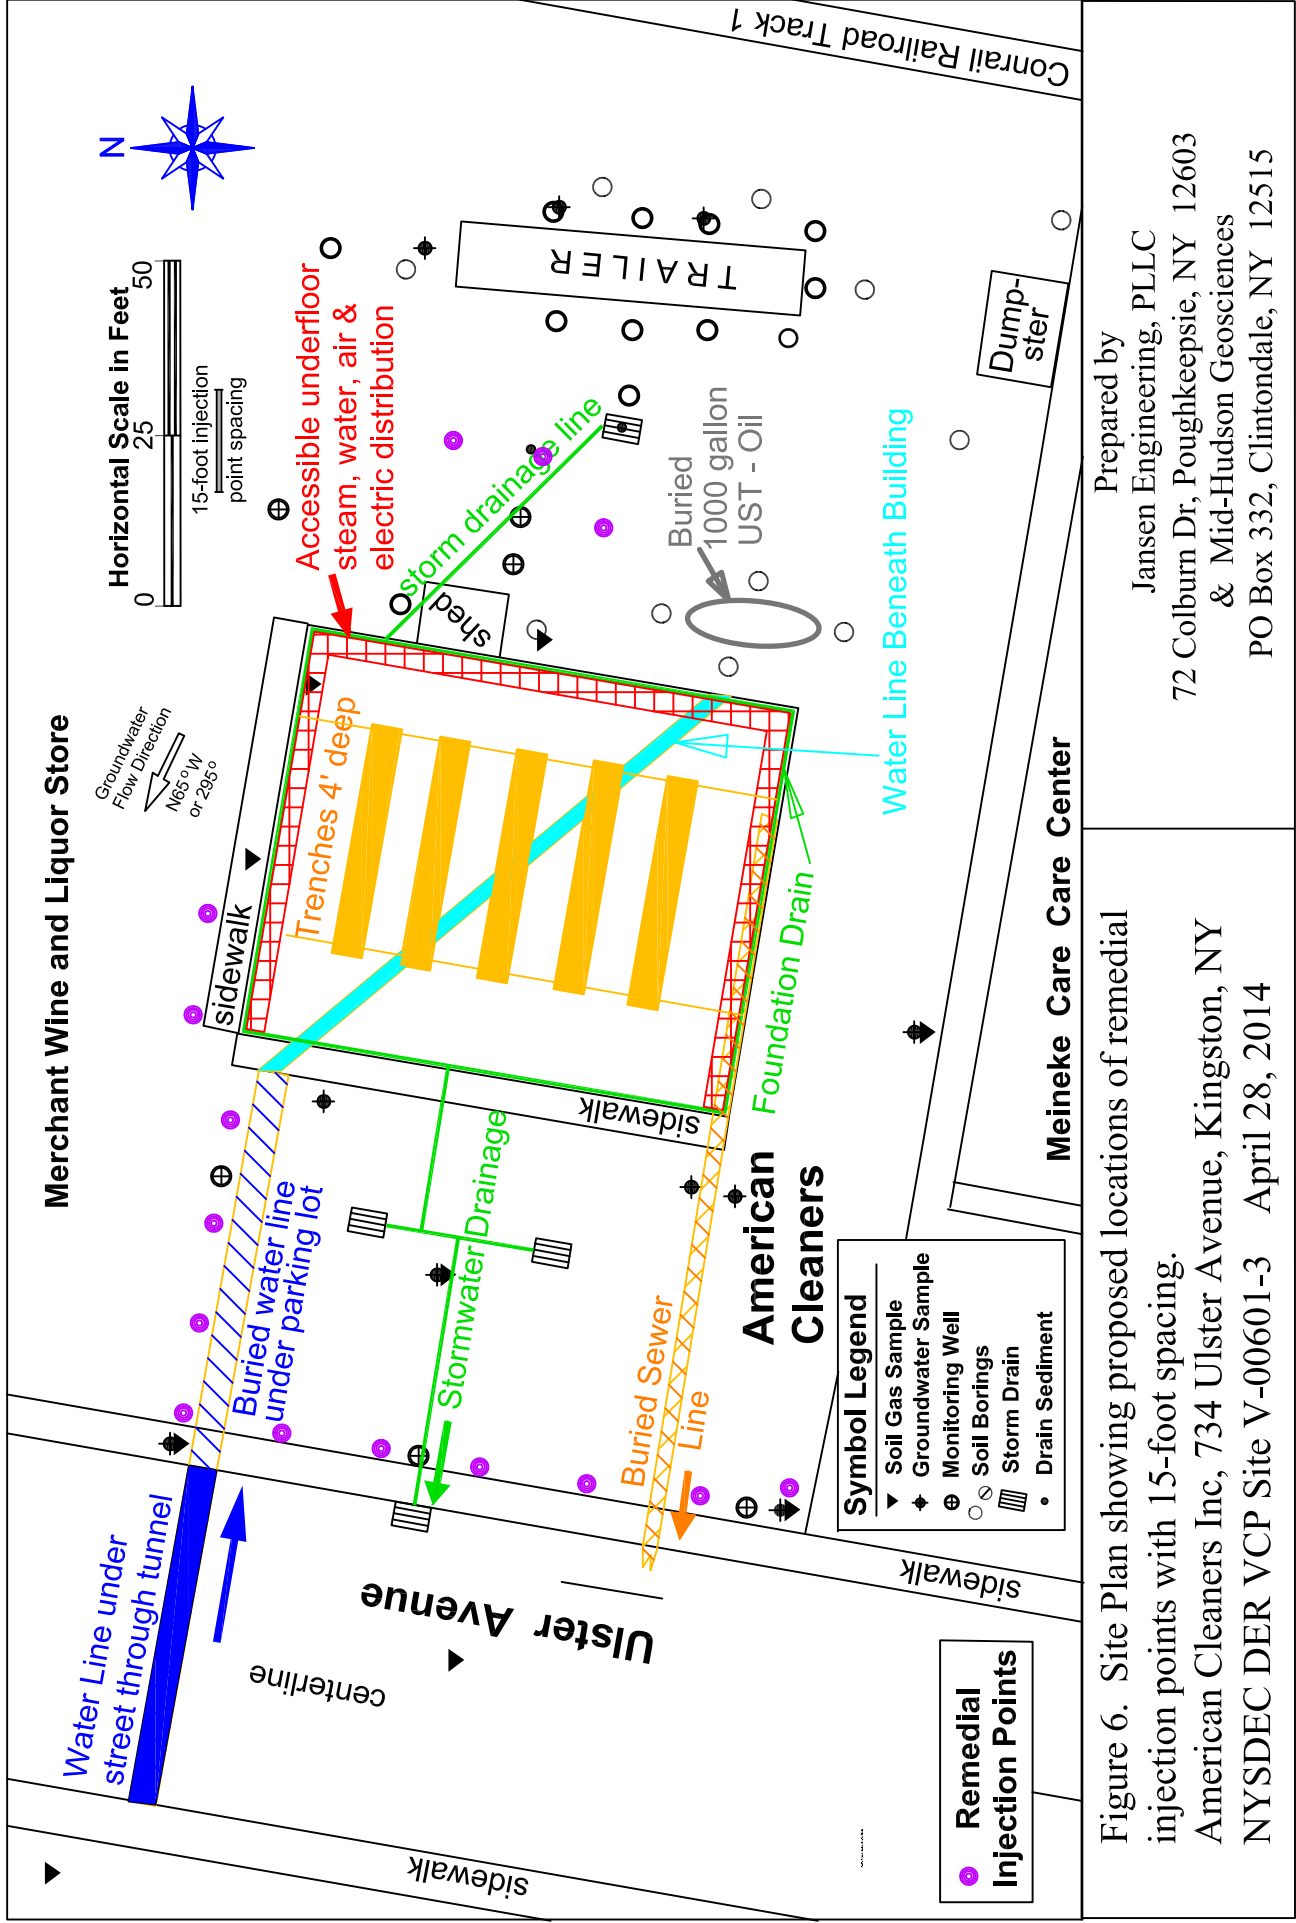
Figure 6. Site Plan showing proposed locations of remedial injection points with 15-foot spacing.  
American Cleaners Inc, 734 Ulster Avenue, Kingston, NY  
NYSDEC DER VCP Site V-00601-3 April 28, 2014

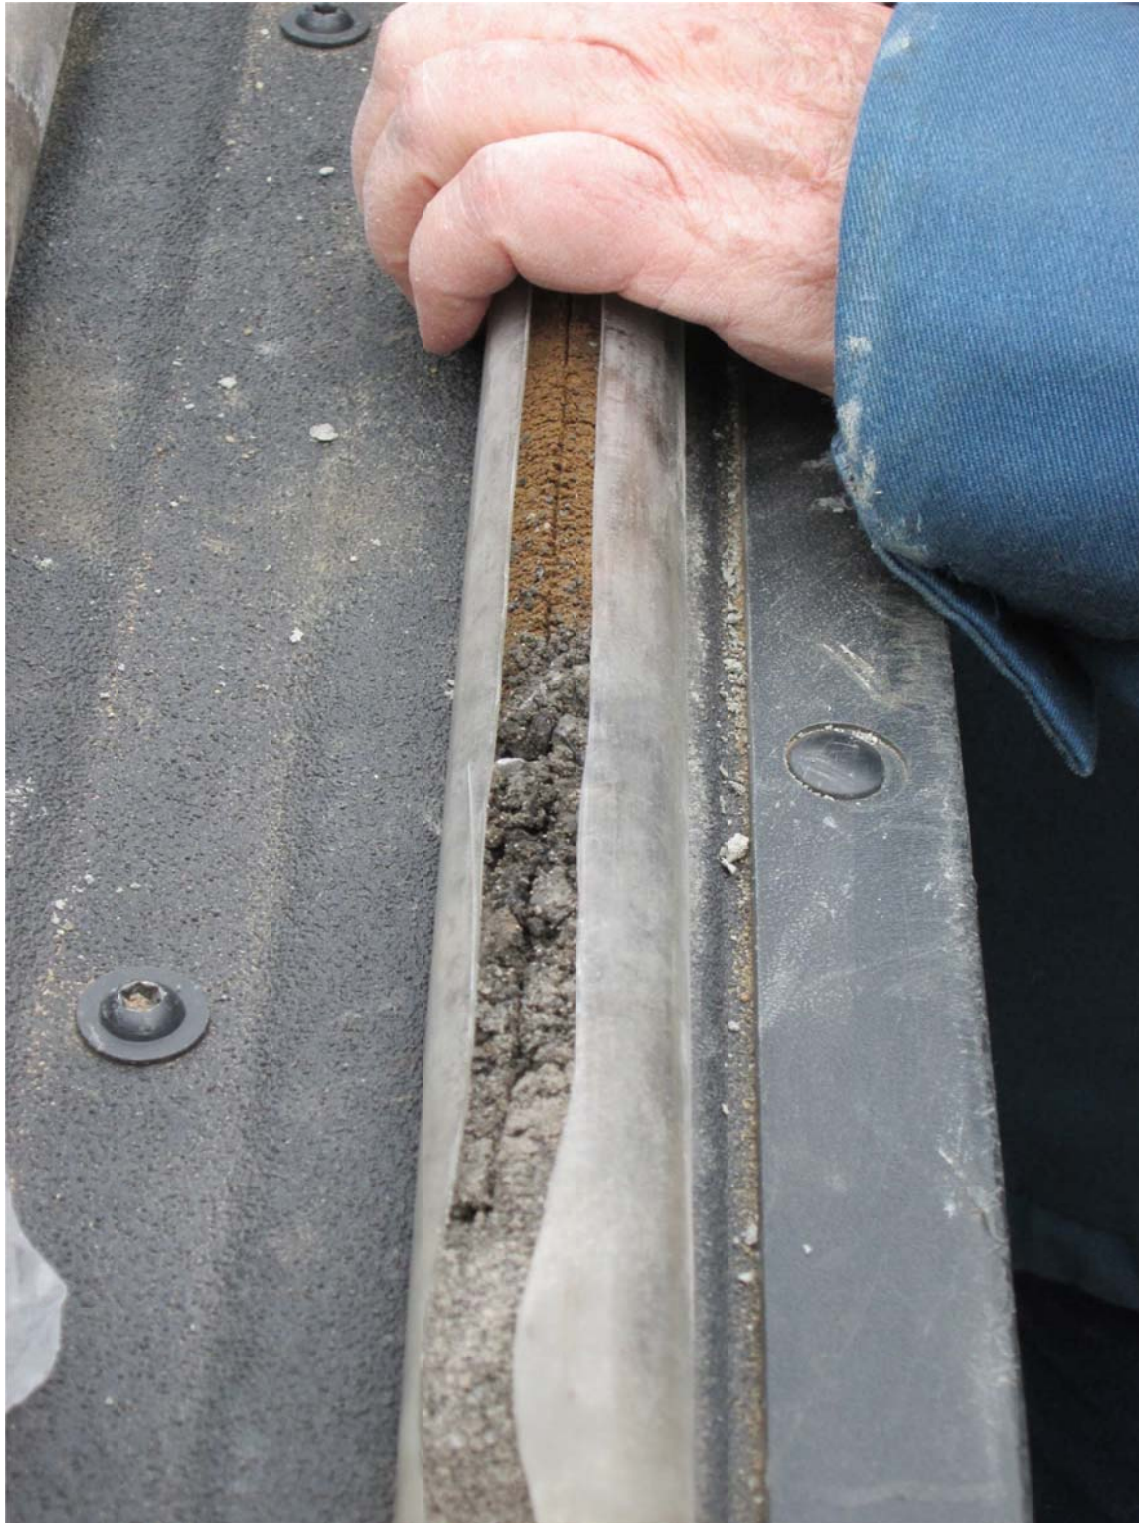
P5. Core examination, ground concrete at bottom of photo, above that  
itme 4 material, and the natural red sand closest to the geologist's hand.  
3/25/13

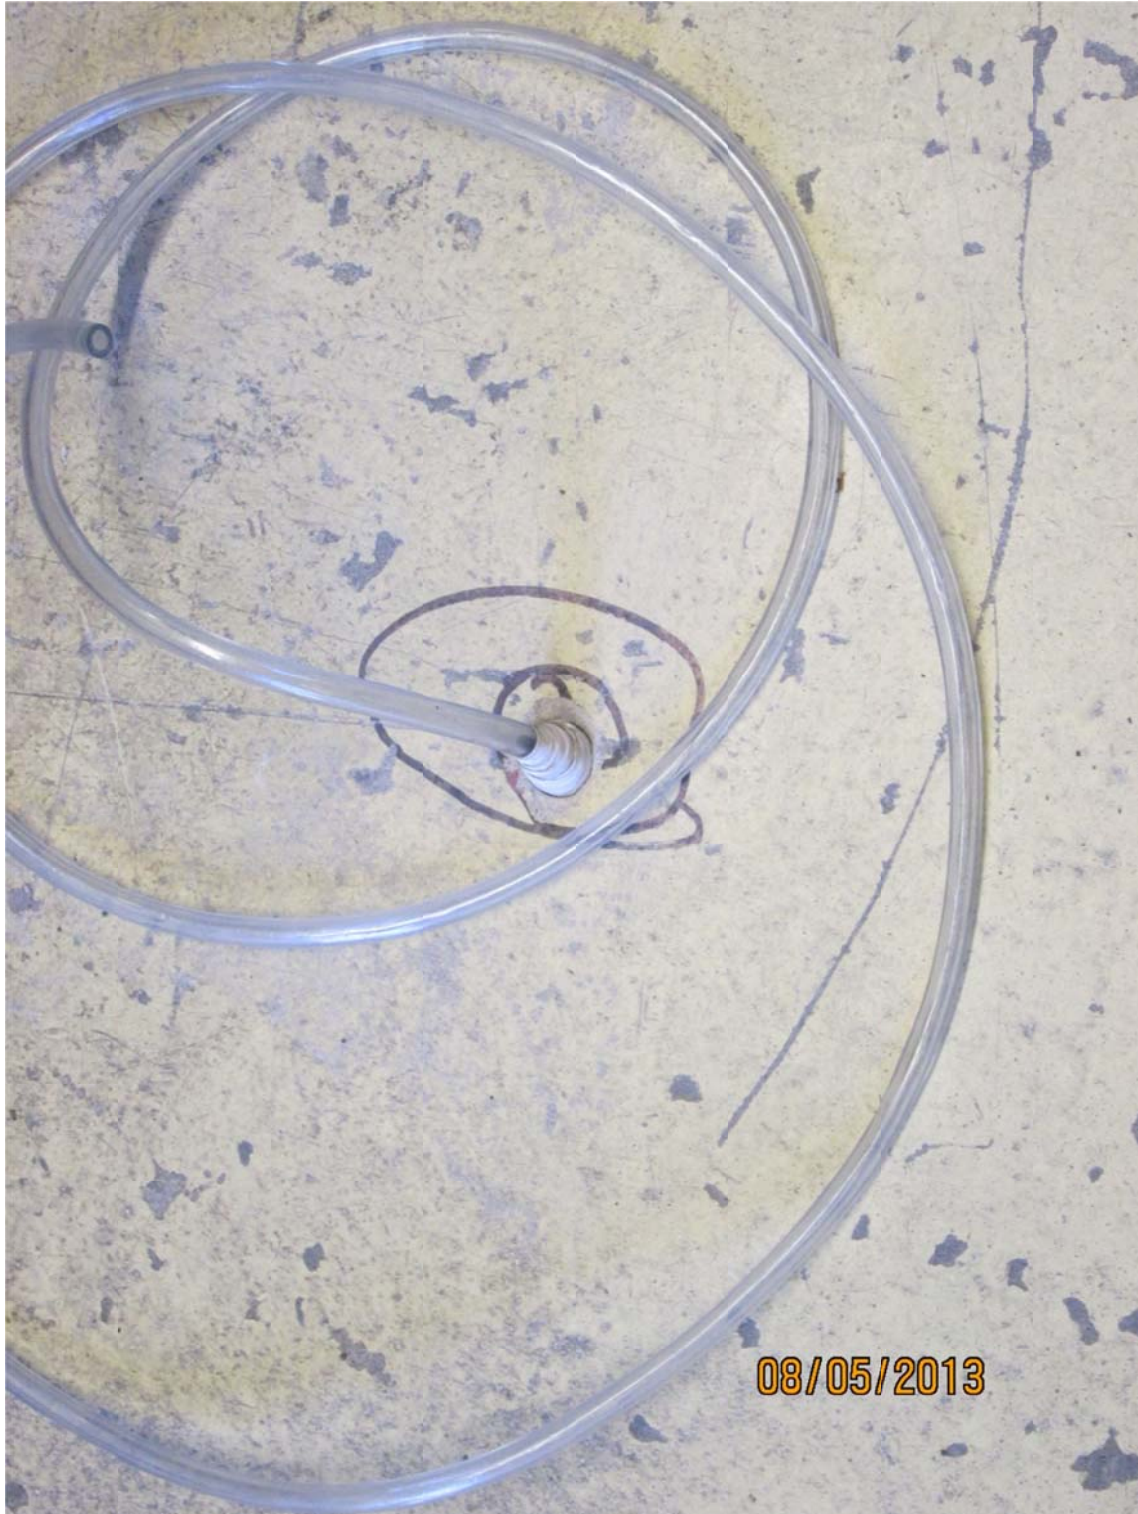
P11. Tests were conducting by applying a vacuum to each extraction point (XP1, XP2, XP3, XP4) and measuring any detectable vacuum at the other three XPs while the vacuum was applied to one. No positive results were detected. Hence, Vapor measuring points VP1 and VP2 were installed. 8/5/13

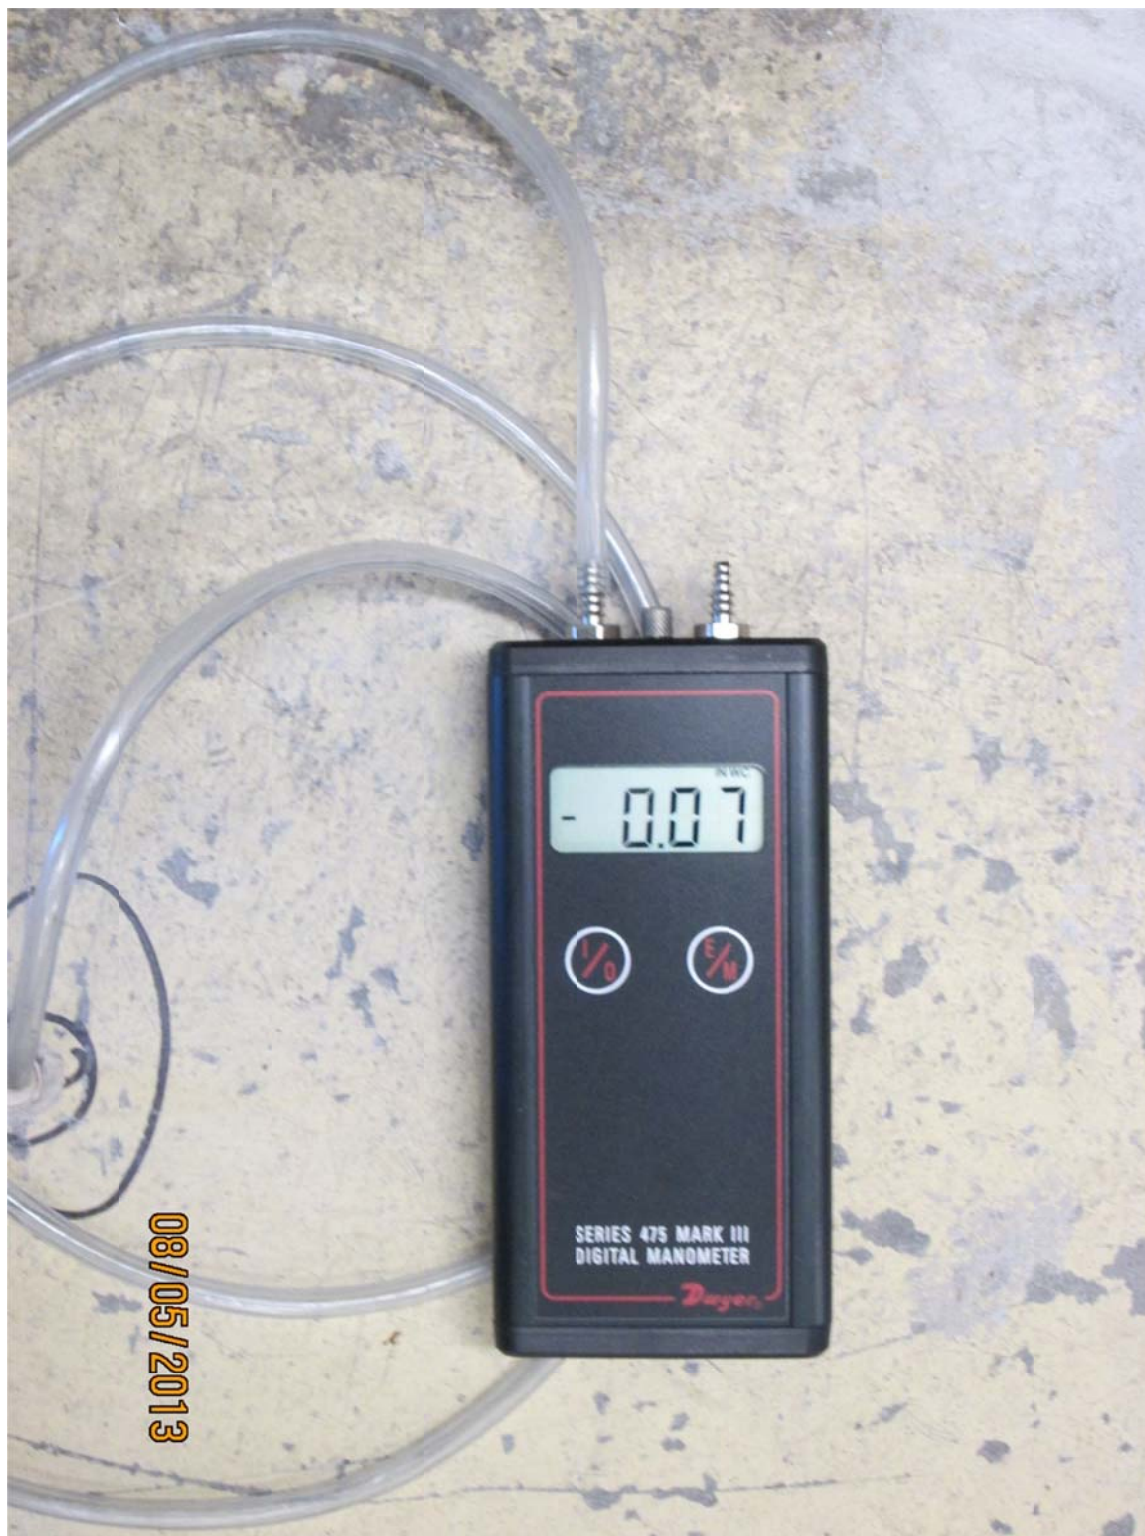
P12. Manometer measuring a vacuum of -0.07 inches of water at VP1 located 5 feet southwest of XP2 while vacuum is applied to XP2 using a 1 horsepower Fuji Blower. 8/5/13

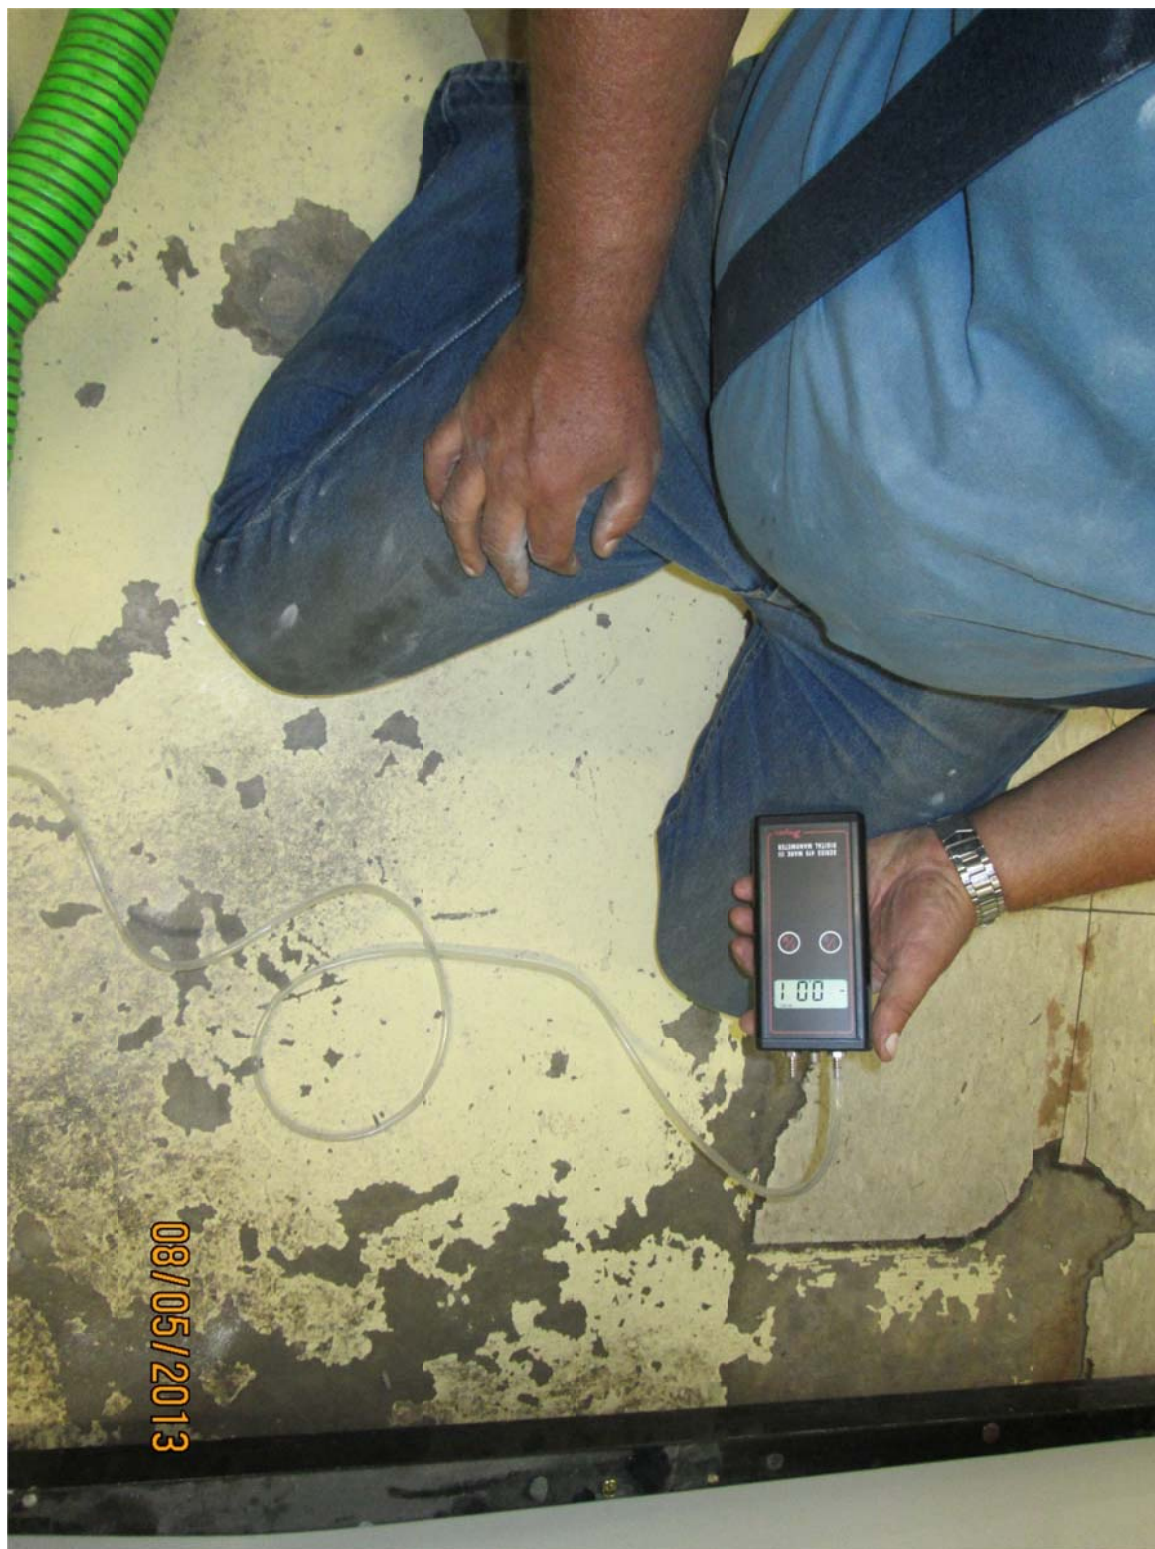
P14. Measuring vacuum of -0.01 inches of water at VP2 86 inches from XP1 where vacuum is applied from blower. 8/5/13

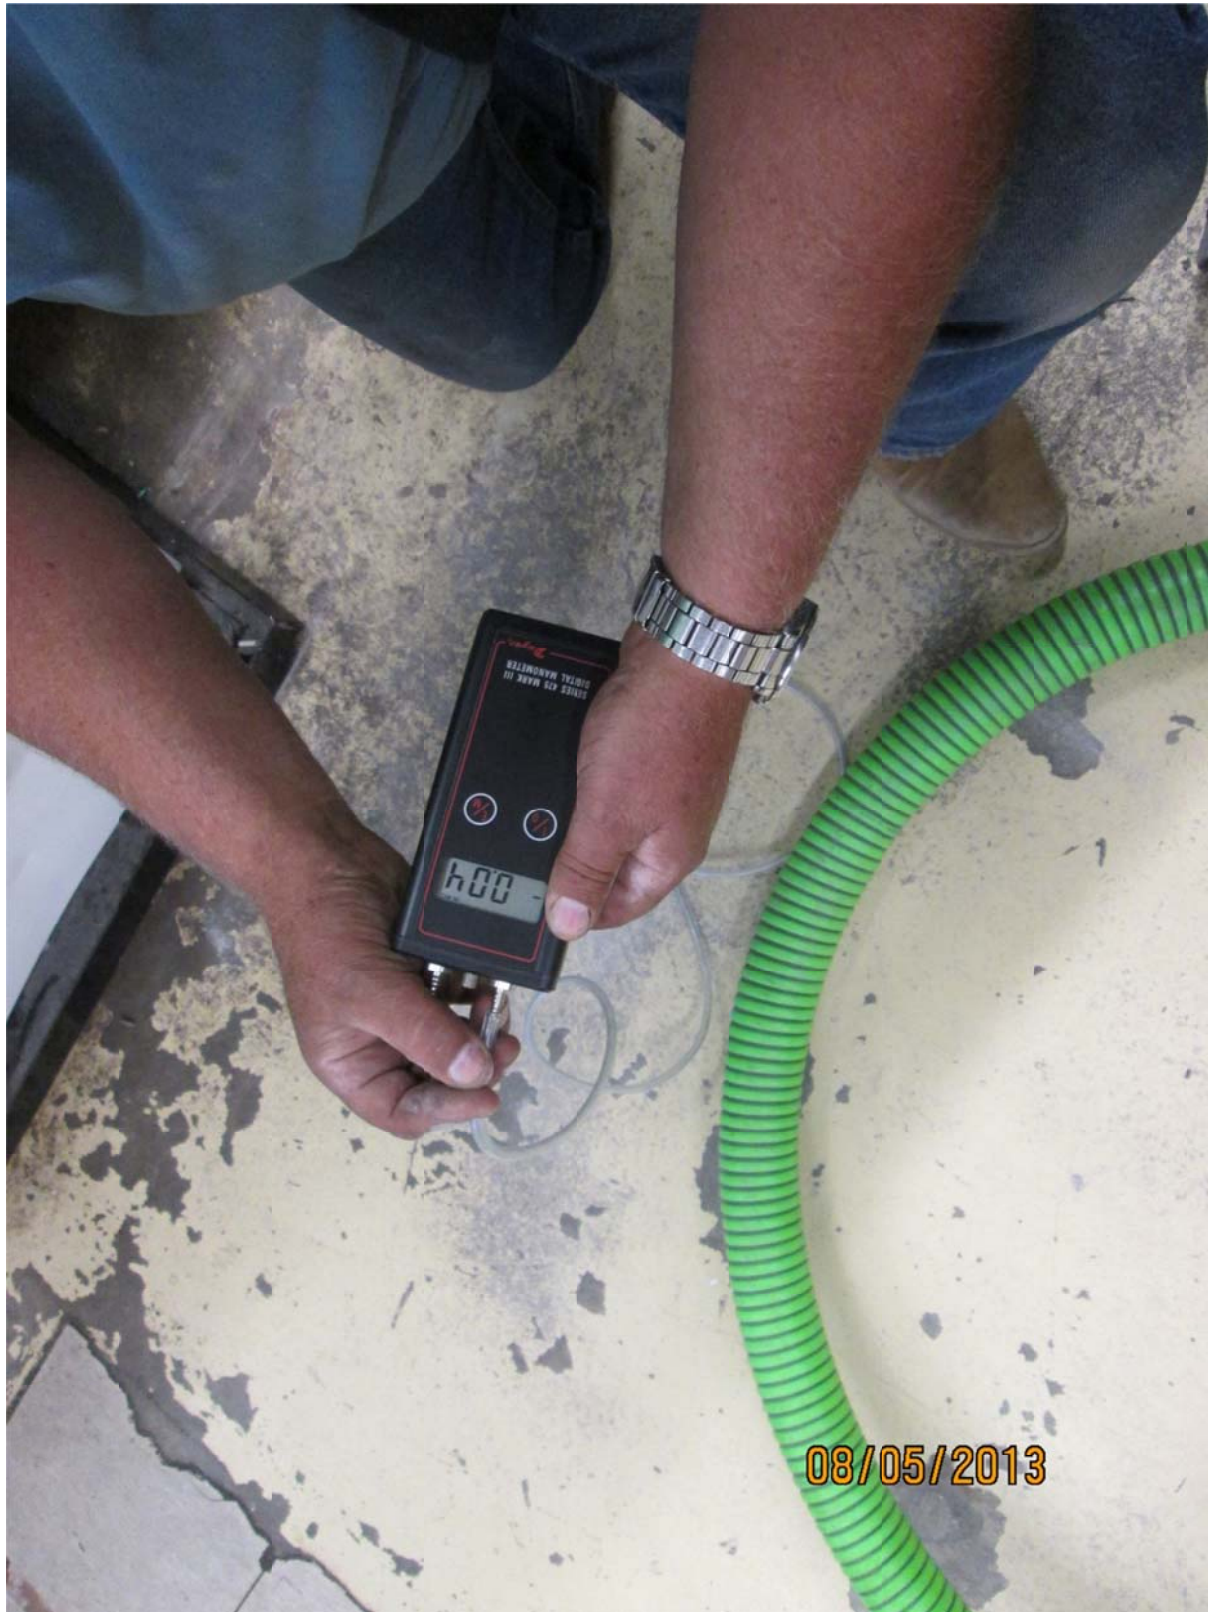
XP16. Vacuum of -0.04 inches of water measured at VP2 105 inches from XP3 where vacuum was applied with blower. 8/5/13

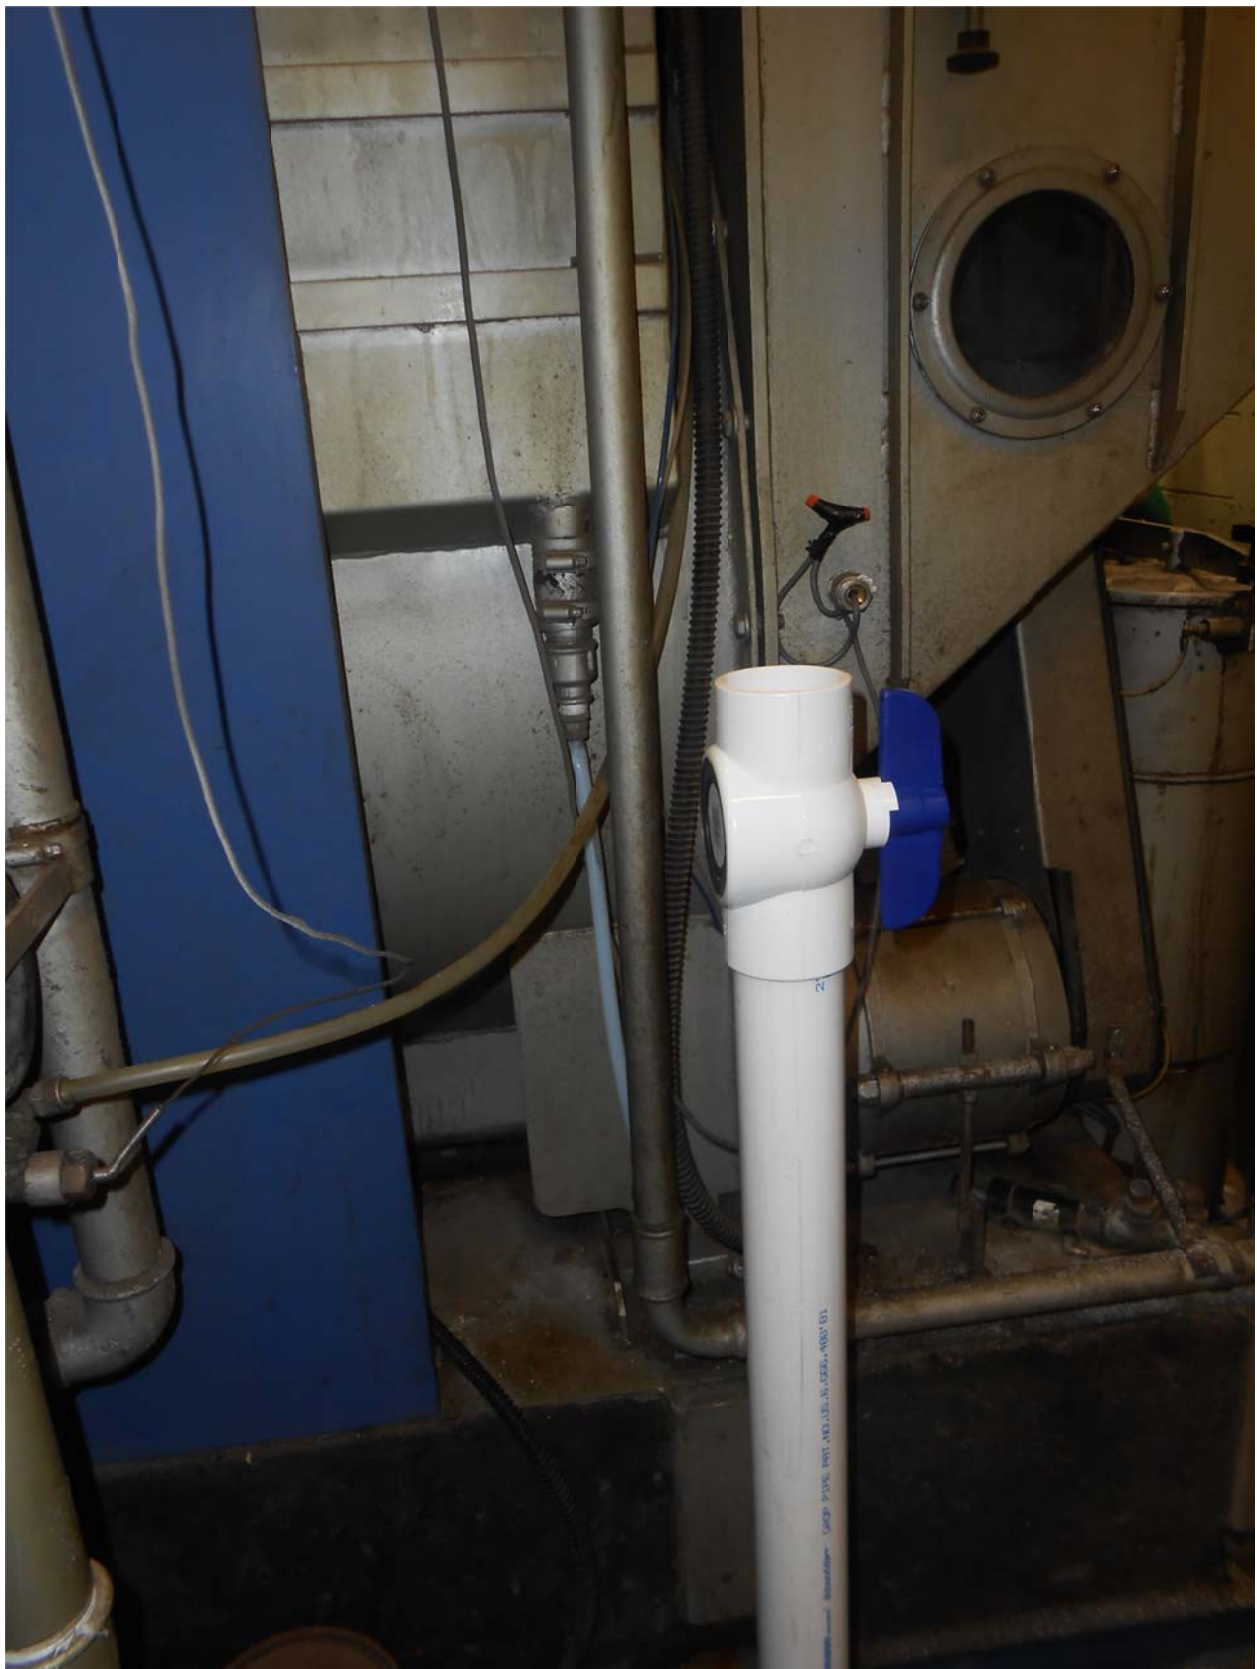
P17. 2-inch schedule 80 PVC vertical shaft installed at XP1 with blue-handled on/off valve to close shaft from atmosphere during vapor testing with Summa Canister or Photoionization Detector. 4/10/15

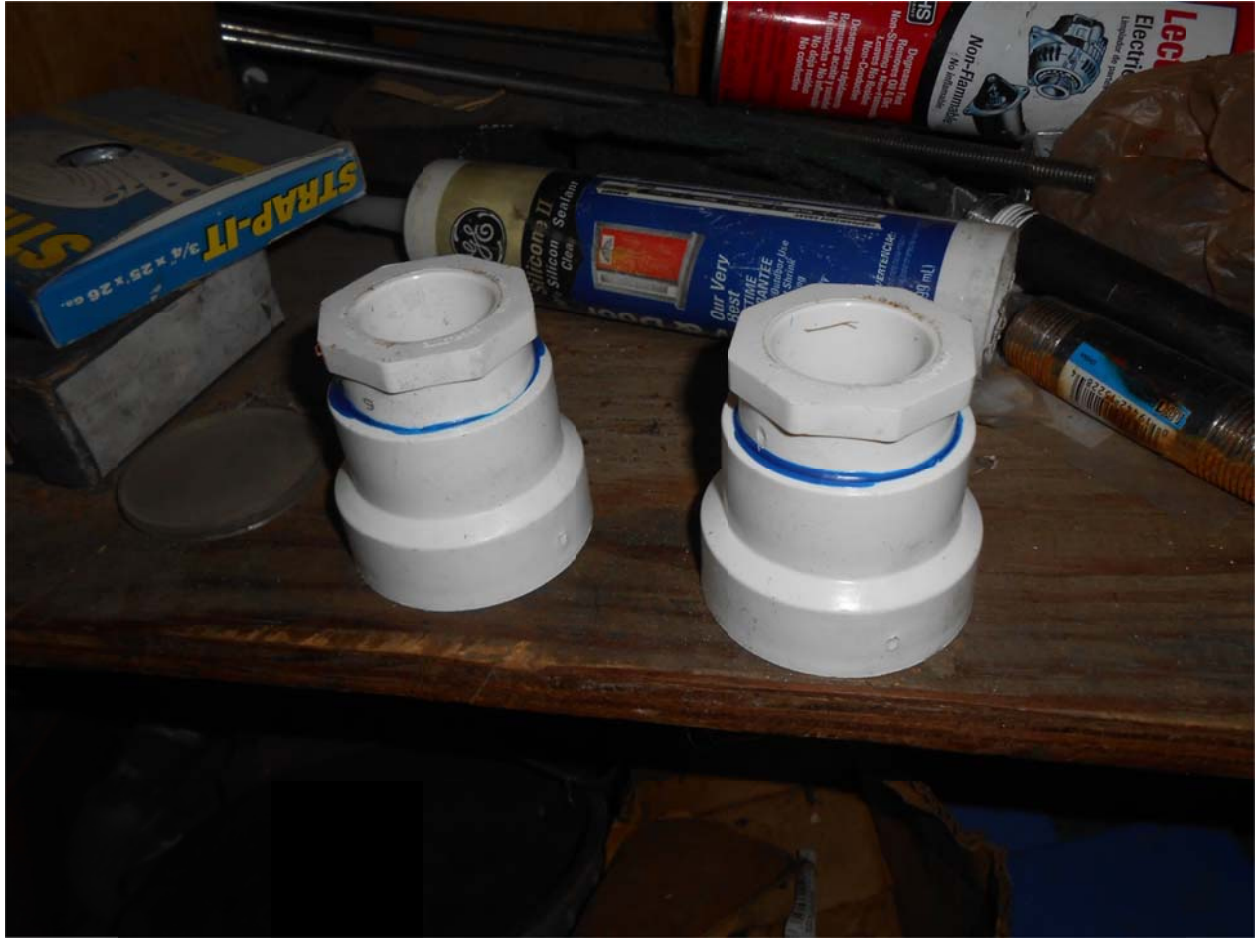
P21. Adapters for top of 2-inch PVC shaft above the roof to accommodate the 4-inch Stainless Turbines. For strength a glue had to be used to attach the components. 4/10/15

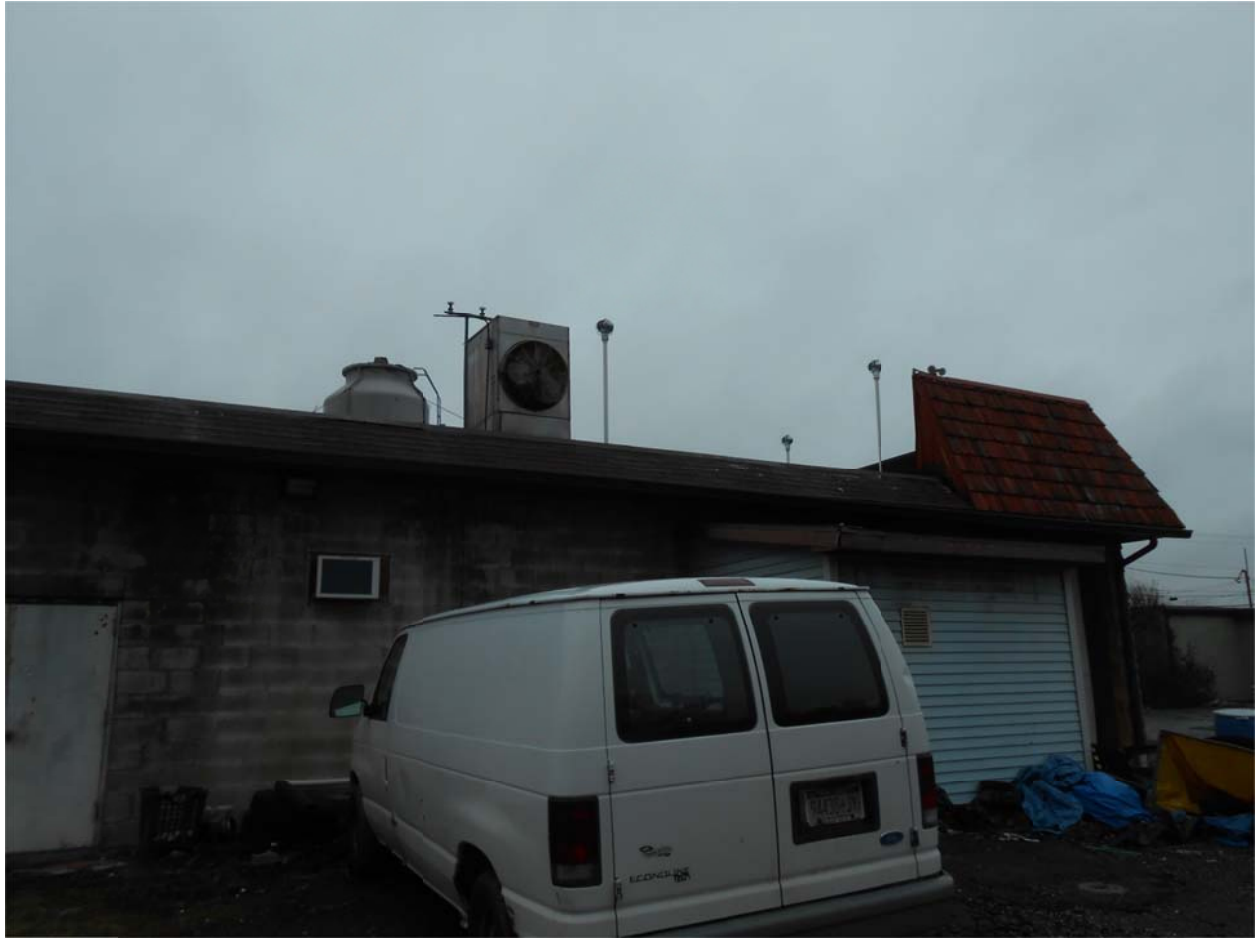
P22. Three of the turbines are seen from the back of the building. From left to right XP2, XP1, XP3. The turbine for XP4 can be seen from in front of the building. 4/10/15
