**American Cleaners Kingston  
Ulster County, New York**

**Interim Remedial Measures  
Construction Completion Report:**

**Sub-Slab Soil Vapor Extraction and  
Bioremediation of Groundwater  
NYSDEC Site Number: V-00601-3**

**SEPTEMBER 2017**

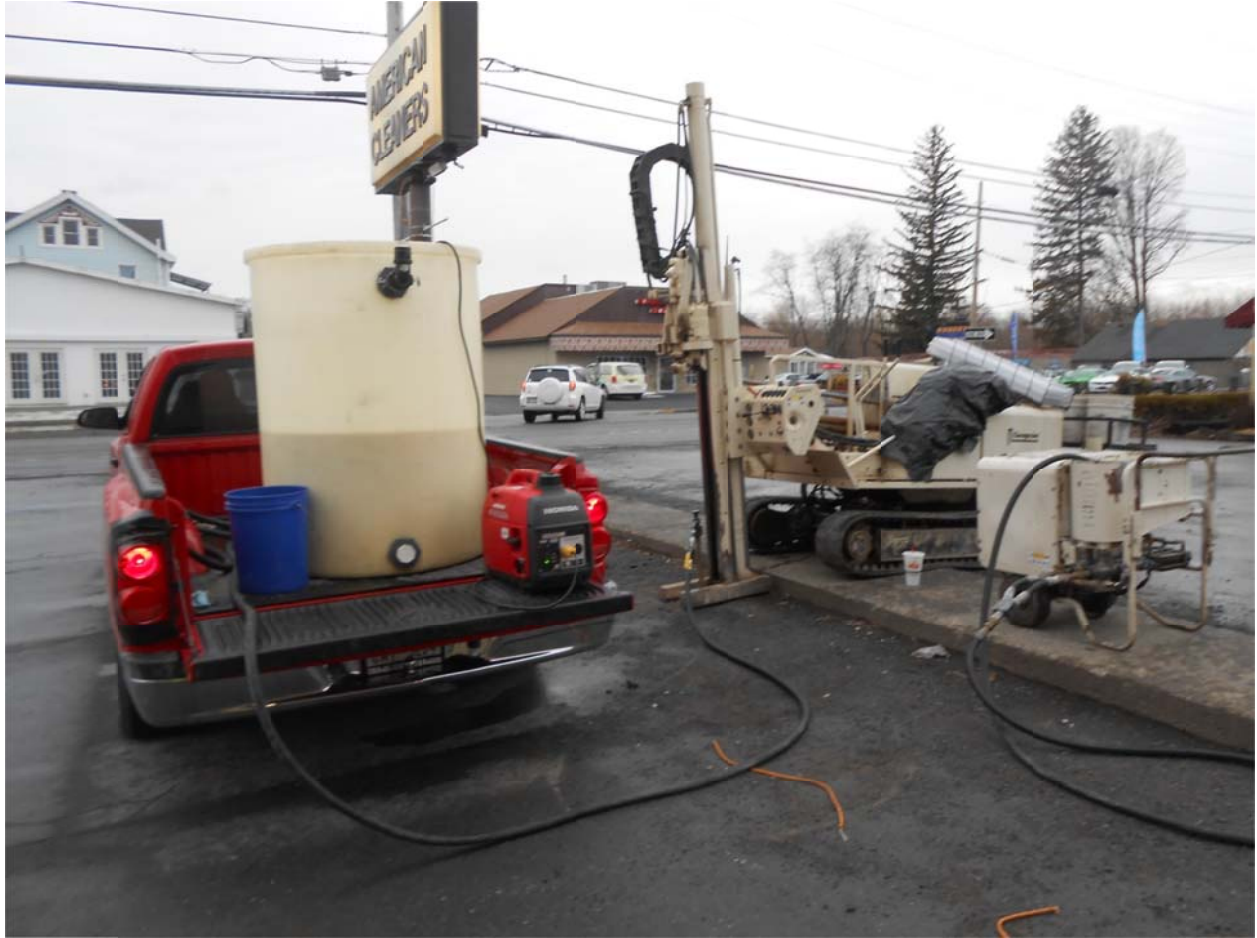
P30. The soils in some borings seem to be more permeable and did not require the high pressure pump. in that case a submersible pump in the tank on the truck was used to pump the fluid to the drill rod injection point. Injection was faster with this method. 4/15

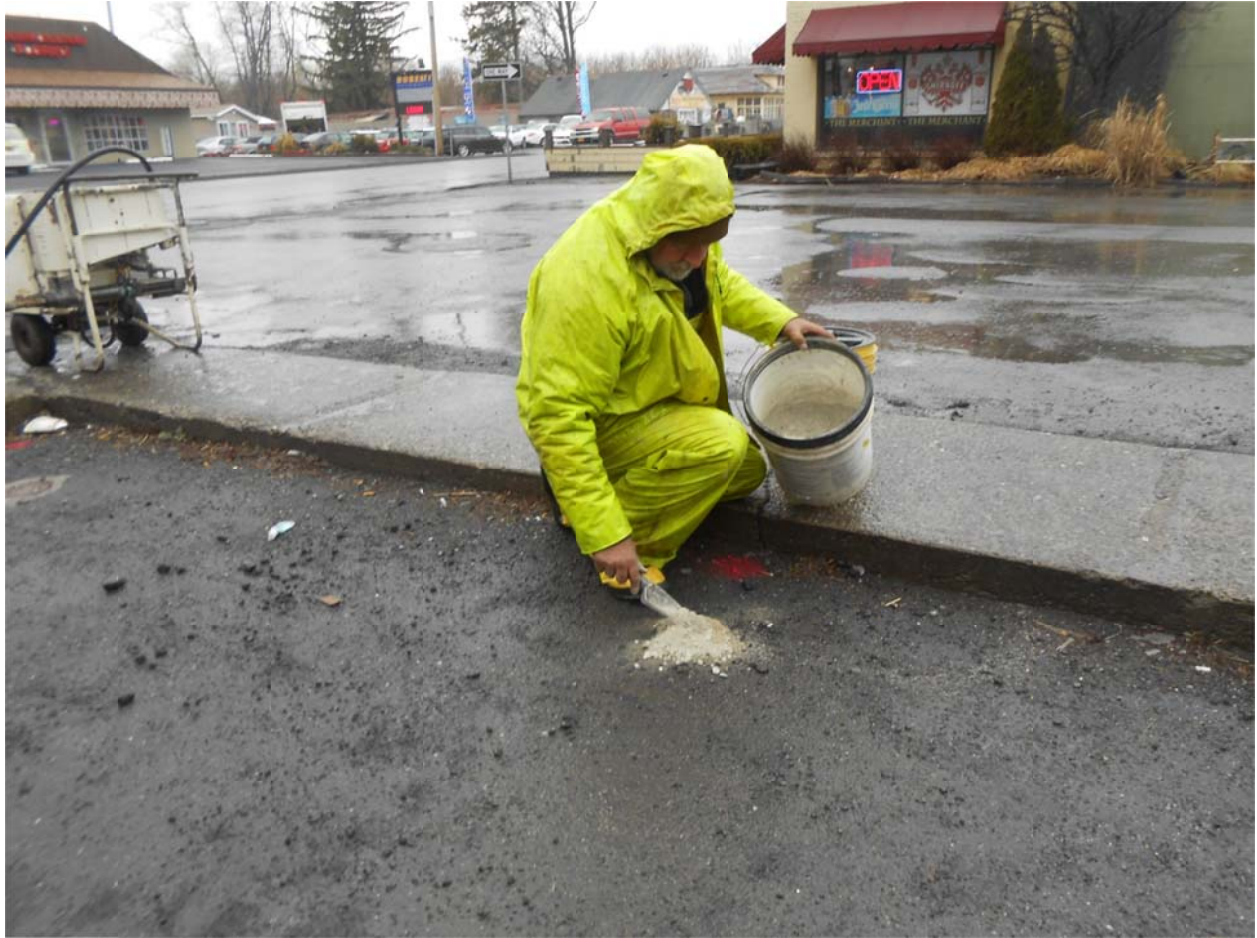
P33. Concrete was placed at the surface to seal the injection borings. 4/15

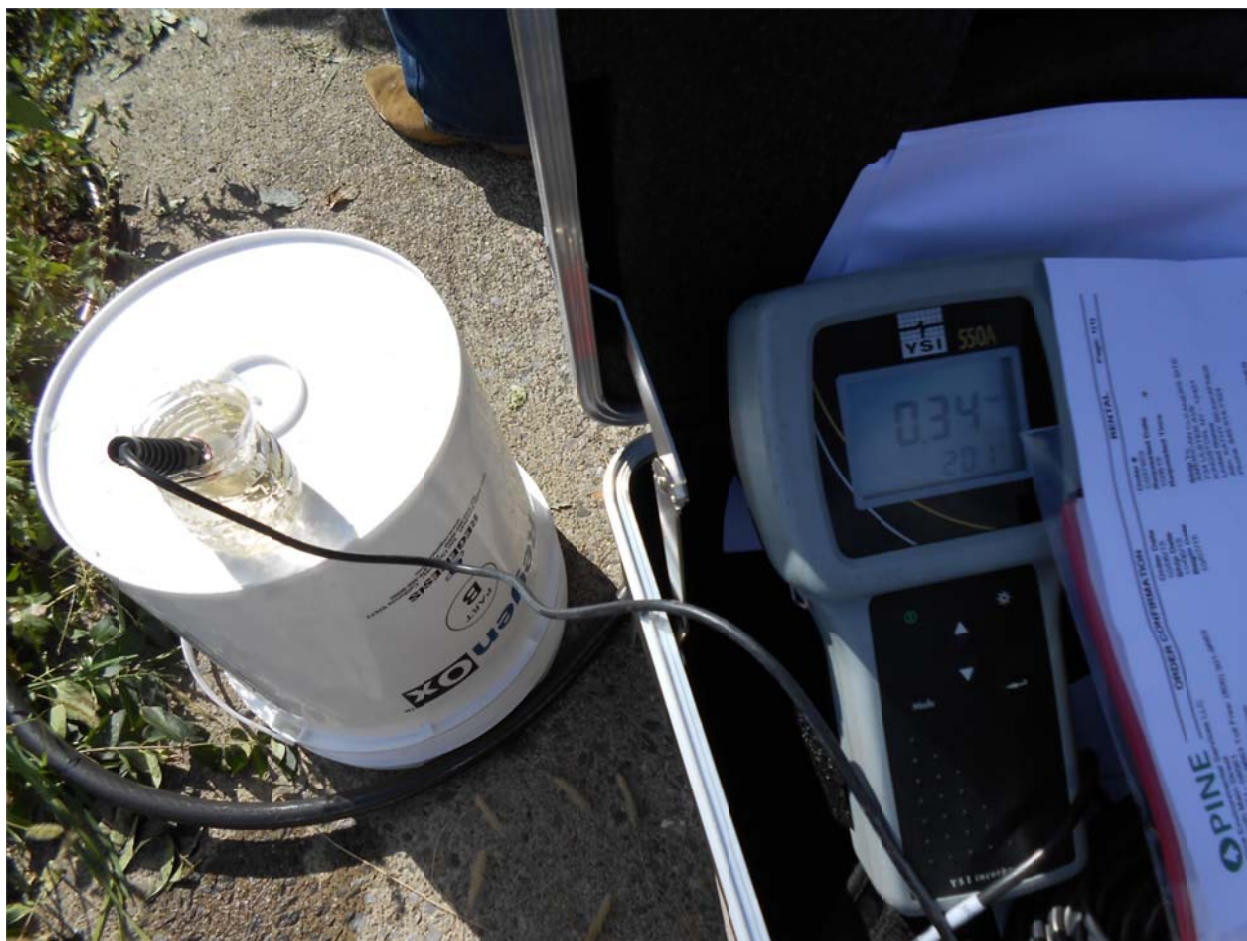
P39. The deoxygenated water in the beaker is tested to measure the concentration of dissolved oxygen with the YSI DO meter. The meter reads 0.34 mg/L at 20.1°C. Octper 7, 2015

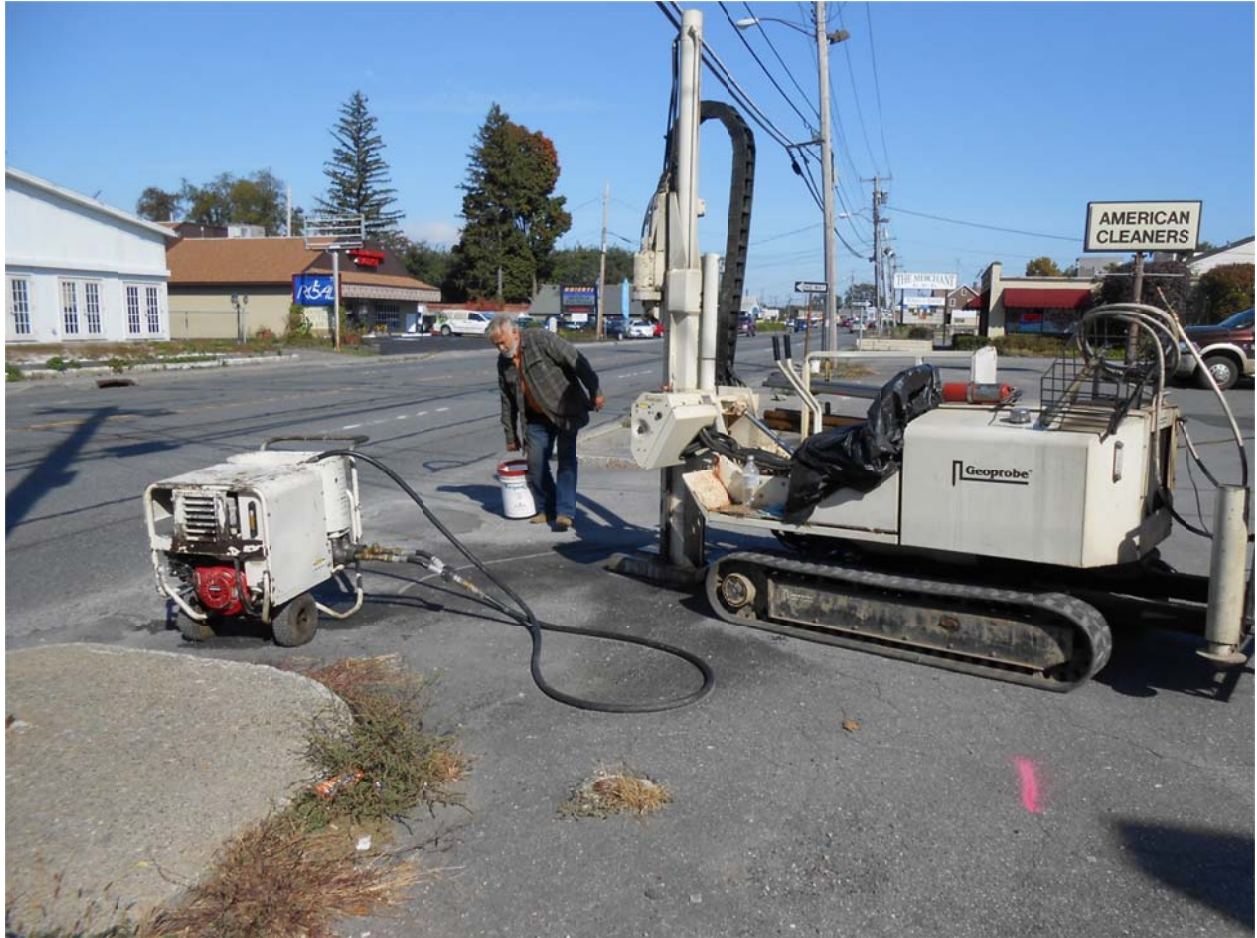
P46. Boring hole in the foreground is filled with sand and bentonite. October 8, 2015
