South Buffalo Redevelopment Plan: Steel Manufacturing Site

Voluntary Cleanup Site Assessment Report Volume 1: Text

**SOUTH BUFFALO REDEVELOPMENT PLAN
STEEL MANUFACTURING SITE**

VOLUNTARY CLEAN-UP SITE ASSESSMENT REPORT

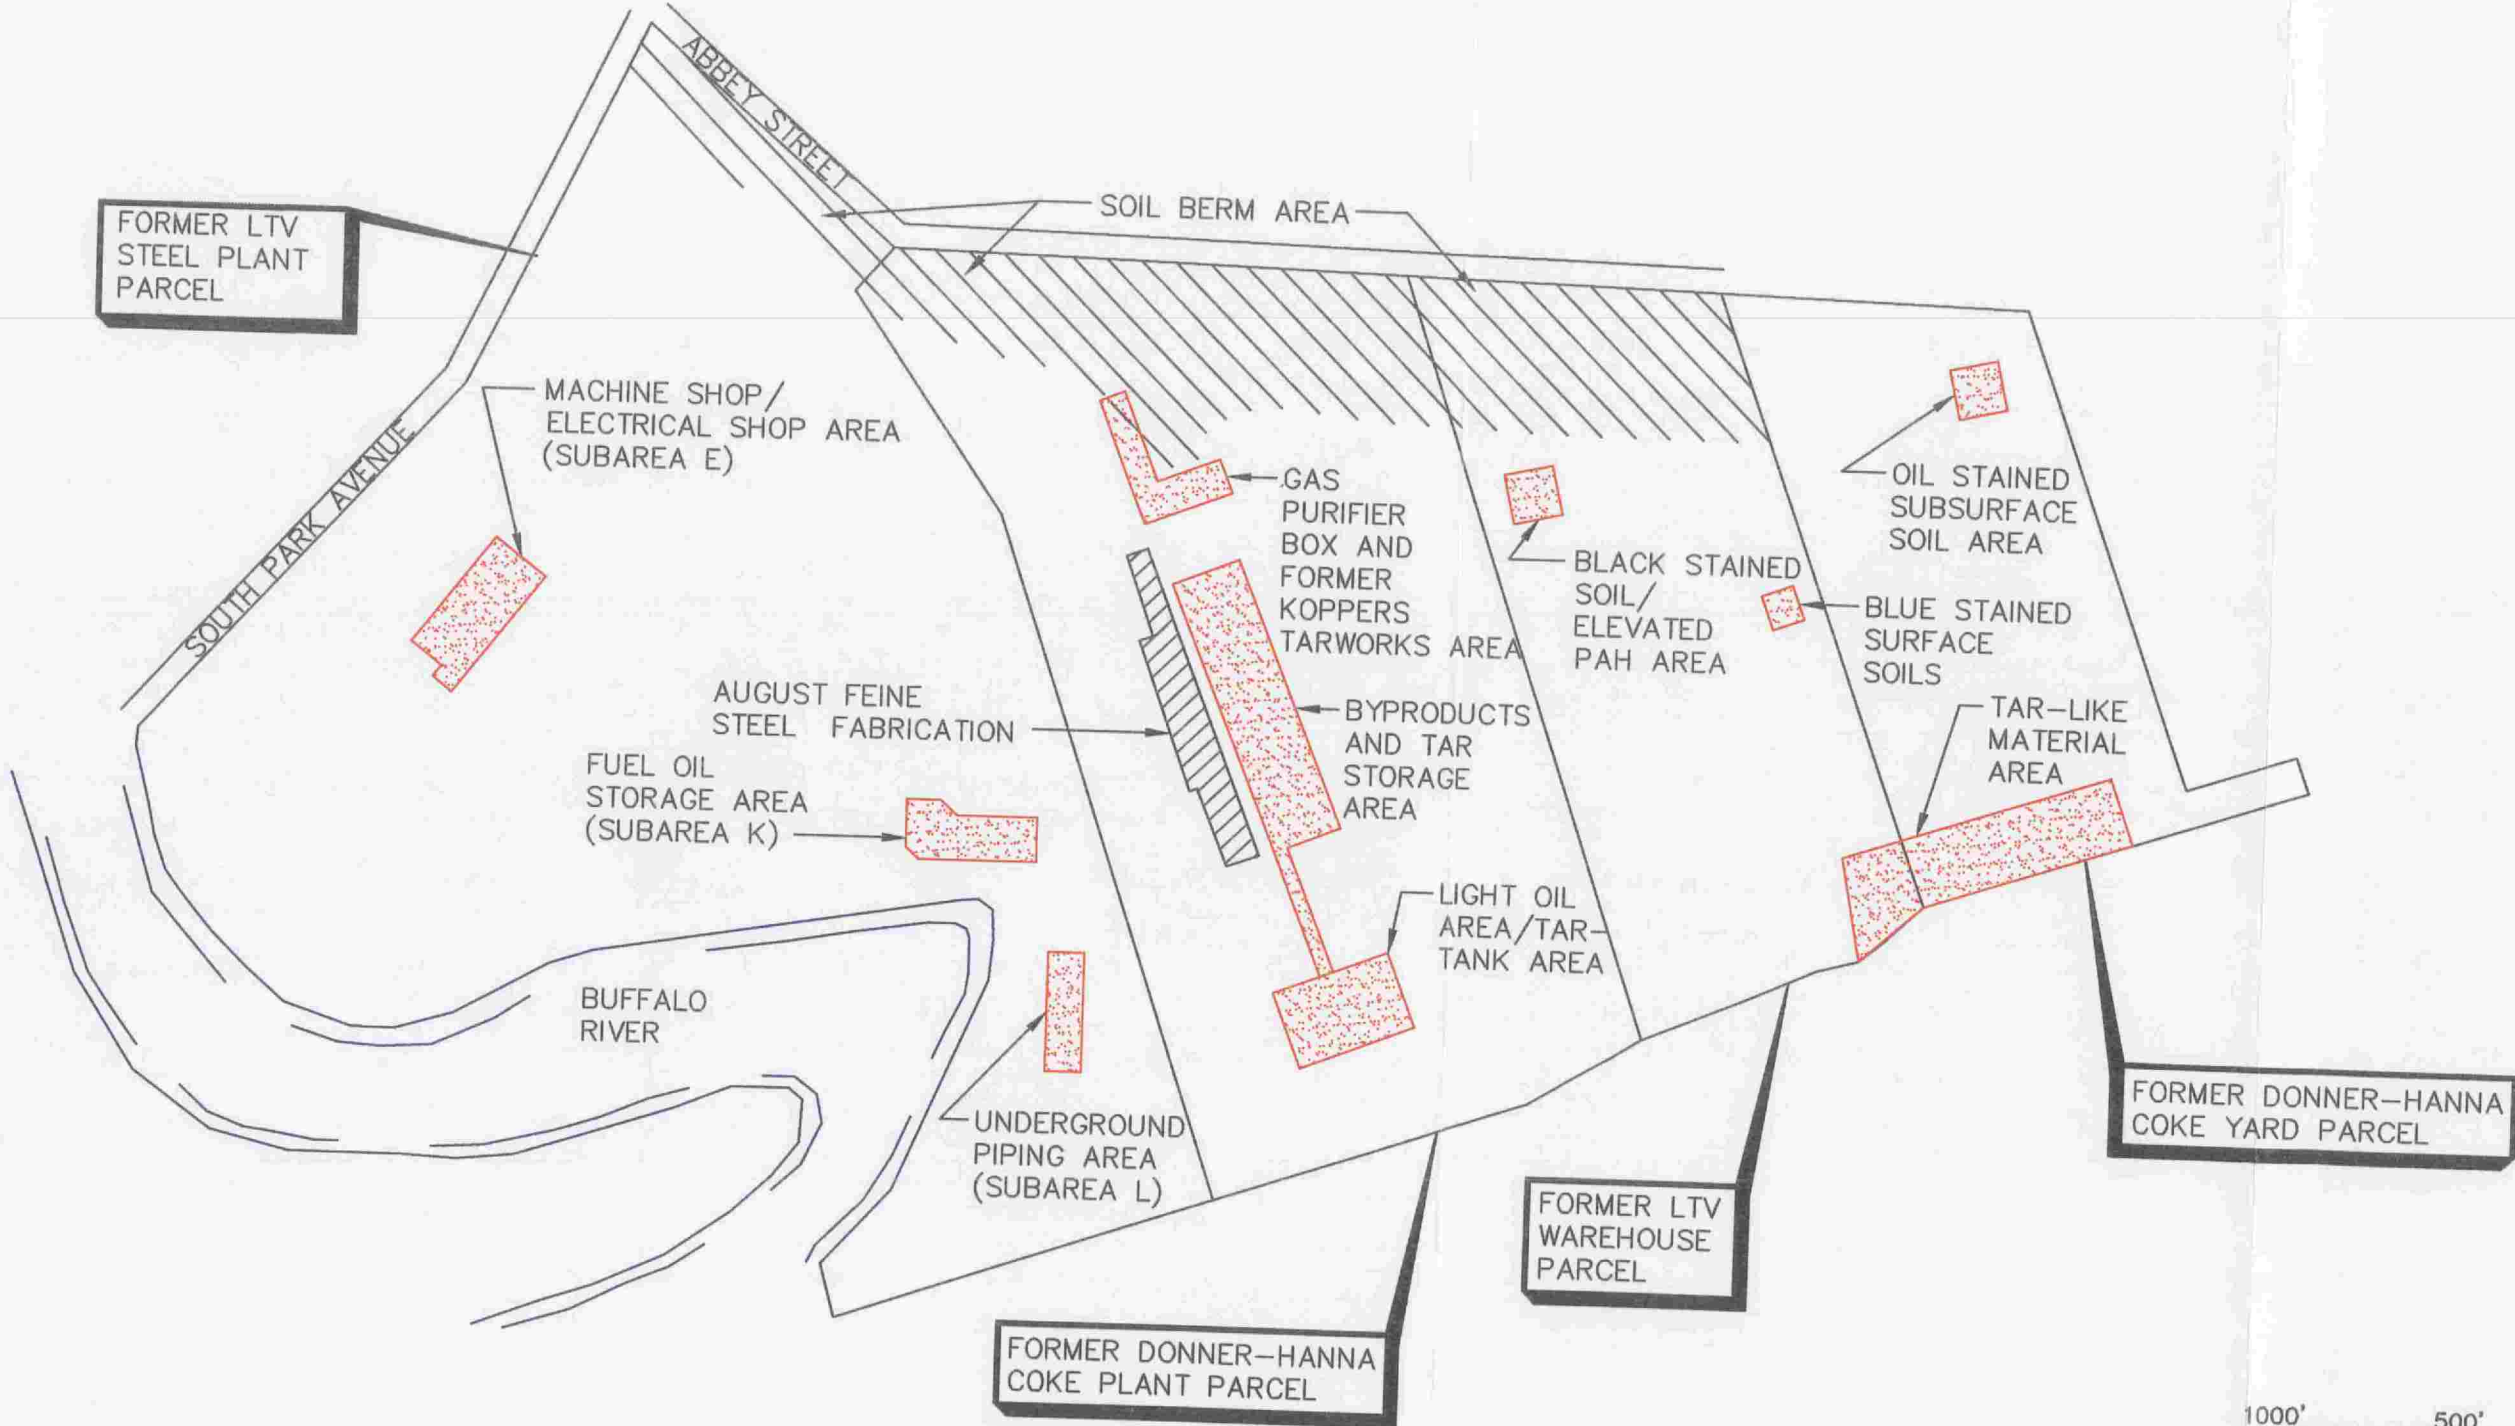
Subsurface soil sampling during the Phase II ESA identified three subareas with subsurface soil contamination. These three subareas include:

- The former machine shop/electric shop subarea (Subarea E).
- The former fuel oil storage subarea (Subarea K).
- The tar/fuel oil underground piping subarea (Subarea L).

Subsurface contamination was characterized by elevated PAH compounds associated with the former storage and transport of fuel oil. Stained soils and/or tar-like oil were observed in several boreholes in these three subareas.

The subsurface soils were contaminated with aromatic hydrocarbons (BTEX) and PAHs. Many of the PAH compound concentrations exceeded EPA risk-based concentrations. Black stained soils, elevated PID readings, and olfactory evidence of contamination were apparent at these subareas.

Area III is contaminated with BTEX and PAH compounds. Cyanide concentrations detected in the blue stained surface soils in the south-central portion of Area III did not exceed EPA risk-based concentrations for industrial sites, but the potential of higher cyanide concentrations in this subarea exists and its potential impact on groundwater presents an environmental concern. Black stained soils and elevated PAH concentrations were detected in the northeastern portion of Area III.
