**SITE MANAGEMENT
PERIODIC REVIEW REPORT (PRR)
WHILPOOL BRIDGE SOILS REMEDIATION**

**NIAGARA FALLS BRIDGE COMMISSION
NIAGARA FALLS, NY**

**Submitted to
NYSDEC, Buffalo, NY**

WHIRLPOOL BRIDGE SOILS REMEDIATION PERIODIC REVIEW (PRR) REPORT March 2014

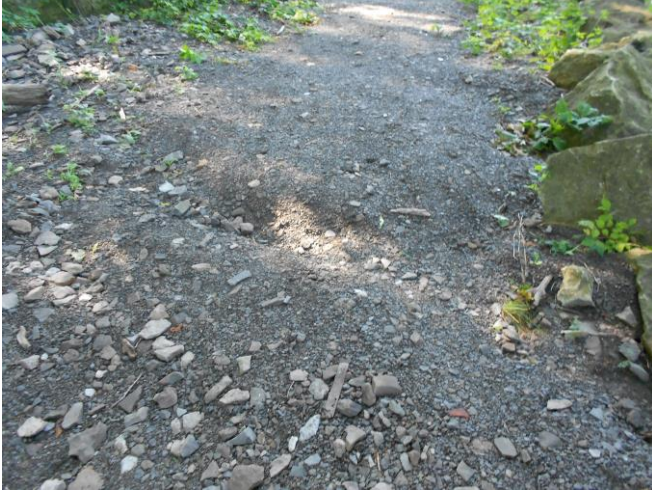
Ruts are forming across the Improved Trail as storm water and landslide debris flows across it near SW-2.

There is no O&M associated with the environmental remedy for this site. Trail repair work necessary due to erosion being done by the NFBC and NYSOPRHP. Side slope erosion from runoff during significant storm events has been observed in the area around MW-1/SW-2 (see photos on Figure 3A). As part of its bridge maintenance program, the NFBC will be addressing the soil erosion at MW-1/SW-2, and a sink hole that appeared on the trail above the Lower Retaining Wall (see photos on Figure 3B). Design efforts for these repairs are underway, and the repair work will be completed by the NFBC this construction season.

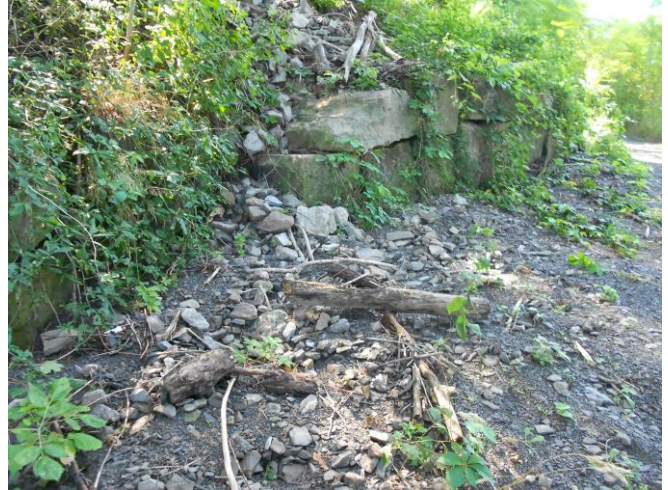
SW-2 and the improved trail are repeatedly covered with landslide debris after storm events. Landslide material easily washes over the existing stone block wall.

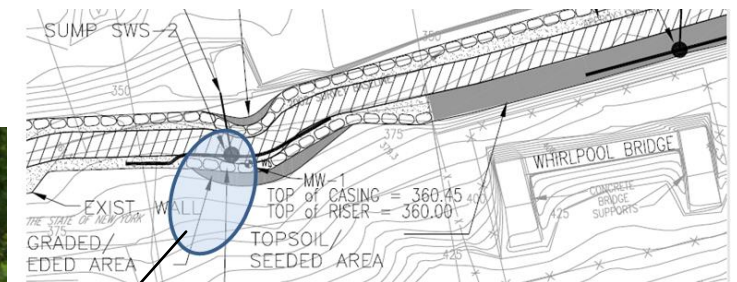
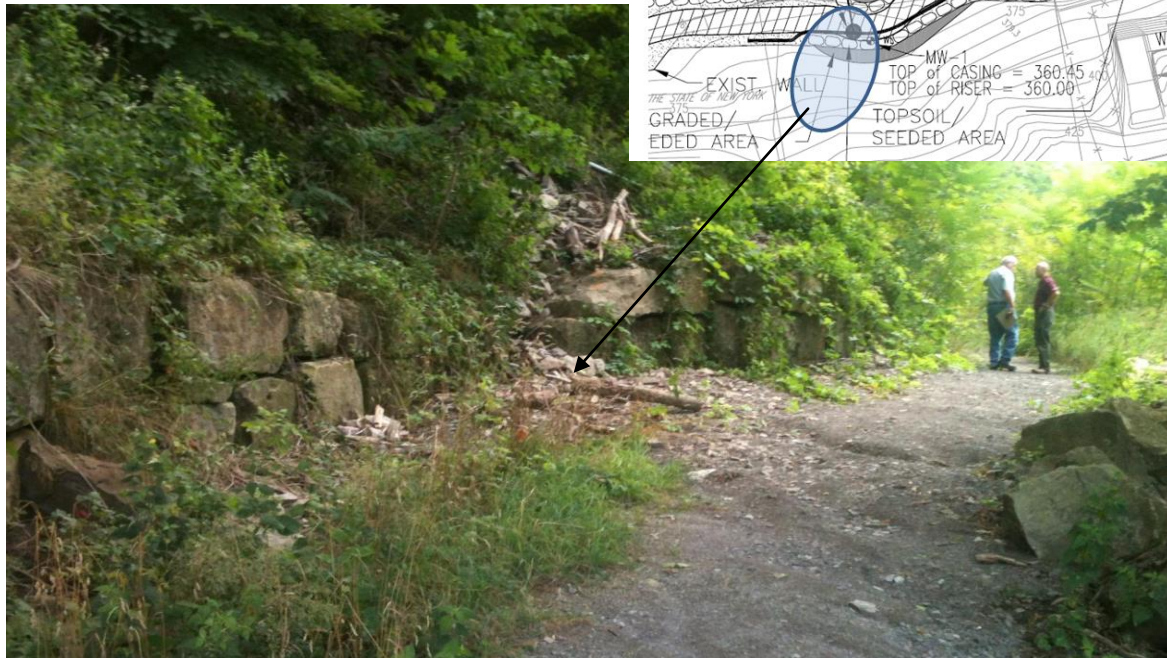
Overview showing the block wall to the north and south of the landslide area near SW-2. MW-1 is located a few yards east of SW-2 and has the same type of stone block wall protecting it. Movement of the slope is slowly pushing the adjacent stone over the monitoring well.

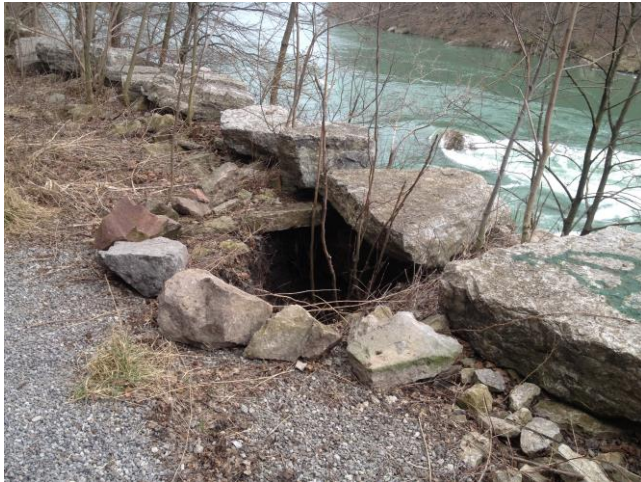
Side slope erosion from runoff during storm events has been significant lately in the area around MW-1/SW-2. IEG developed a Memo in March 2013 to address this side slope erosion. IEG prepared another Memo in May 2013 to address a sink hole that occurred on the trail above the Lower Retaining Wall. The NFBC will be repairing these two areas as part of its bridge maintenance program.

SINK HOLE BY LOWER RETAINING WALL;
UPPER RETAINING WALL TO THE LEFT

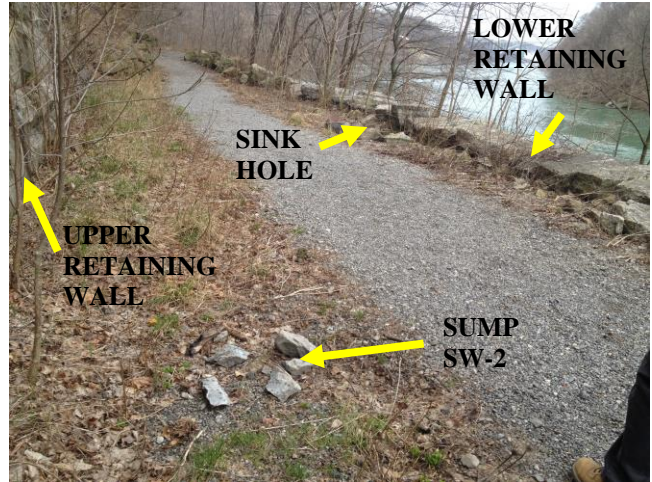
RELATIVE LOCATIONS OF SINK HOLE AND
SW-2 SUMP

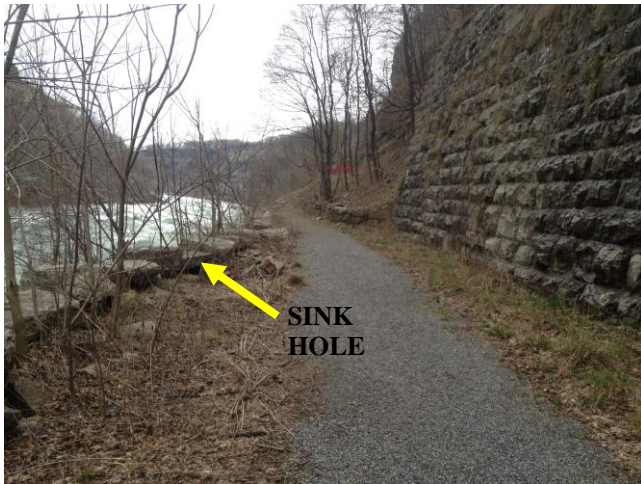
THE UPPER TRAIL REMAINS IN EXCELLENT
CONDITION

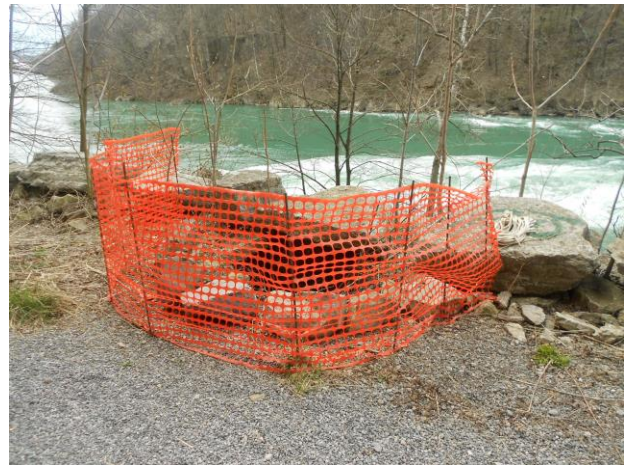
TEMPORARY SAFETY FENCE AT SINK
HOLE
