RE: WHIRLPOOL BRIDGE SOILS (Site #V00655)
Periodic Review Report and IC/ECC Certification Submittal
Period January 1, 2014 through January 1, 2017

SITE MANAGEMENT PERIODIC REVIEW REPORT (PRR) WHILPOOL BRIDGE SOILS REMEDIATION

WHIRLPOOL BRIDGE SOILS REMEDIATION
PERIODIC REVIEW REPORT (PRR)
Period from January 1, 2014 through January 1, 2017

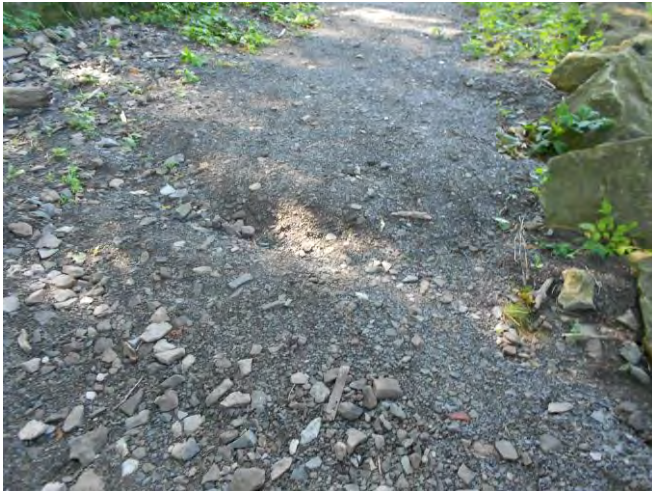
Ruts are forming across the Improved Trail as storm water and landslide debris flows across it near SW-2.

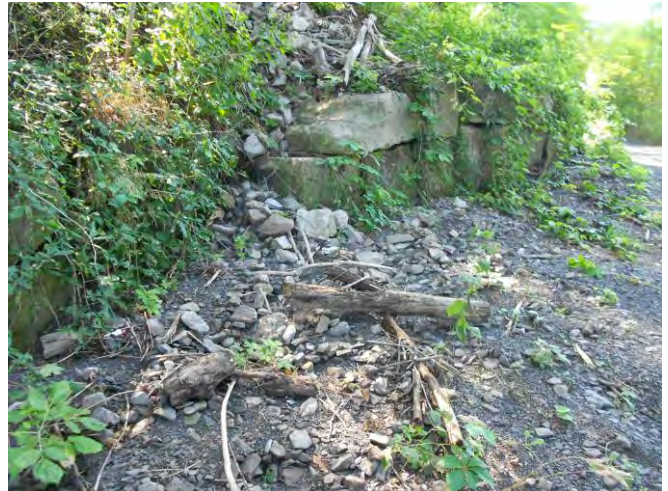
SW-2 and the improved trail are repeatedly covered with landslide debris after storm events. Landslide material easily washes over the existing stone block wall.

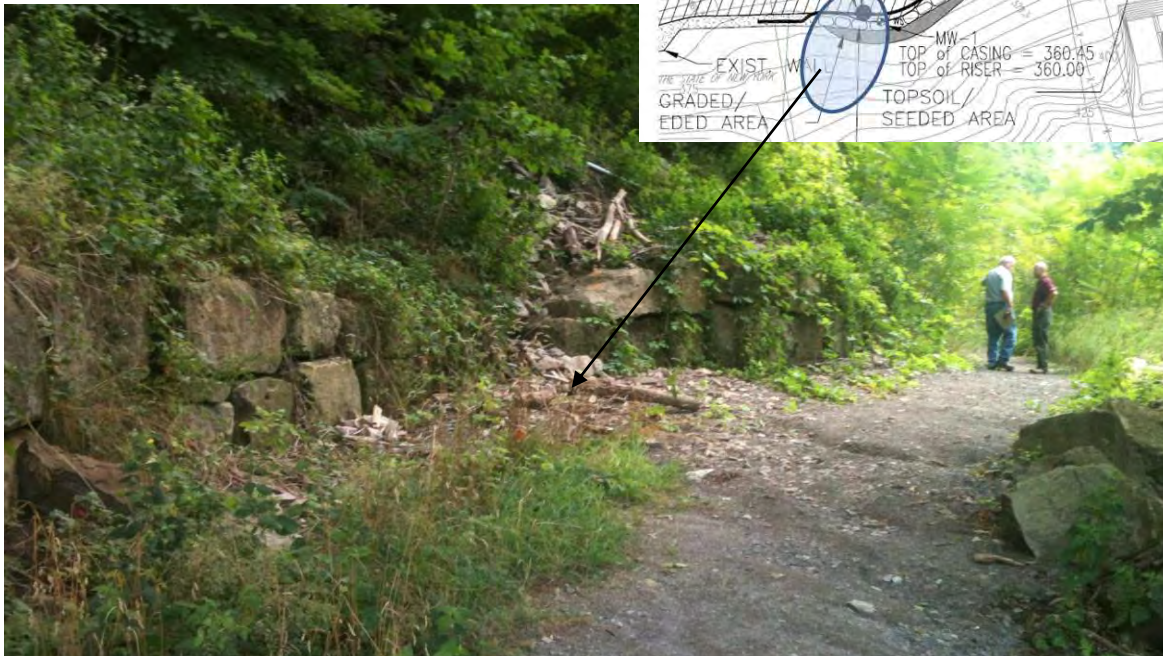
Overview showing the block wall to the north and south of the landslide area near SW-2. MW-1 is located a few yards north of SW-2 and has the same type of stone block wall protecting it. Movement of the slope is slowly pushing the adjacent stone over the monitoring well.

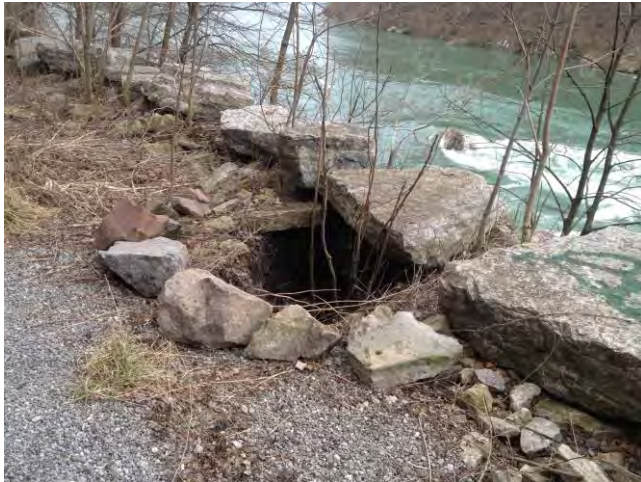
Side slope erosion from runoff during storm events had been significant in 2012 and 2013 in the area around MW-1/SW-2 (see Figure 3a). In addition, a sink hole formed above the Lower Retaining Wall (see Figure 3b). These erosions resulted in elevated levels of lead and other metals in surface and groundwater but still well below pre-remediation levels. The NYSDEC directed the NFBC to undertake erosion repair work and restore the trail.

Sink hole by lower retaining wall; upper retaining wall is to the left (not visible)

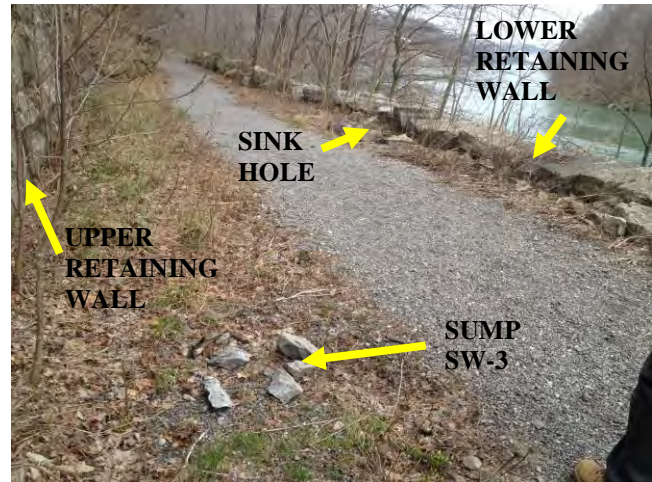
Relative locations of sink hole and SW-3 sump

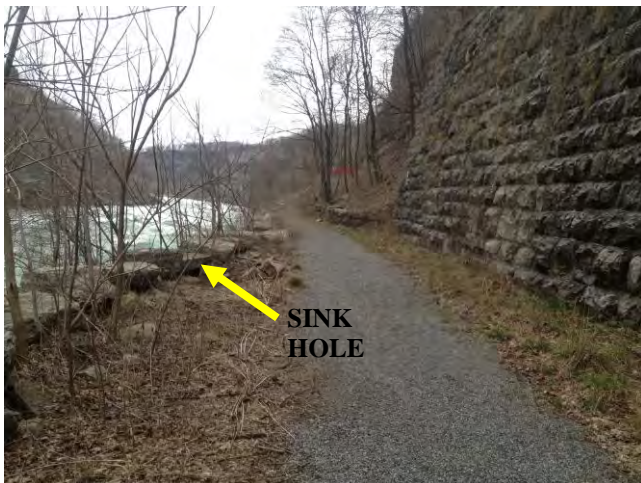
The upper trail remains in excellent condition

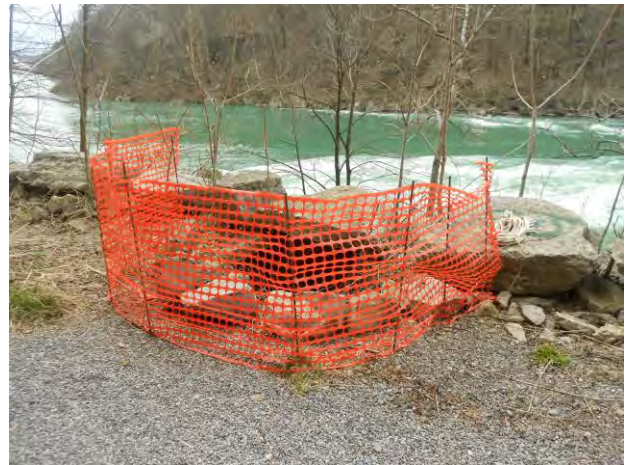
Temporary safety fence at sink hole

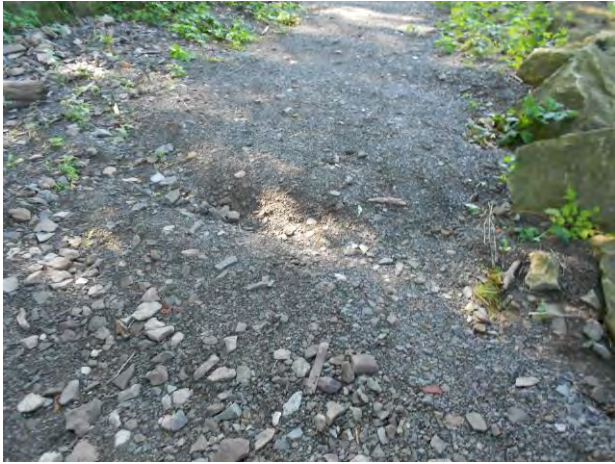
Before – Ruts are forming in the Improved Trail caused by storm water runoff near SW-2

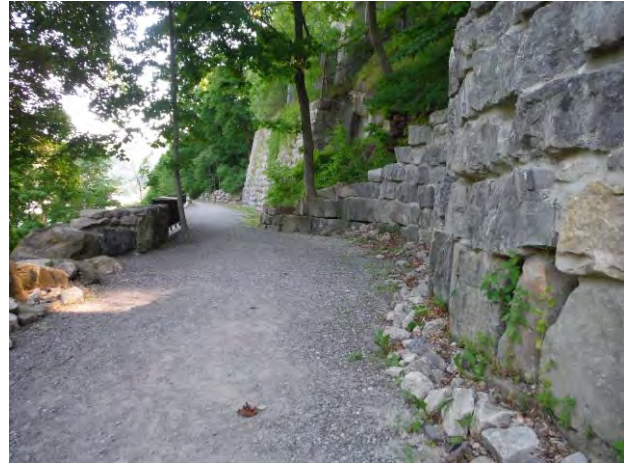
After – Improved Trail is level and smooth

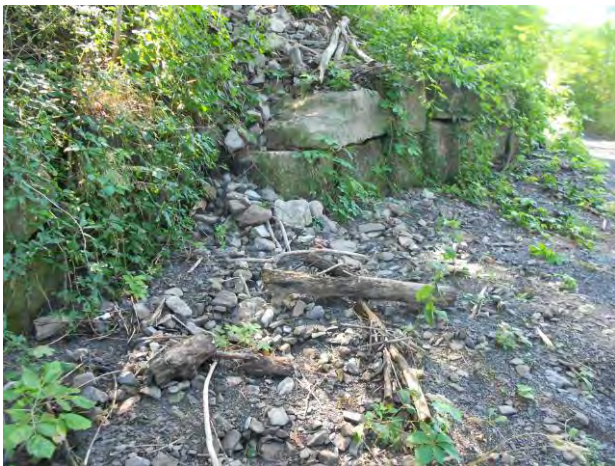
Before – Landslide debris washes over existing stone walls onto Improved Trail near SW-2

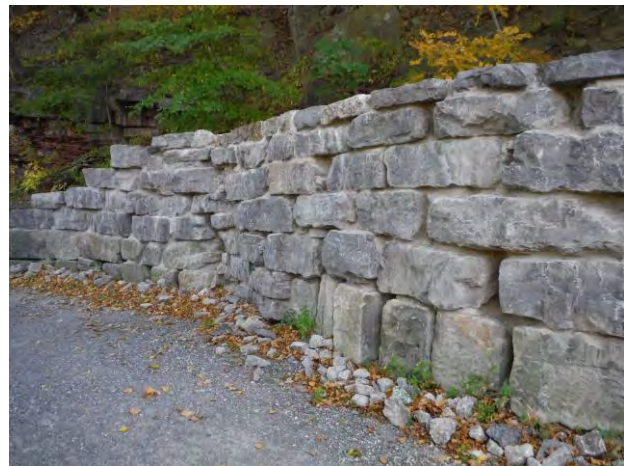
After – The larger Erosion Control Wall prevents landslide debris from reaching the Improved Trail

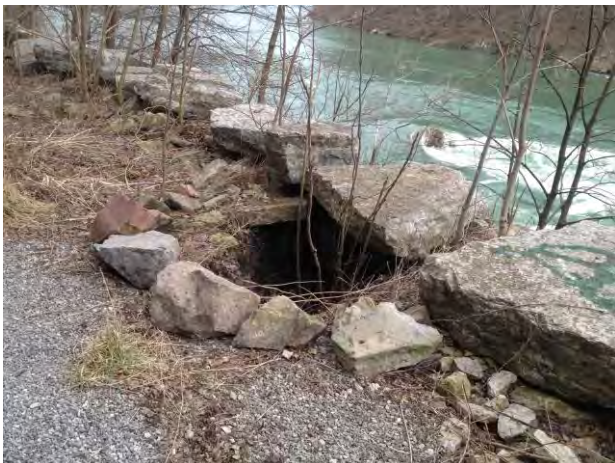
Before – Sink hole above the Lower Retaining Wall adjacent to the Improved Trail

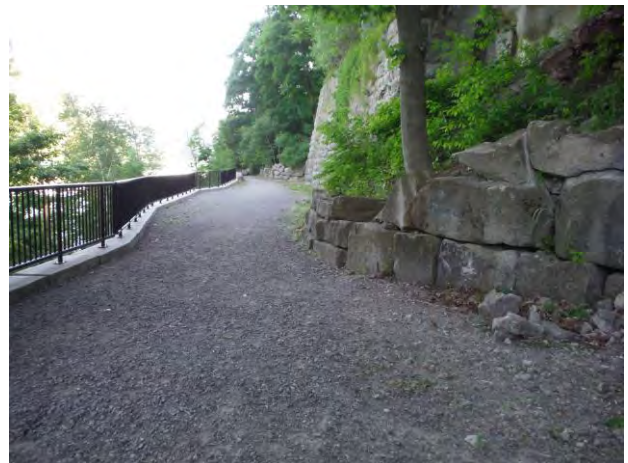
After – The sink hole is filled and a metal railing has been added above the Lower Retaining Wall

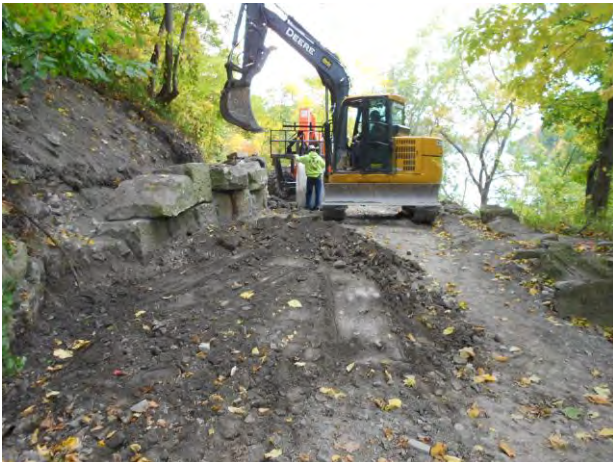
A Landslide material on the trail is excavated and disposed

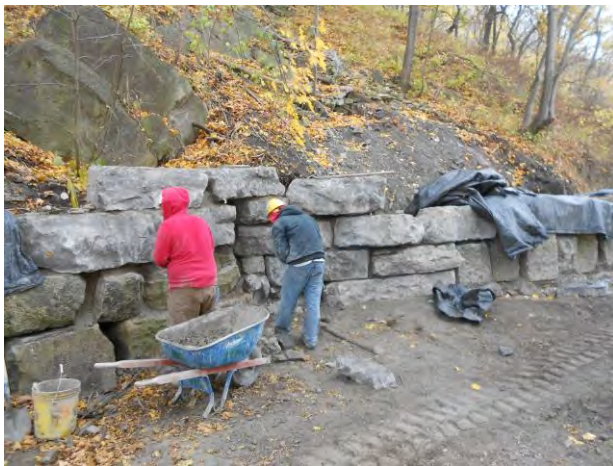
Grout is added to both the front and back of the wall after stones are placed

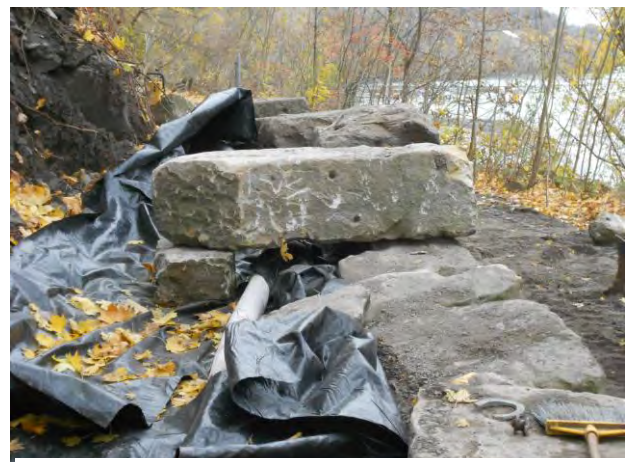
Pilasters are incorporated into the wall to add stability

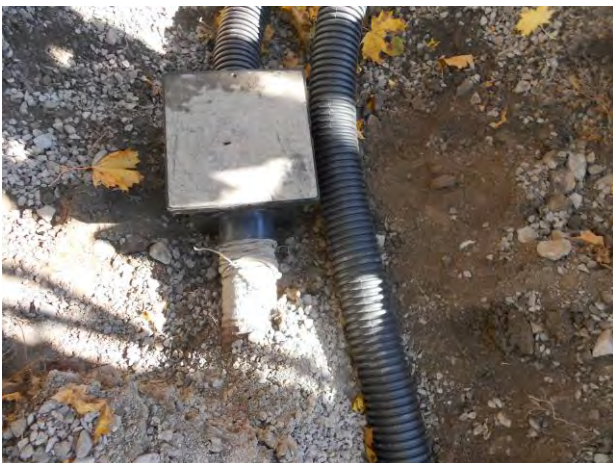
The Erosion Control drain pipe and SW-2 drain pipe run parallel under the Improved Trail

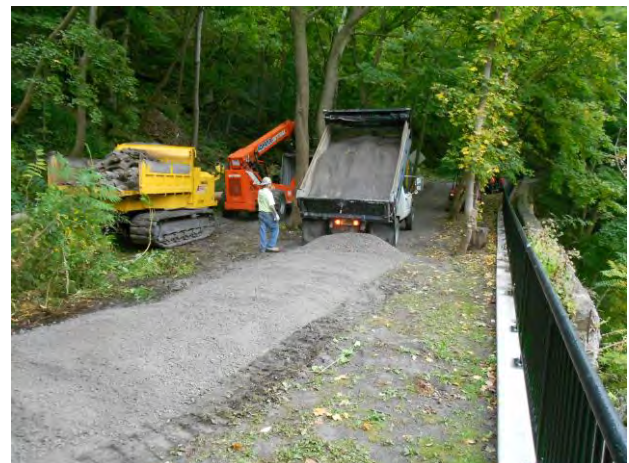
Crushed stone is brought in to protect the Improved Trail

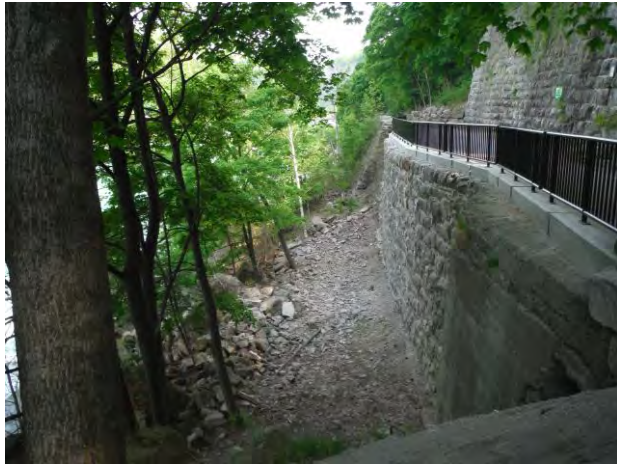
Looking north - view of the repaired Lower Retaining Wall and new handrail
