Whirlpool Rapids Bridge, Site No.: V00655
Niagara Falls, Niagara County

**SITE MANAGEMENT
PERIODIC REVIEW REPORT (PRR)
WHILPOOL BRIDGE SOILS REMEDIATION**

January 2026

Iyer Environmental Group, PLLC

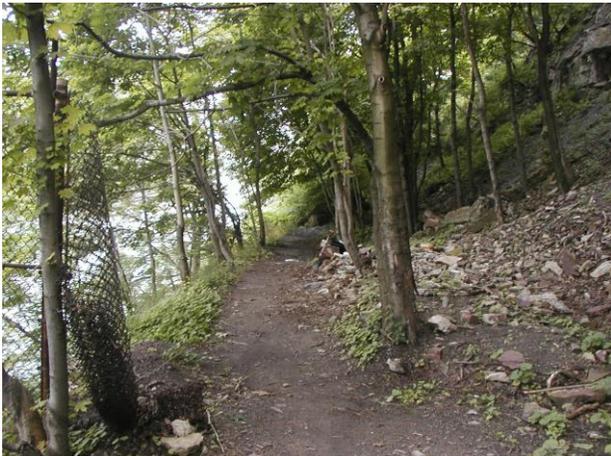
Before – North end of Trail in Excavation Zone

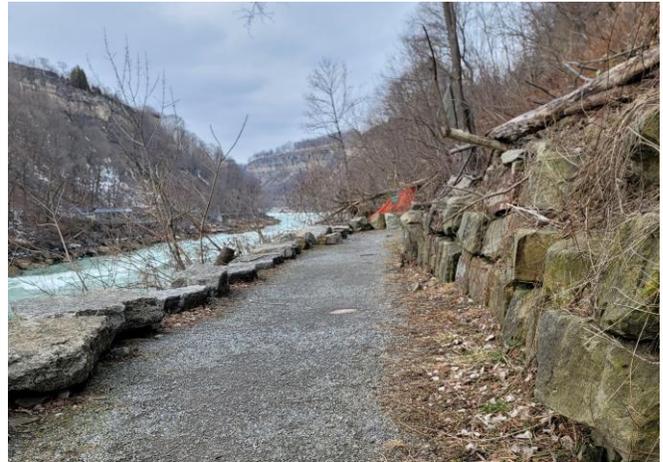
After – North section of Trail in Excavation Zone

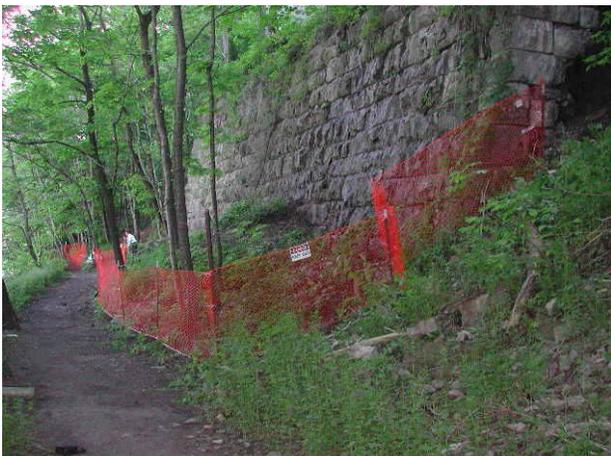
Before – Looking North at Upper Retaining Wall

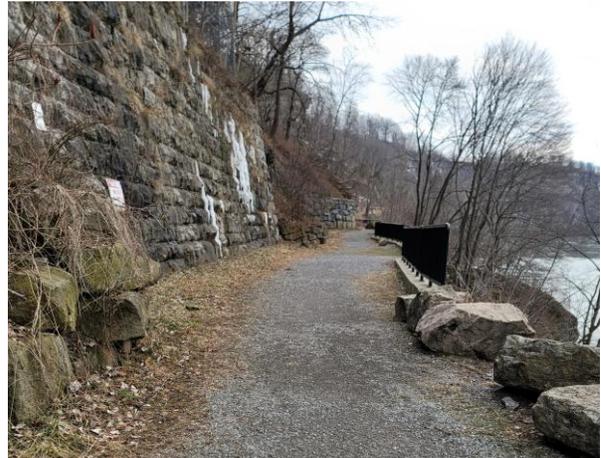
After – Looking South at Upper Retaining Wall

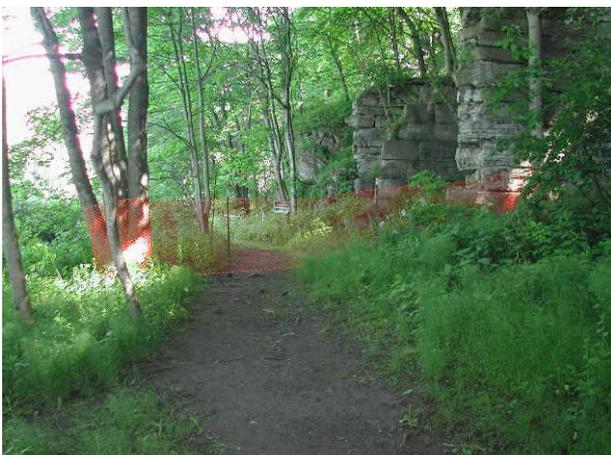
Before – South end of Excavation Zone near Old Bridge Supports

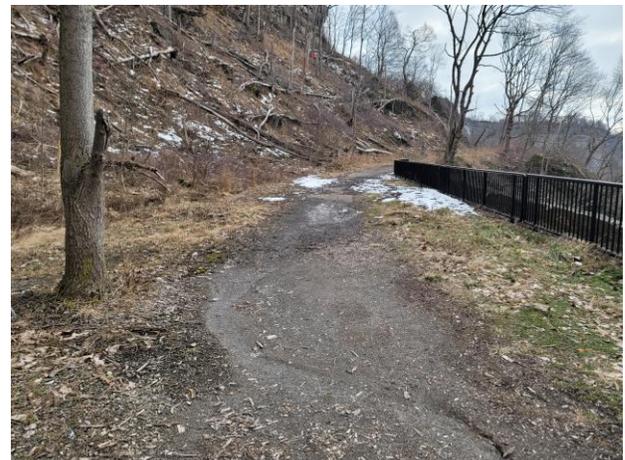
After – South end of Excavation Zone near Old Bridge Supports

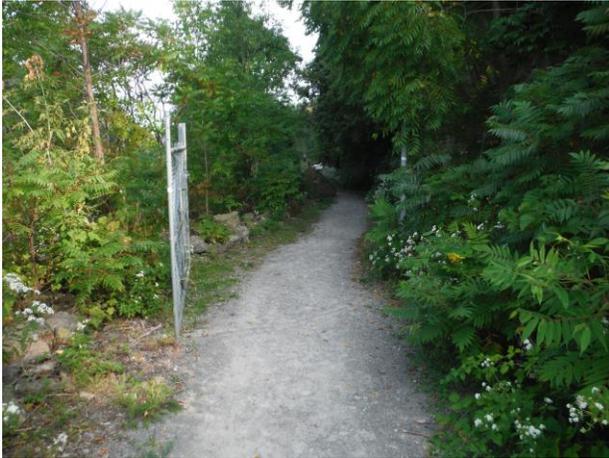
Looking North on the Improved Trail at the gate near the south end

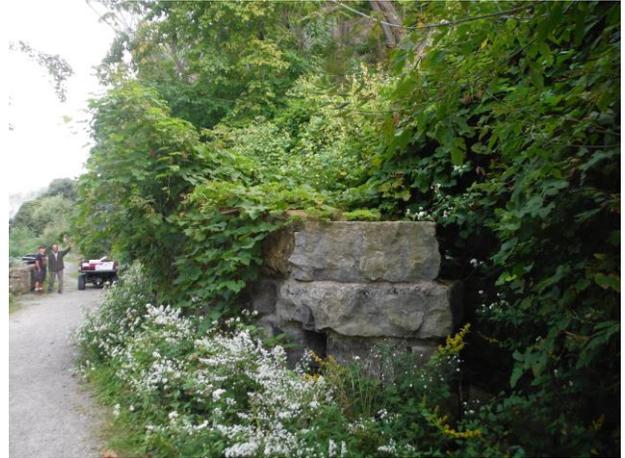
A wetter than normal summer has fostered rapid non-woody plant growth

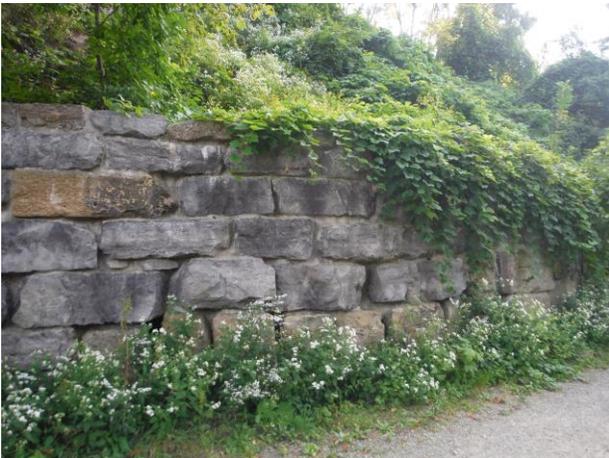
The Erosion Control Wall is still in excellent condition

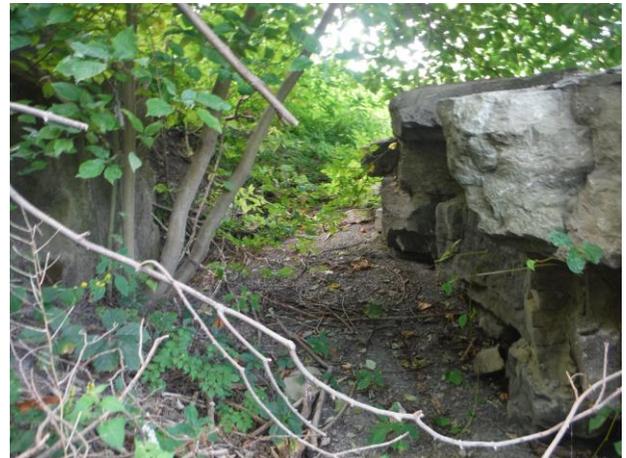
There has been no significant side slope erosion within the remediation zone since the repair of the last such event in June 2015. No landslide debris was observed in front of the Erosion Control Wall during this PRR reporting period, and the space (vertical and horizontal) remaining behind this Wall appeared to be adequate for potential erosions in the near future.

Landslide debris behind the Erosion Control Wall is about 2/3s of the total wall height

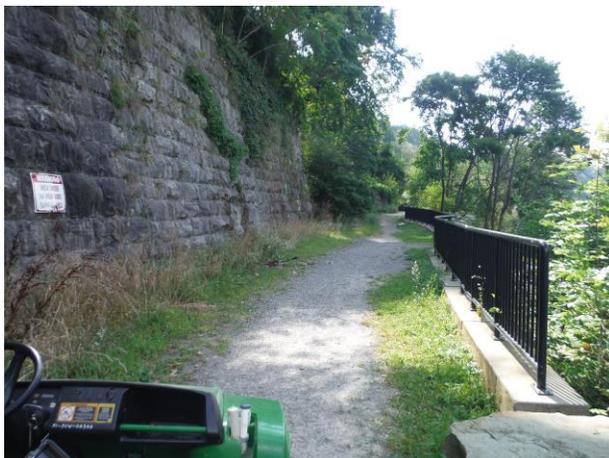
The Improved Trail remains in excellent condition. Vigorous plant growth is visible below the wall.

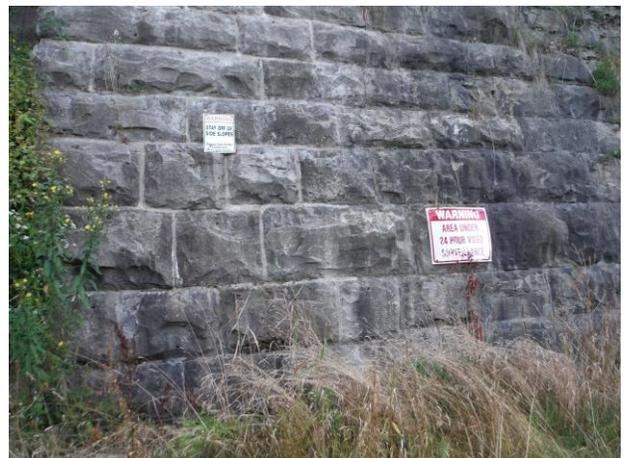
Most of the signs on the Upper Retaining Wall remain in good condition

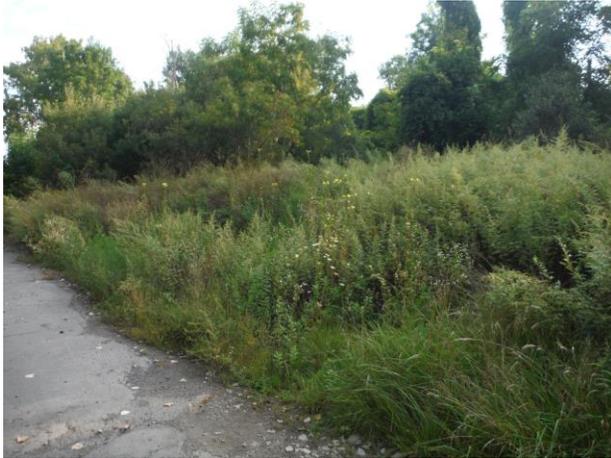
The Upper Staging Area remains dominated by non-woody plants

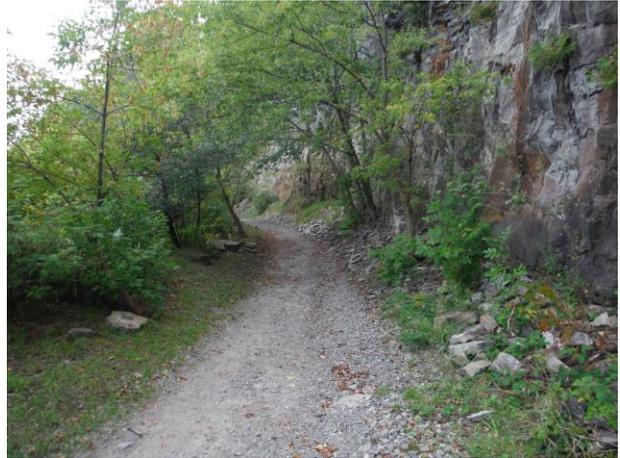
There are a few small ruts in the steep area under the rock cliff of the Upper Trail

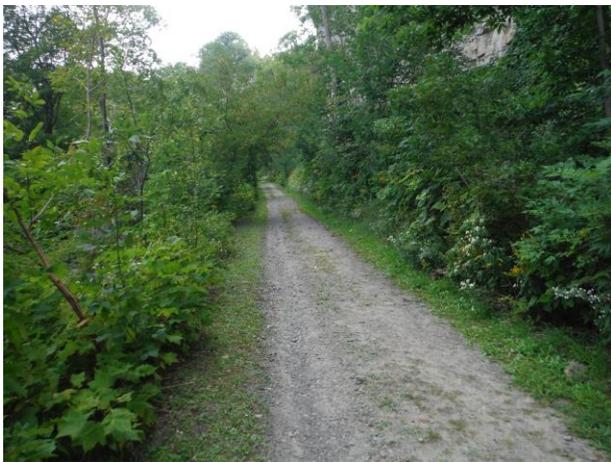
Most of the Upper Trail remains in excellent condition

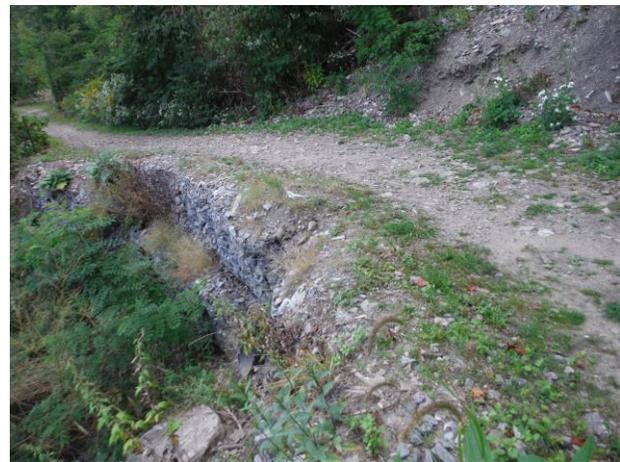
In July 2021 (a month after the 2021 sampling event), Niagara Falls area experienced close to 5 inches of rain which created a major washout (mostly rock coming down) of a small section of the trail south (upriver) of the CN bridge. NYS Parks closed the Niagara Gorge trail to the public until it undertook repair work of the eroded trail section in 2022. The remediated, rebuilt trail section under the Whirlpool Bridge was not affected by this storm, and site inspection showed it to be in good condition all the way from the south entrance to the north end. See 2023 PRR Report and September 2023 LTM Report.

The washed-out area of the trail has been repaired with secured stone and a culvert

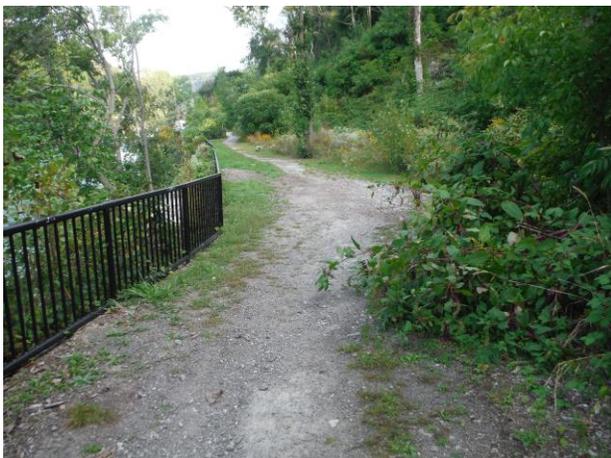
The Lower Staging Area. The removal of the Norway Maples resulted in aggressive plant growth.

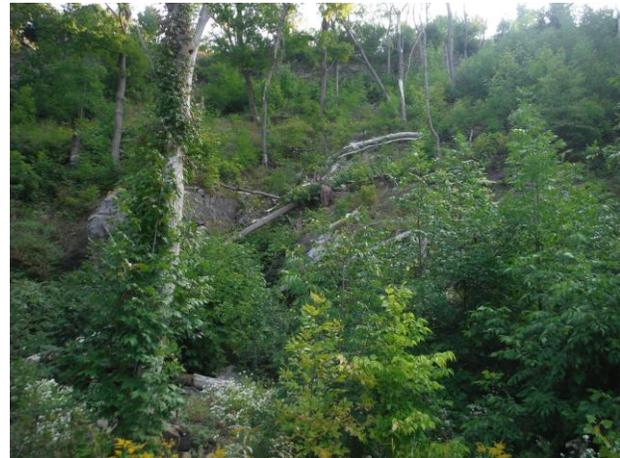
Dead invasive Norway Maples and Ailanthus are still visible on the steep slopes since being girdled.
