Re: One Buffalo Street Site - Annual Certification Report
Hamburg, New York

PERIODIC REVIEW REPORT

ONE BUFFALO STREET SITE
HAMBURG, NEW YORK

November 2009

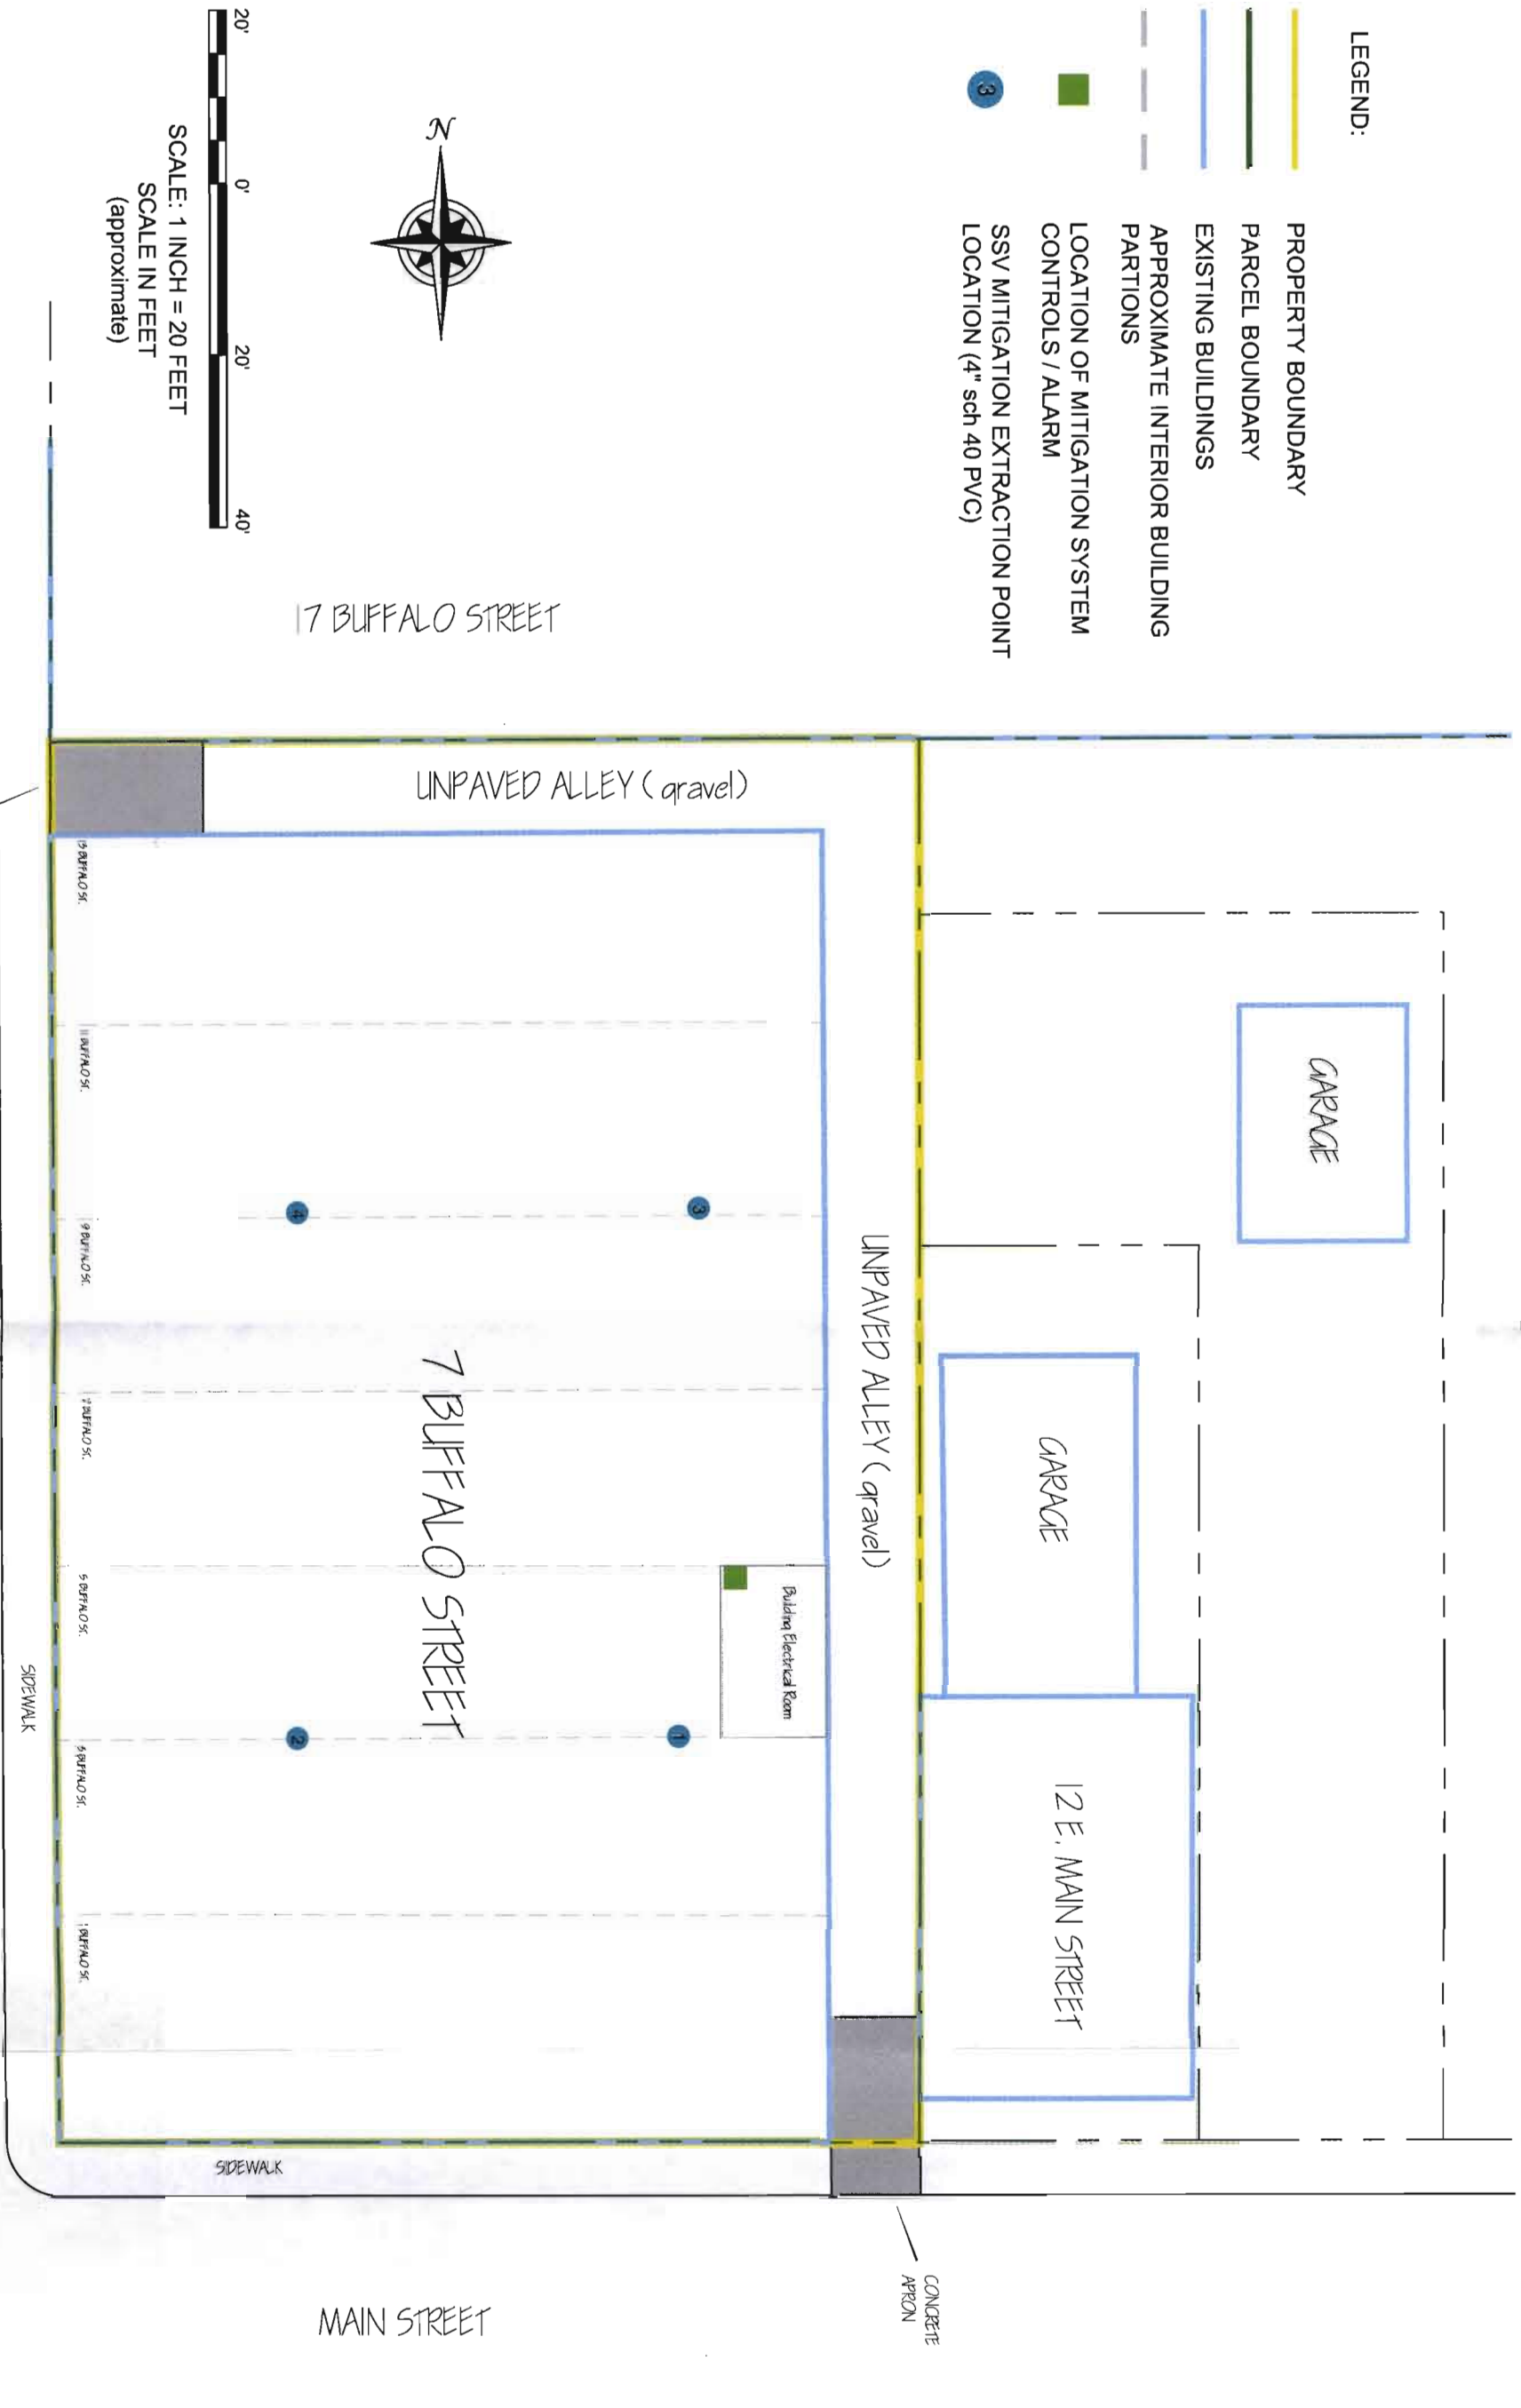
FIGURE 2

According to the SMP, the alley way along the east side of the building is to remain unpaved in the vicinity of storefronts 3 through 9 Buffalo Street. A concrete apron along East Main Street extends from East Main Street to approximately 10 feet unto 1 Buffalo Street. At the time of the site inspection, the remaining alley from 1 Buffalo Street to 13 Buffalo Street remains unpaved, and is in compliance with the SMP (see Figure 2 and Photolog).

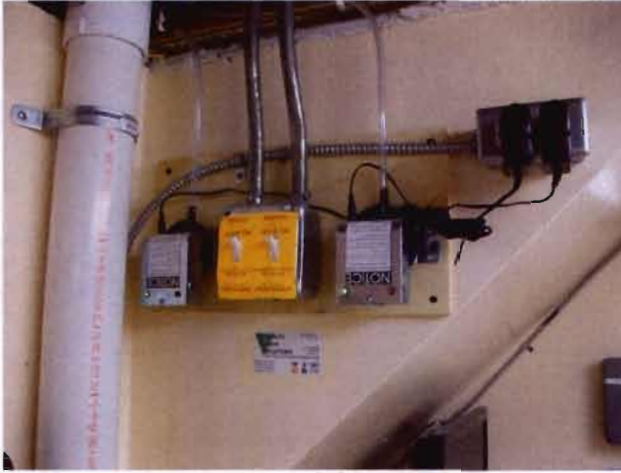
Operation of the SSV mitigation system was confirmed during the annual site inspection. SSV mitigation system monitoring/alarm conditions were manually tripped to confirm system operation. Specifically, upon de-energizing the SSV mitigation fans, the system monitoring gauges changed from green indicator lights to red indicator lights and an audible alarm sounded. Both the North and South branches of the mitigation system were tested and responded properly.

Photo 1: SSV mitigation system controls and monitoring equipment (bldg electrical room)

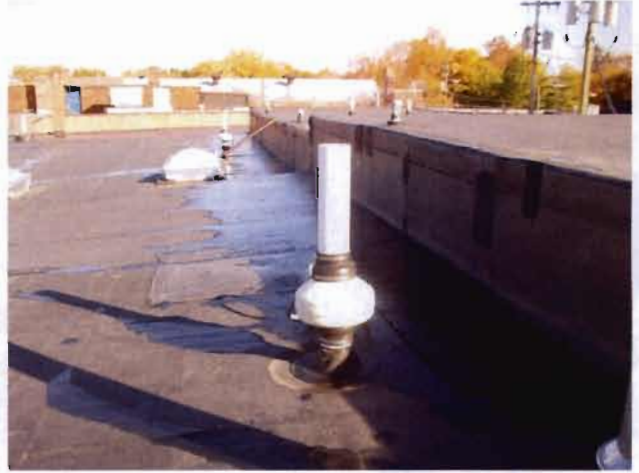
Photo 2: SSV mitigation system roof fans (looking north)

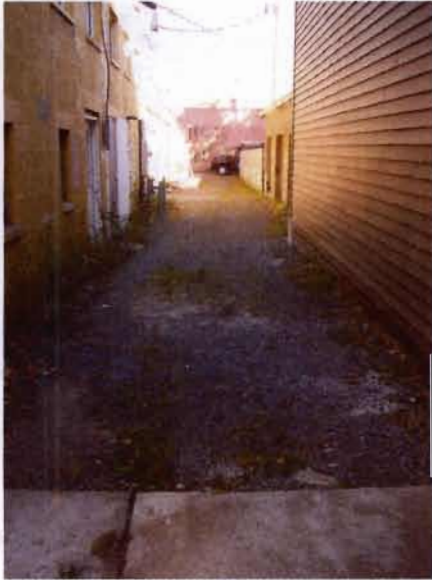
Photo 3: Unpaved alleyway (Looking north from E. Main Street)

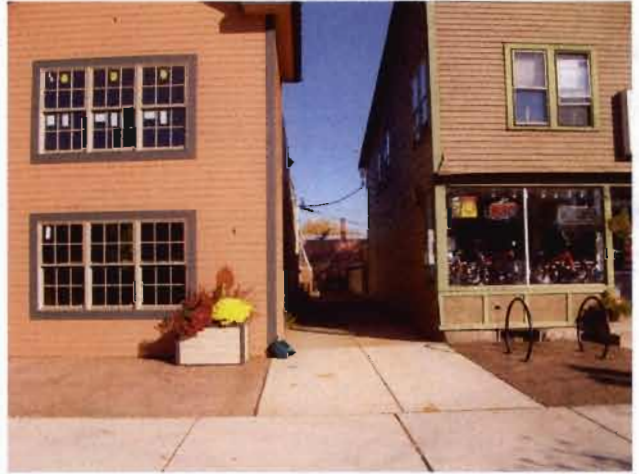
Photo 4: Concrete apron and adjacent building (12 E. Main Street) (looking north)

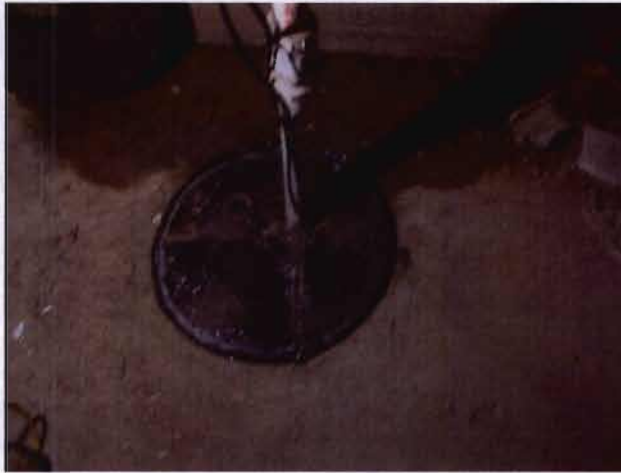
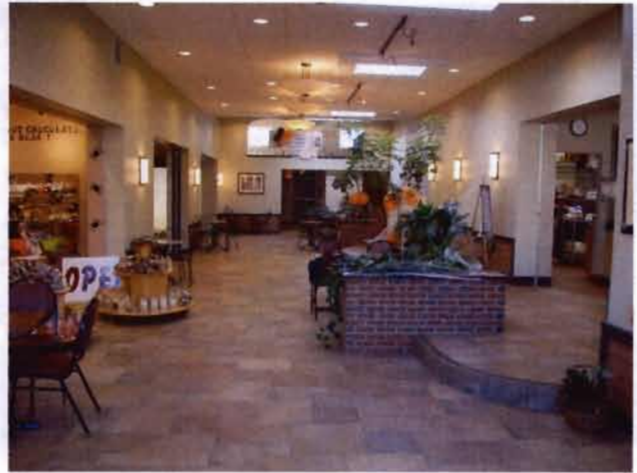
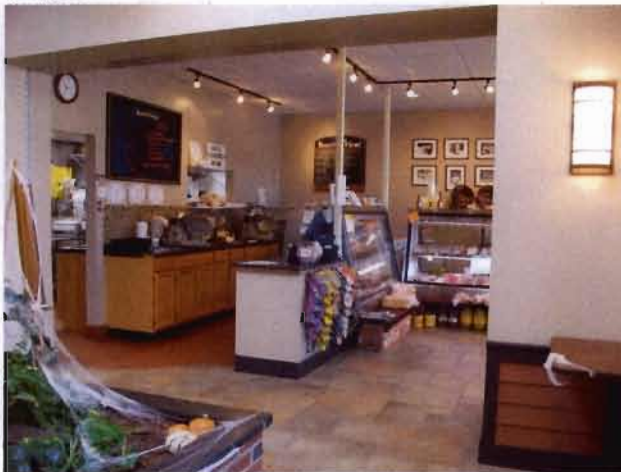
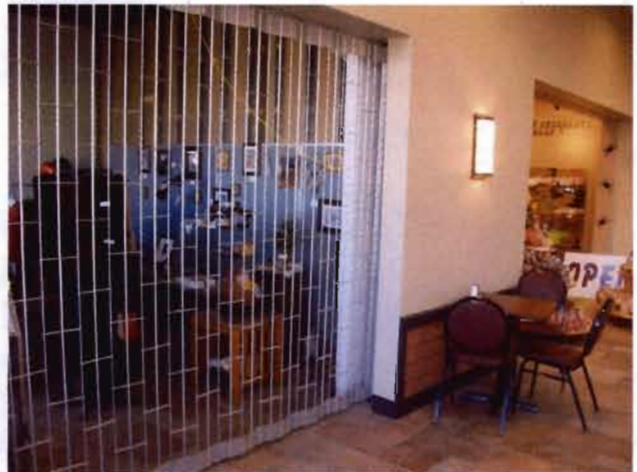
- Photo 5: Sealed sump in basement of 11 Buffalo Street
- Photo 6: Interior of building – commercial redevelopment (7 Buffalo Street)
- Photo 7: Building tenant (5 Buffalo Street – Isabella's Deli)
- Photo 8: Additional tenant retail space (9 Buffalo Street)

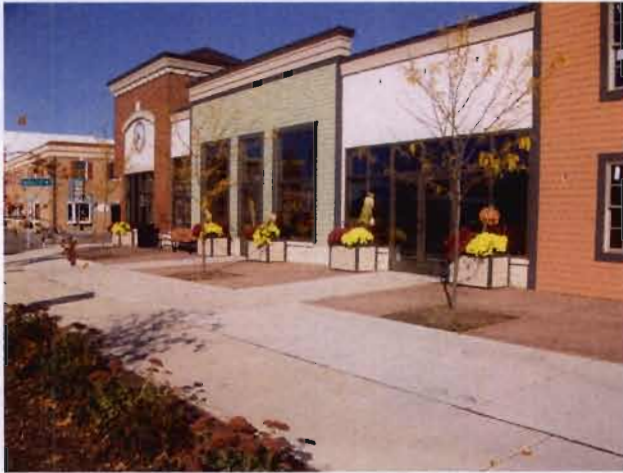
Photo 9: Exterior site conditions (along Buffalo Street – looking west)

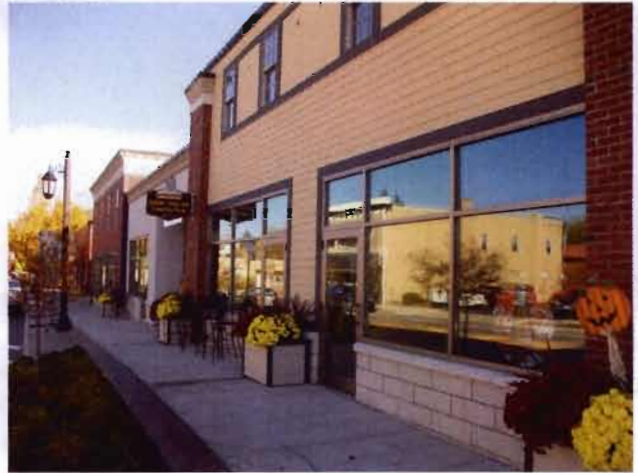
Photo 10: Exterior site conditions (along Buffalo Street (looking north)

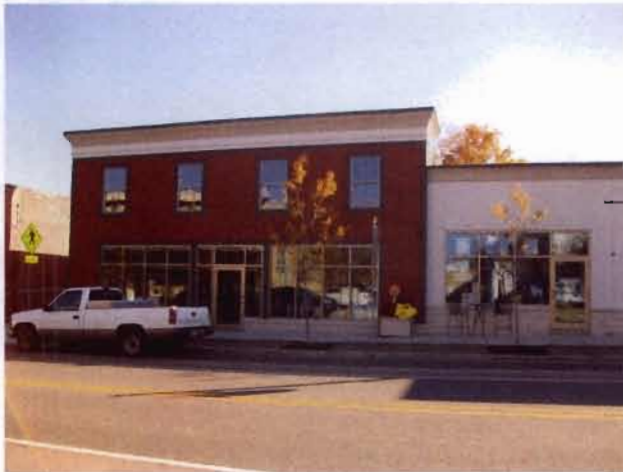
Photo 11: Exterior site conditions (9-13 Buffalo Street – looking east across Buffalo St.)
