# PERIODIC REVIEW REPORT

ONE BUFFALO STREET SITE  
HAMBURG, NEW YORK

VCP SITE NUMBER V-00659-9

February 2011

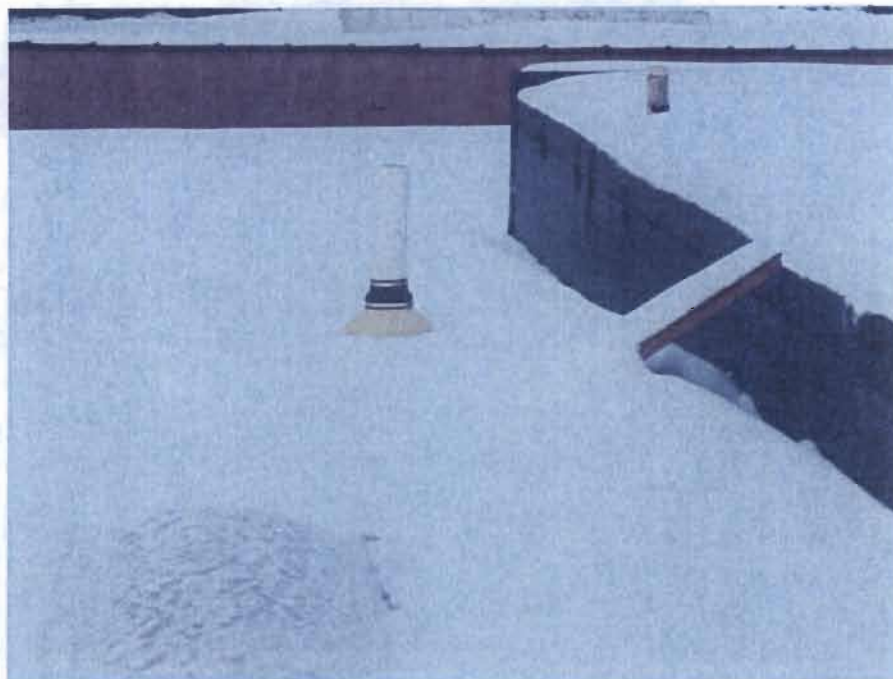
The SMP requires the proper operation and maintenance of the SSV mitigation system. TVGA evaluated the operation of the SSV mitigation system during the annual site inspection. TVGA observed the discharge locations on the roof of the building, and the locations were free of ice and snow build-up. Additionally, TVGA confirmed that the fans were operating and that air was flowing out of the vent pipes. TVGA and Mr. Reekie manually tripped the alarms on the SSV mitigation system monitoring system to confirm system operation by de-energizing both the north and south SSV mitigation fans. The system monitoring gauges

Photograph 1 – Northern SSV Mitigation Roof Fan

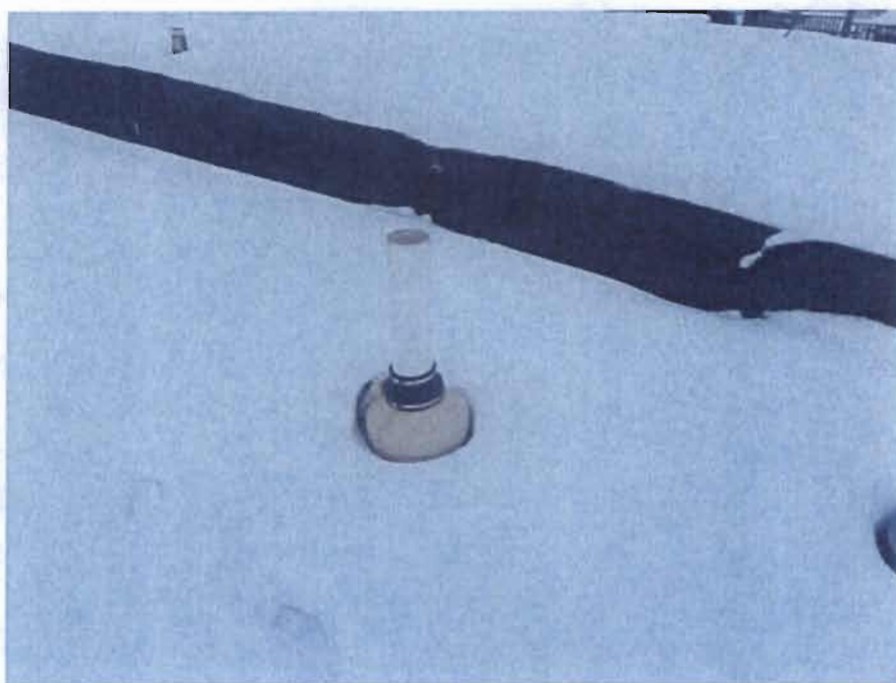
Photograph 2 – Southern SSV Mitigation Roof Fan

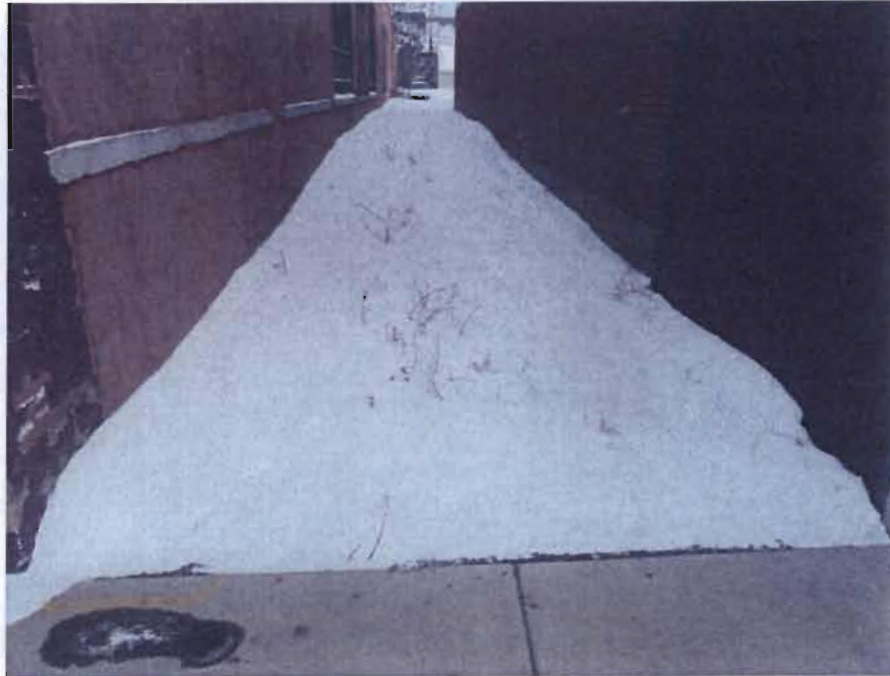
According to the SMP, the alleys immediately to the east and north of the building way are to remain unpaved. Although covered with snow, a walk through the alleys confirmed that the alley surfaces were unpaved and consisted of gravel and/or dirt, with the exception of a small concrete apron that extends from East Main Street to approximately ten feet behind 1 Buffalo Street. This concrete apron has been in place for a few years and is not anticipated to impact the performance of the SSV mitigation system.

**Photograph 3 – Unpaved Alleyway (Immediately North of Building)**

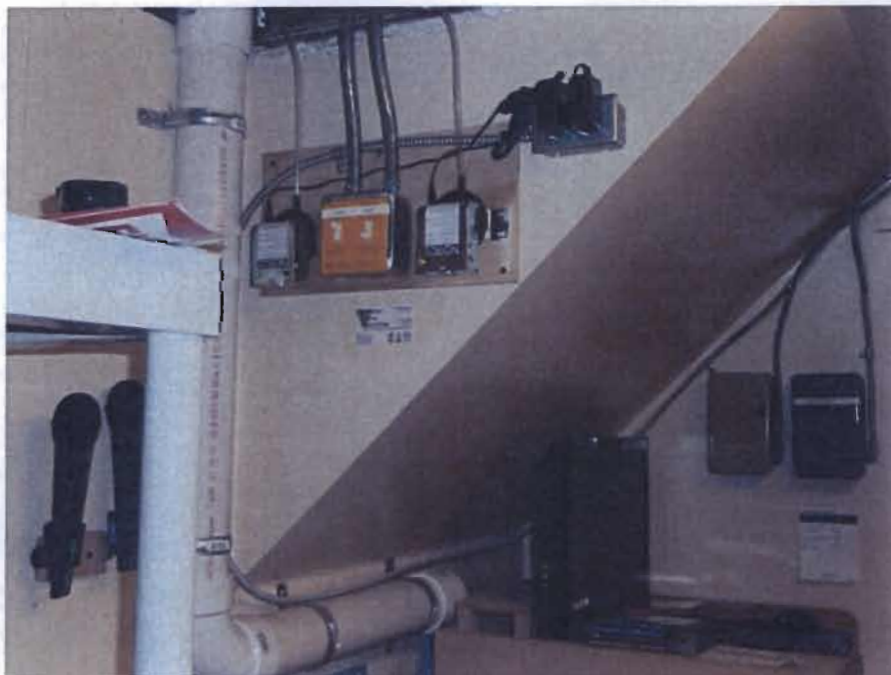
changed from green indicator lights to red indicator lights and an audible alarm sounded. Both the north and south branches of the mitigation system were tested and responded properly. The north branch alarm sounded within a few minutes of shut-off and the south branch alarm sounded within a few hours.

**Photograph 4 – SSV Mitigation System Controls and Monitoring Equipment**

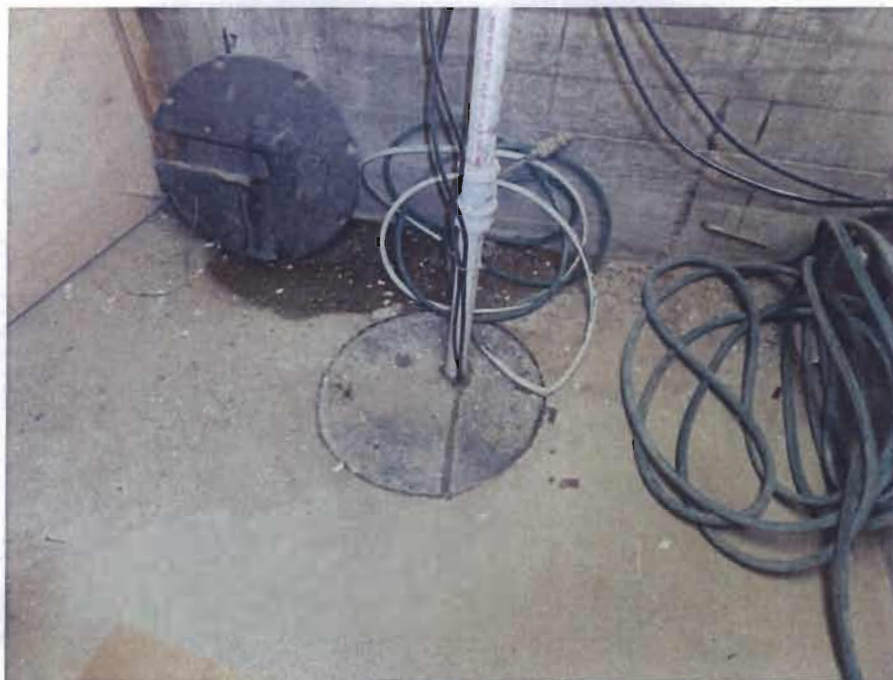
The SMP requires the connection of the sump to the sanitary sewer at all times, and that any additional sumps installed in the future will also be connected to the sanitary sewer. TVGA evaluated the condition of the sump in the basement of 11 Buffalo Street during the annual site inspection. A clear plastic cover is sealed over the sump, and all plumbing connections appeared intact. The cover and seal were not disturbed during the inspection. Additionally, no new sumps were observed in the basement of the building and no modification to the sump or the connection to the sanitary sewer occurred during the recent building renovations.

Photograph 5 – Sealed Sump in Building Basement

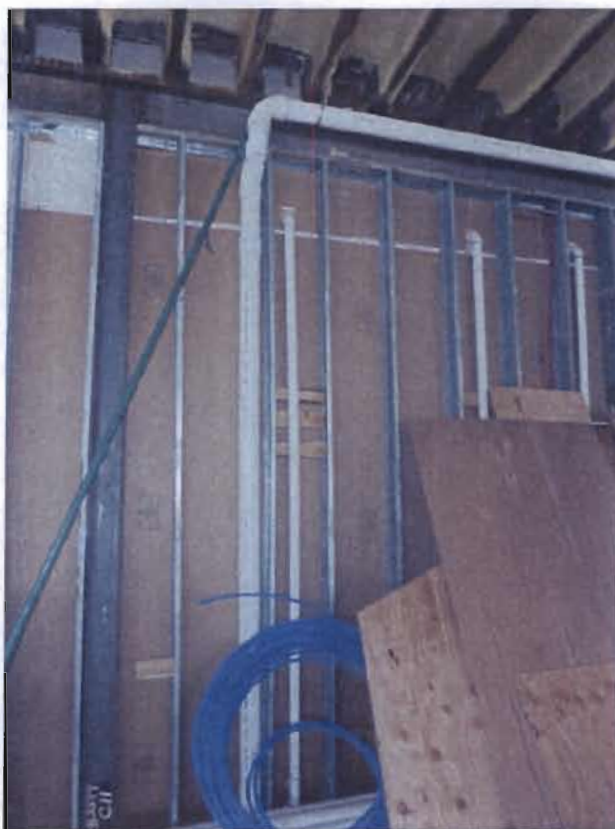
Photograph 6 – SSV Mitigation Piping – Southern Vent

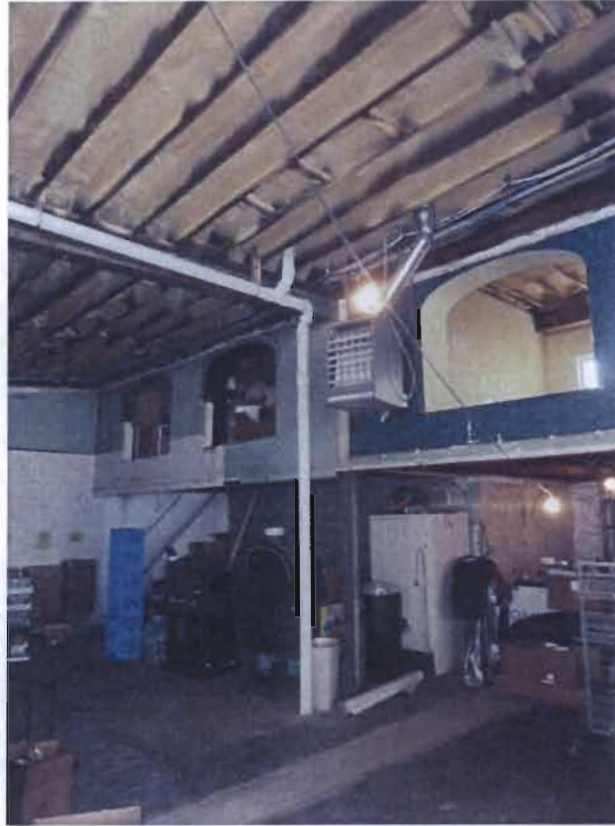
Photograph 7 – SSV Mitigation Piping – Southern Vent

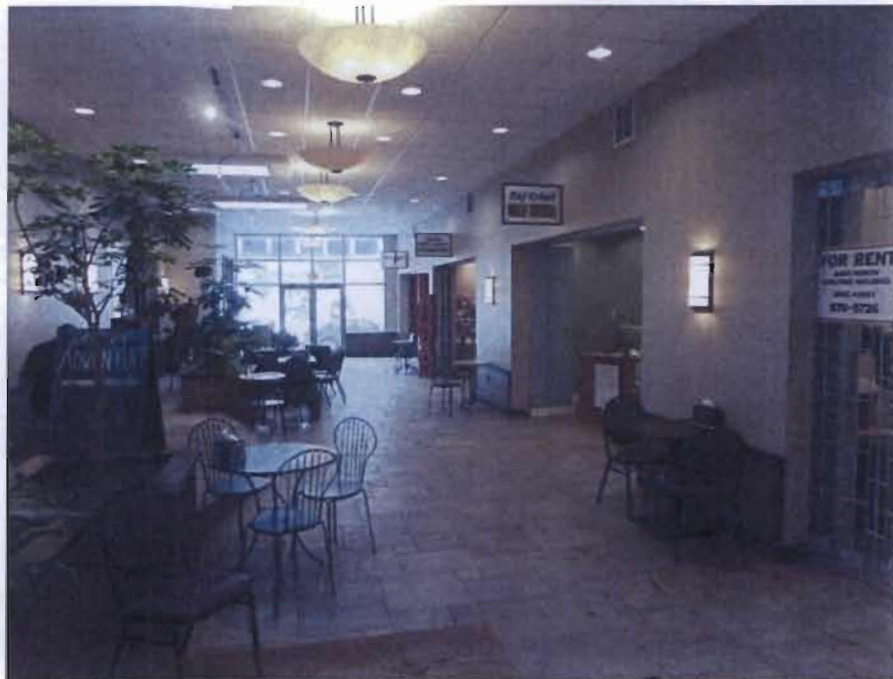
Photograph 8 – The Atrium

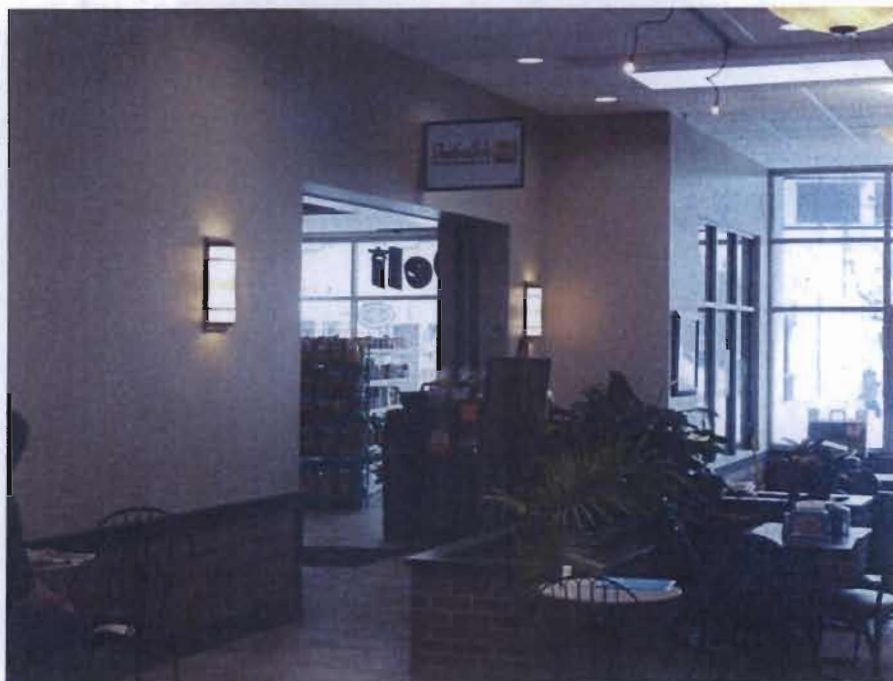
Photograph 9 – Tenant Space - Isabella's Deli

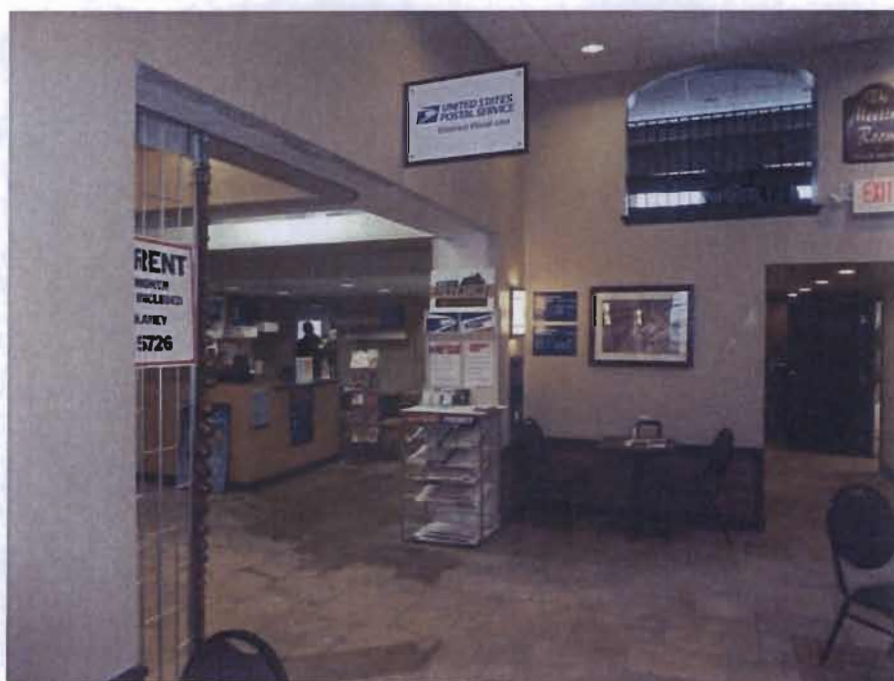
Photograph 10 – Tenant Space - USPS Post Office

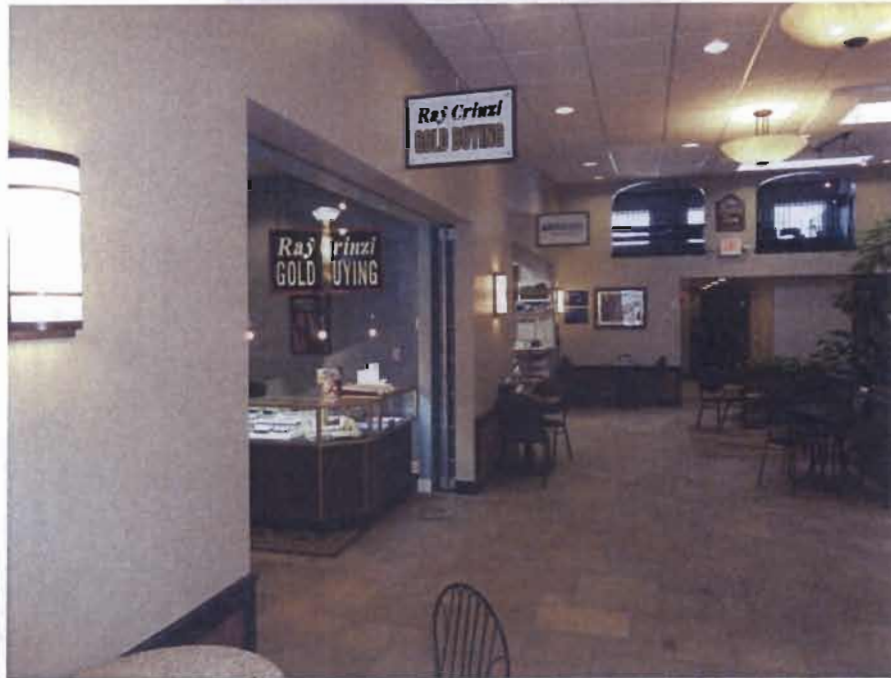
Photograph 11 – Tenant Space – Ray Crinzi

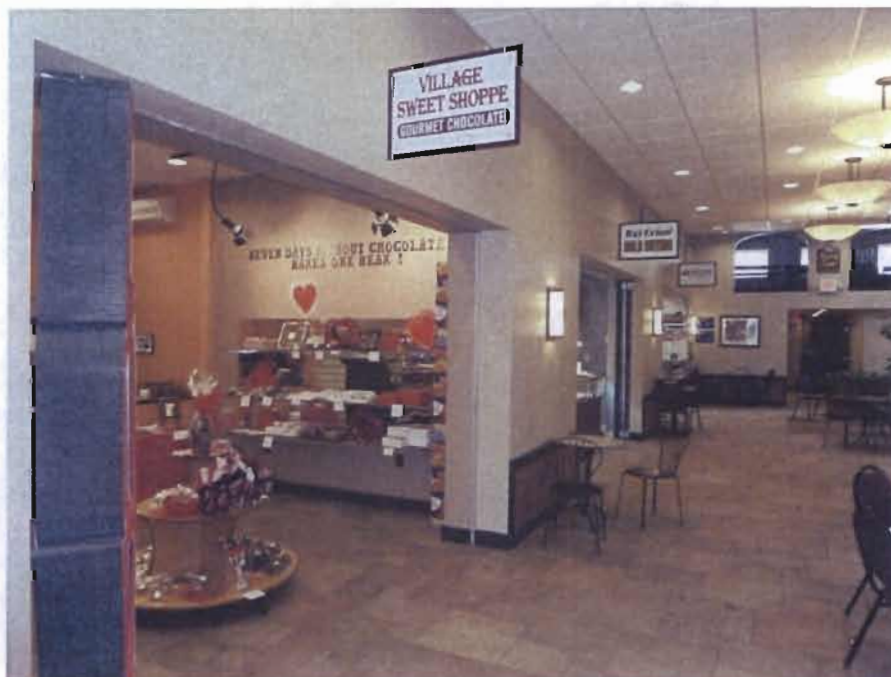
Photograph 12 – Tenant Space – Village Sweet Shop

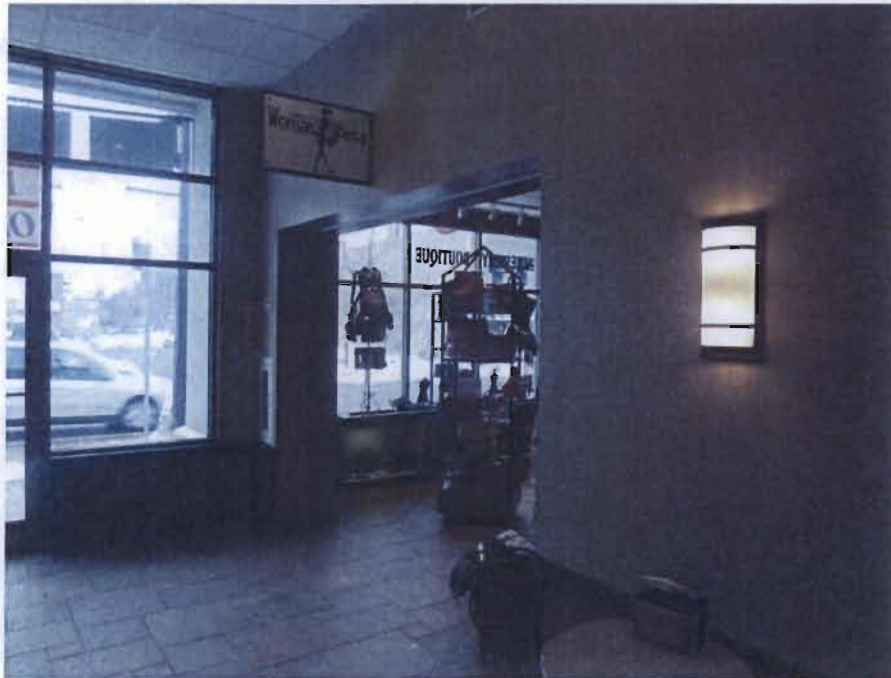
Photograph 13 – Tenant Space – What Women Want

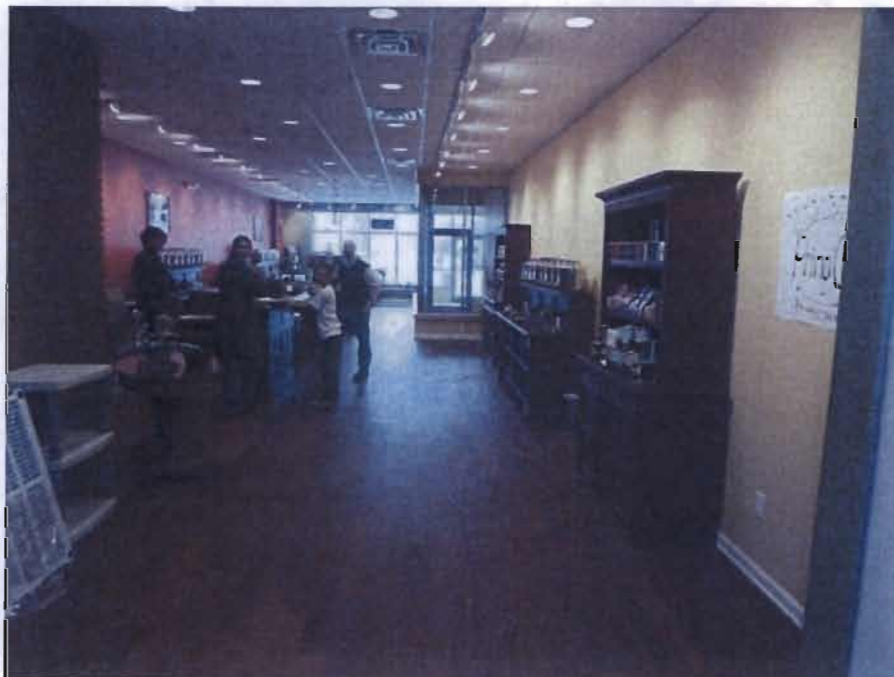
Photograph 14 – Tenant Space – Primo Oliva

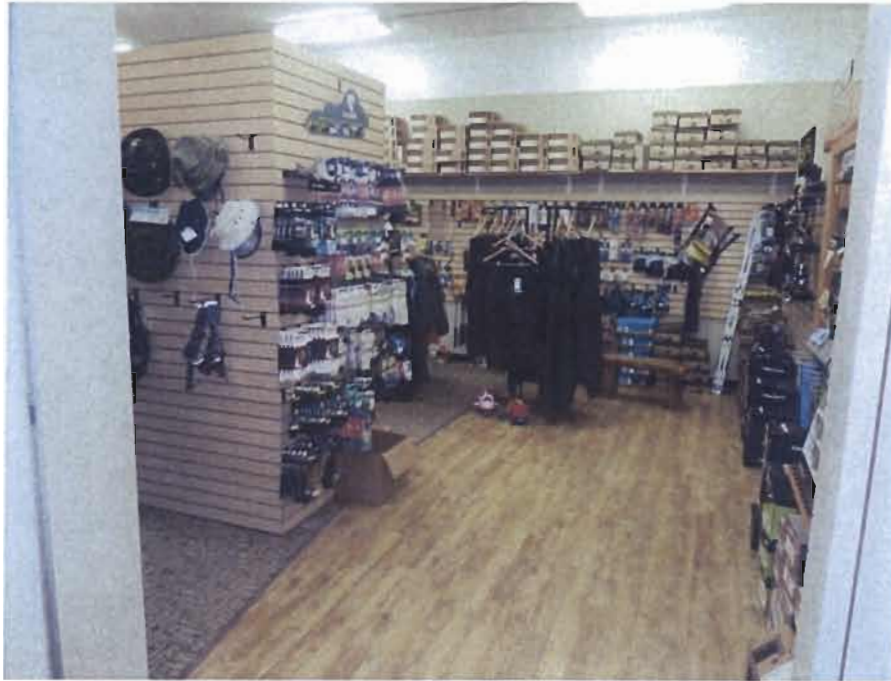
Photograph 15 – Tenant Space – Gear for Adventure
